Well Name : Sheffer Jack 1
API # : 069-05014

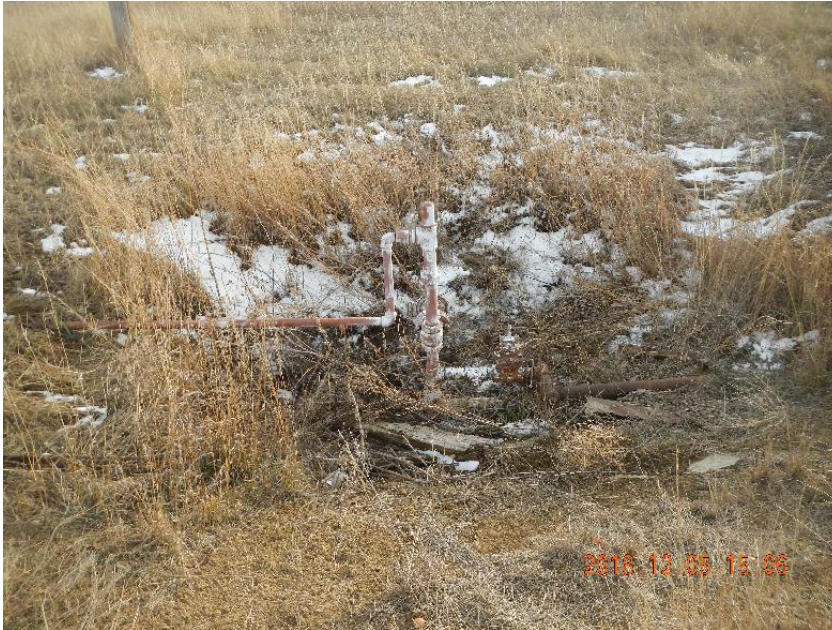
Photo 1: Wellhead.

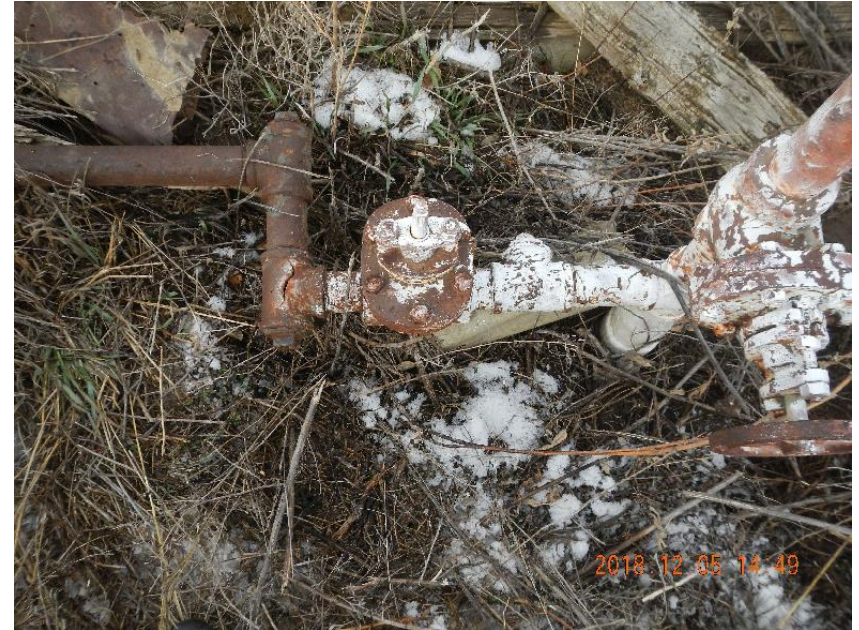
Photo 2: Flowline off W side of wellhead with split in T.

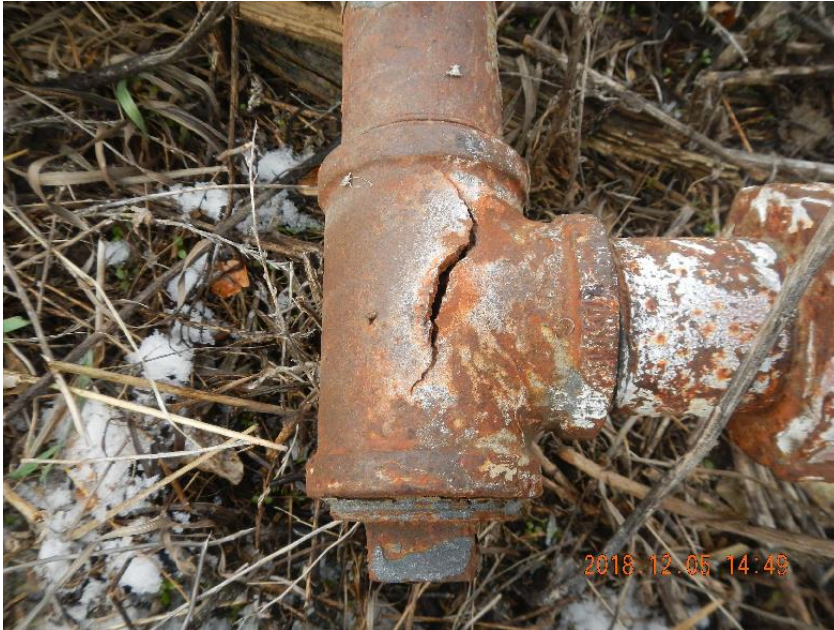
Photo 3: Close up of damaged T.

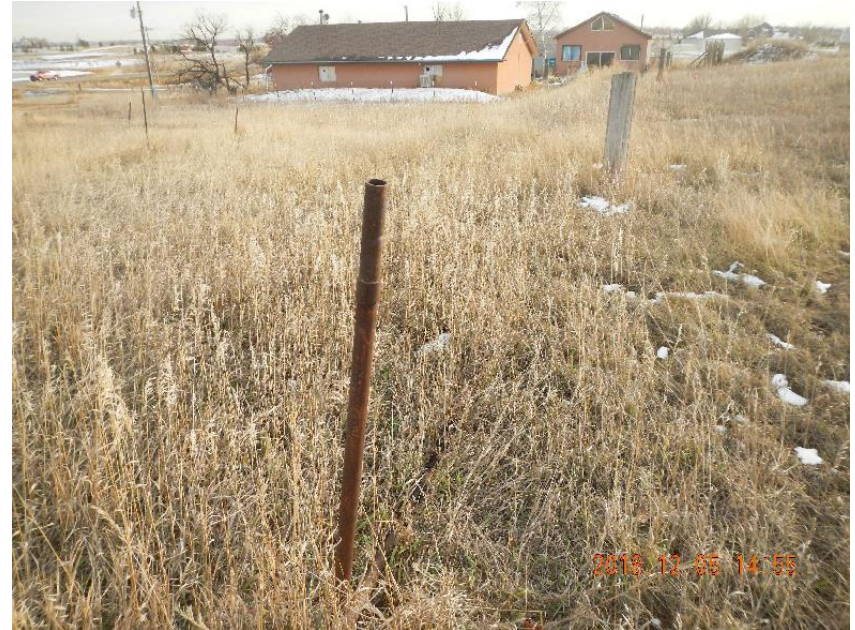
Photo 4: Disconnected line off E side of well looking SE towards house.

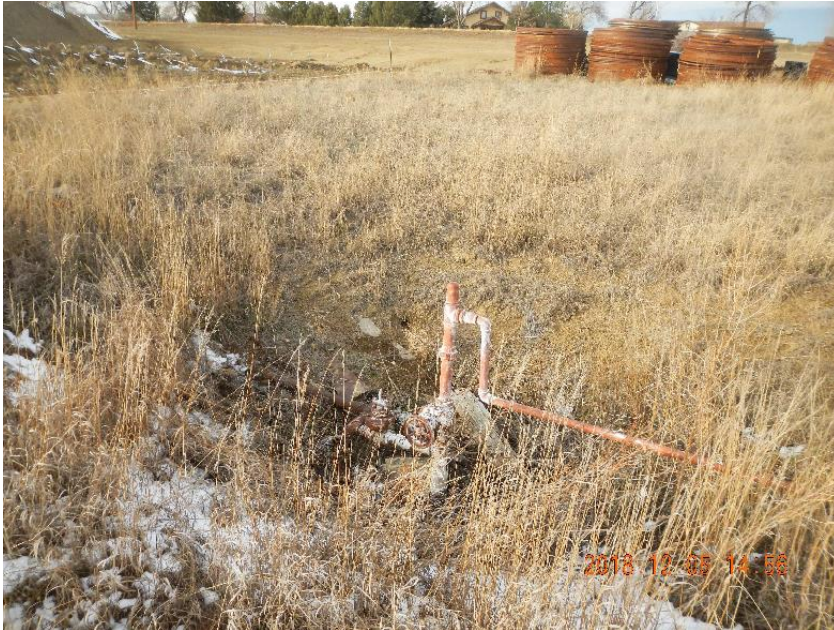
Photo 5: Wellhead looking N.

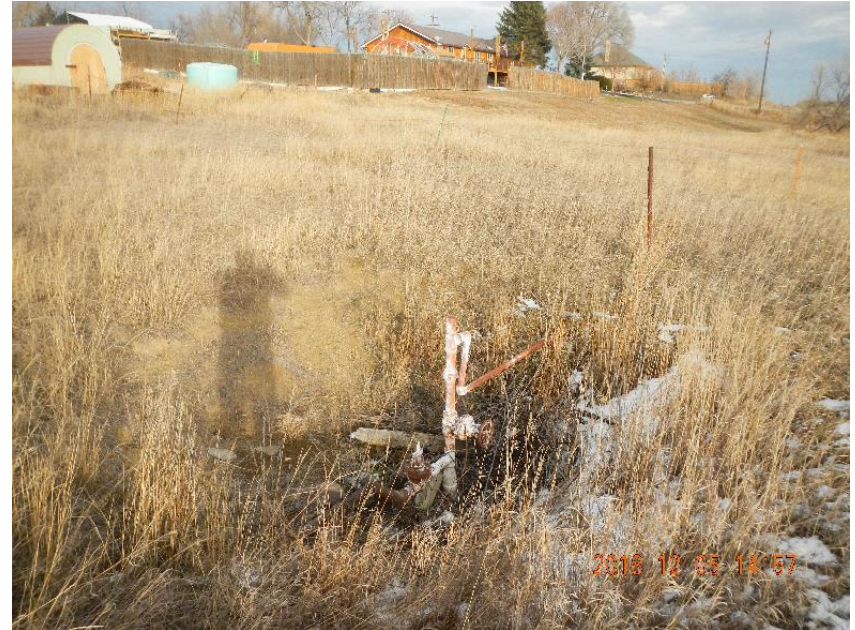
Photo 6: Wellhead looking E.

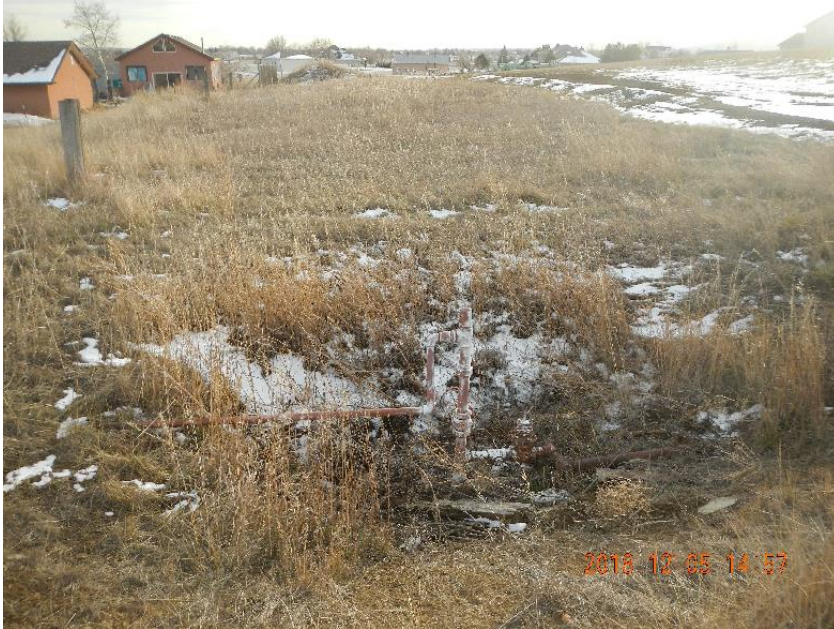
Photo 7: Wellhead looking S.

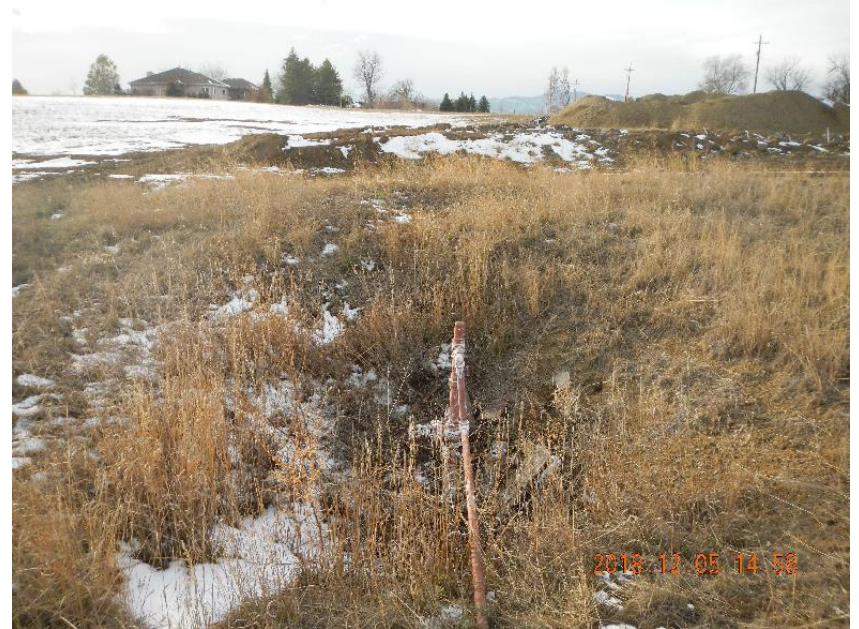
Photo 8: Wellhead looking W.

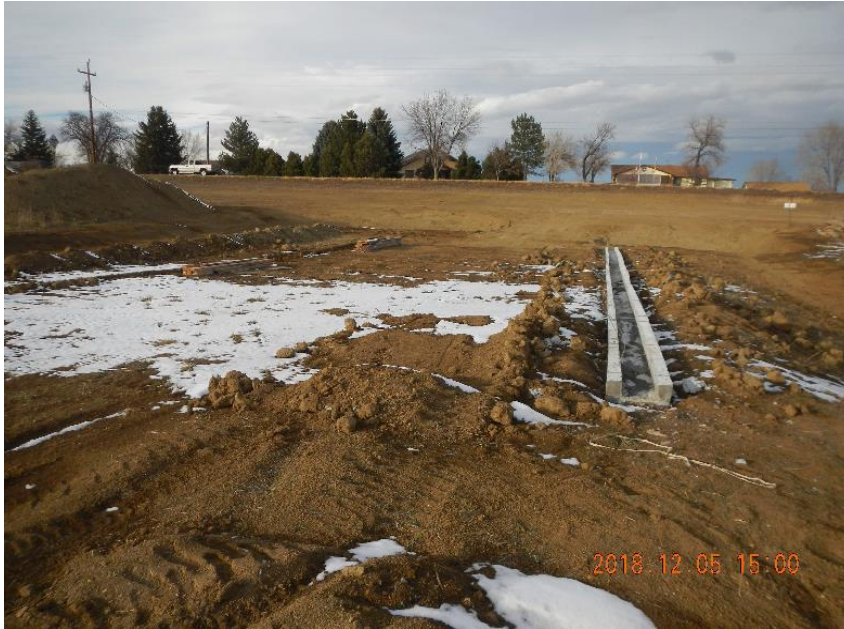
Photo 9: Construction site on lot W of wellhead.

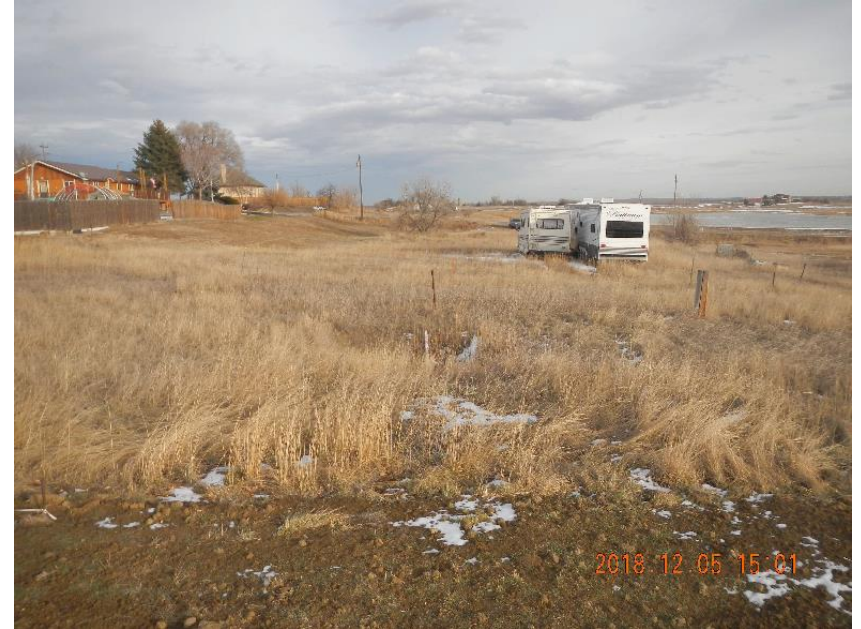
Photo 10: Wellhead center of picture looking SE from construction site.

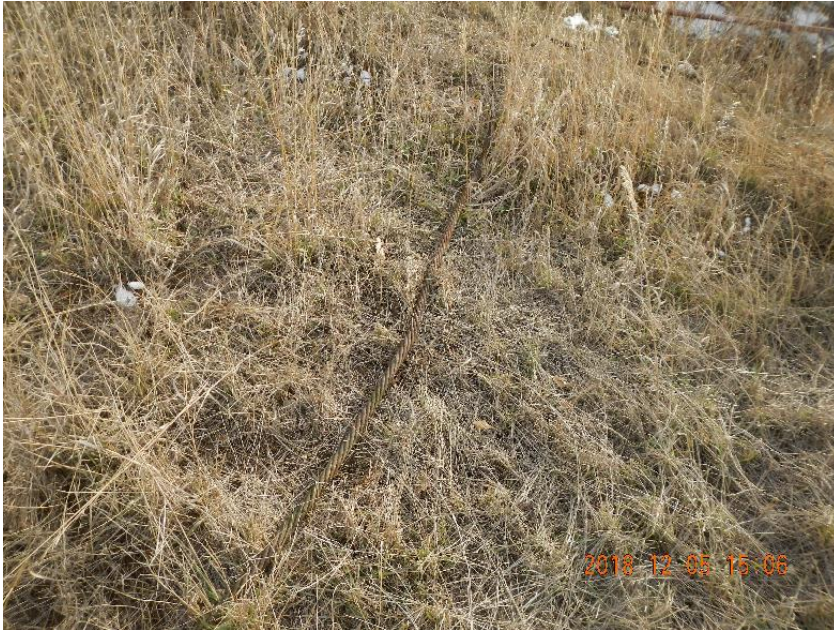
Photo 11: Abandoned steel cable.
