Inspection Photos
Location Name: Marlatt 12-22
Location ID: 320350

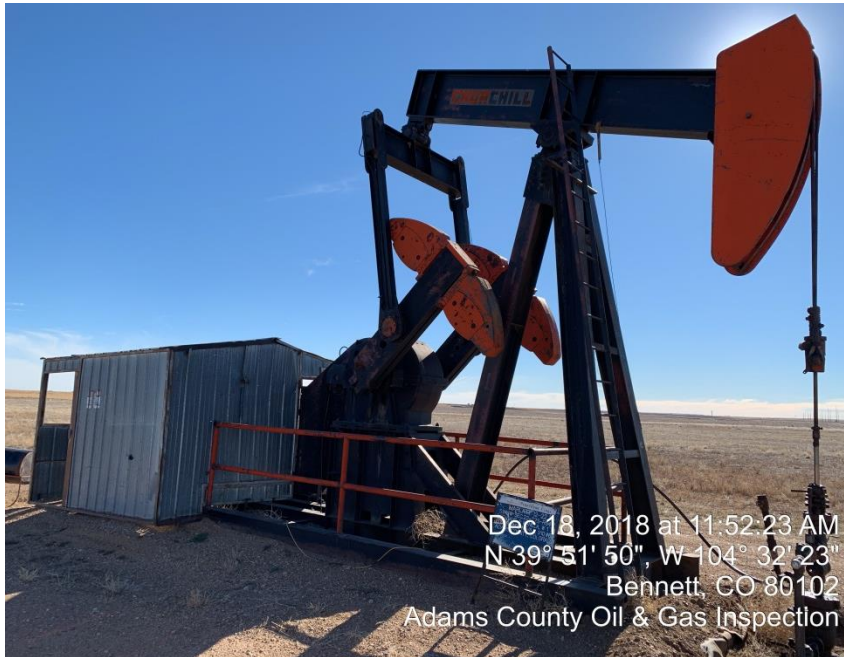
Photo#1 Pumpjack

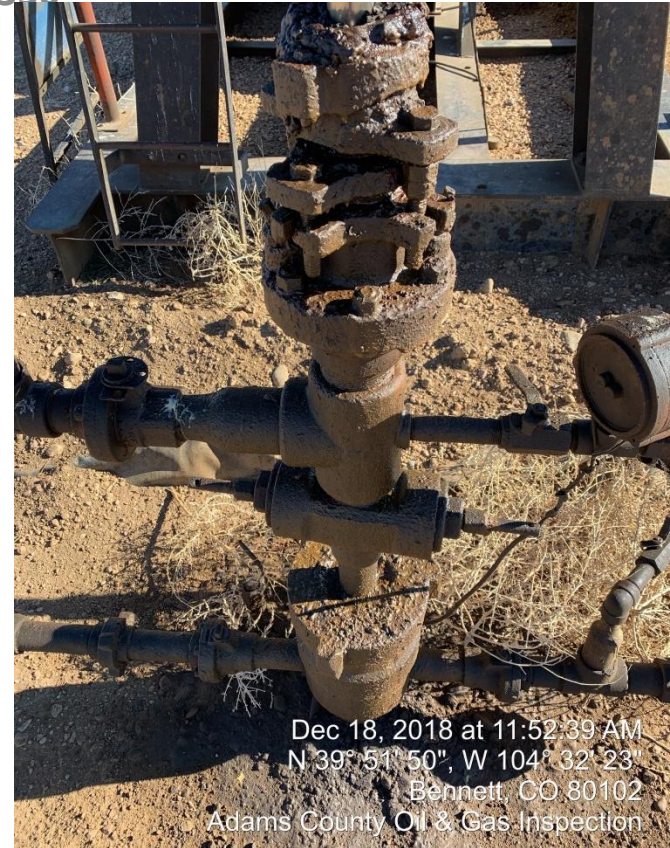
Photo#2 Corrective Action: Wellhead leaking/Stained Soil

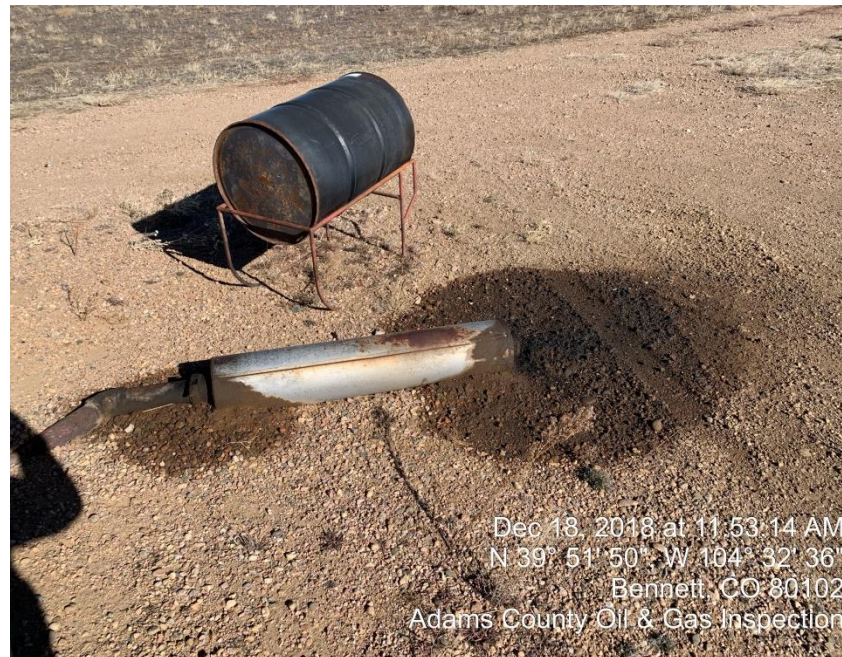
Photo#3 Corrective Action: Stained Soil
