# Inspection Photos

Operator: BP Production

API: 05-067-09705

Date: 11/28/2018

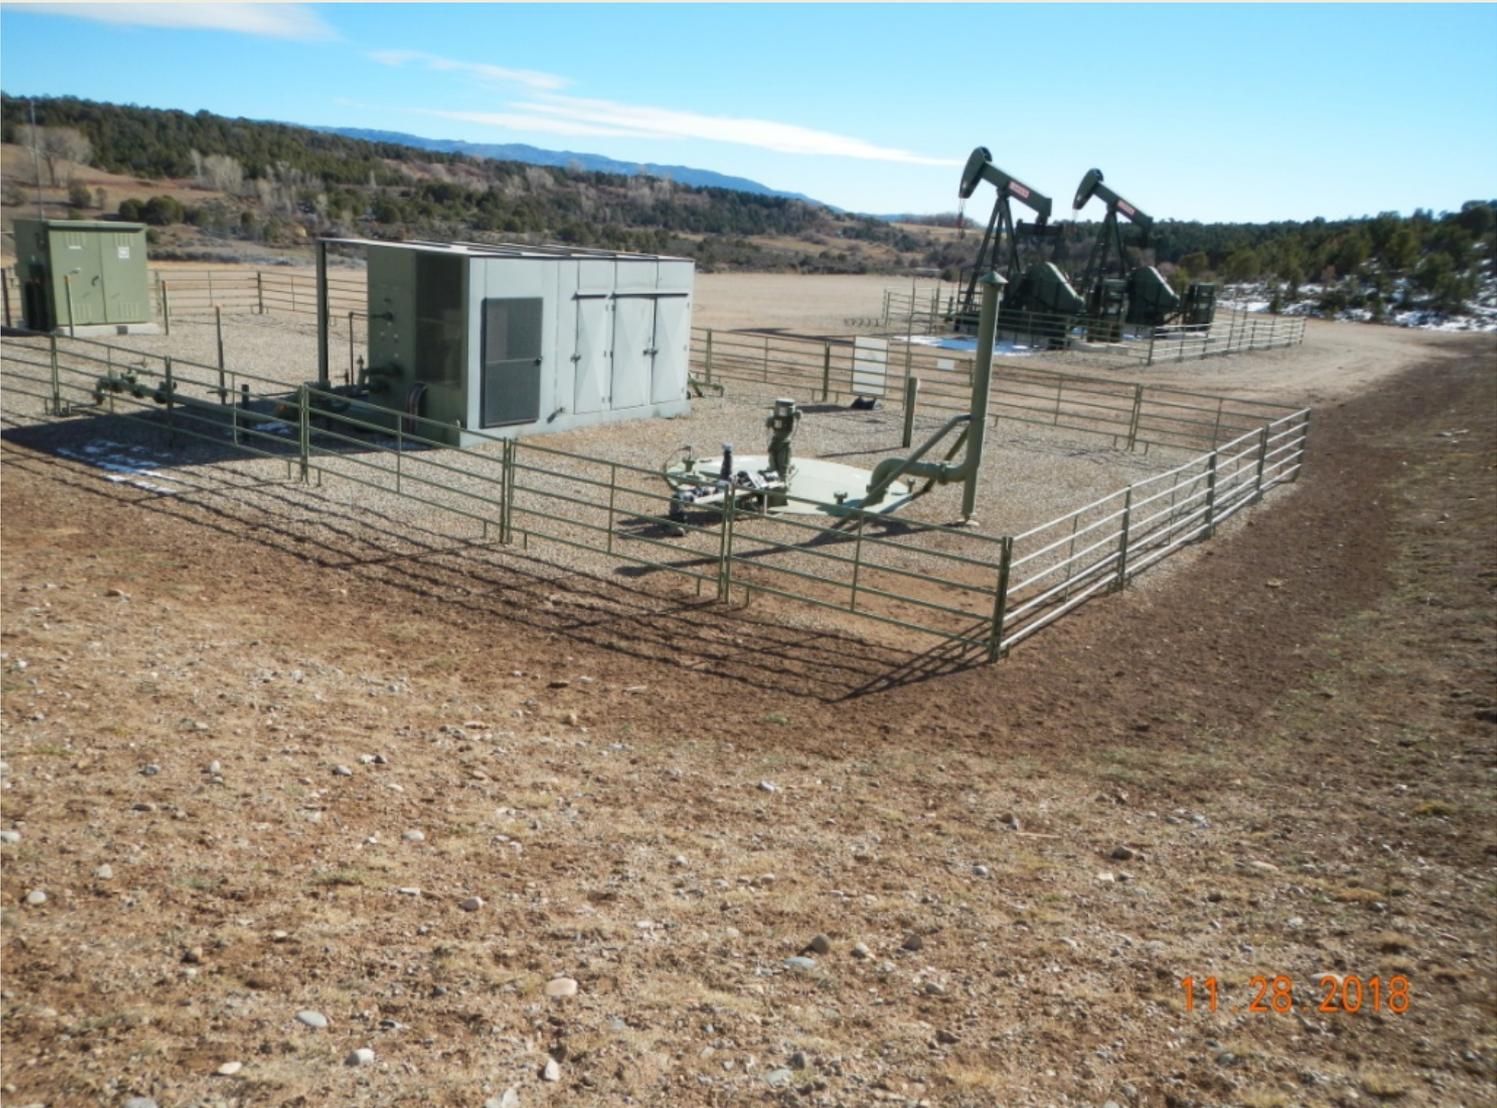
**Photo 1. View of the project area from the northwestern corner facing center.**

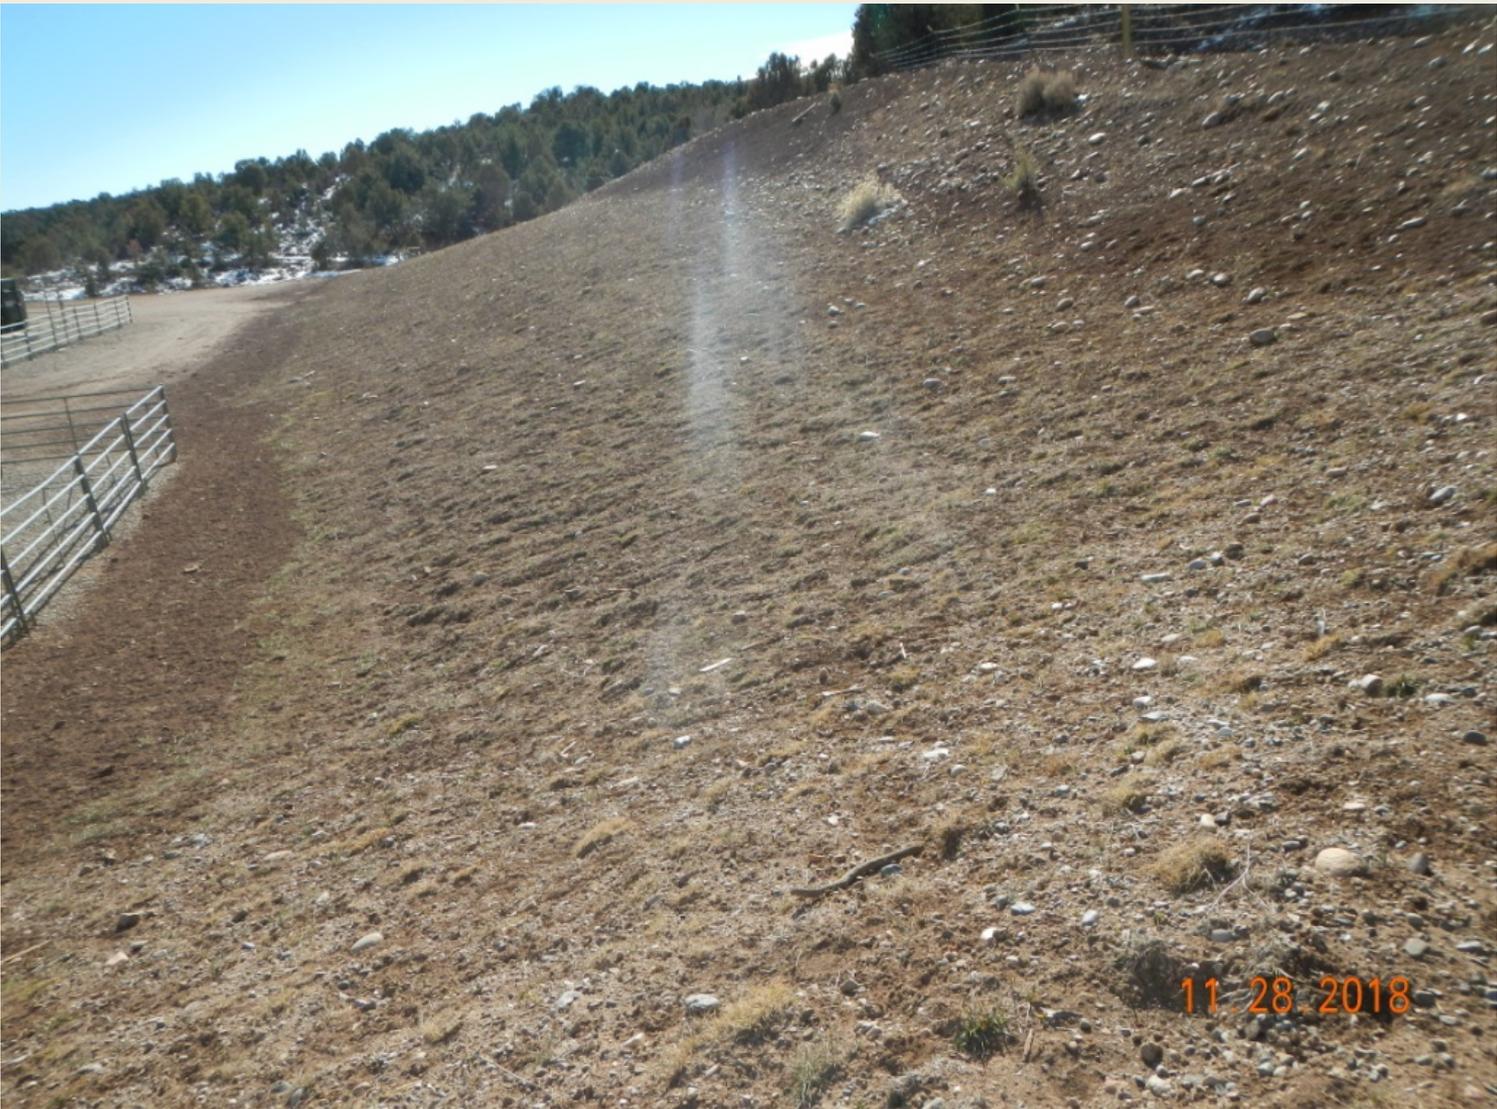
**Photo 2. View of the western project area from the northwestern corner facing southward. Revegetation is sparse and appears grazed. This needs to be monitored and revegetation installed if erosion worsens. Cattle exclusion may be needed.**

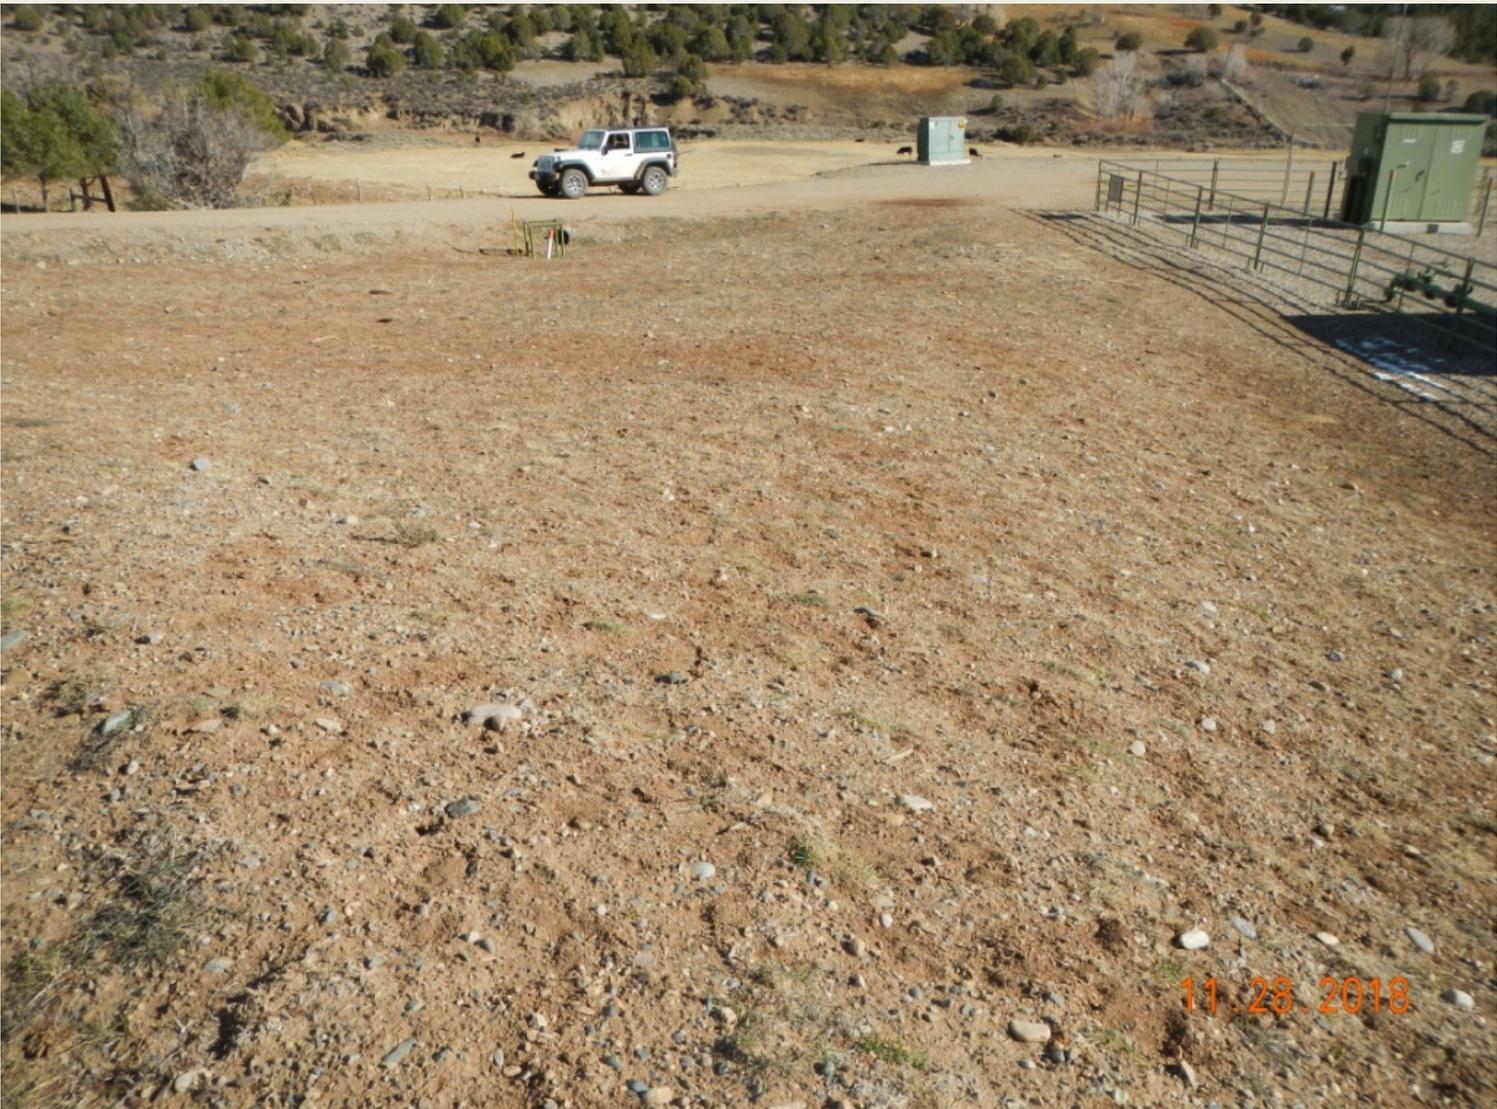
**Photo 3. View of the northern project area from the northwestern corner edge facing eastward.**

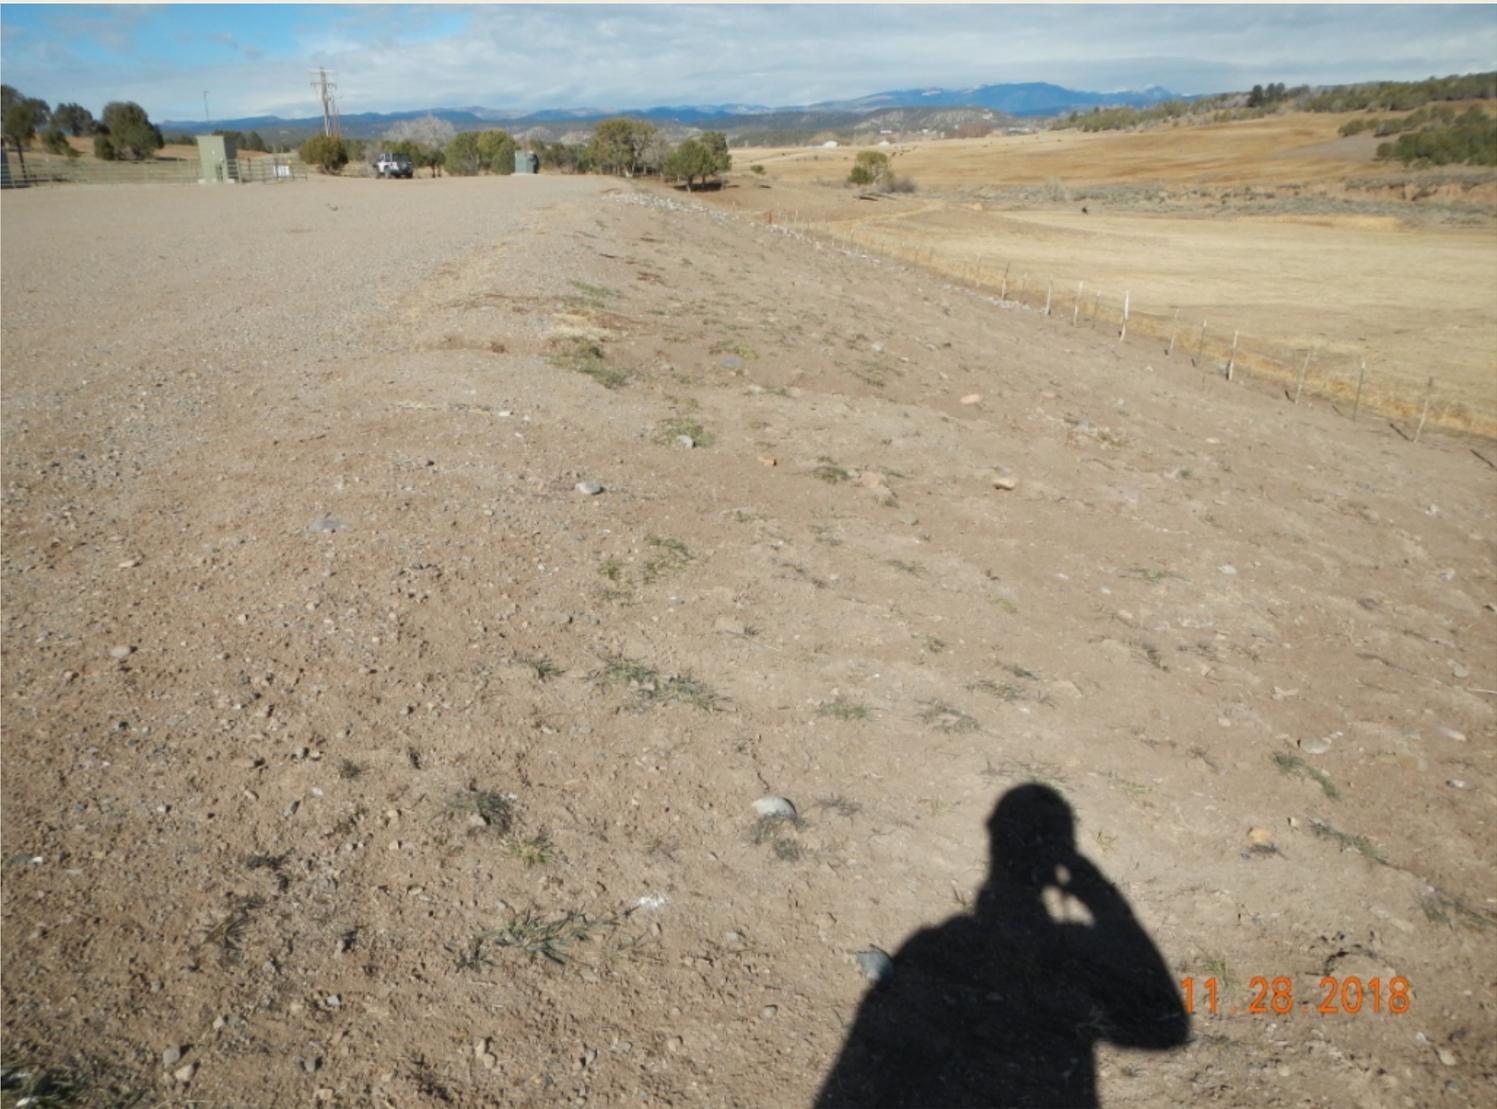
**Photo 4. View of the eastern project area from southeastern corner facing northward. Sparse revegetation within this area.**

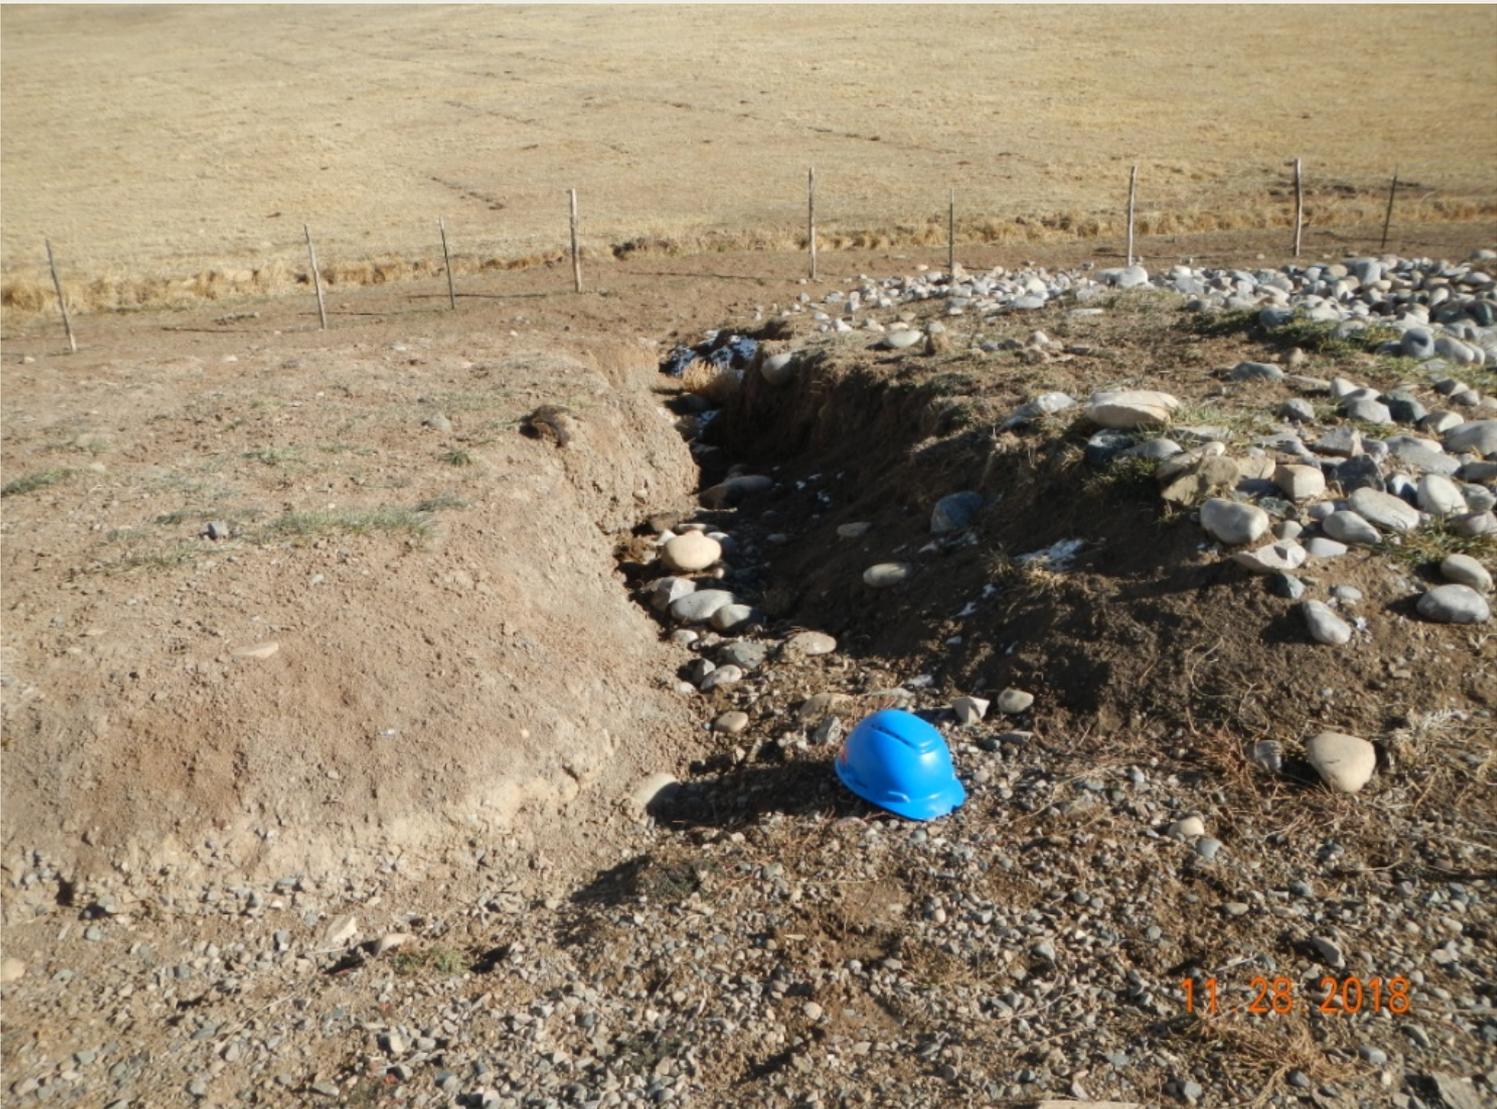
**Photo 5. View of erosional channel approximately 36 inches wide and deep within the eastern portion of the project area.**

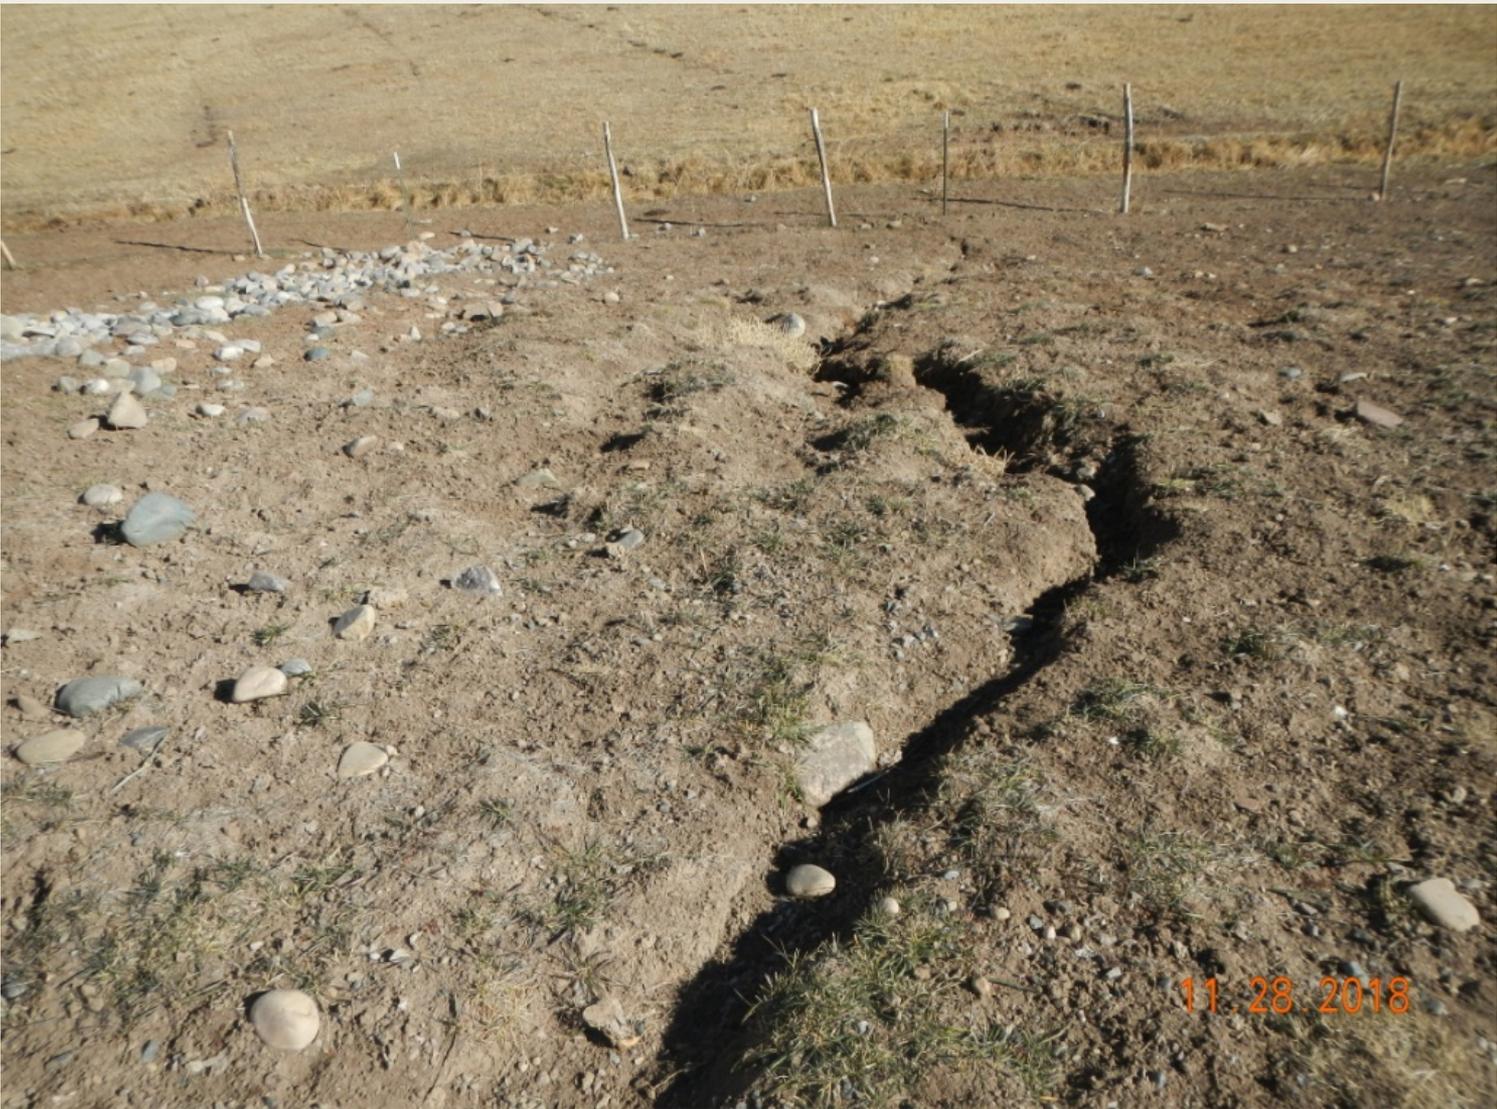
**Photo 6. View of another erosional channel within the eastern project area.**

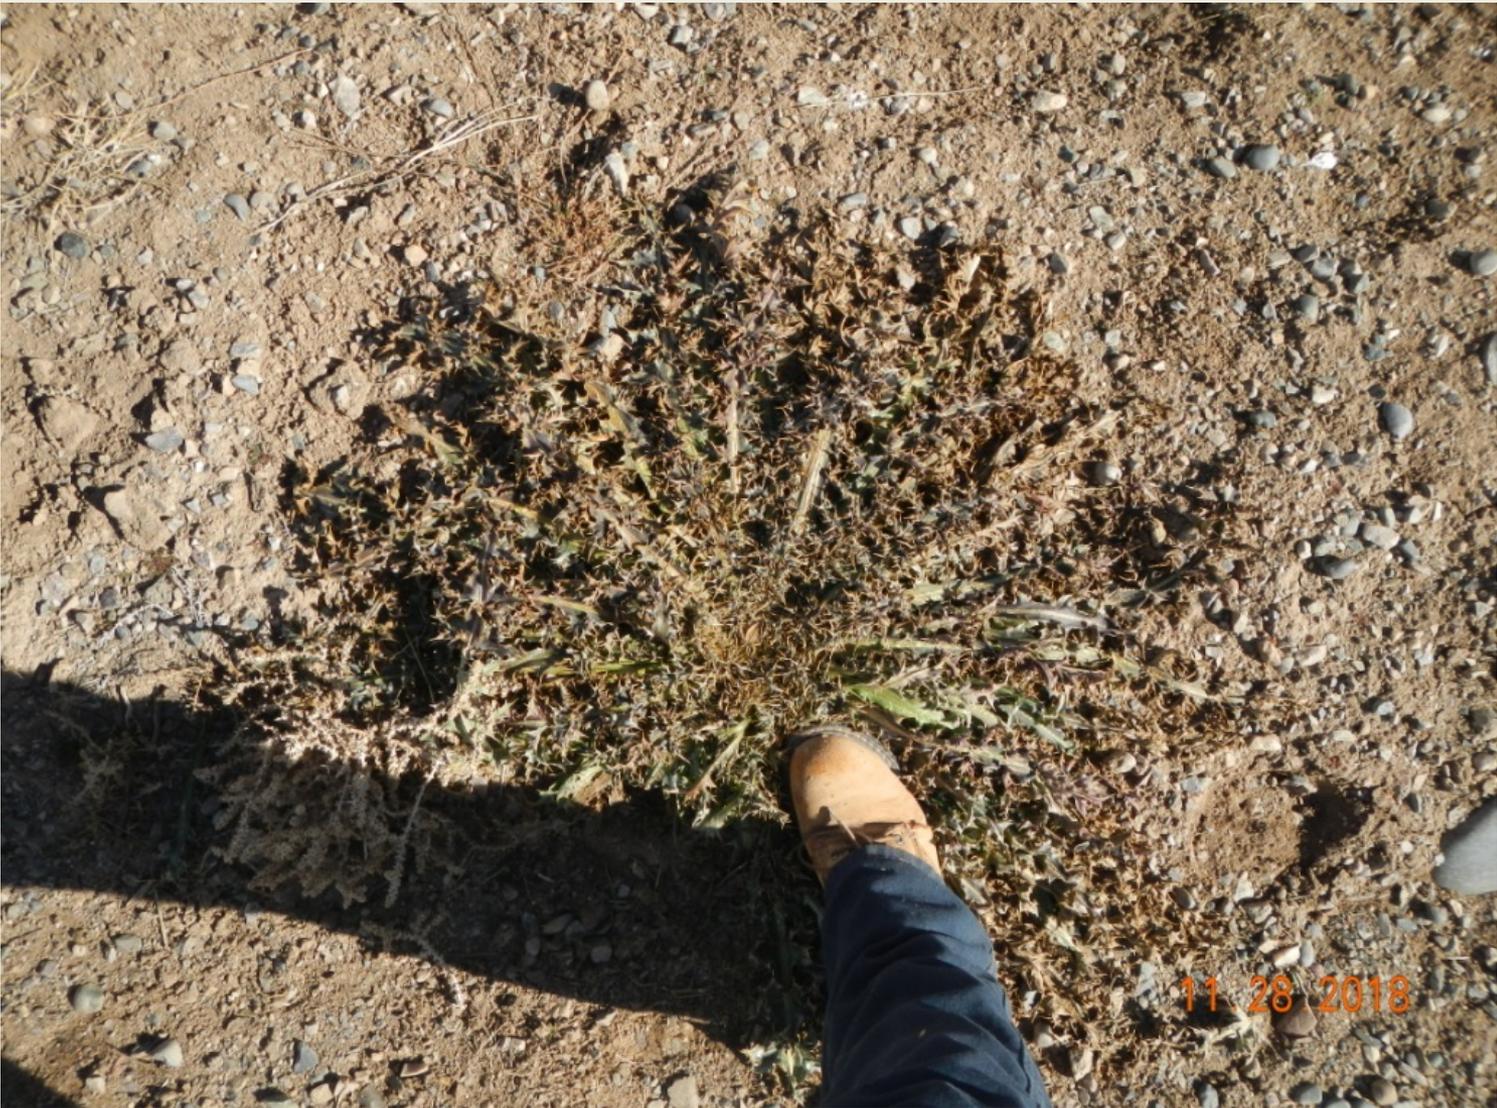
Photo 7. View of musk thistle (*Carduus nutans*) within the eastern project area.
