Construction and Storm Water Inspection

December 11, 2018

Operator: BURLINGTON RESOURCES OIL & GAS LP – 26580

Location ID: 456540

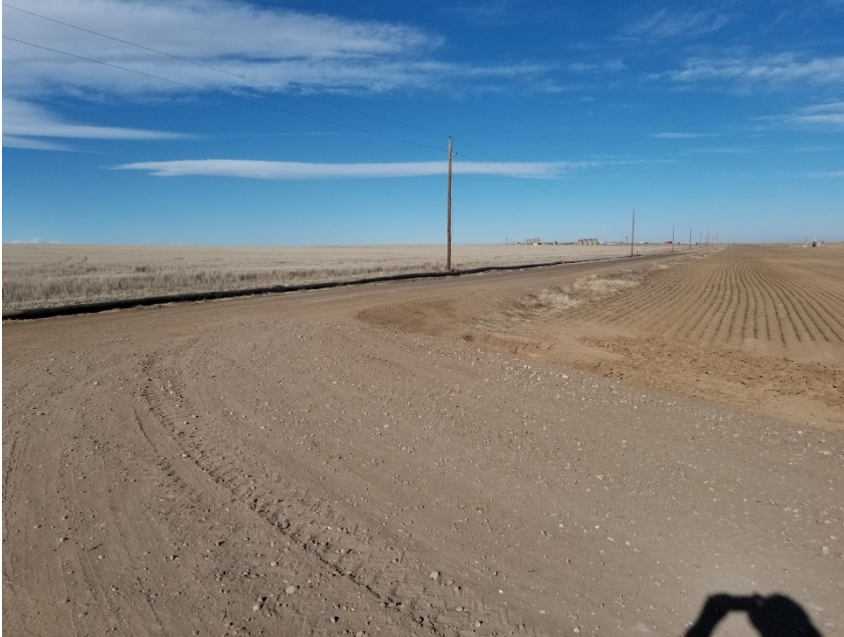
Photo 1. Photo taken from the entrance of the location off CR 89, facing North. Operator has installed gravel potentially to limit tracking onto the county road. BMPs in proper functioning condition at the time of this inspection. BMPs in proper functioning condition at the time of this inspection.

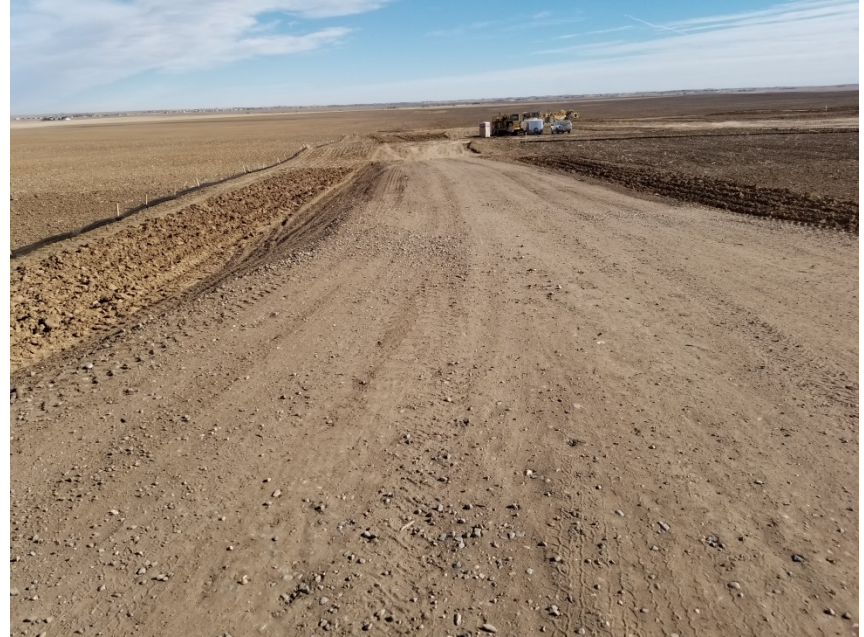
Photo 2. Photo taken from the entrance of the location off CR 89, facing East. See comments from Photo 1.

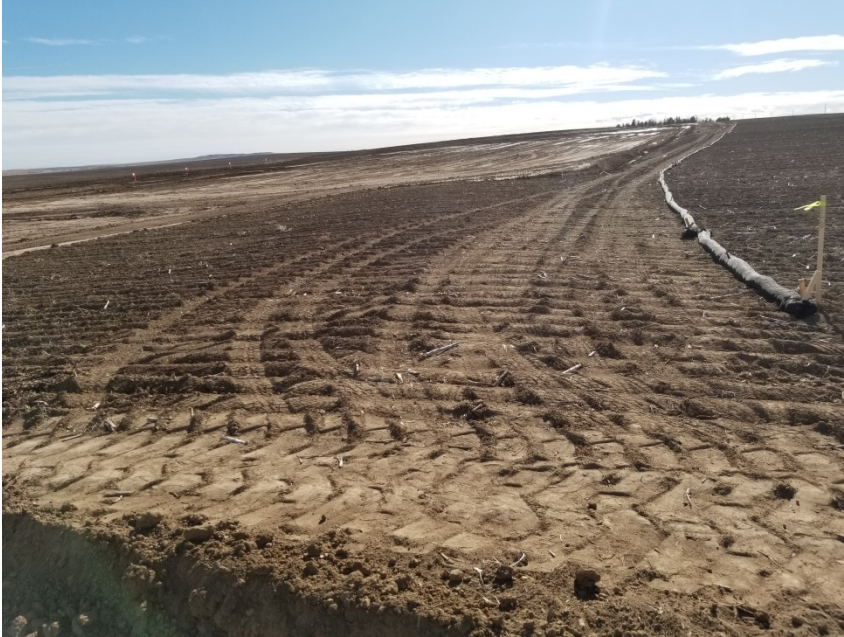
Photo 3. Photo taken from the northwestern perimeter of the location, facing North. Photo illustrates a filterxx BMP that has been installed around the entire perimeter of the location in conjunction with other BMPs.

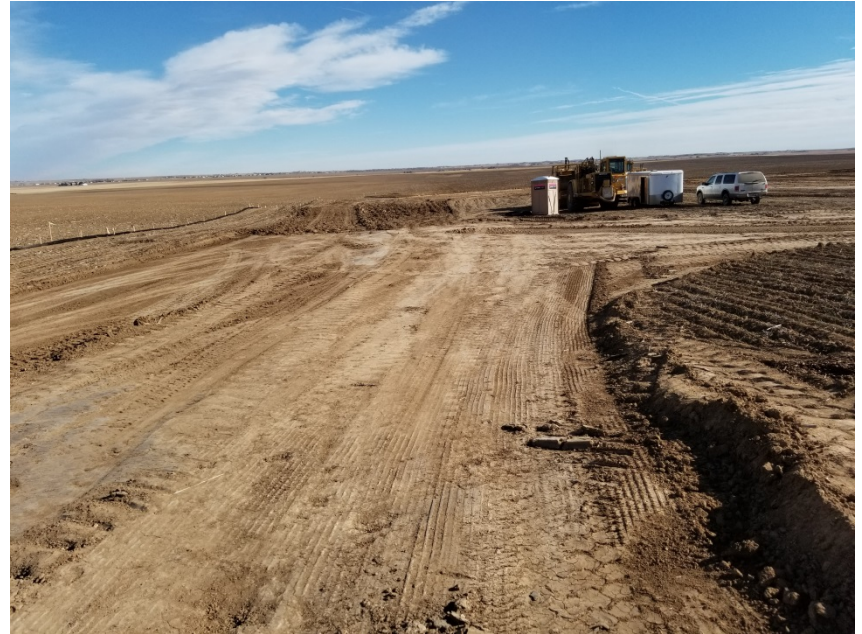
Photo 4. Photo taken from the northwestern perimeter of the location, facing East. Photo illustrates the start of a ditch and berm BMP that will be installed around the entire perimeter of the location in conjunction with other BMPs.

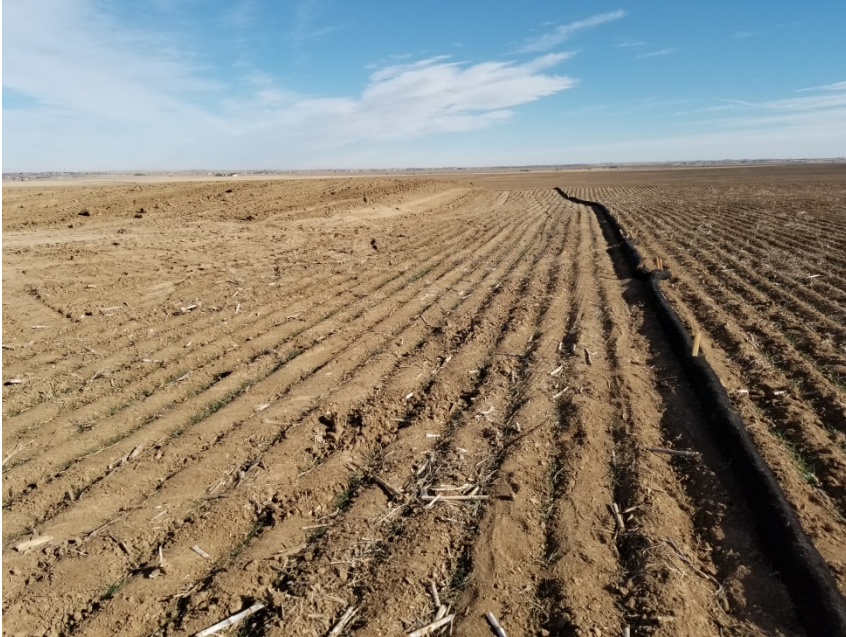
Photo 5. Photo taken from the southwestern perimeter of the location, facing East. See comments from Photo 3.

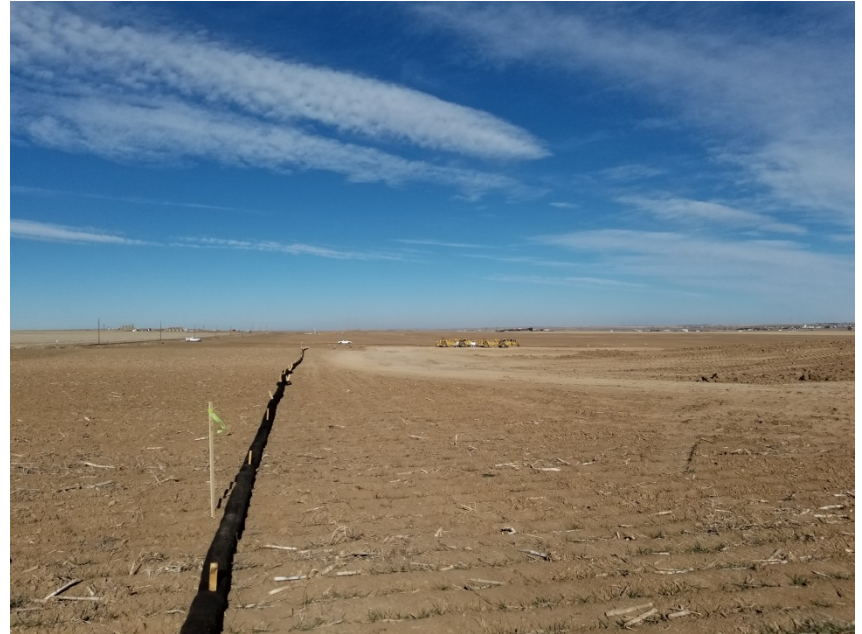
Photo 6. Photo taken from the southwestern perimeter of the location, facing North. See comments from Photo 3.

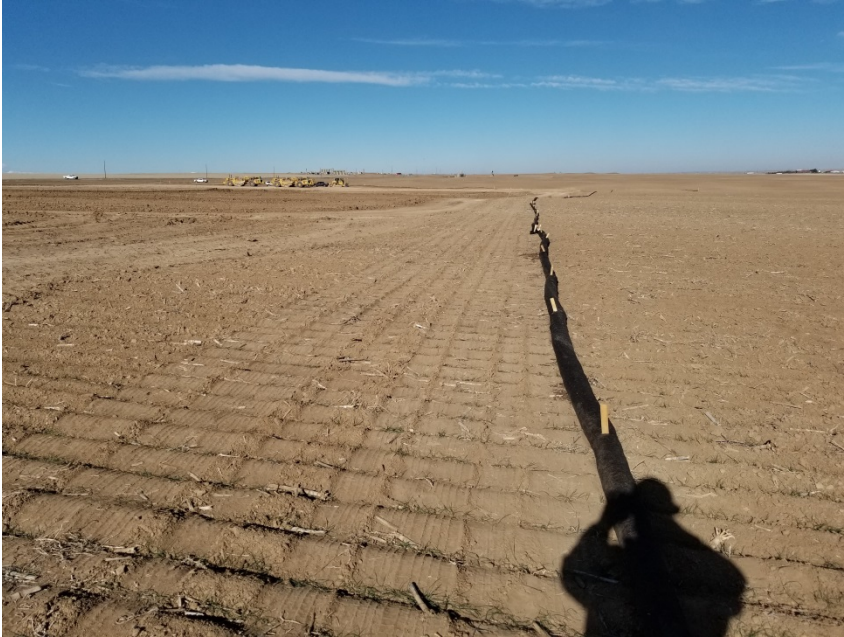
Photo 7. Photo taken from the southeastern perimeter of the location, facing North. See comments under Photos 3.

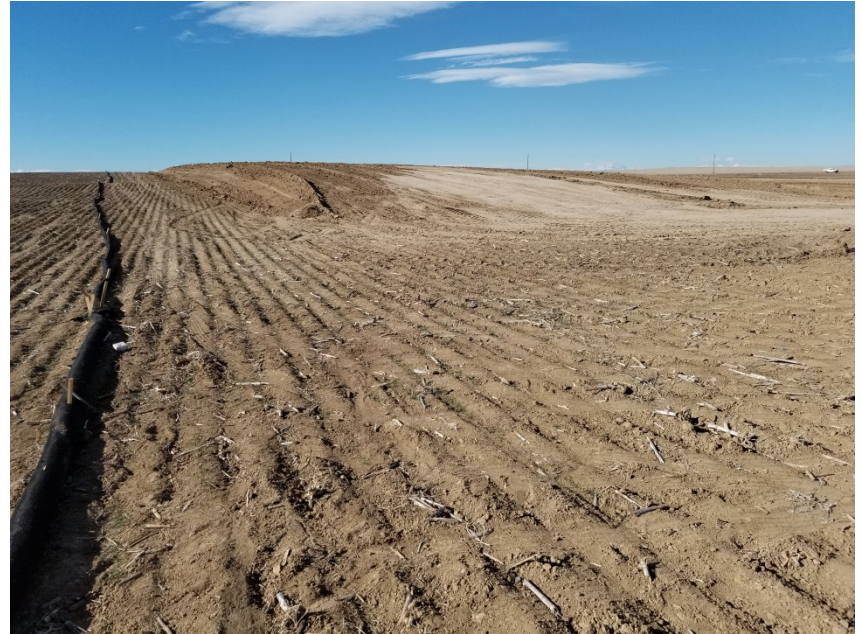
Photo 8. Photo taken from the southeastern perimeter of the location, facing West. Photo illustrates the topsoil stockpile being stored along the eastern area and has been temporarily stabilized with equipment tracking. Also see comments under Photo 3.

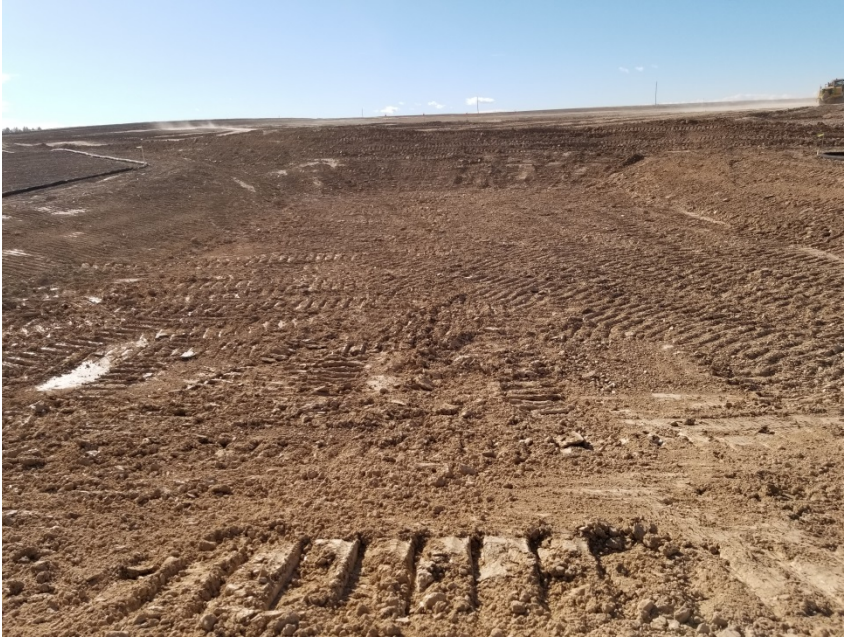
Photo 9. Photo taken from the northeastern perimeter of the location, facing East. Operator is in the process of installing a sediment trap with a temporarily stabilized outlet.

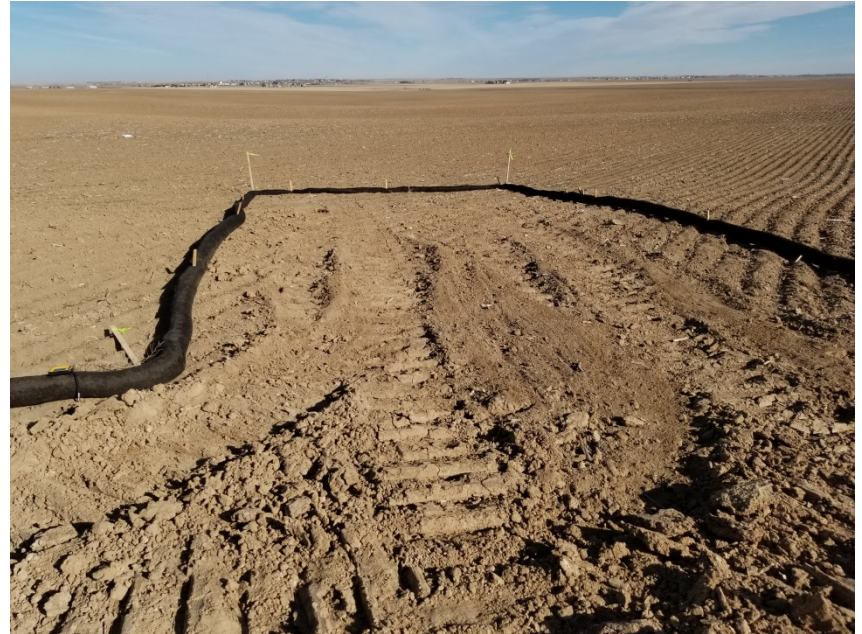
Photo 10. Photo taken from the northeastern perimeter of the location, facing North. See comments under Photos 9.

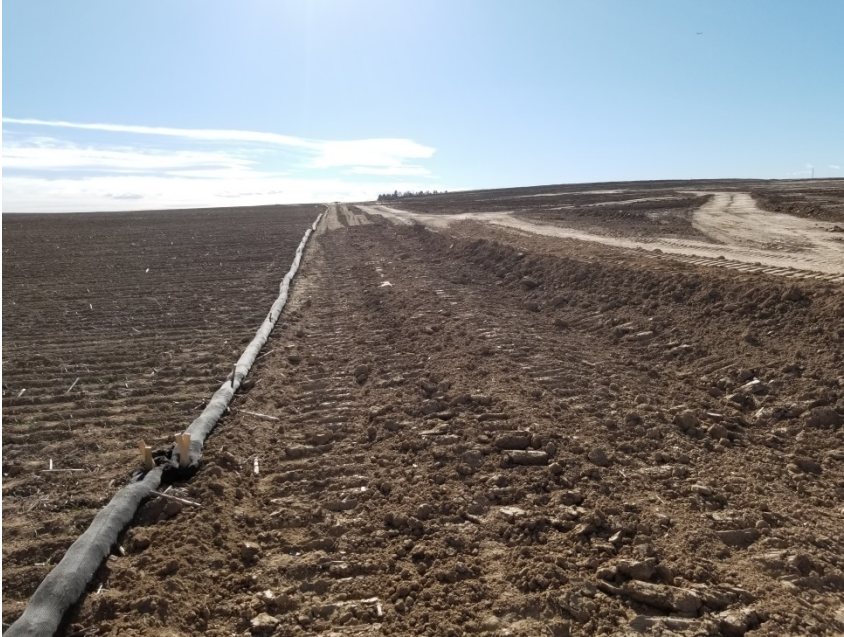
Photo 11. Photo taken from the northeastern perimeter of the location, facing South. See comments under Photo 3.

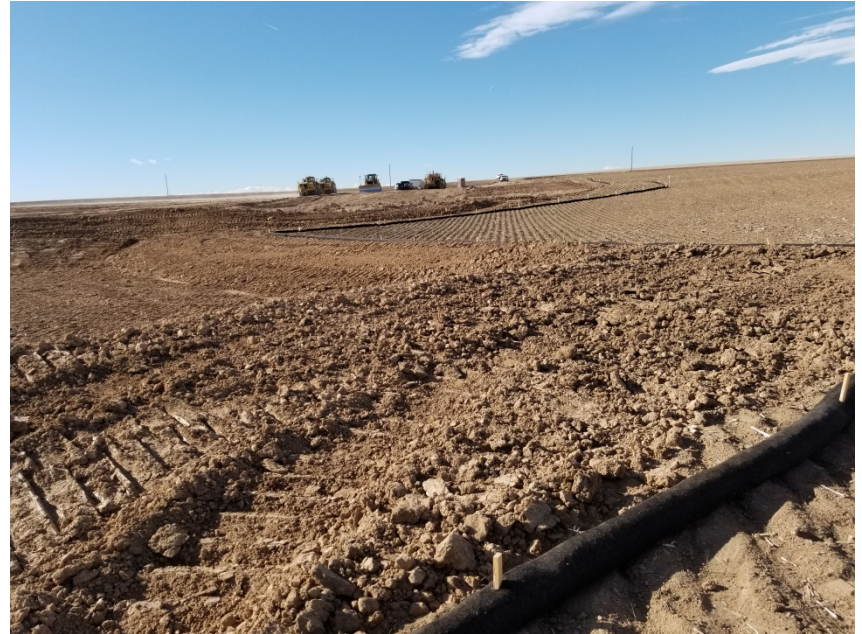
Photo 12. Photo taken from the northeastern perimeter of the location, facing West. See comments under Photo 3.
