Interim Reclamation and Stormwater Inspection

December 19, 2018

Operator: SRC ENERGY INC- #10311

Inspection Photos
Location Name: SRC /Vista Pad
Location ID: 431367

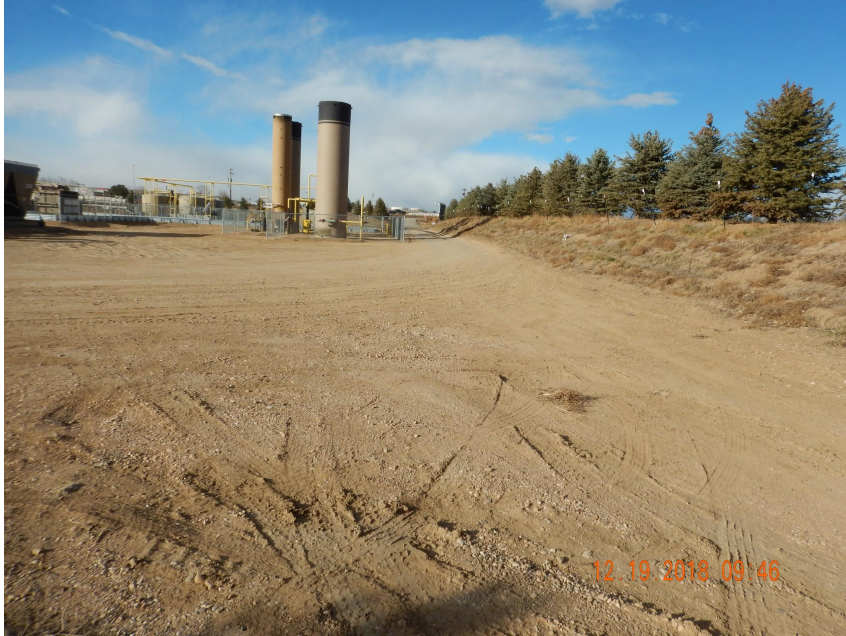
Photo 1. Photo taken from the northeast well pad, facing West. Appears the Operator has performed interim reclamation to reduce disturbance areas only needed for production operations. Interim areas will remain in-process as vegetation does not meet Rule 1003 standards.

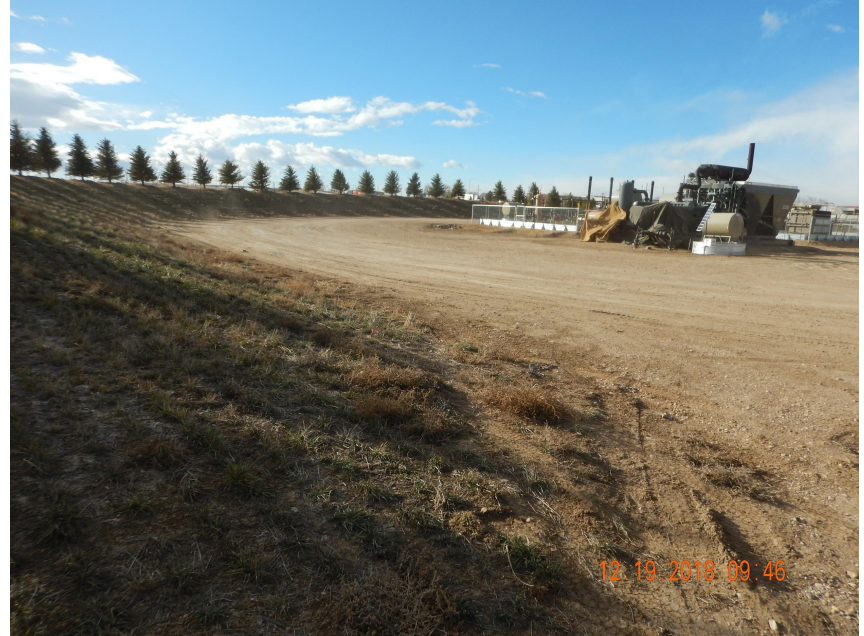
Photo 2. Photo taken from the northeast well pad, facing Southwest. See comments under Photo 1.

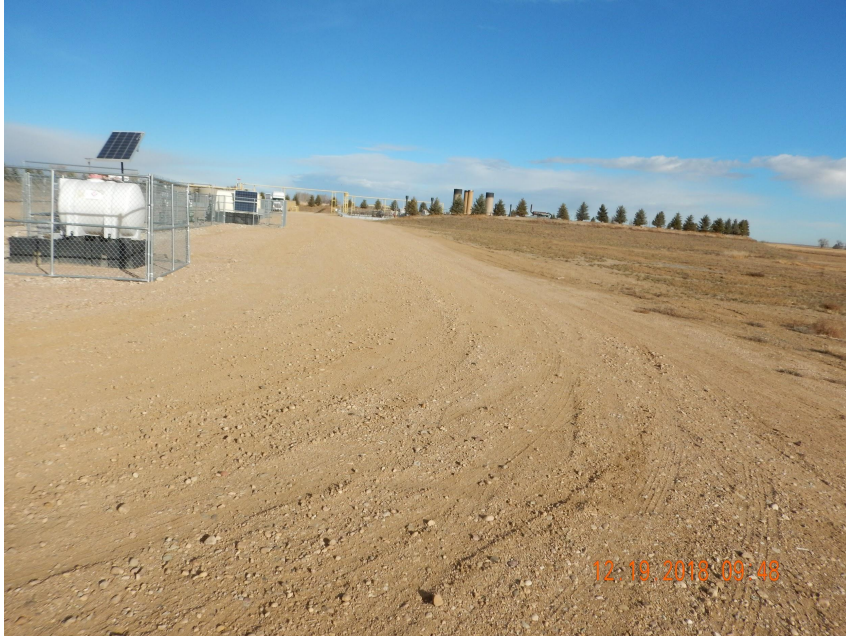
Photo 3. Photo taken from the southeast well pad, facing North. See comments under Photo 1.

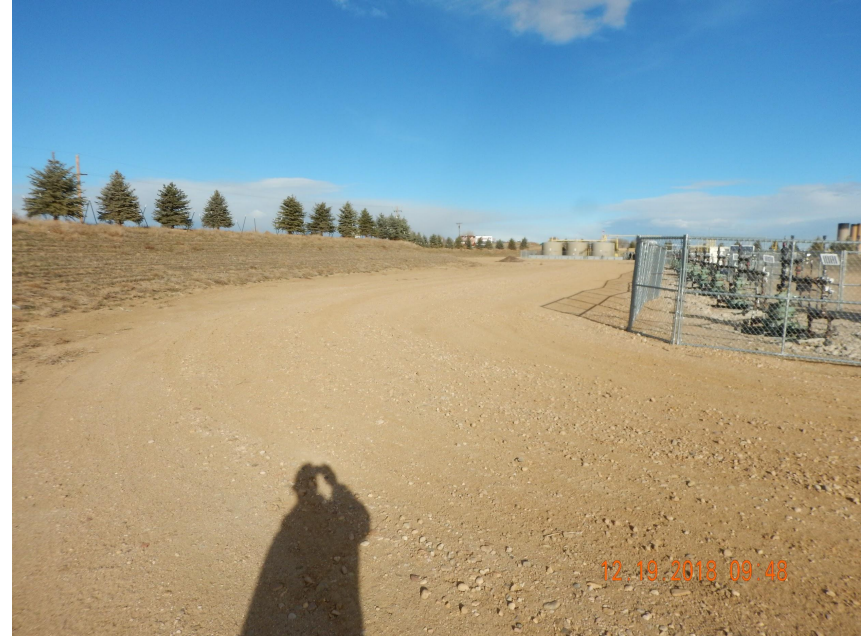
Photo 4. Photo taken from the southwest well pad, facing North. See comments under Photo 1.

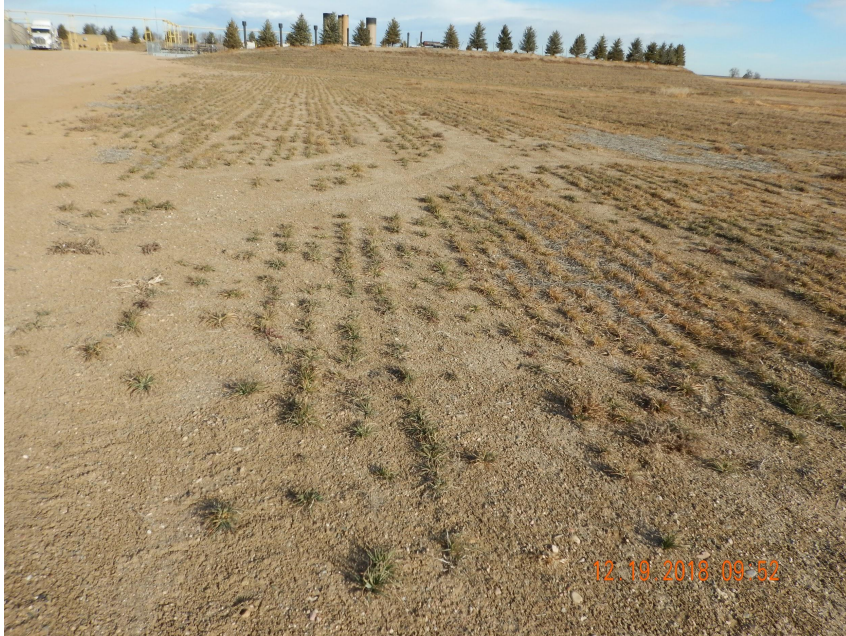
Photo 5. Photo taken from the southwest interim area, facing North. Photo illustrates germination of desirable species; however, germination was not uniform throughout the interim area which is not reflective of reference area vegetative levels. Operator may need to perform additional reclamation activities along the southern interim area.

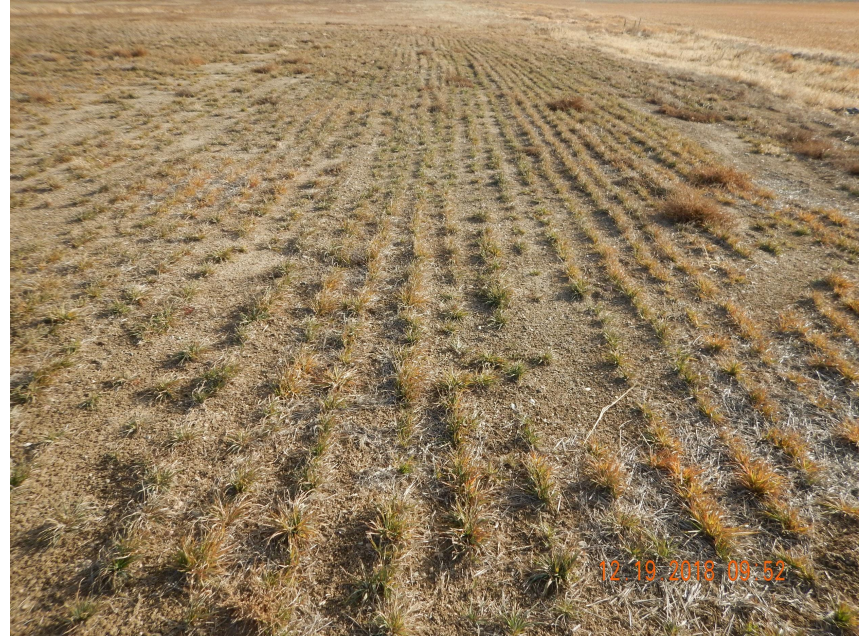
Photo 6. Photo taken from the southwest interim area, facing East. See comments under Photo 5.

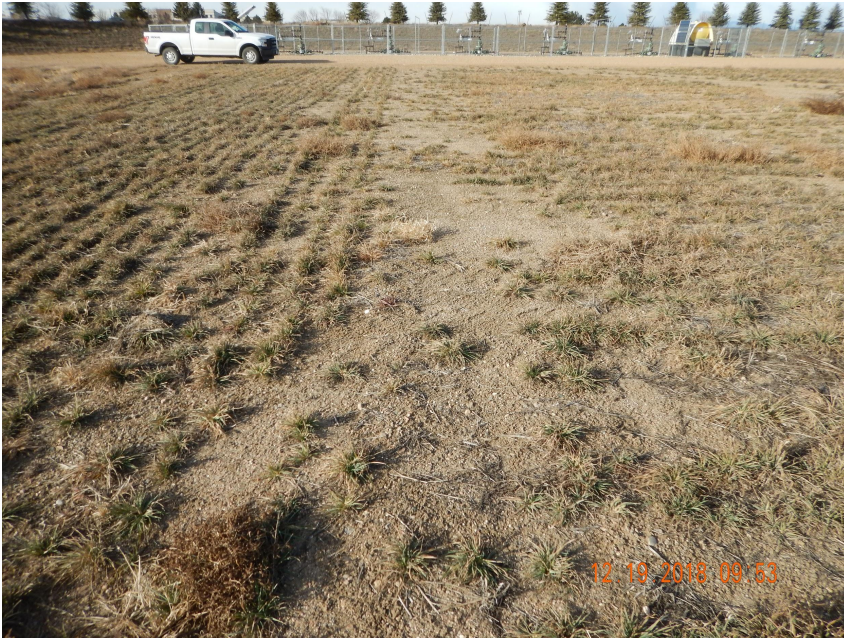
Photo 7. Photo taken from the southern interim area, facing West. See comments under Photo 5.

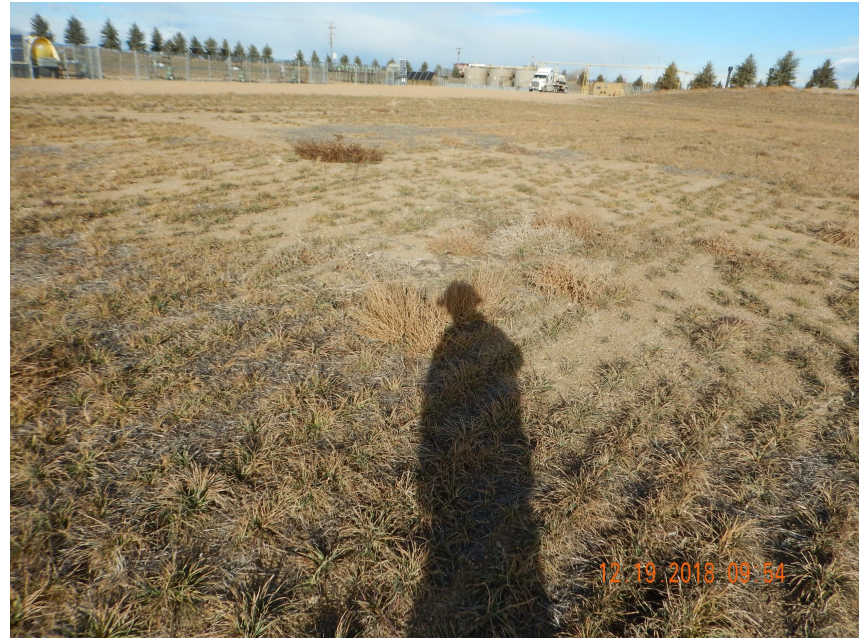
Photo 8. Photo taken from the southern interim area, facing Northwest. See comments under Photo 5.

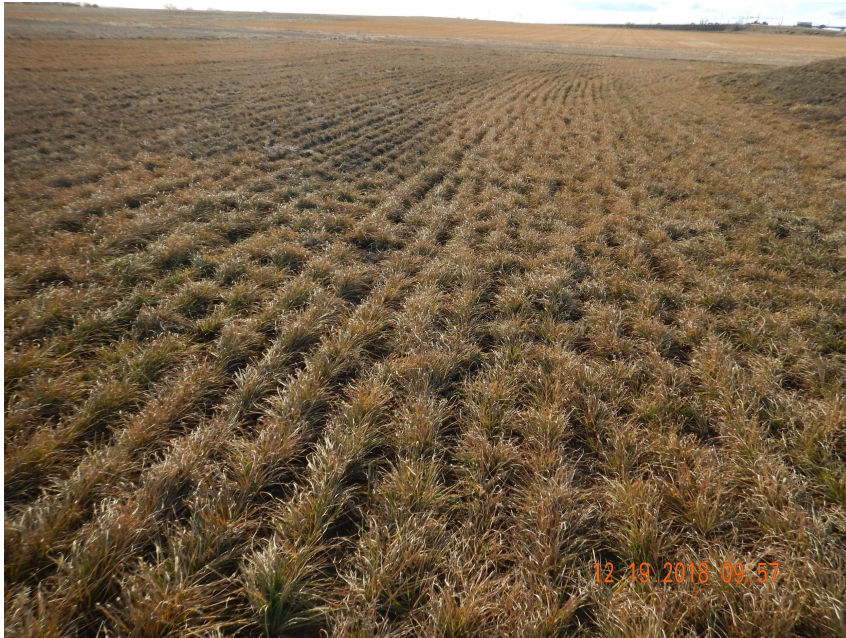
Photo 9. Photo taken from the northern interim area, facing South. The north/northeast interim area appears to meet Rule 1003 standards.

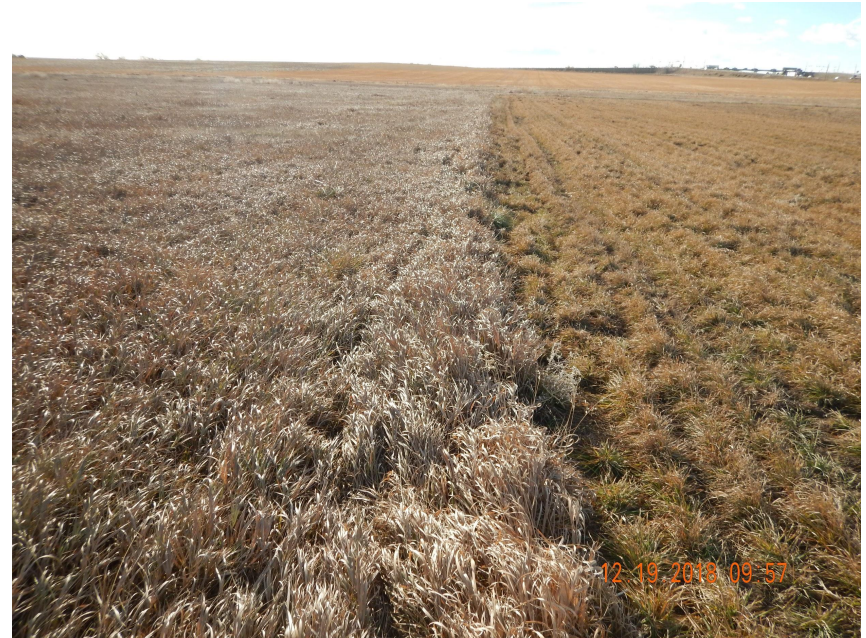
Photo 10. Photo taken from the northeastern interim area, facing South. The left half of the photo illustrates the reference area (Smooth brome) and the right half of the photo illustrates the interim area that appears to meet Rule 1003 standards.

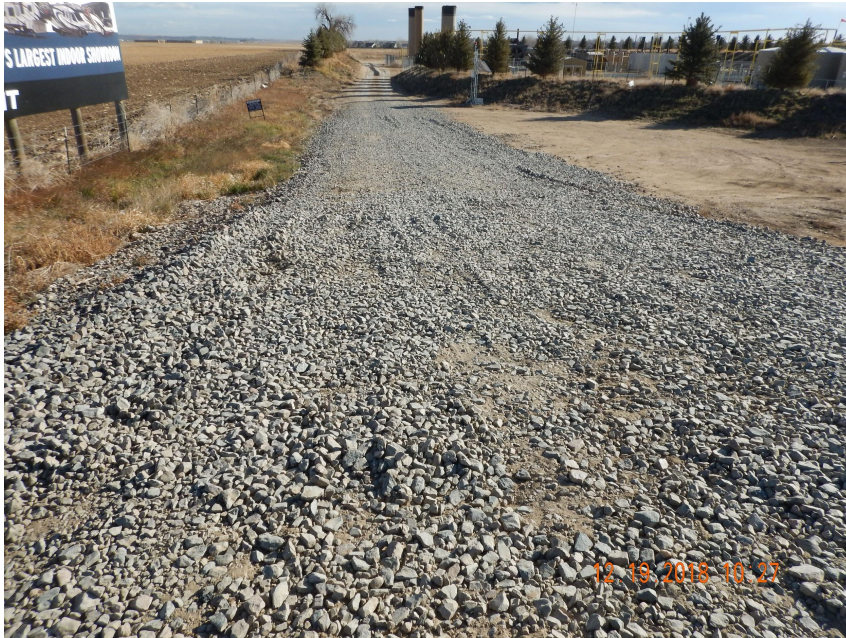
Photo 11. Photo taken from the entrance of the location, facing East. Vehicle tracking BMP appears to be in proper functioning condition.

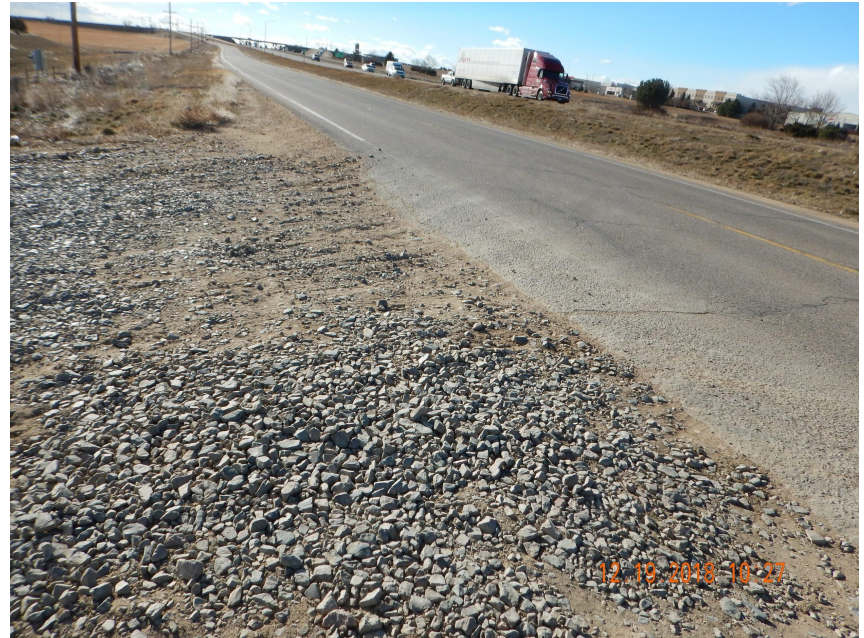
Photo 12. Photo taken from the entrance of the location, facing South. No observed track out issues.
