# Inspection Photos

Operator: BP Production

API: 05-067-10010

Date: 11/29/2018

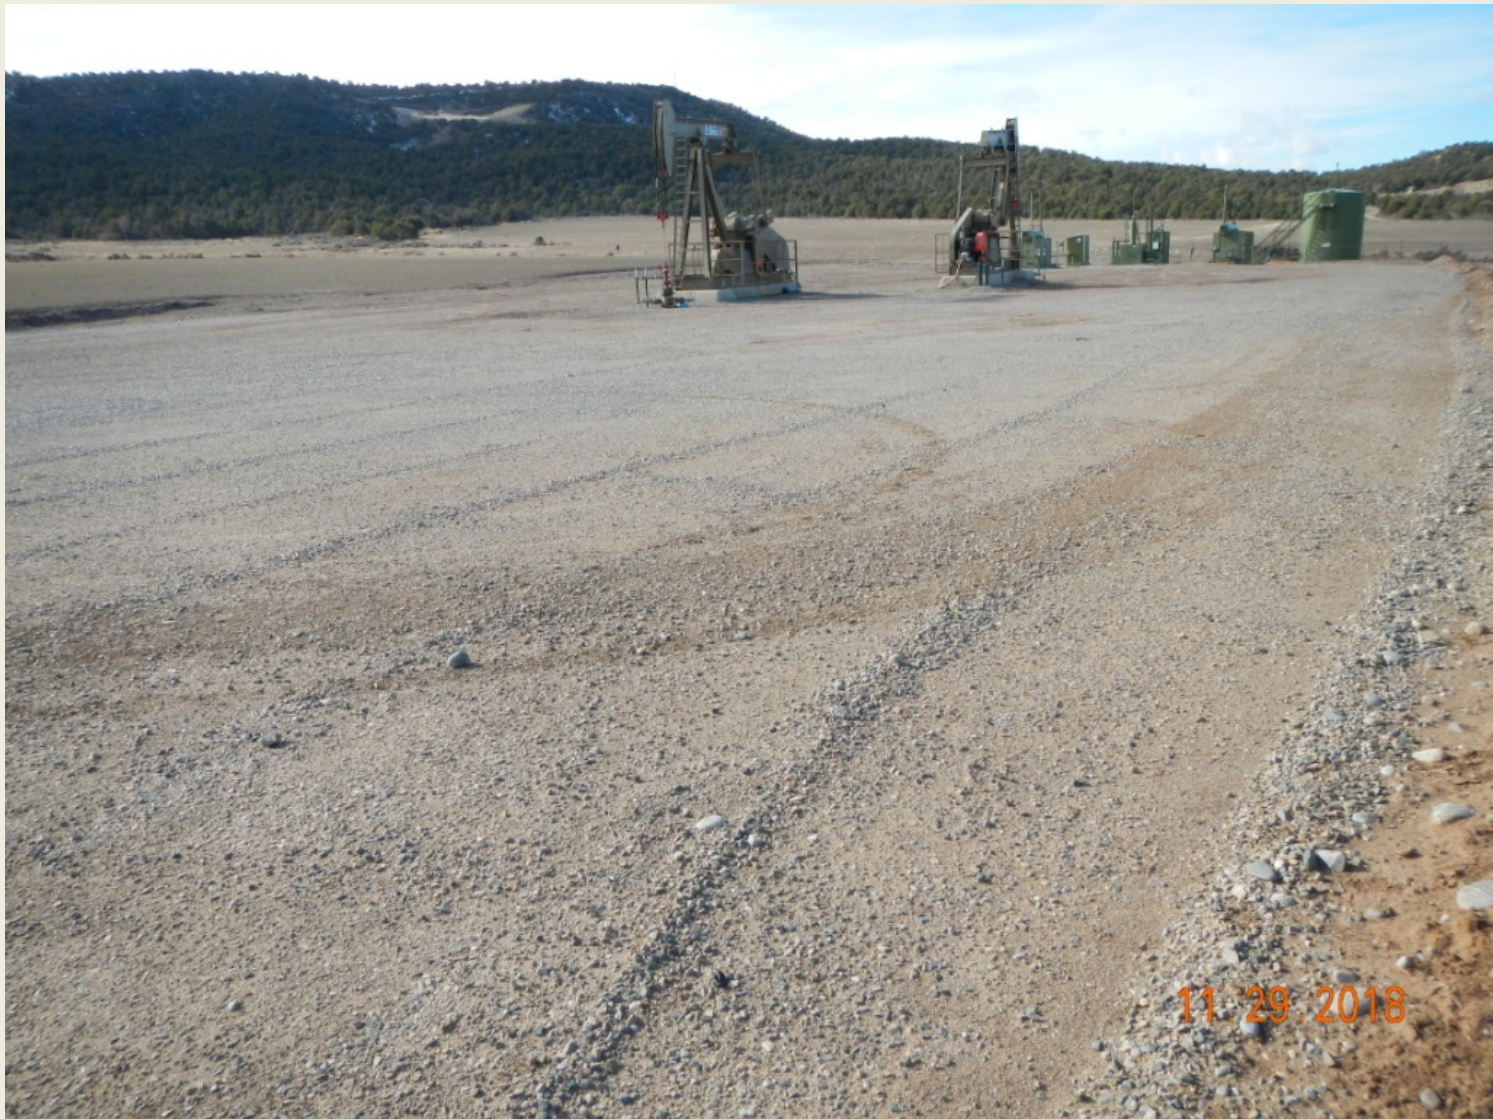
**Photo 1. View of the project area from the northeastern corner facing center.**

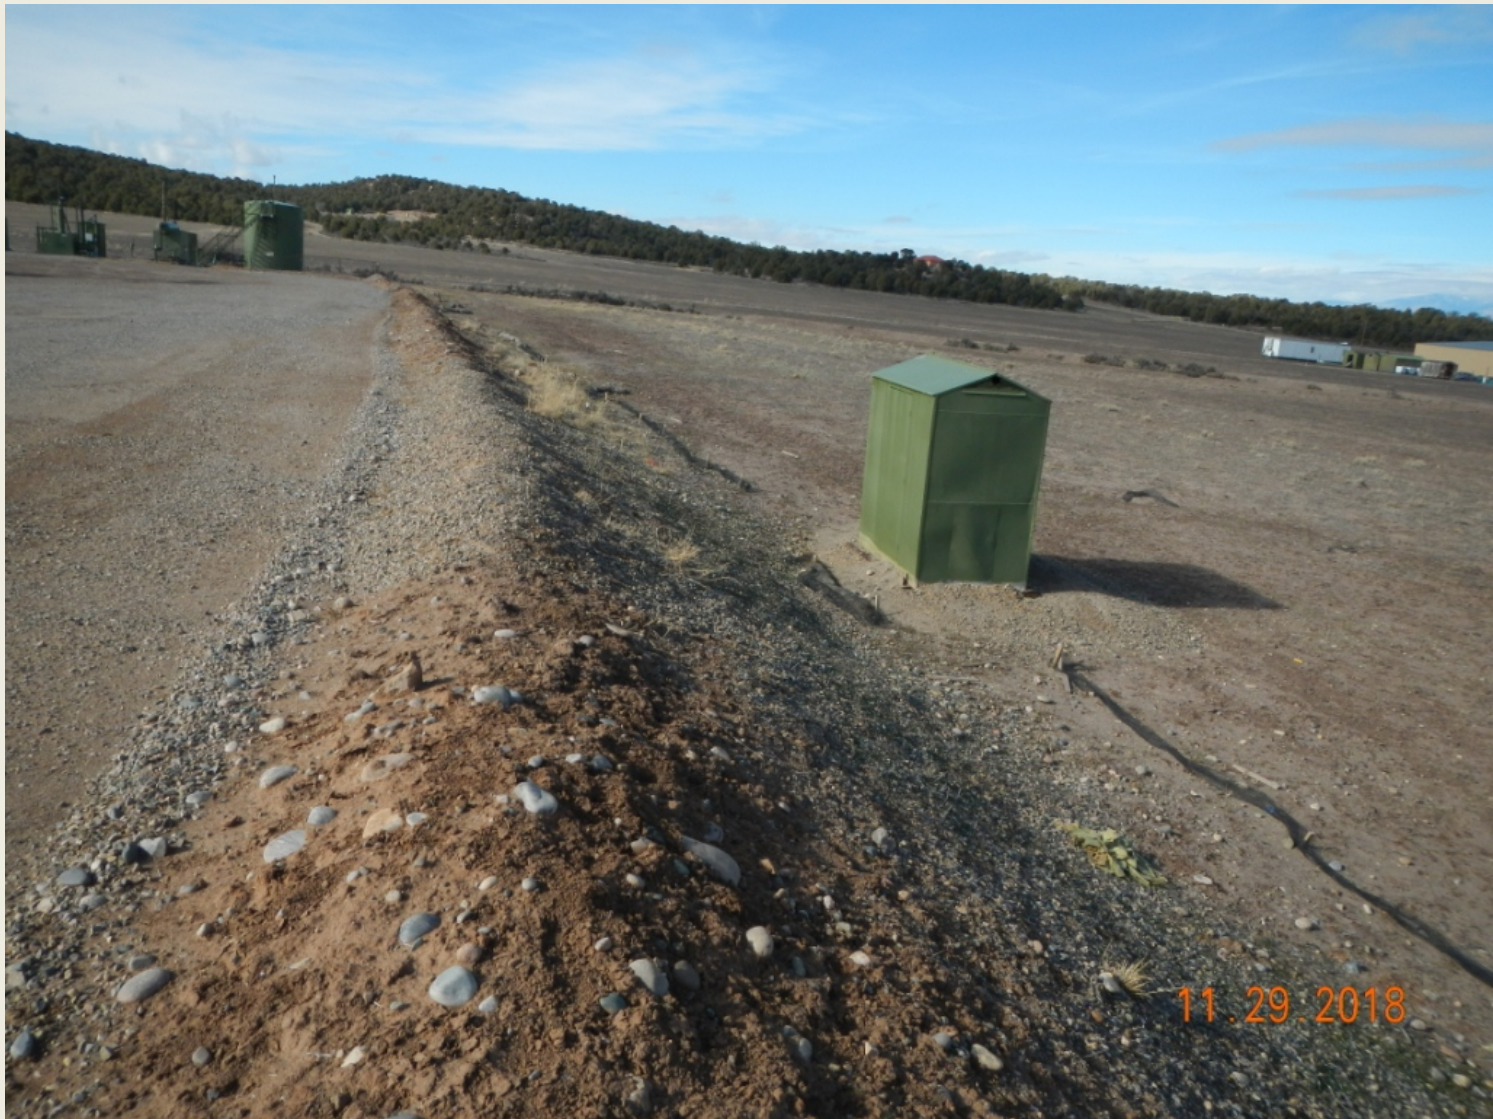
**Photo 2. View of the northern project area from the northeastern corner facing westward. Revegetation is sparse and appears grazed. This needs to be monitored and revegetation installed if vegetation is not increasing. Livestock exclusion may be needed.**

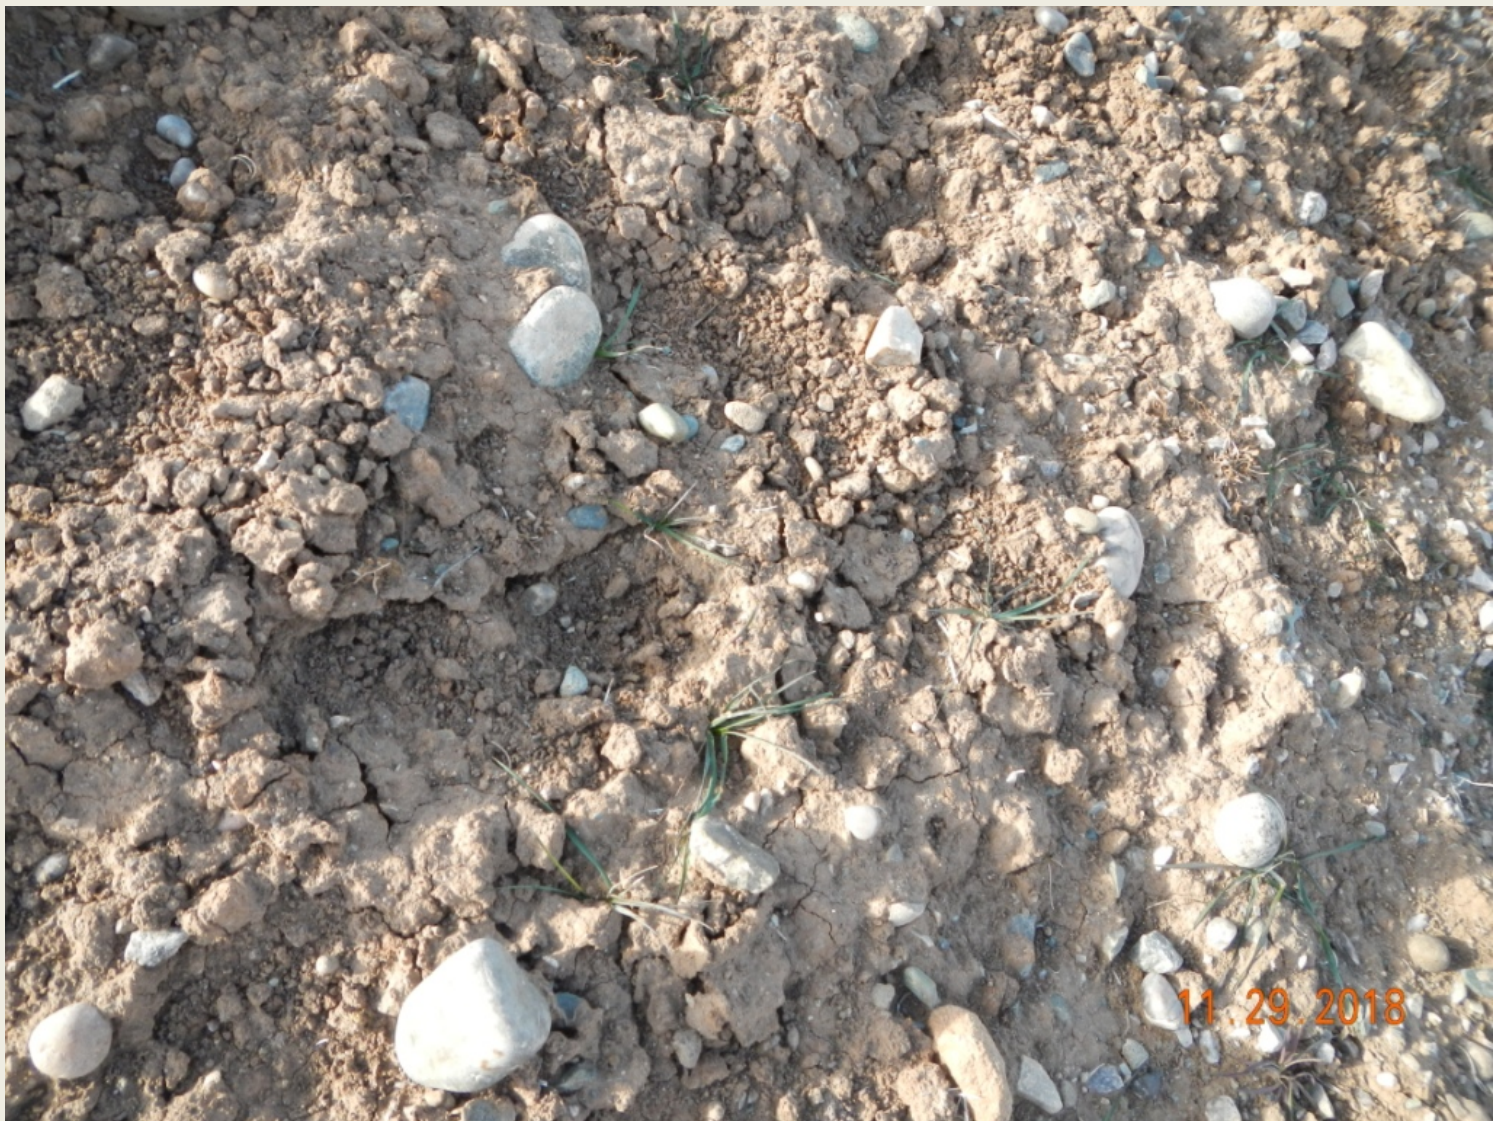
**Photo 3. View of seedlings becoming established on well pad berms.**

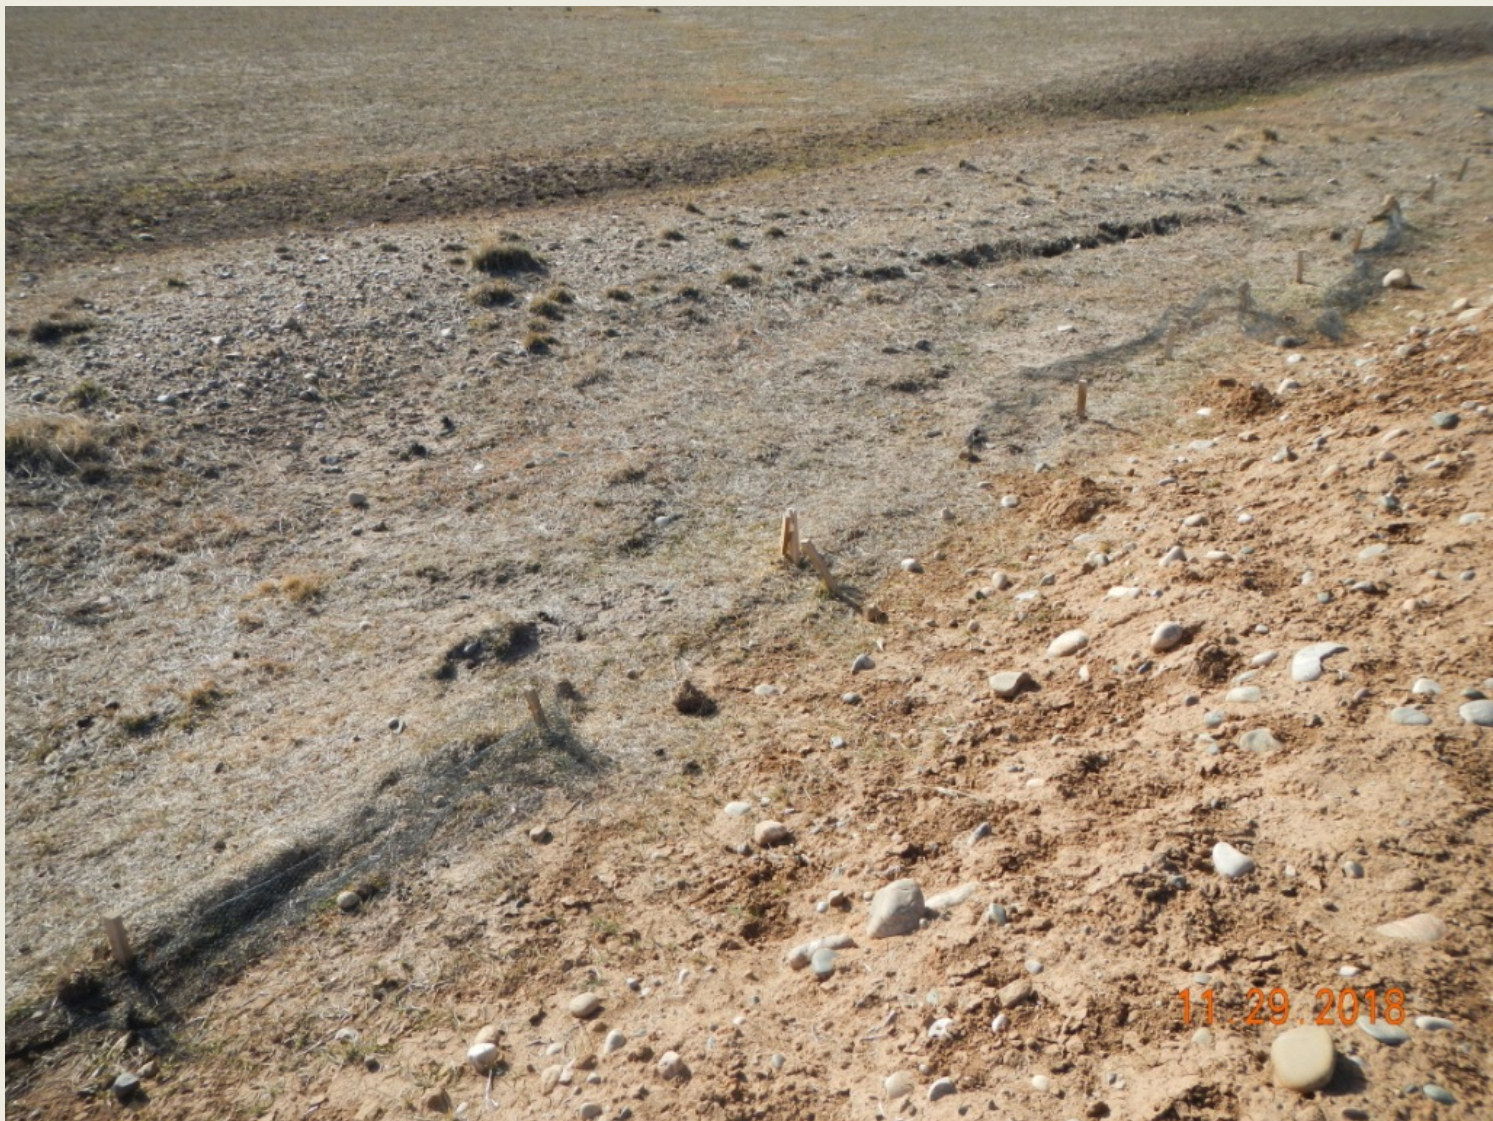
**Photo 4. View of wattle debris that needs to be removed.**

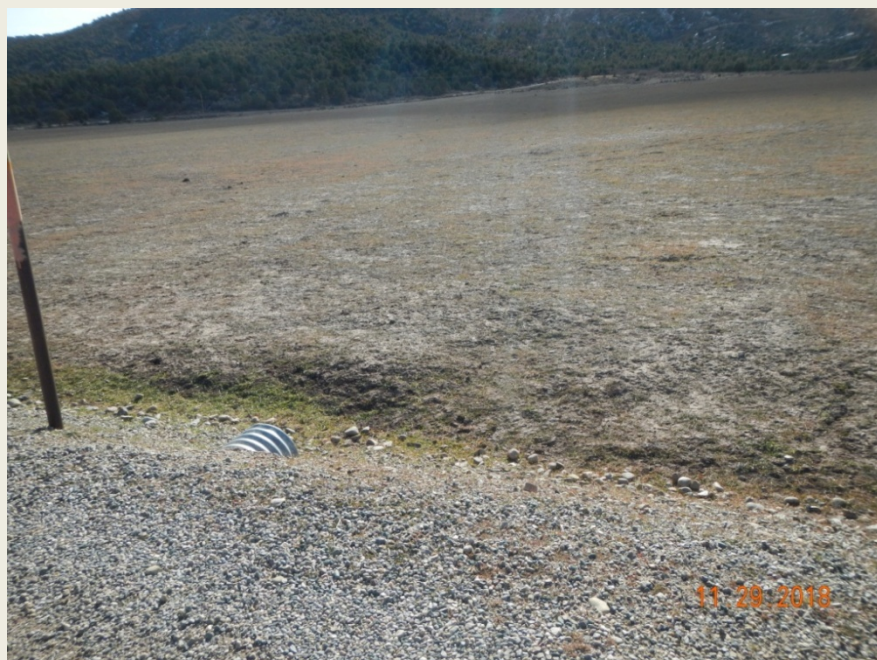
**Photo 5. View of area upstream of culvert, no down-cutting observed.**

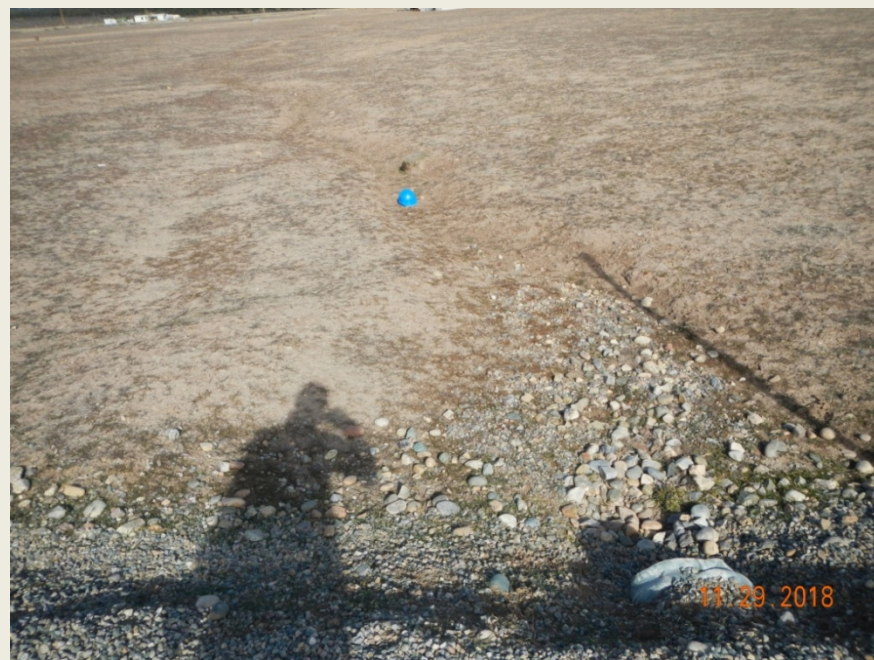
**Photo 6. View of area downstream of culvert, erosional downcutting up to 1.5 feet deep and 3 feet wide observed. Stabilization is needed.**
