Inspection Photos
Operator Name: Laramie Energy LLC
Location ID: 334529

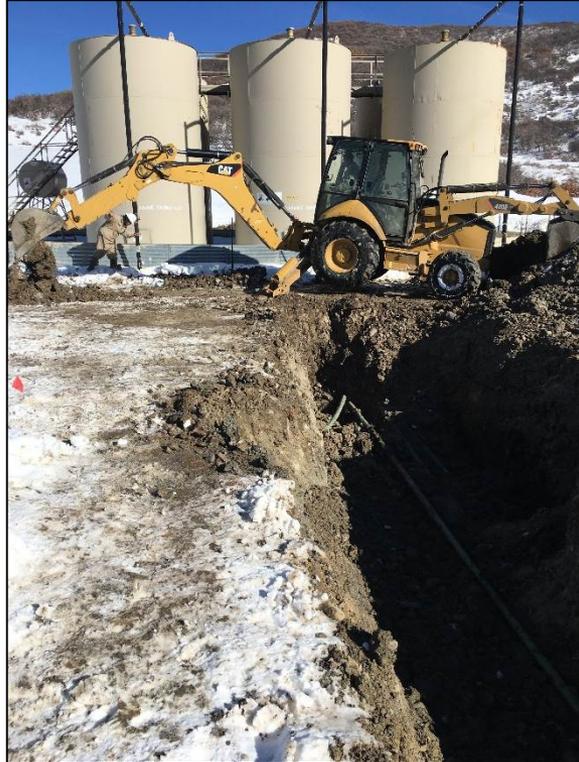
Spill area, Flowline with leak travels to the tanks on right side

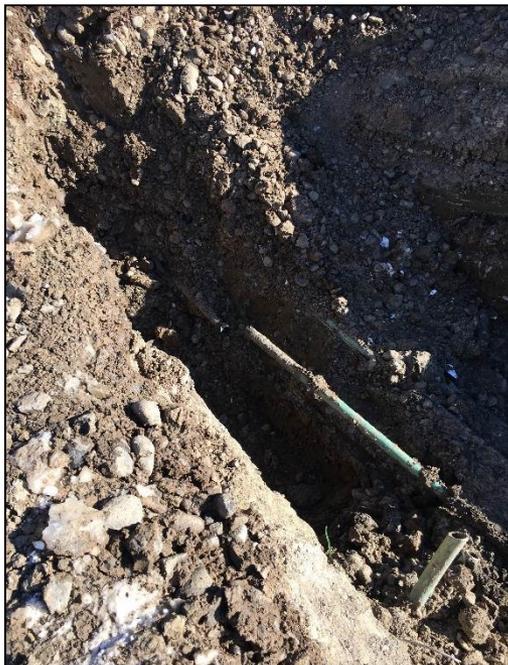
Flowlines pictured in excavation

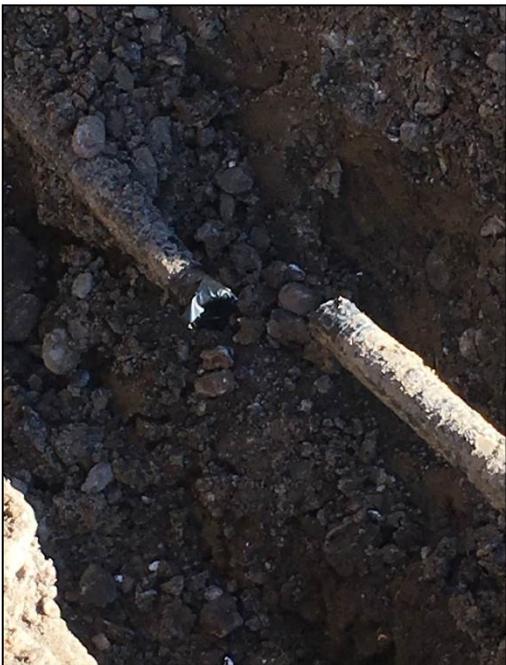
Flowline with section cut out where leak was found

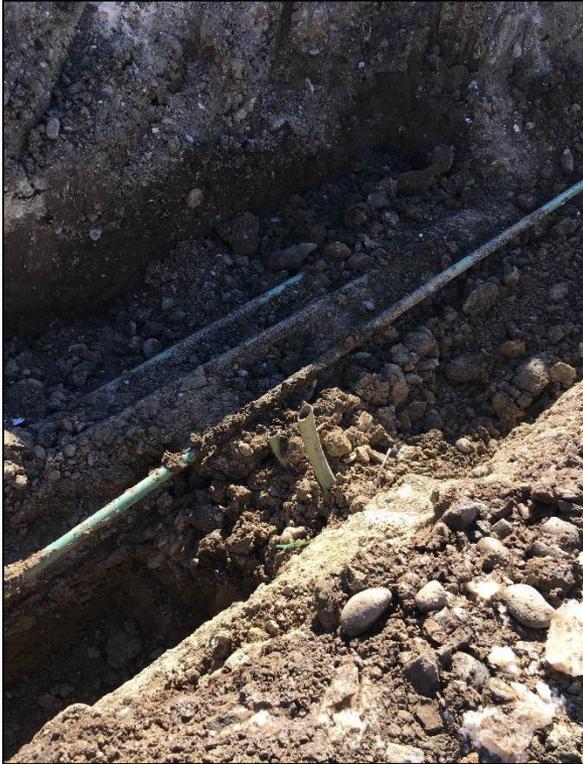
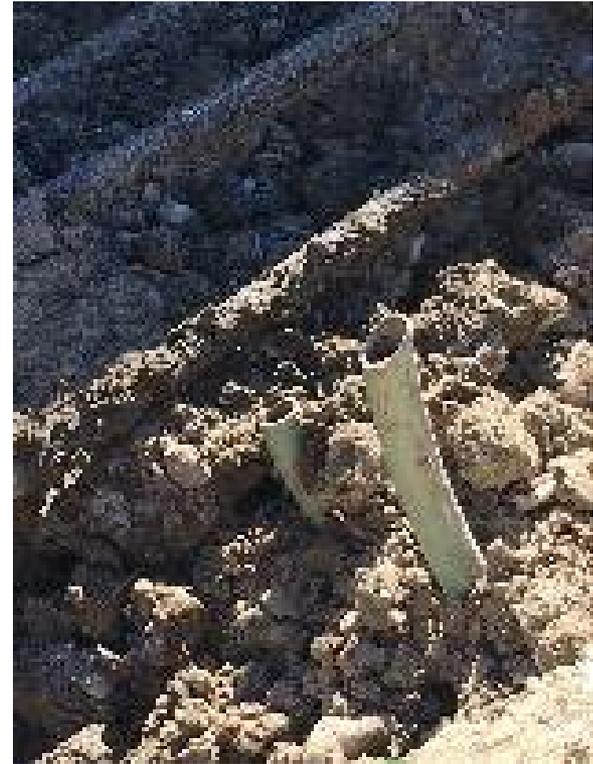
**Flowlines in exaction trench with 2 other
Abandoned flowlines discovered when digging.
They were open ended**

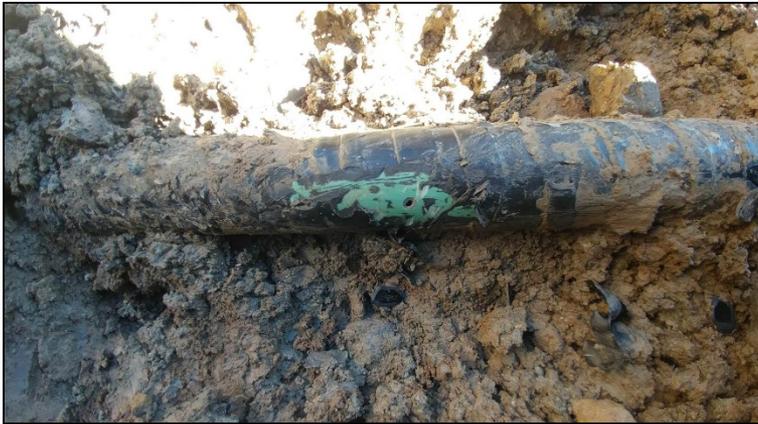
Flowline pictured with pinhole

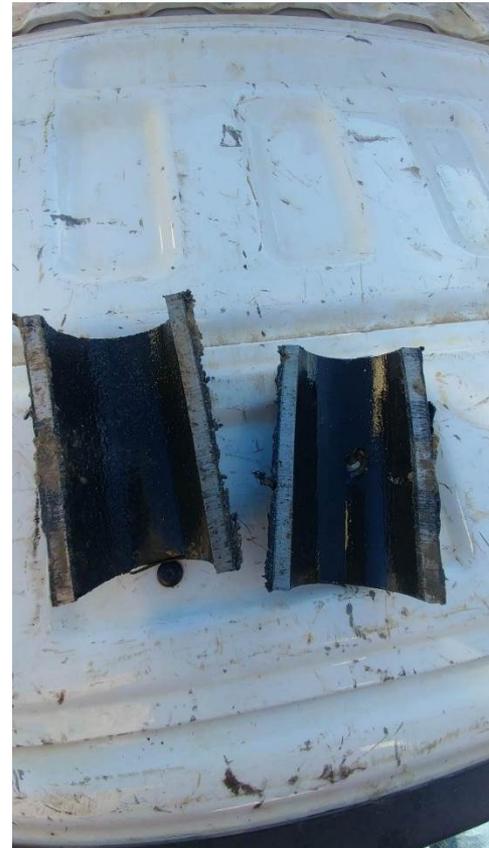
Flowline cut section with pinhole
