Inspection Photos

API#045-06914

Operator: Caerus

Inspection Number: 692400457

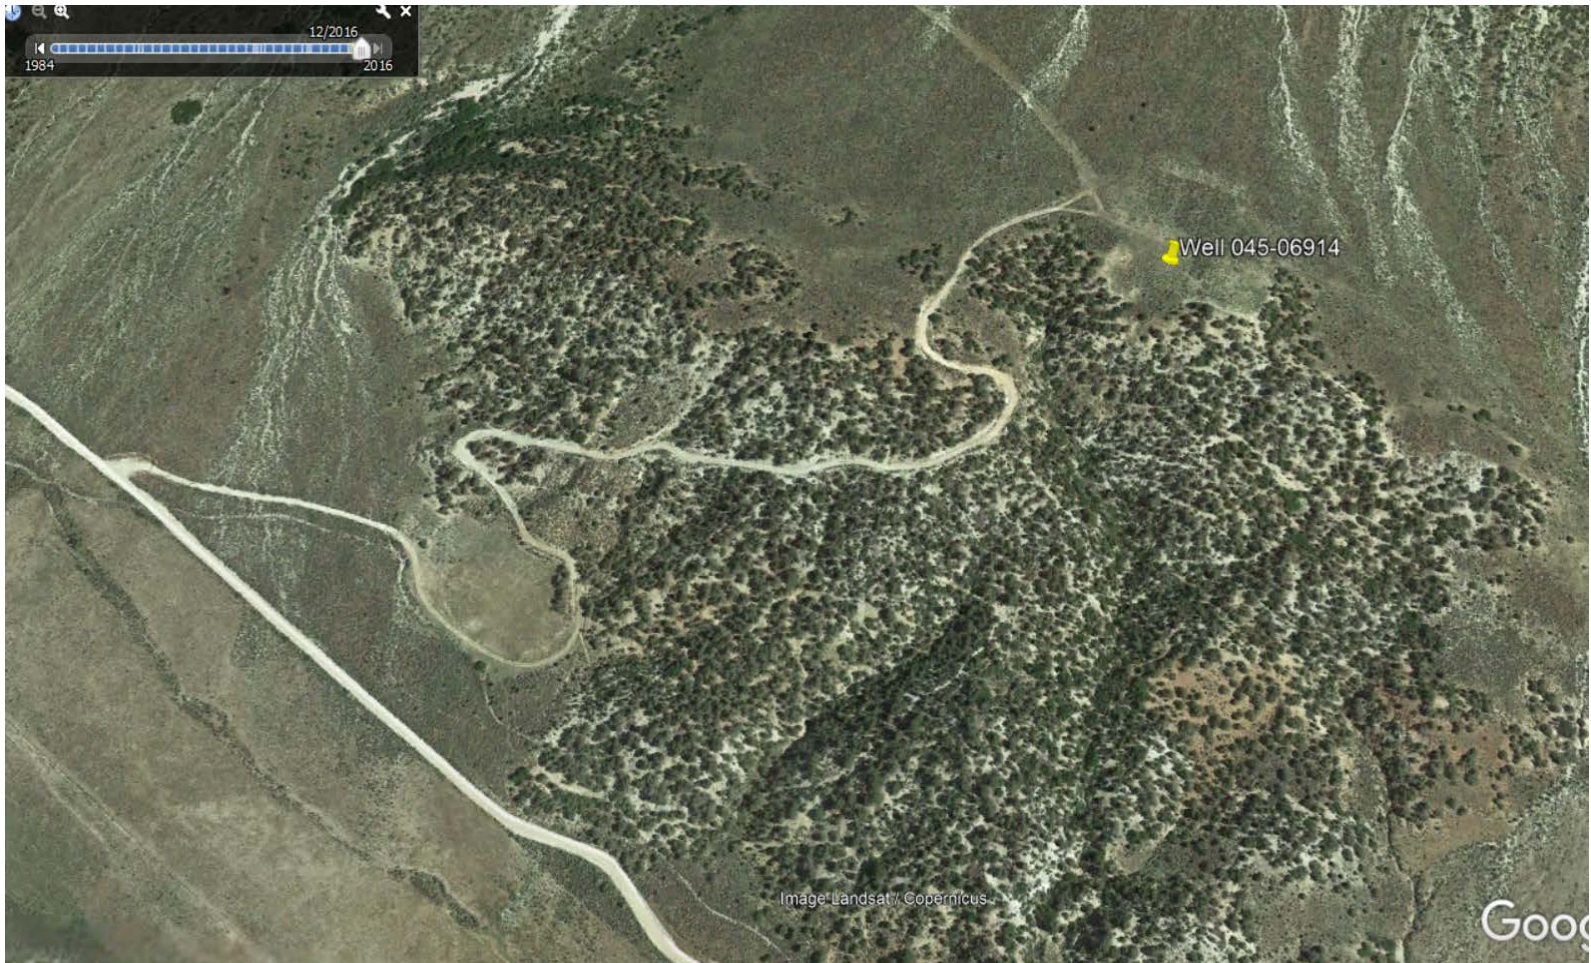
Aerial:
2016 Google Earth aerial view of access road and Location.

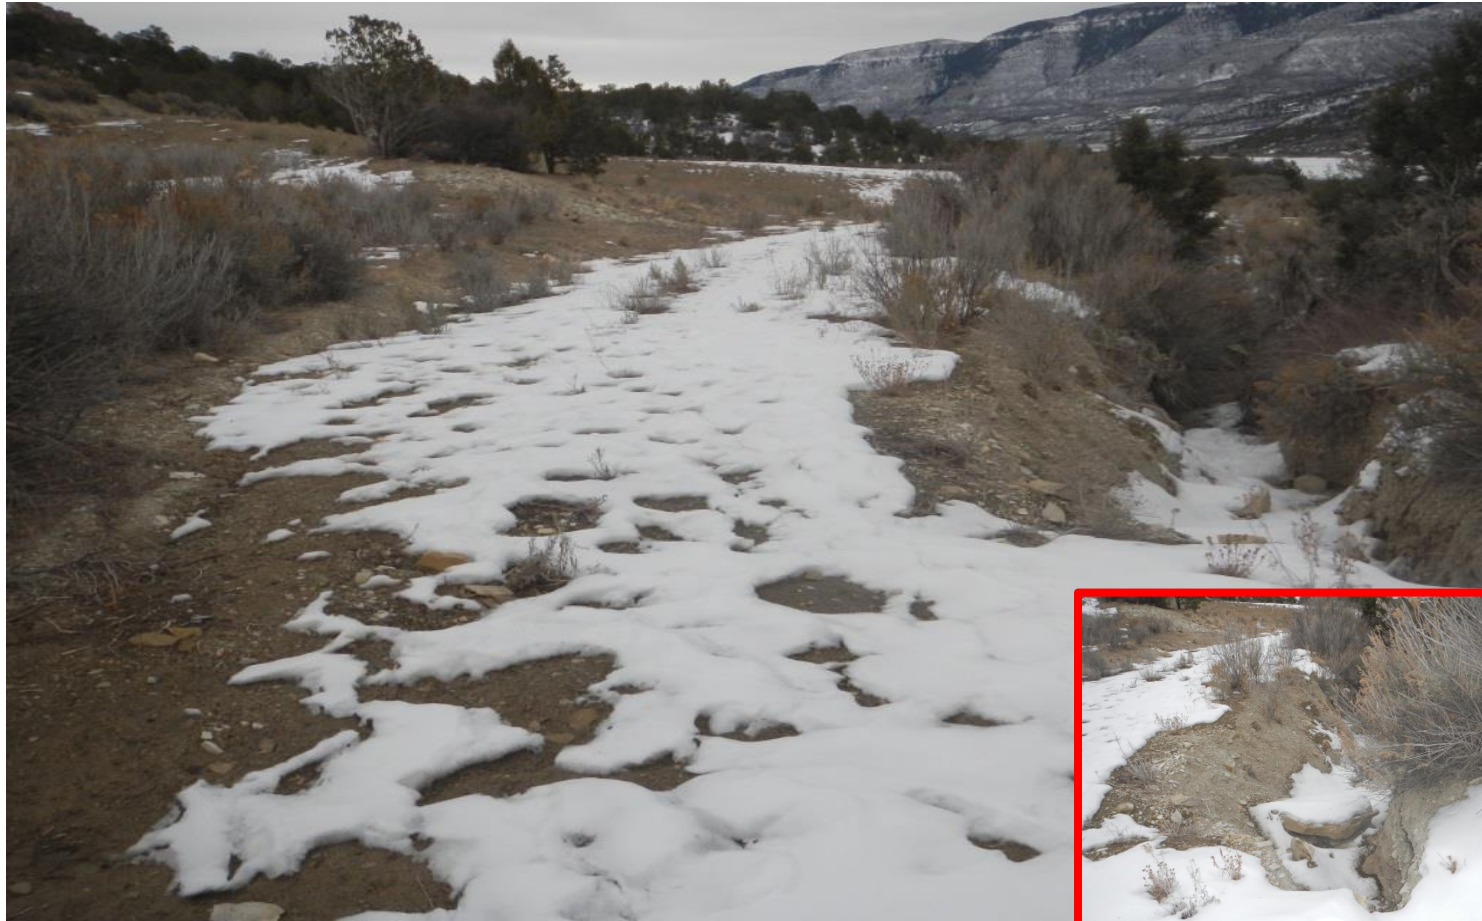
Photo#1:
View to East, up access road as it begins to climb from flat.

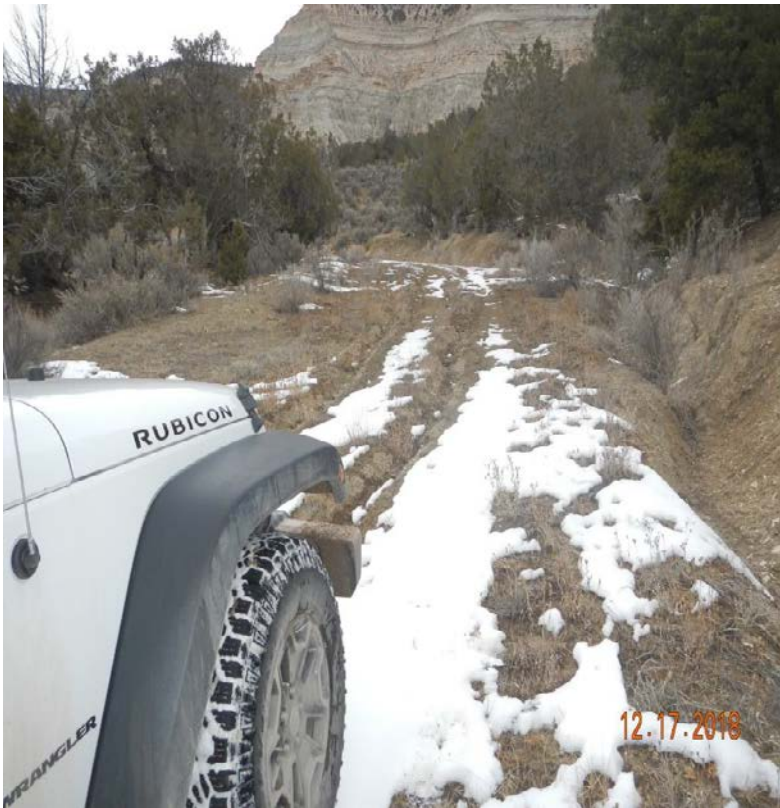
Photo#2:

This & following photos are views moving up & along road to the North.

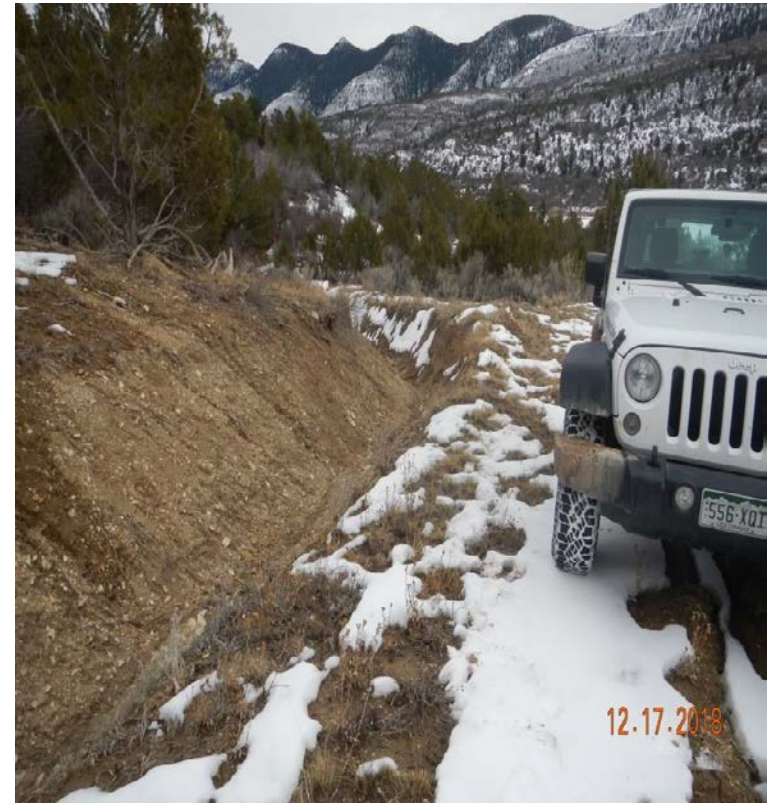
Photo#3:

View moving up & along road to the North.

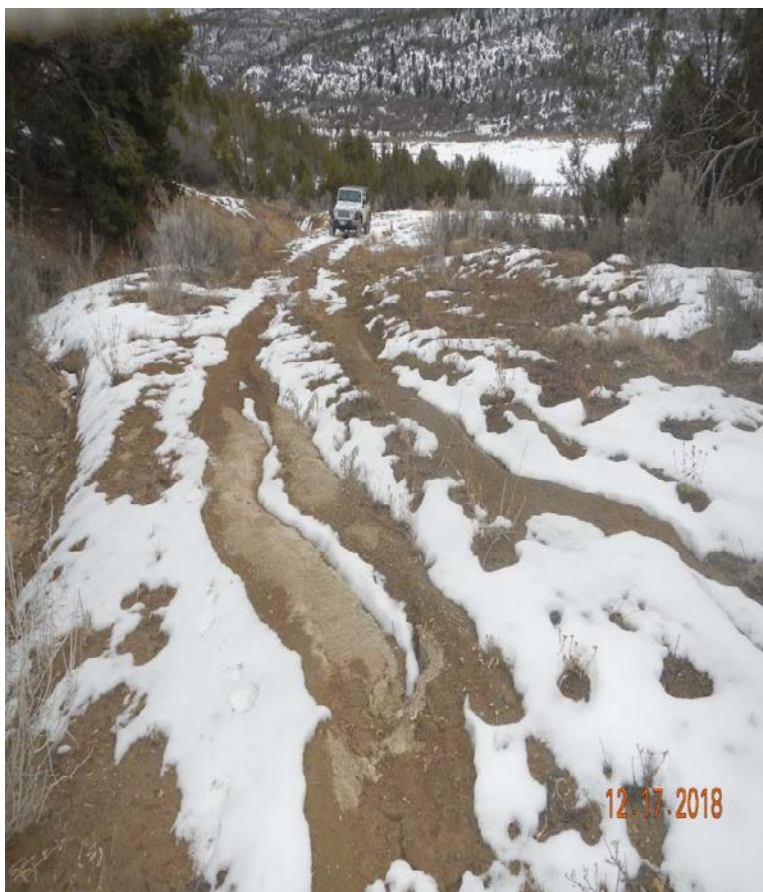
Photo#4:
View moving up & along road to the North.

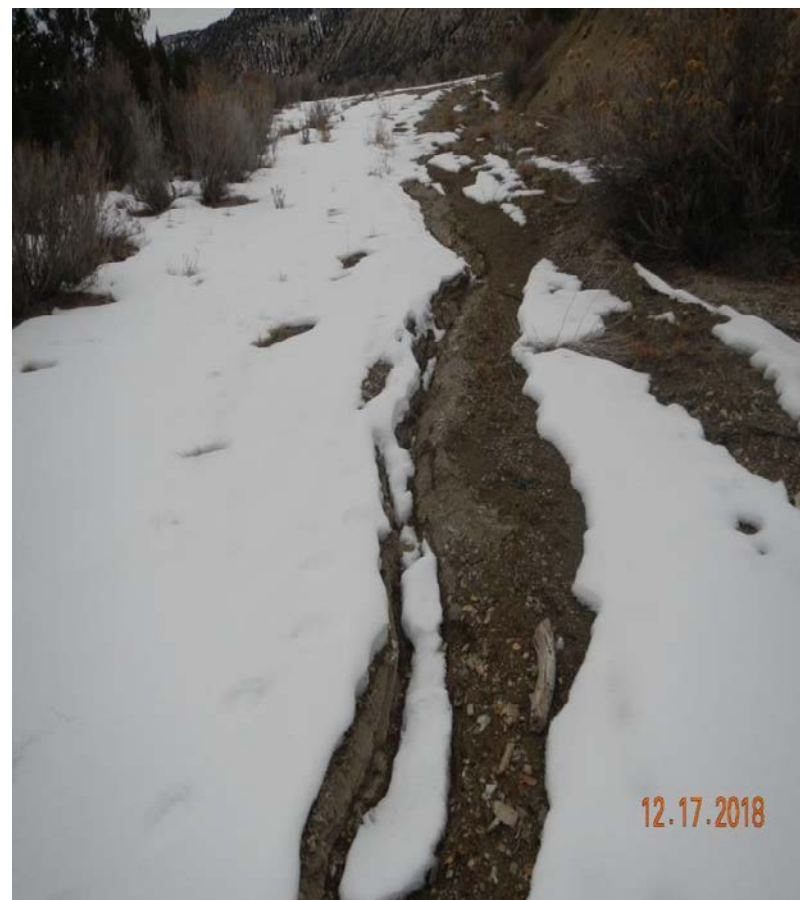
Photo#5:
View moving up & along road to the North.

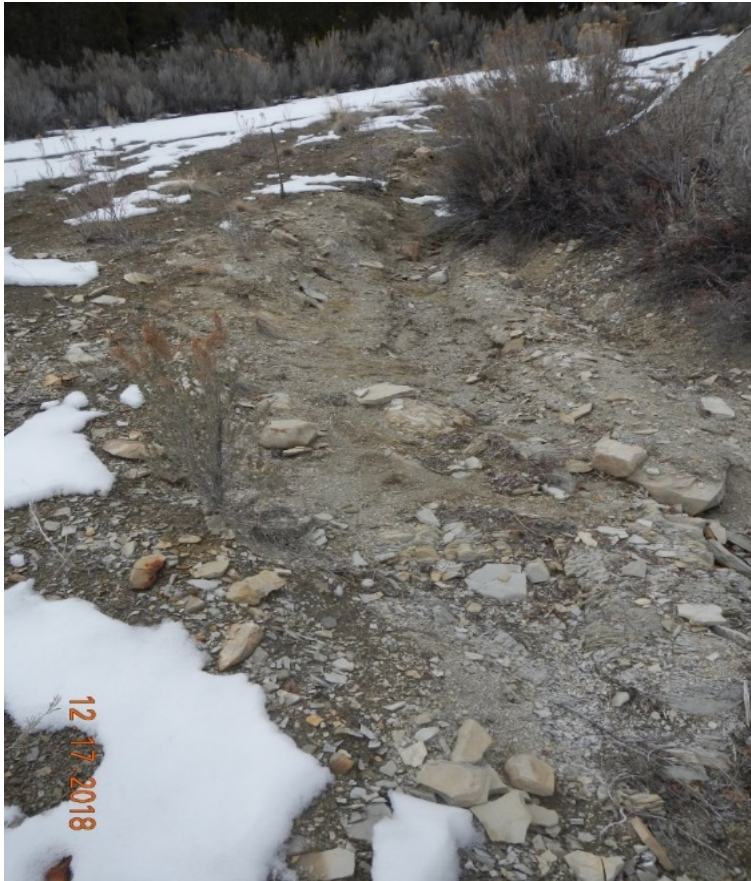
Photo#6:
View moving up & along road to the North.

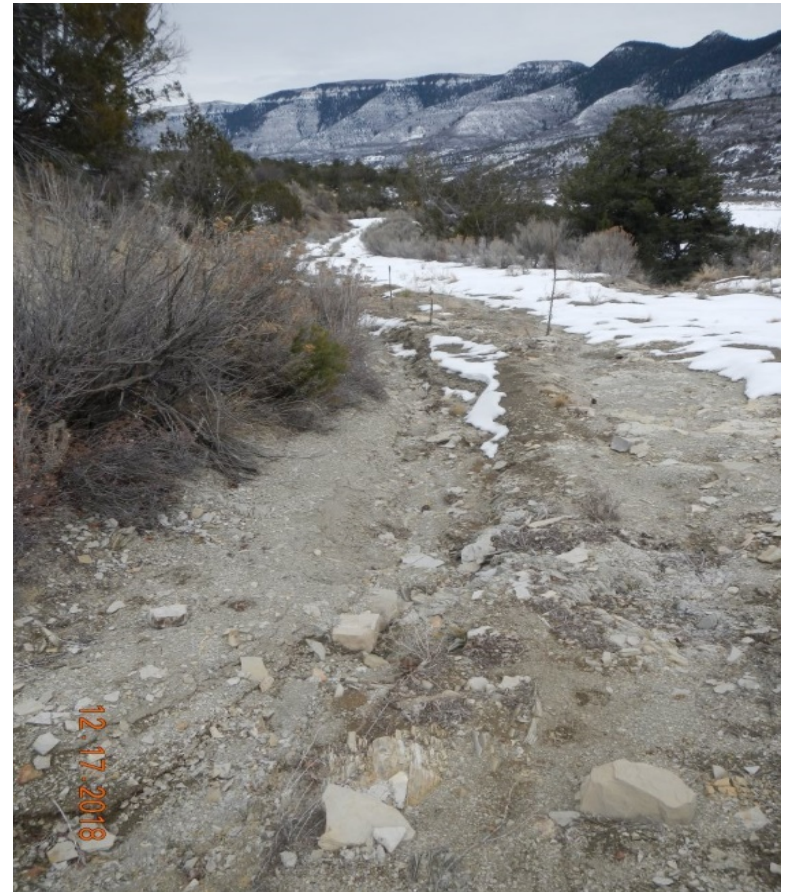
Photo#7:
View moving up & along road to the North.

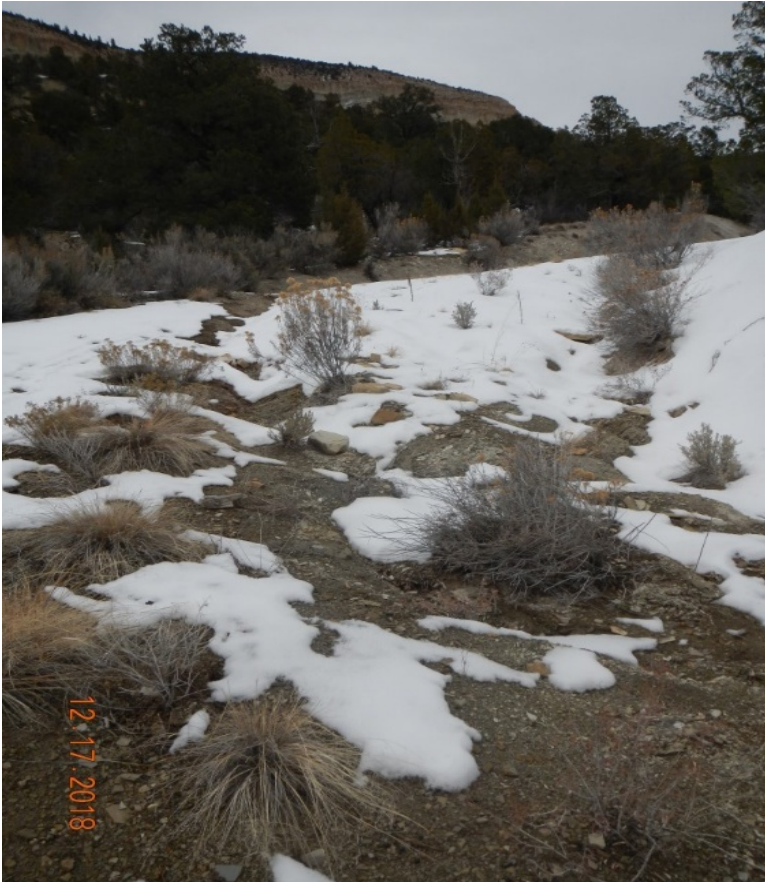
Photo#8:
View moving up & along road to the North.

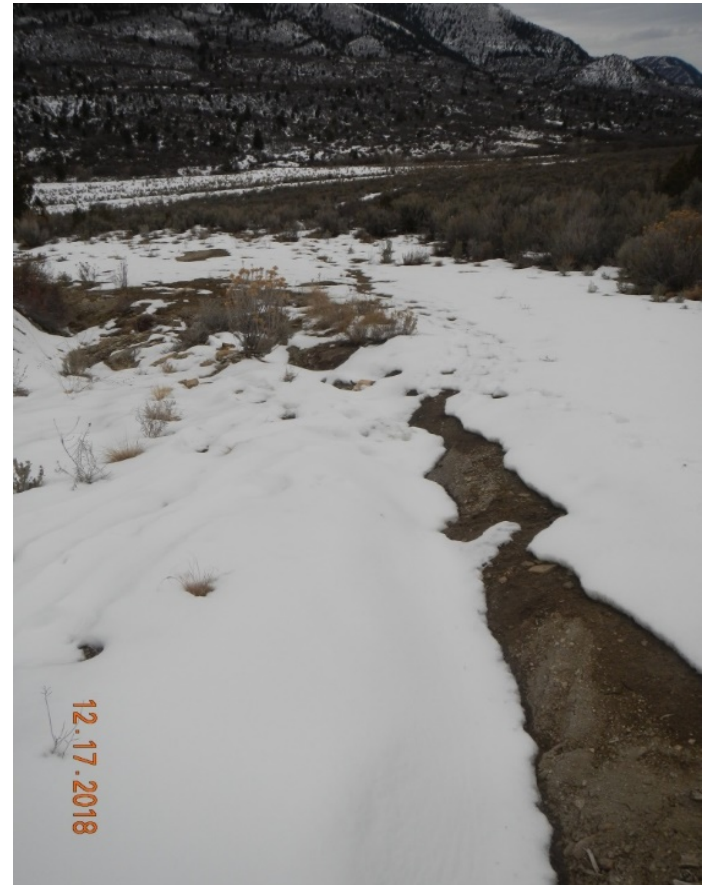
Photo#9:
View moving up & along road to the North.

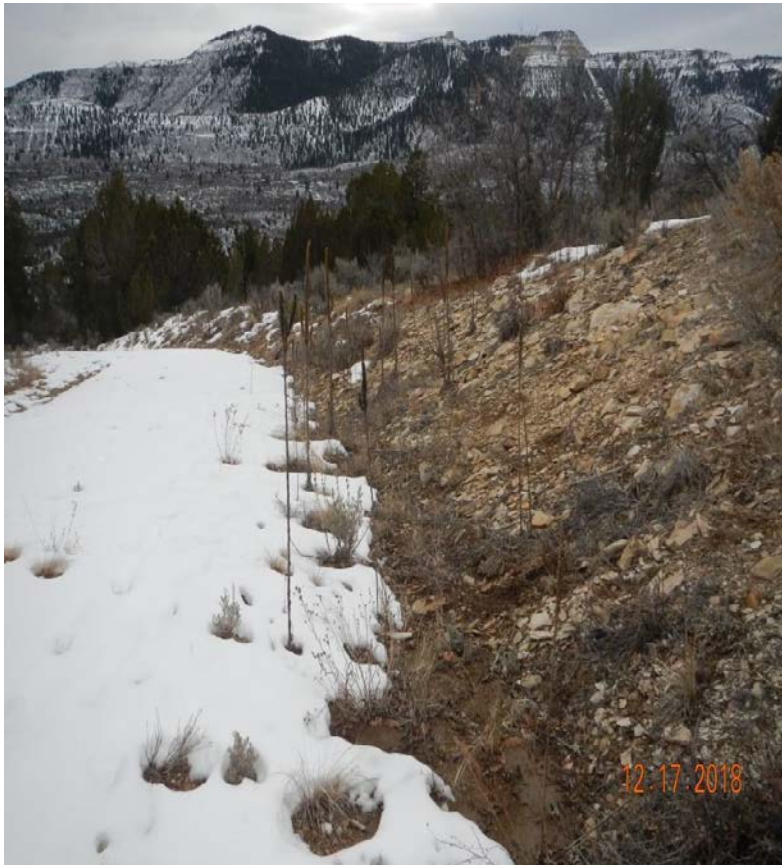
Photo#10:
View as road ascends to top of grade; Note C list weed, Mullein established on cut bank.

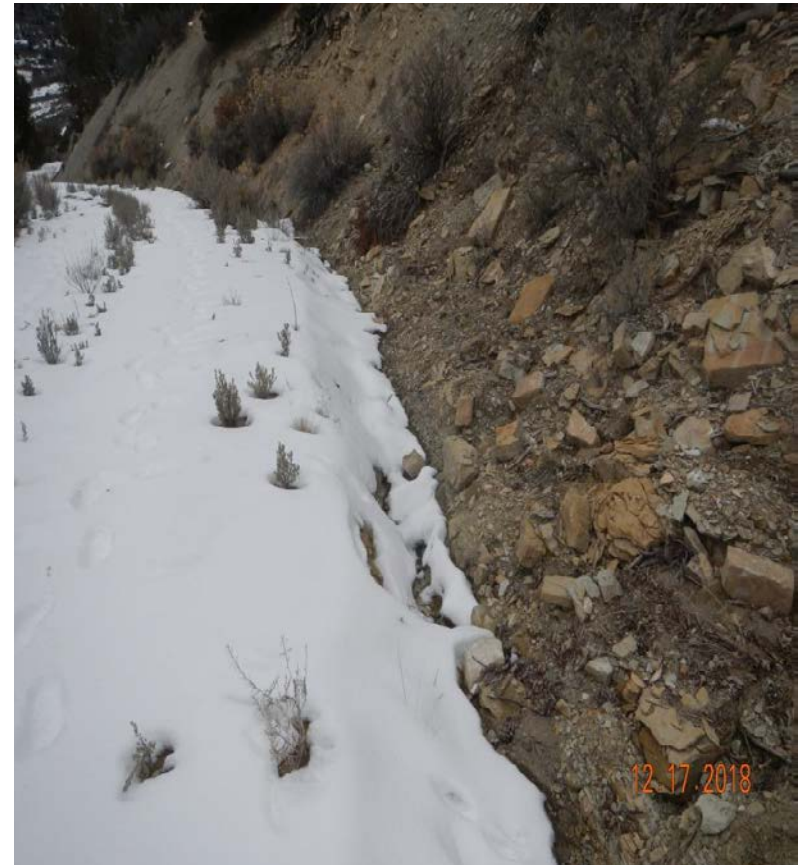
Photo#11:
View as road ascends to top of grade.

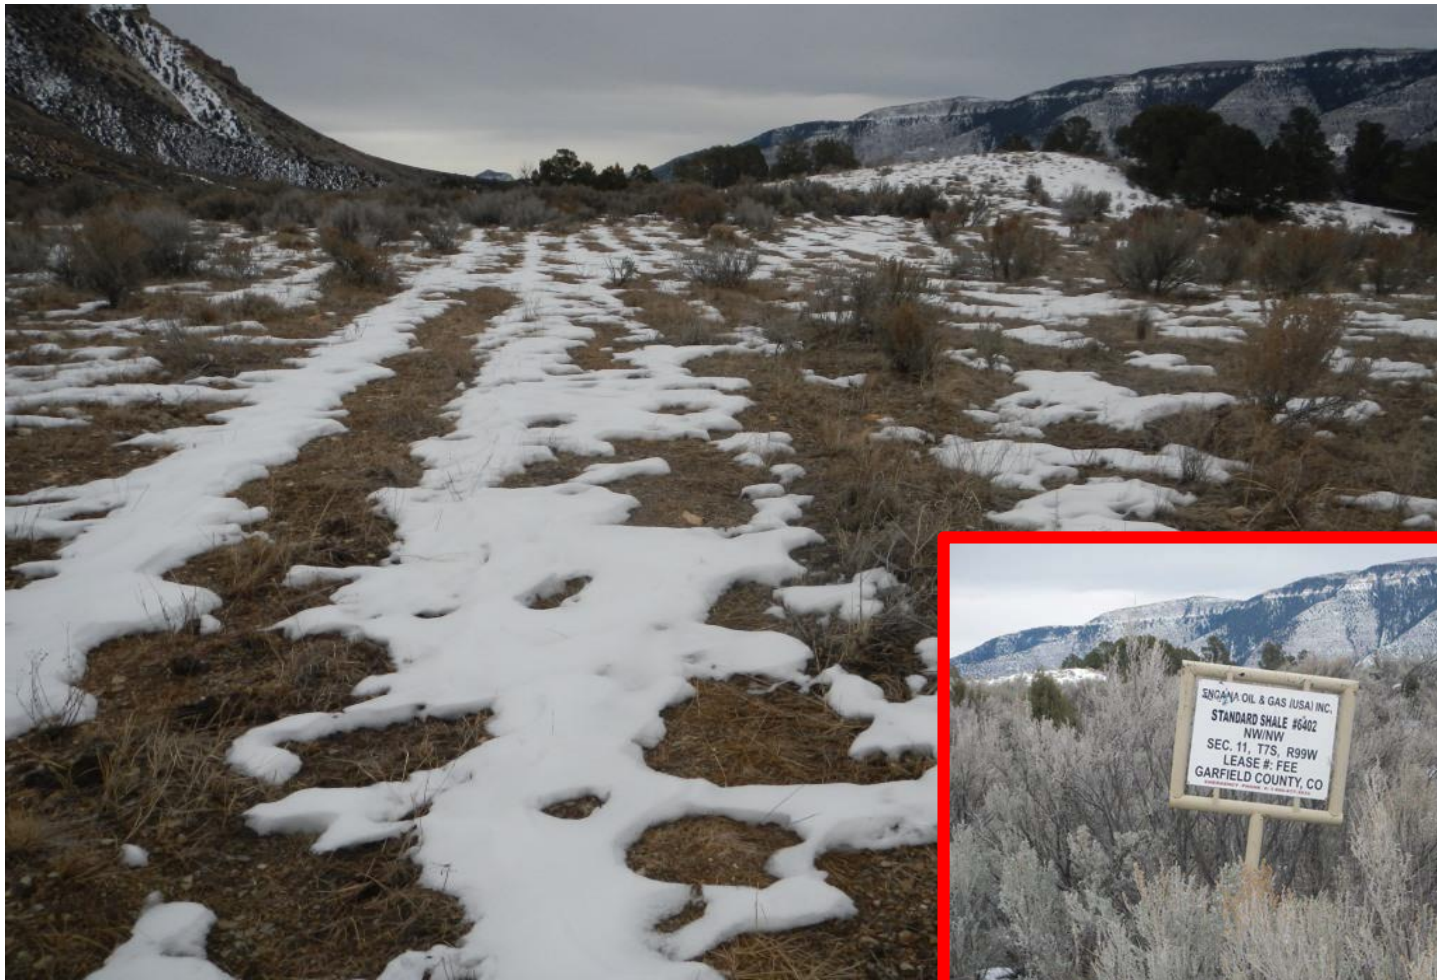
Photo#12:
View on top, to East where road enters into Location.
