Final Reclamation and Stormwater Inspection

Operator: ANADARKO E&P ONSHORE LLC - 2800

Location ID: 380608

Inspection Document #: 674902364

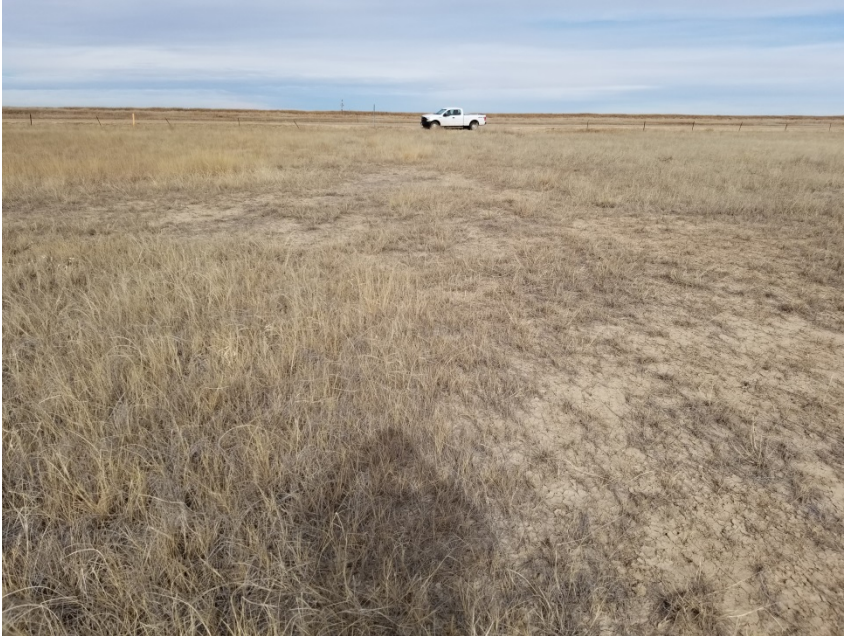
Photo 1. Photo taken from the location, facing North. Appears the Operator has performed final reclamation activities. However, several locations throughout the site lack uniform perennial vegetation and are covered in weedy, annual vegetation which includes but not limited to kochia.

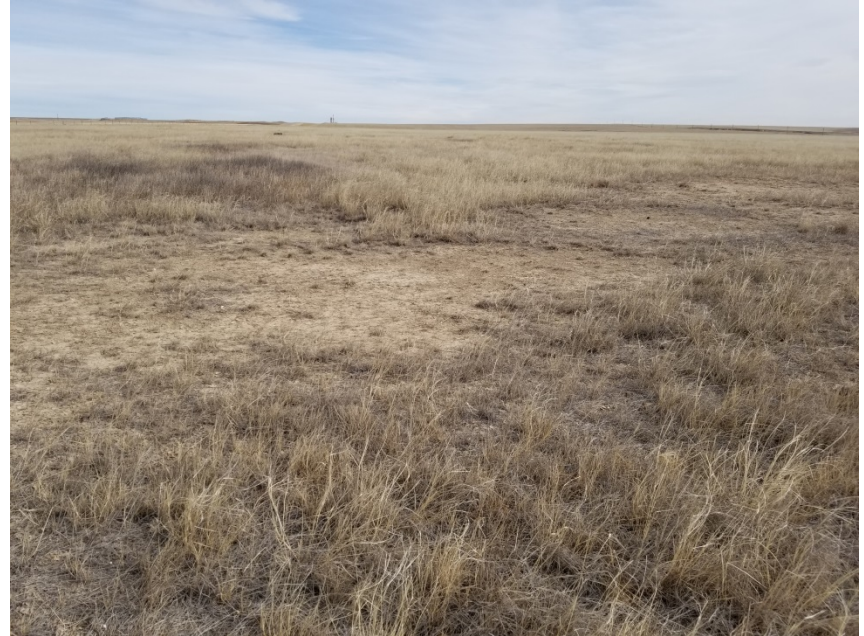
Photo 2. Photo taken from the location, facing South. See comments from Photo 1.

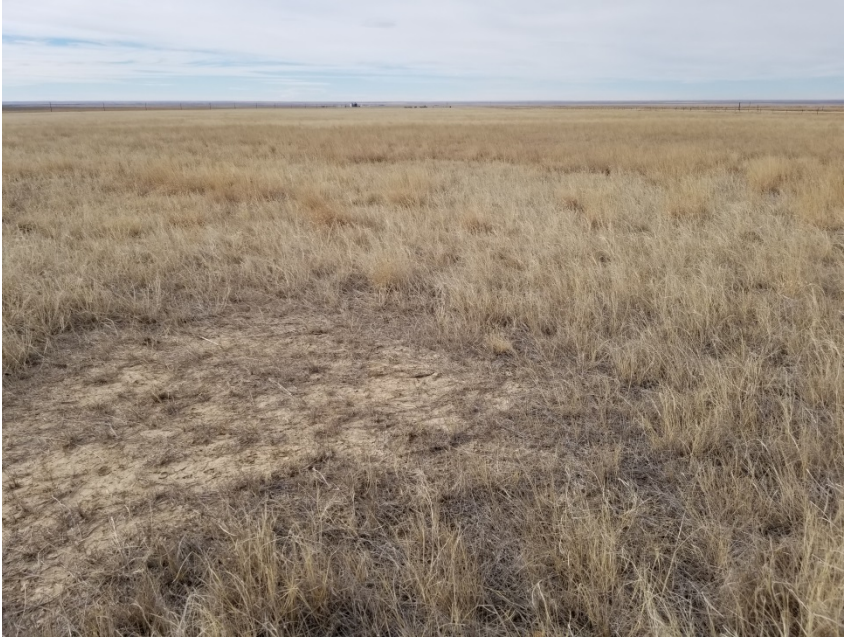
Photo 3. Photo taken from the location, facing East. See comments from Photo 1.

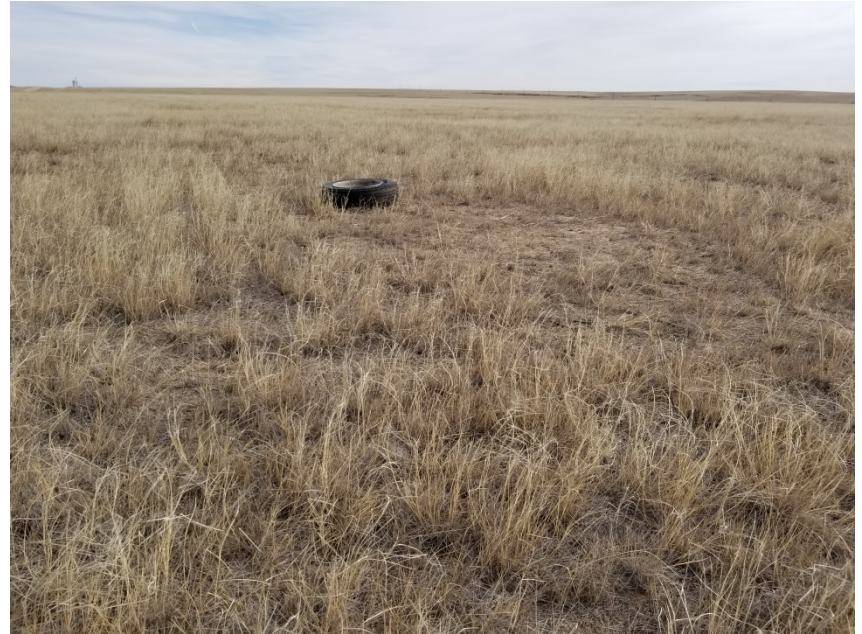
Photo 4. Photo taken from the location, facing East. See comments from Photo 1 and note the debris left on site.

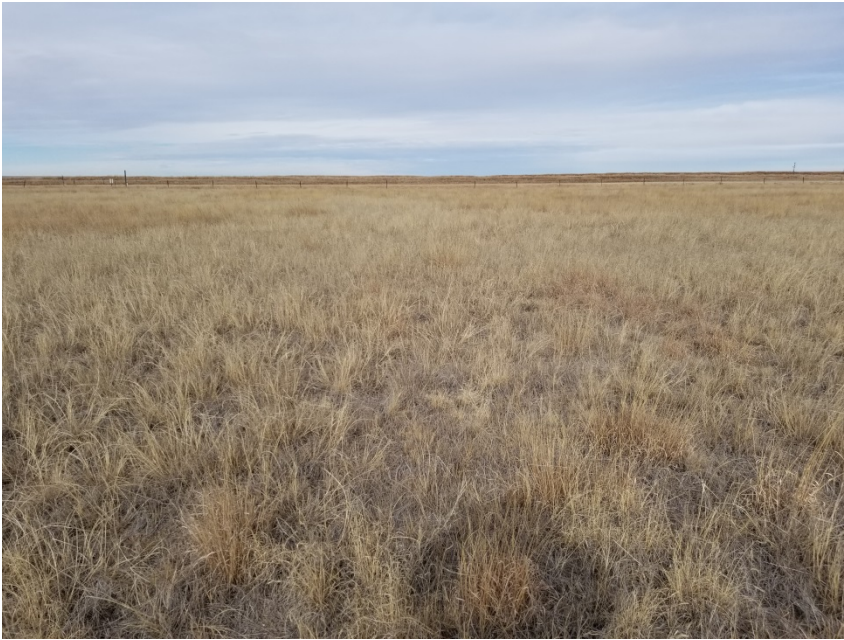
Photo 5. Photo taken from the reference location , facing North. Note the uniform perennial grass cover.

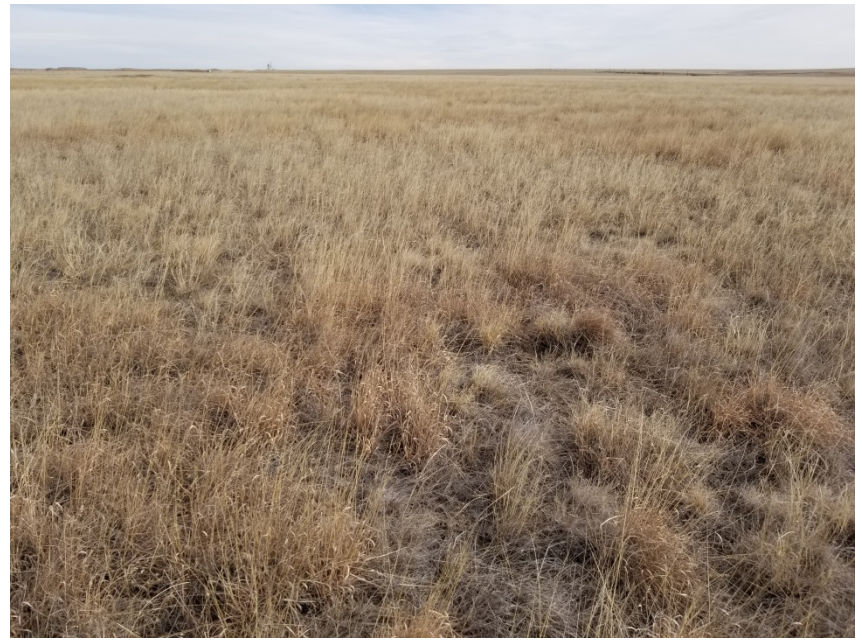
Photo 6. Photo taken from the reference location , facing East. See comments from Photo 5.

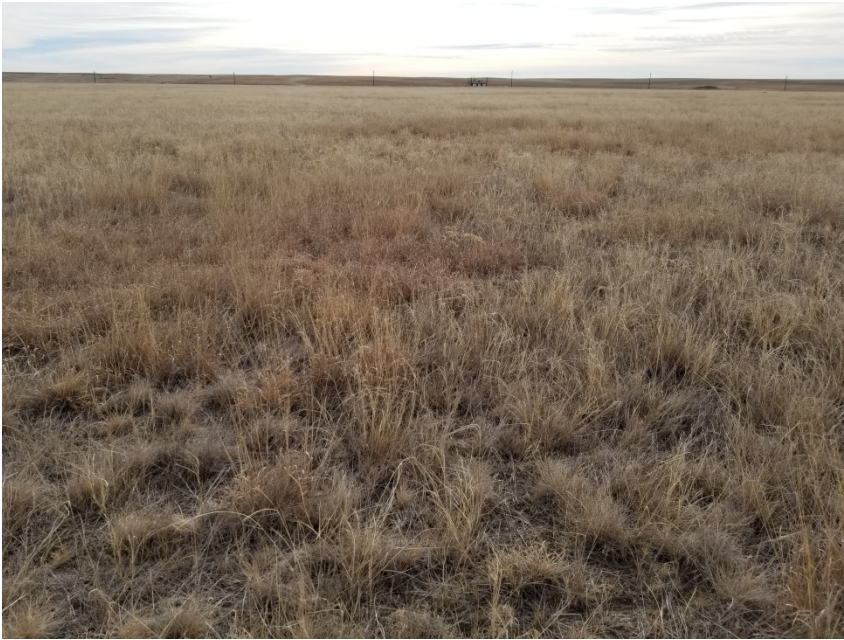
Photo 7. Photo taken from the reference location , facing South. See comments from Photo 5.

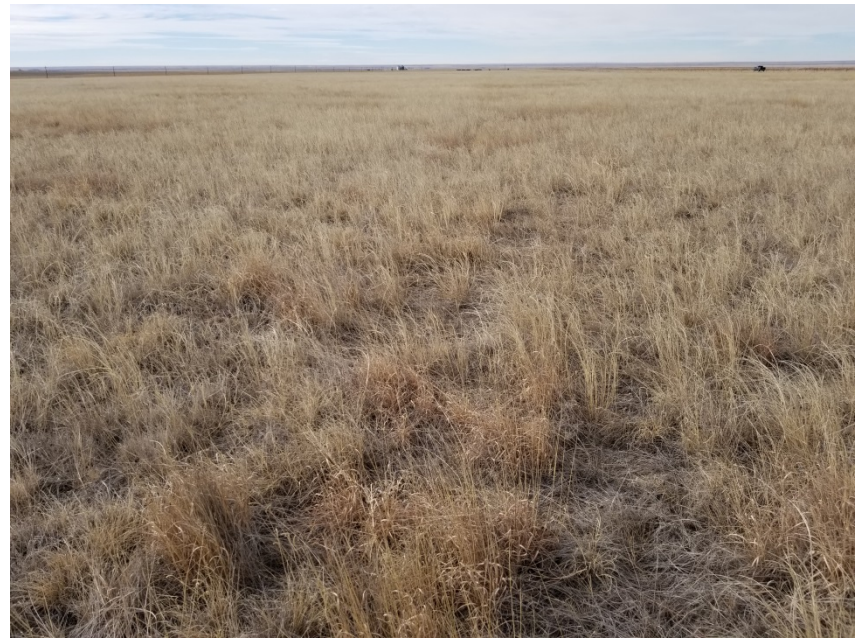
Photo 8. Photo taken from the reference location , facing West. See comments from Photo 5.
