Inspection Photos

Operator: ST CROIX OPERATING INC # 81490

Location ID: 458423

Inspection Doc. Number: 682504351

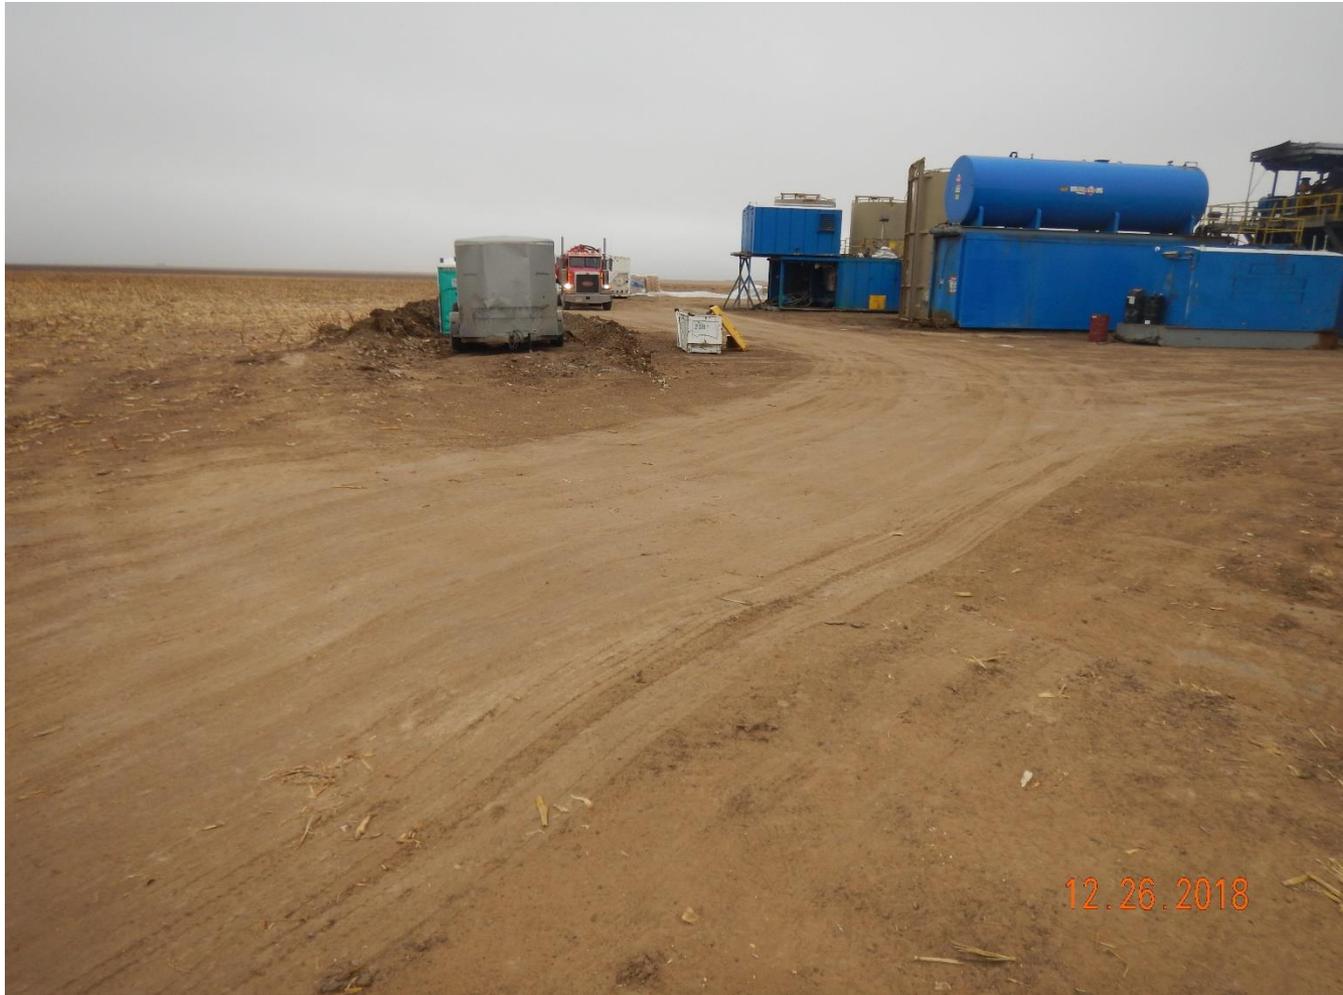
Photo 1: Photo taken from the southwest corner of the location, facing north. Photo shows a sotrmwater ditch has been constructed along the perimeter of the pad.

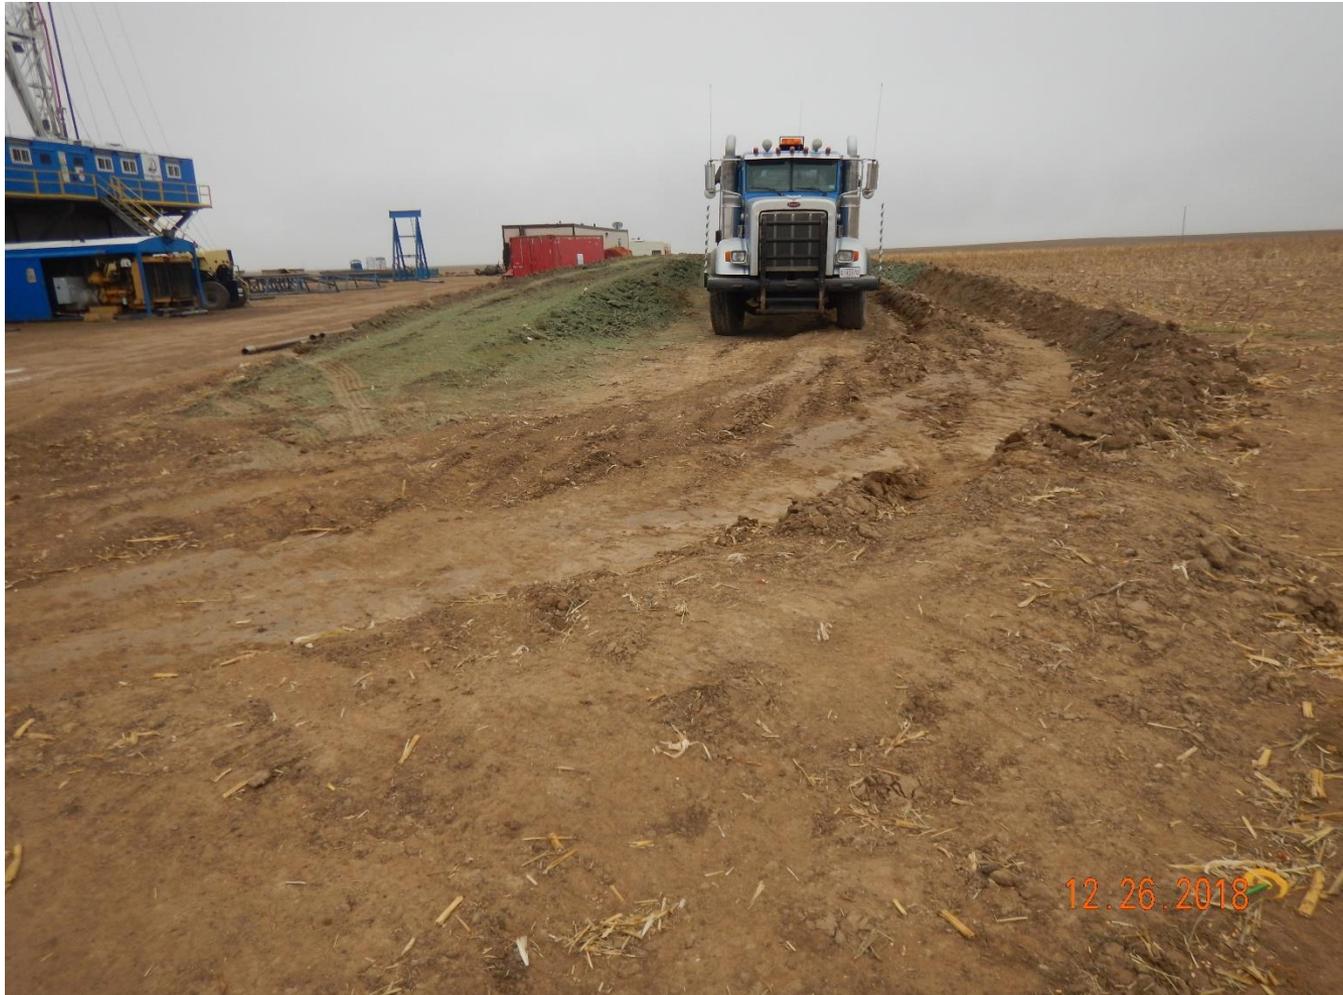
Photo 2: Photo taken from the southwest corner of the location, facing east. Photo shows a sotrmwater ditch has been constructed along the perimeter of the pad. Ditch does not appear to have been constructed with good engineering practices.

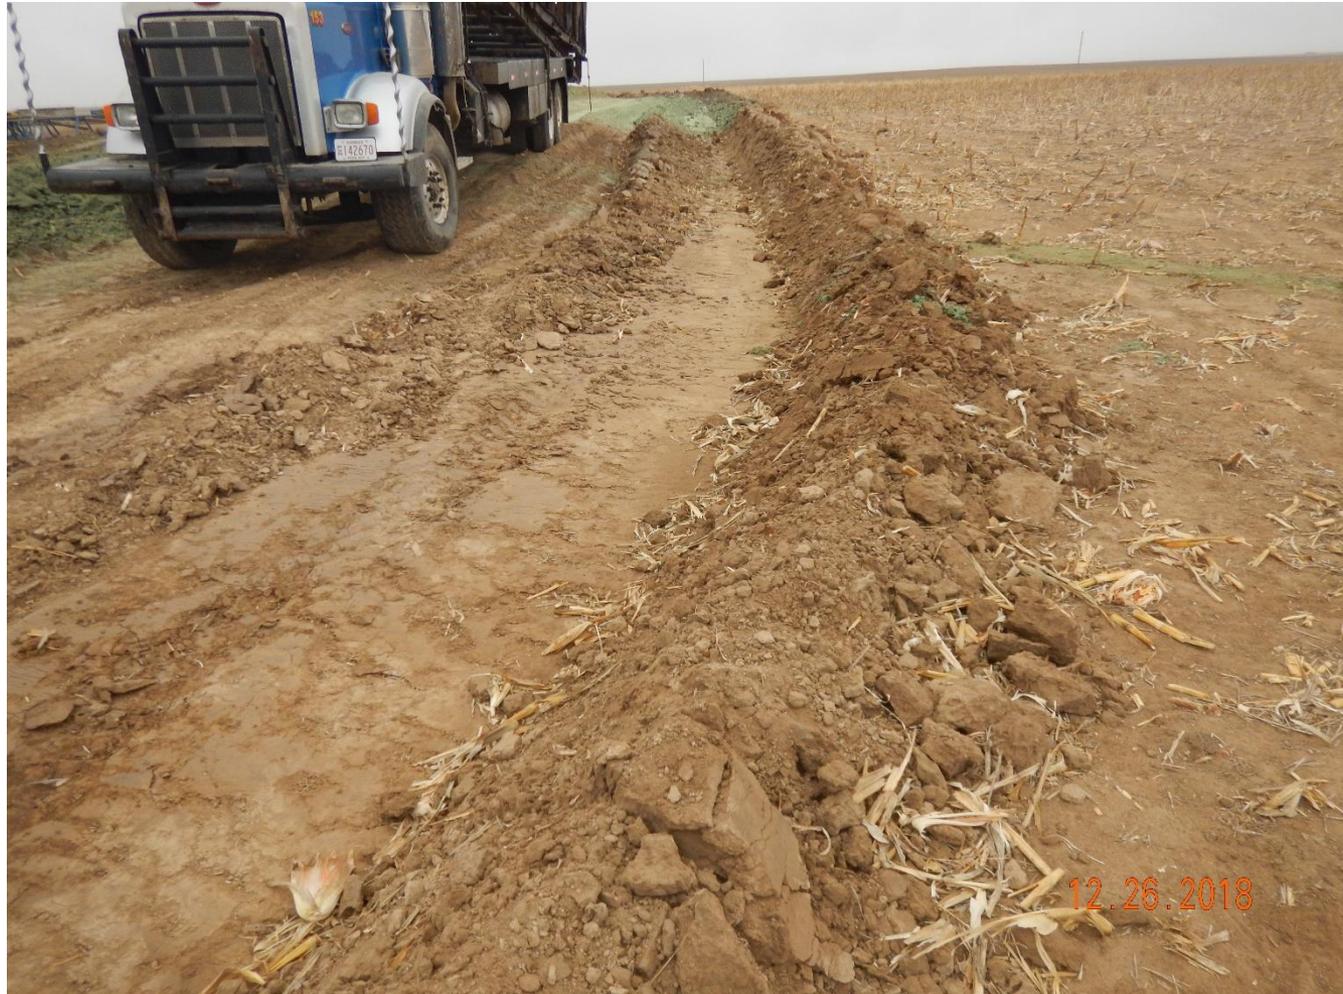
Photo 3: Photo taken from the southwest corner of the location, facing east. Photo shows a sotrmwater ditch has been constructed along the perimeter of the pad. Ditch does not appear to have been constructed with good engineering practices; ditch walls have not been compacted with unconsolidated soils left as a “berm”.

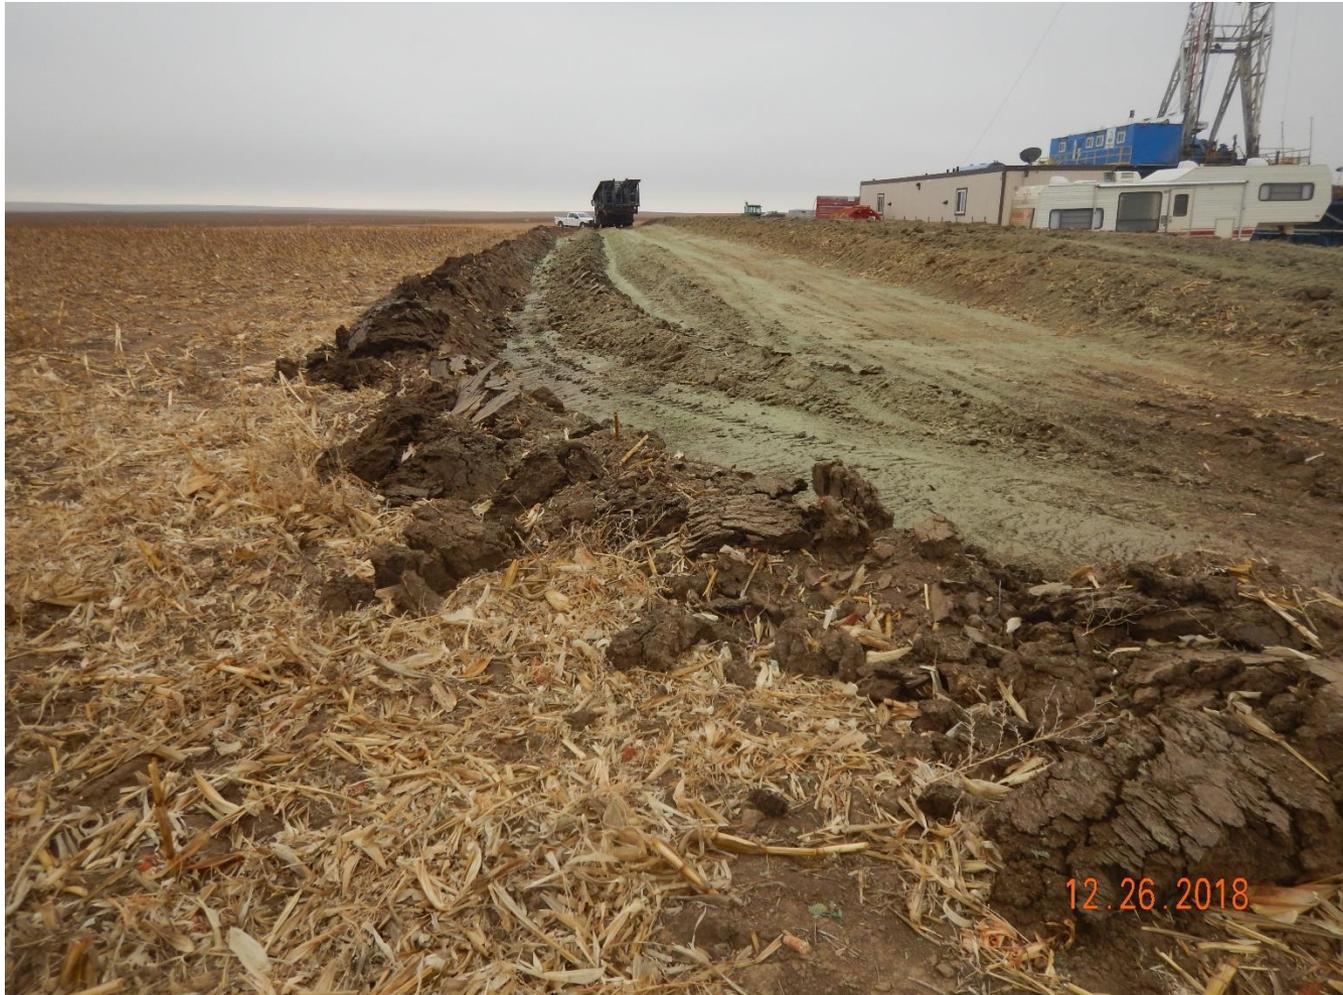
Photo 4: Photo taken from the southeast corner of the location, facing west Photo shows a sotrmwater ditch has been constructed along the perimeter of the pad. Ditch does not appear to have been constructed with good engineering practices; ditch walls have not been compacted with unconsolidated soils left as a “berm”.

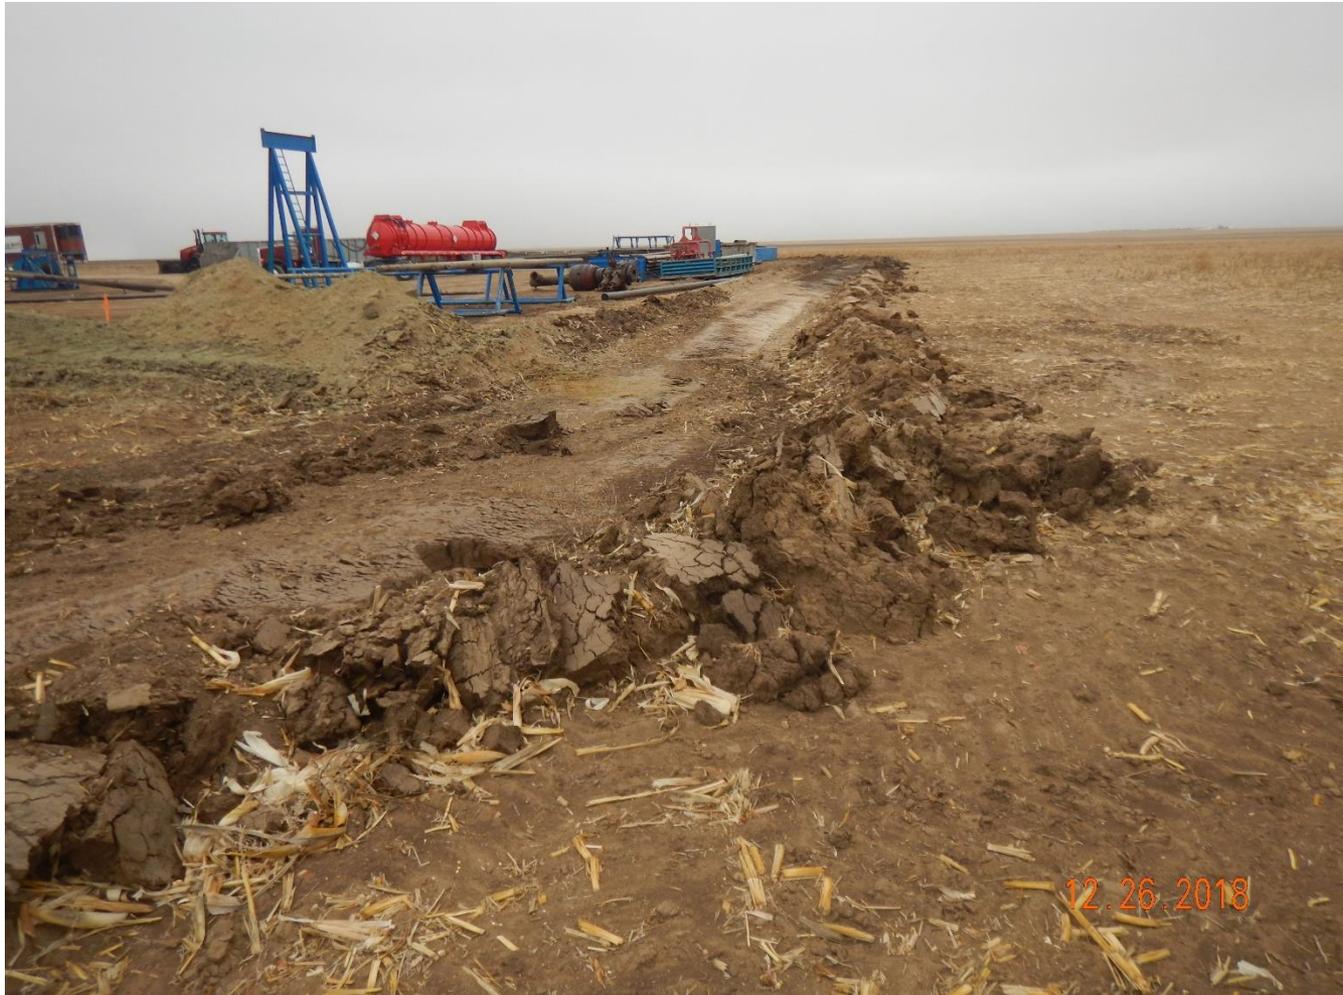
Photo 5: Photo taken from the southeast corner of the location, facing north. Photo shows a stormwater ditch has been constructed along the perimeter of the pad. Ditch does not appear to have been constructed with good engineering practices; ditch walls have not been compacted with unconsolidated soils left as a “berm”.

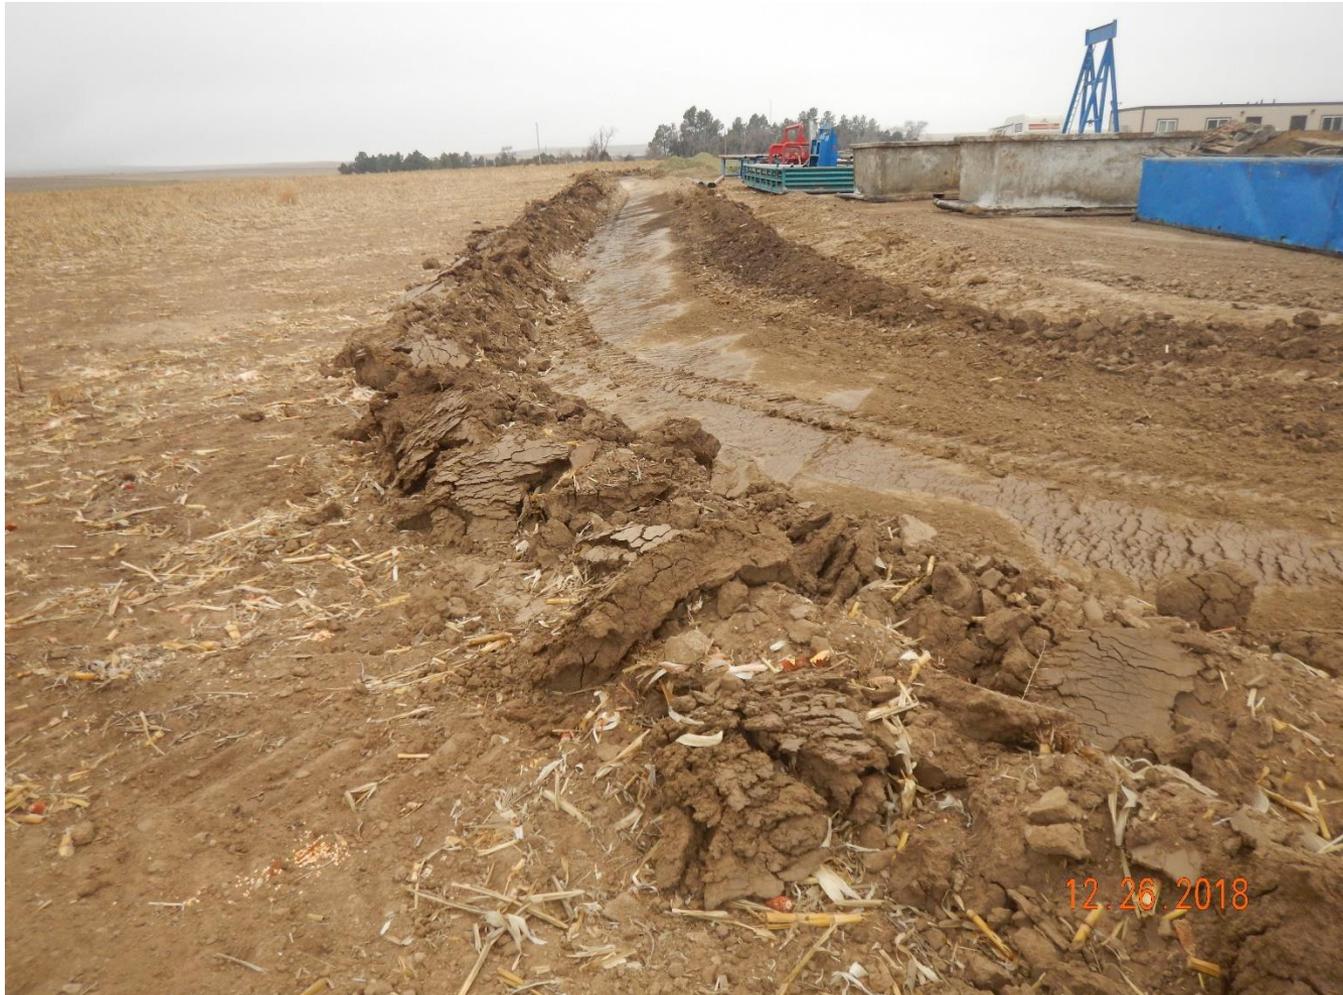
Photo 6: Photo taken from the northeast corner of the location, facing southwest. Photo shows a stormwater ditch has been constructed along the perimeter of the pad. Ditch does not appear to have been constructed with good engineering practices; ditch walls have not been compacted with unconsolidated soils left as a “berm”.

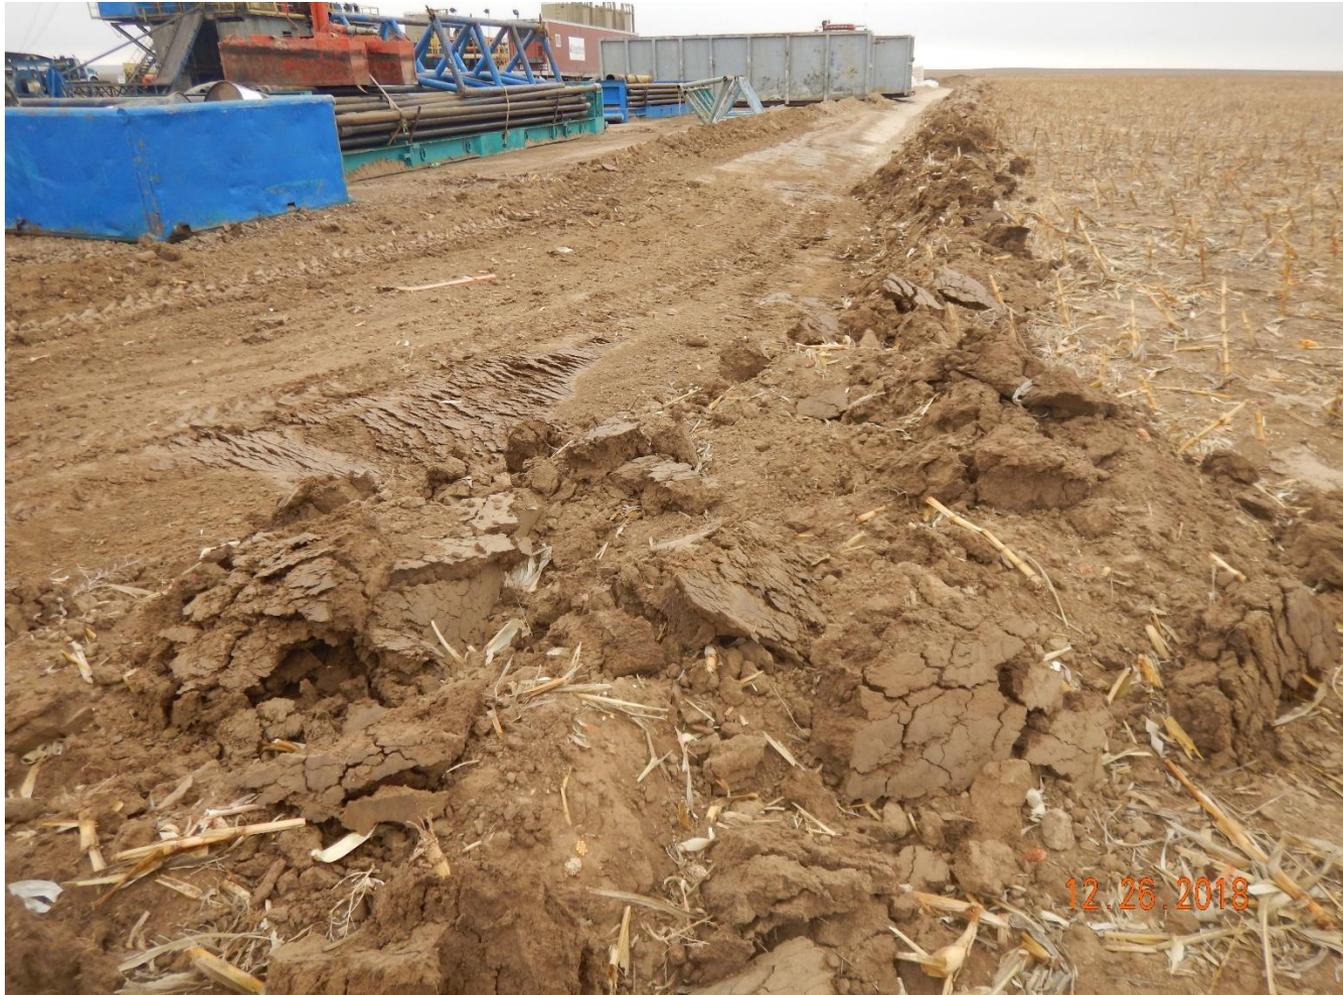
Photo 7: Photo taken from the northeast corner of the location, facing west Photo shows a sotrmwater ditch has been constructed along the perimeter of the pad. Ditch does not appear to have been constructed with good engineering practices; ditch walls have not been compacted with unconsolidated soils left as a “berm”.

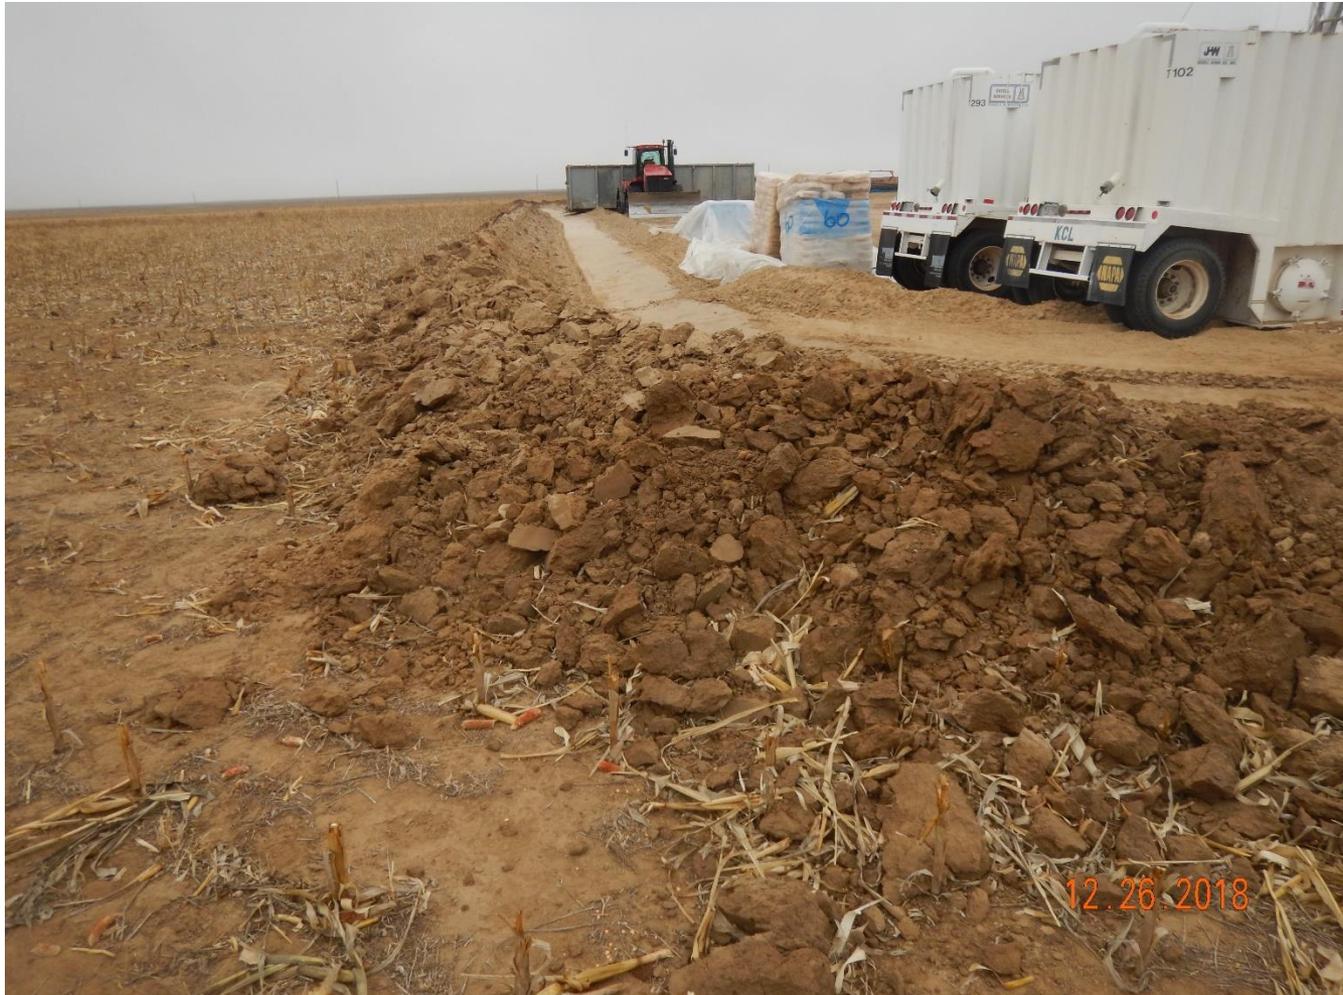
Photo 8: Photo taken from the northwest corner of the location, facing east Photo shows a sotrmwater ditch has been constructed along the perimeter of the pad. Ditch does not appear to have been constructed with good engineering practices; ditch walls have not been compacted with unconsolidated soils left as a “berm”.

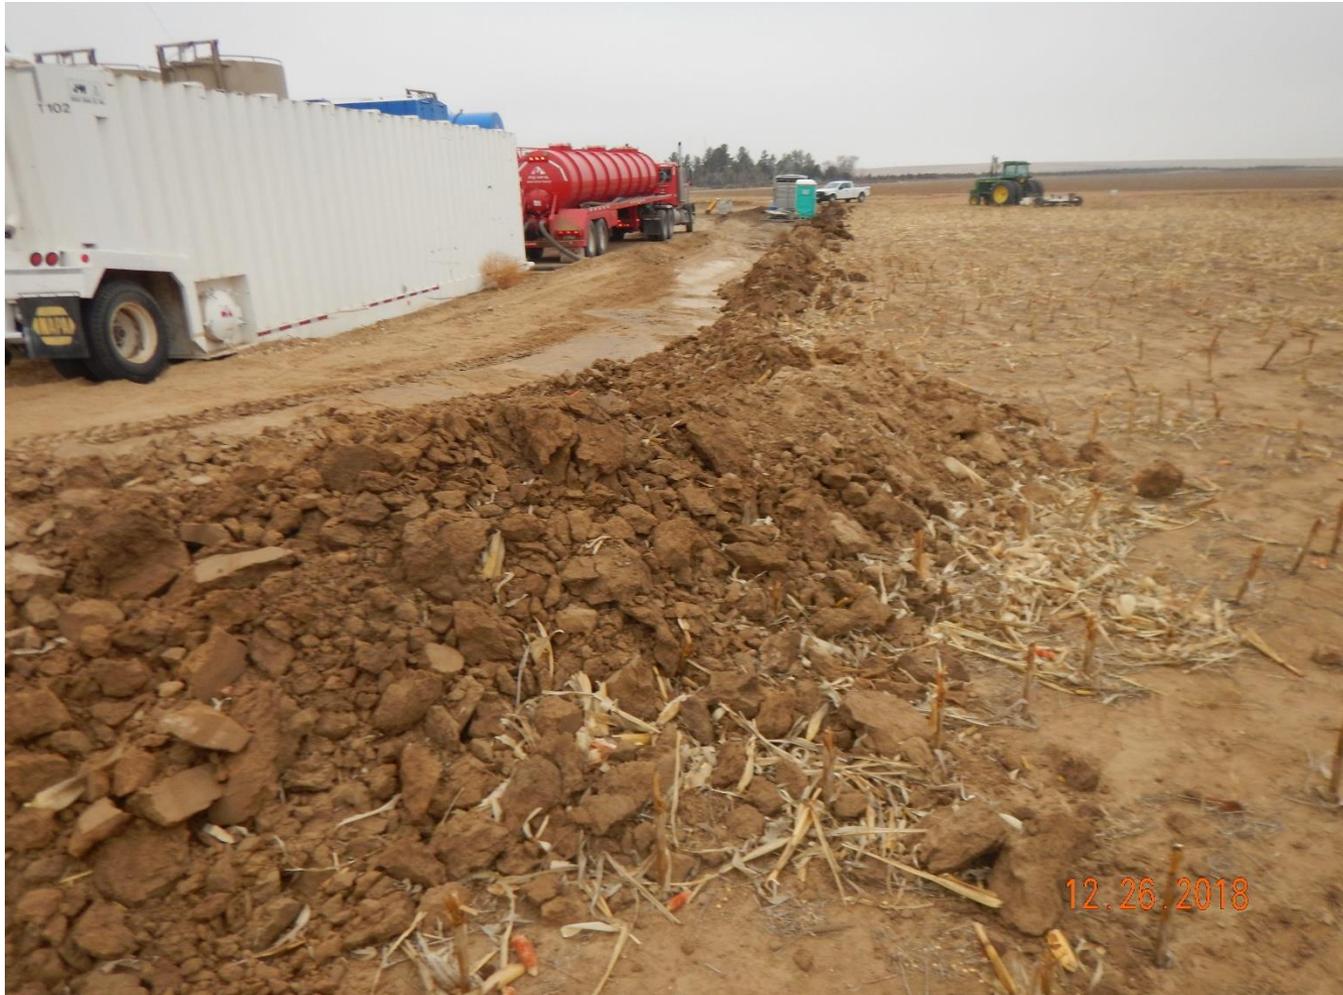
Photo 9: Photo taken from the northwest corner of the location, facing southwest. Photo shows a stormwater ditch has been constructed along the perimeter of the pad. Ditch does not appear to have been constructed with good engineering practices; ditch walls have not been compacted with unconsolidated soils left as a “berm”.
