Final Reclamation and Stormwater Inspection

December 21, 2018

Operator: VECTA OIL & GAS LTD – 10267

Location ID: 418793

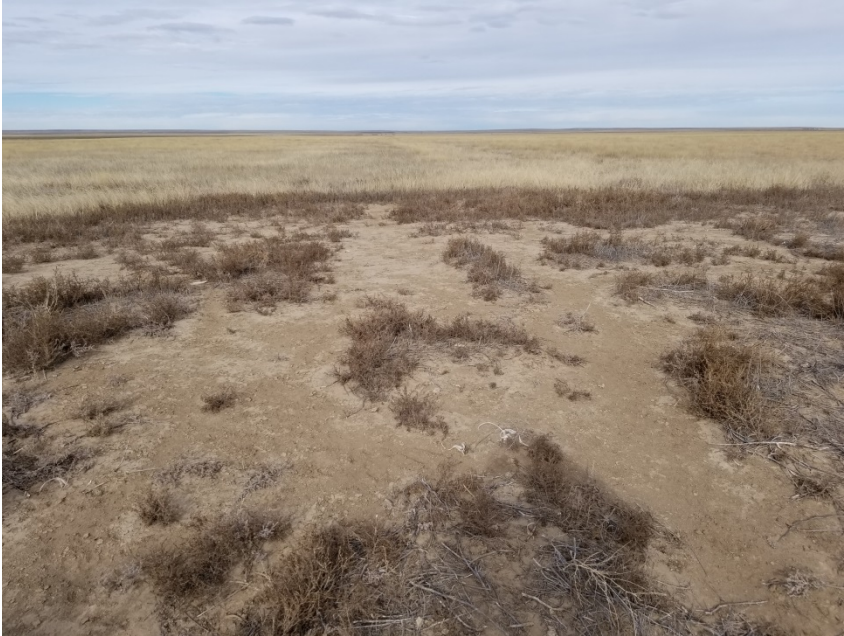
Photo 1. Photo taken from the location, facing East. Appears the Operator has performed final reclamation activities, with the evidence of drilling rows and straw crimped mulch. However, the majority of the site is barren or covered in weedy, annual vegetation which includes but not limited to field bindweed and kochia, with little perennial grass cover establishment.

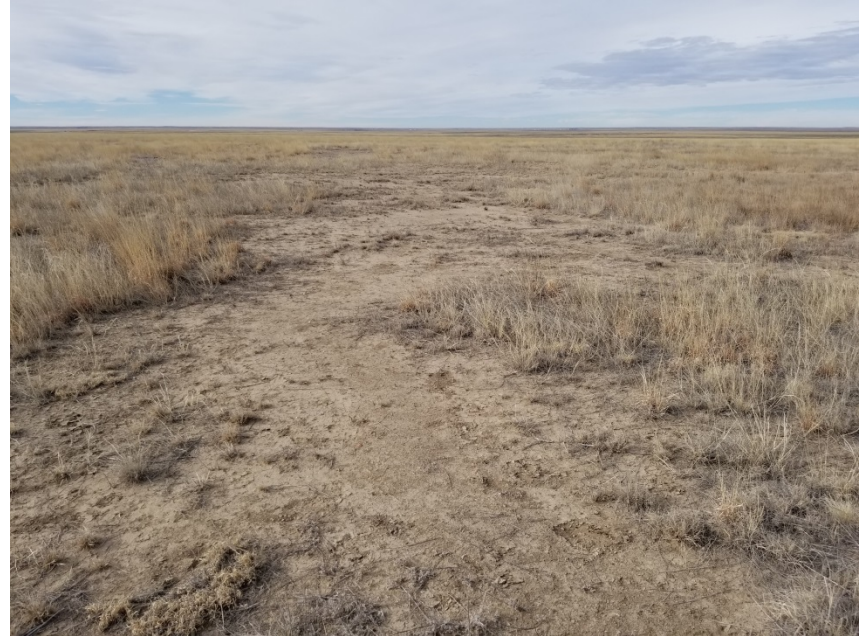
Photo 2. Photo taken from the facility, facing North. See comments from Photo 1.

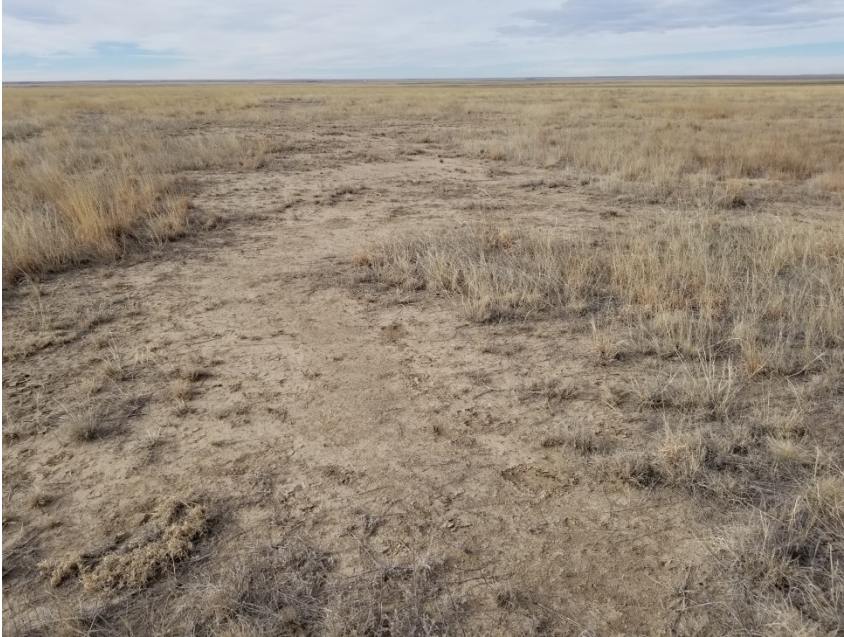
Photo 3. Photo taken from the facility, facing West. See comments from Photo 1.

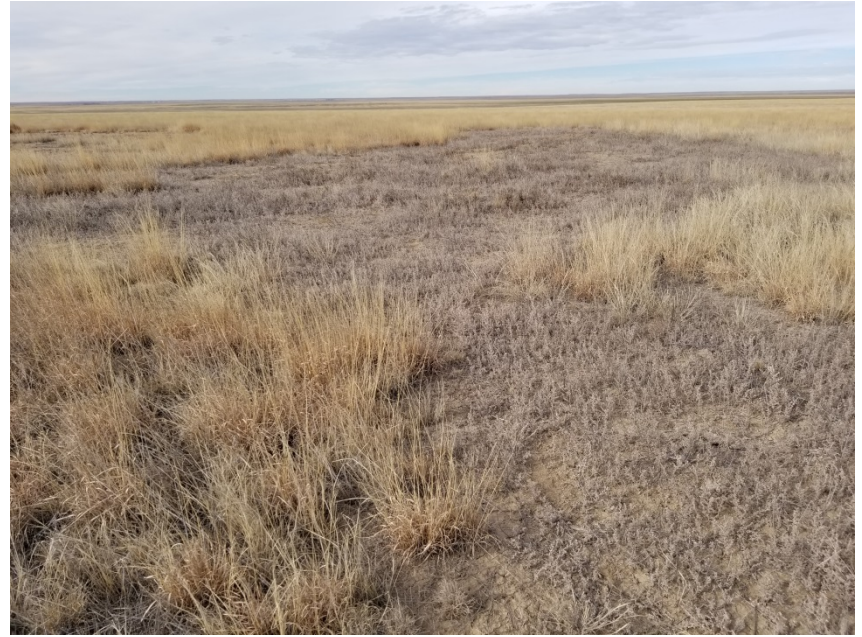
Photo 4. Photo taken from the facility, facing West. See comments from Photo 1.

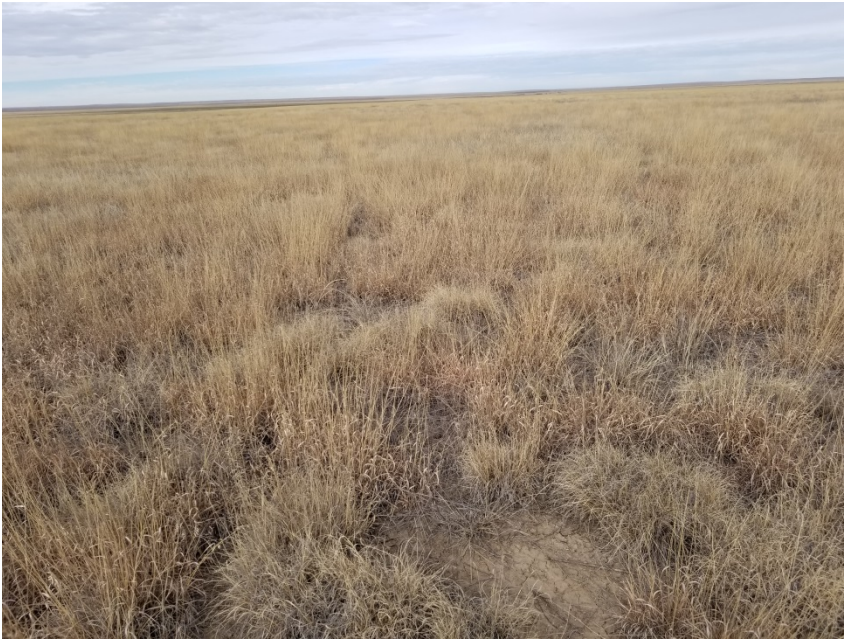
Photo 5. Photo taken from the reference location , facing North. Note the uniform perennial grass cover.

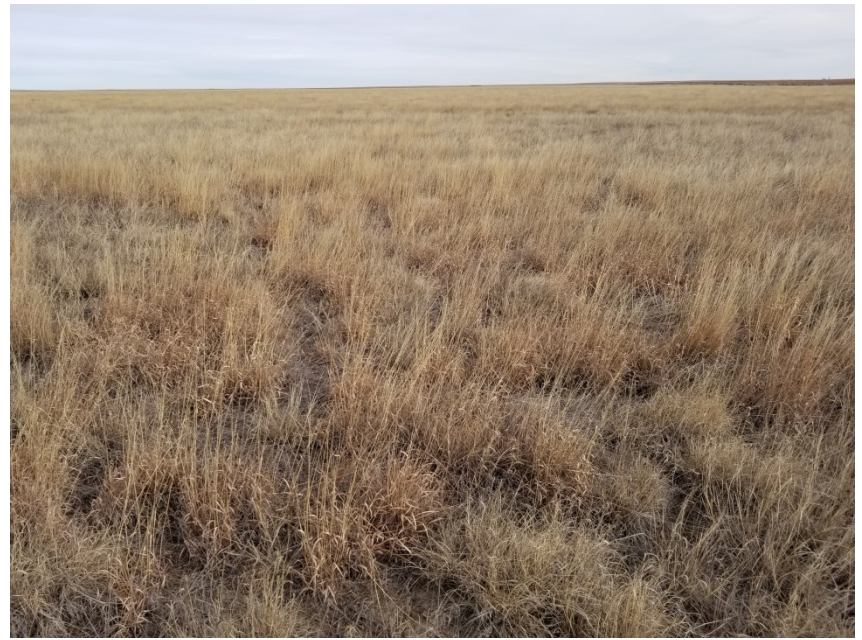
Photo 6. Photo taken from the reference location , facing East. See comments from Photo 5.

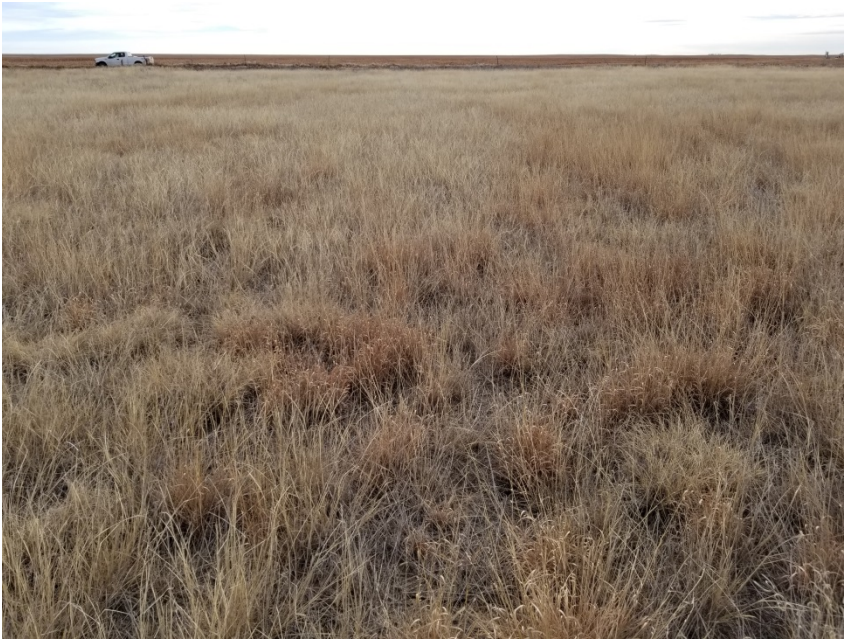
Photo 7. Photo taken from the reference location , facing South. See comments from Photo 5.

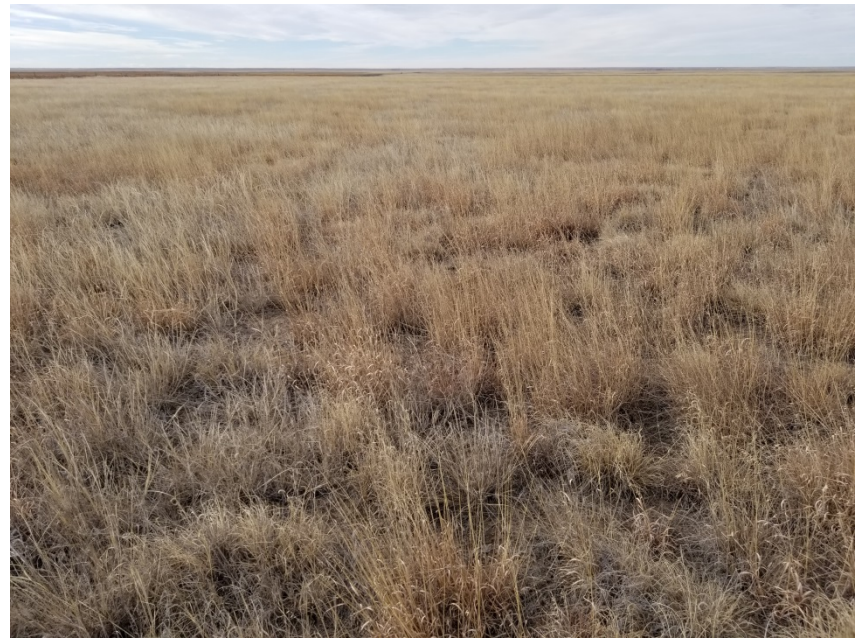
Photo 8. Photo taken from the reference location , facing West. See comments from Photo 5.
