Final Reclamation Inspection

December 24, 2018

Operator: NOBLE ENERGY INC- #100322

Location Name: STATE SLW #18-24

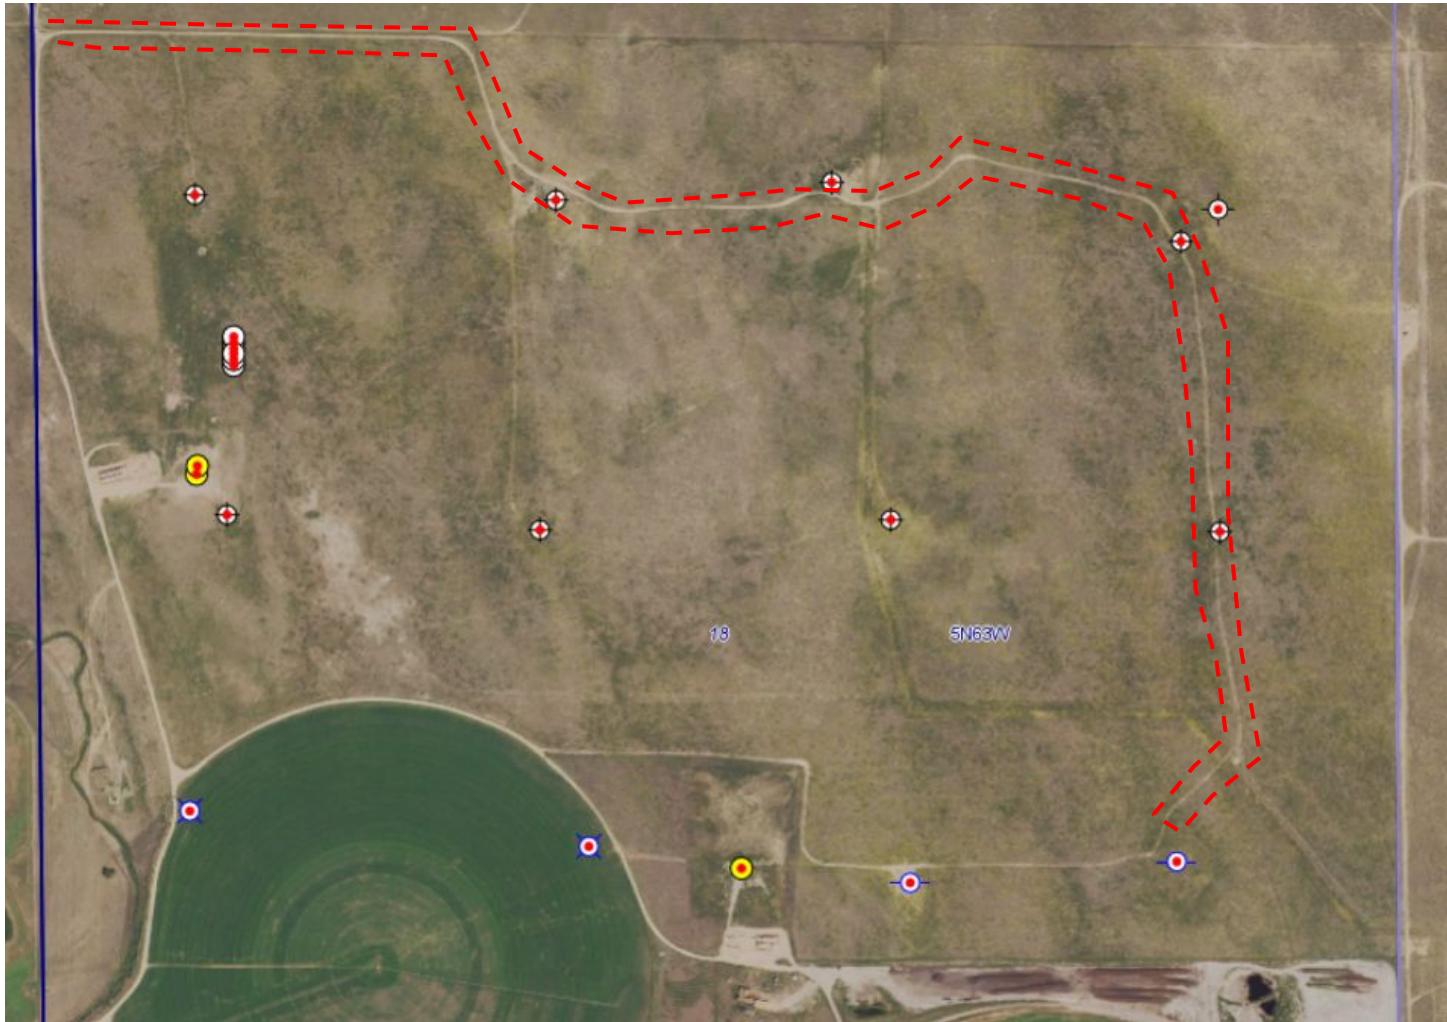
COGCC GISOnline aerial imagery from 2017. The main access road (highlighted in the red-dashed line) is no longer in need for oil and gas operations and historic imagery indicates this was not a pre-existing road. All associated wells and facilities have been plugged and abandoned along the main access road. Last well plugged along the main access road was 8/3/2015.

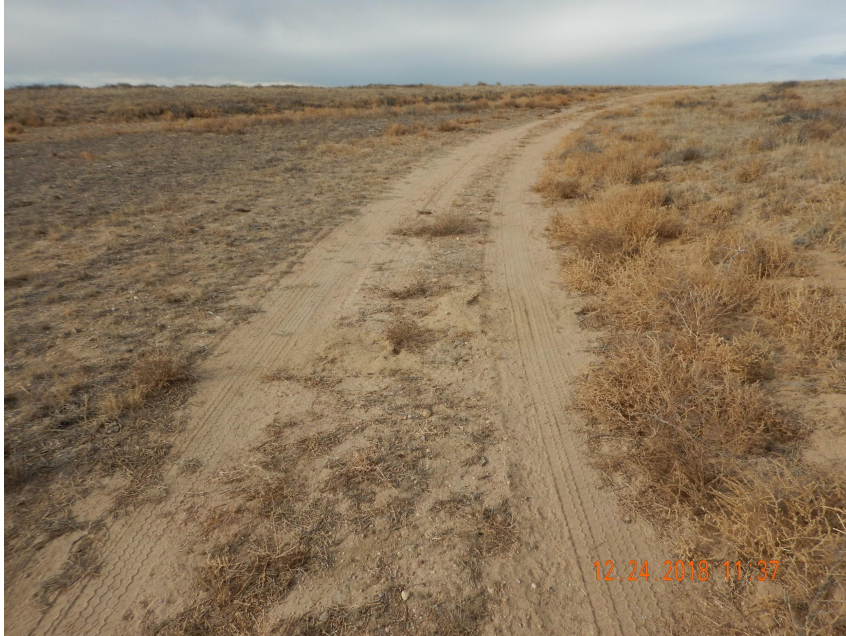
Photo 1. Photo taken from the main access road (shown in the aerial image), facing West. Operator has failed to reclaim the access road per Rule 1004 standards (e.g., recontour, decompact, etc.). Wind erosion was observed along portions of the main access road.

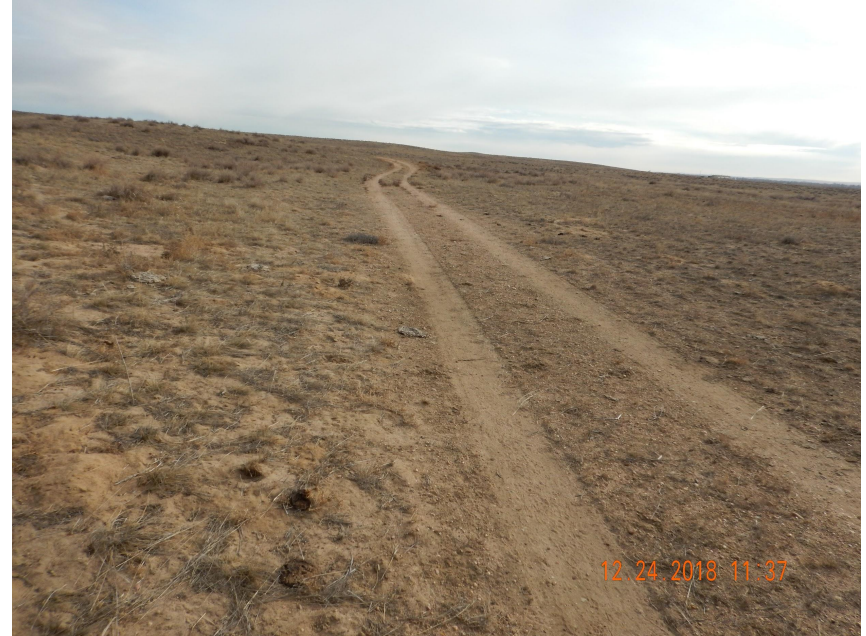
Photo 2. Photo taken from the main access road (shown in the aerial image), facing East. See comments under Photo 1.

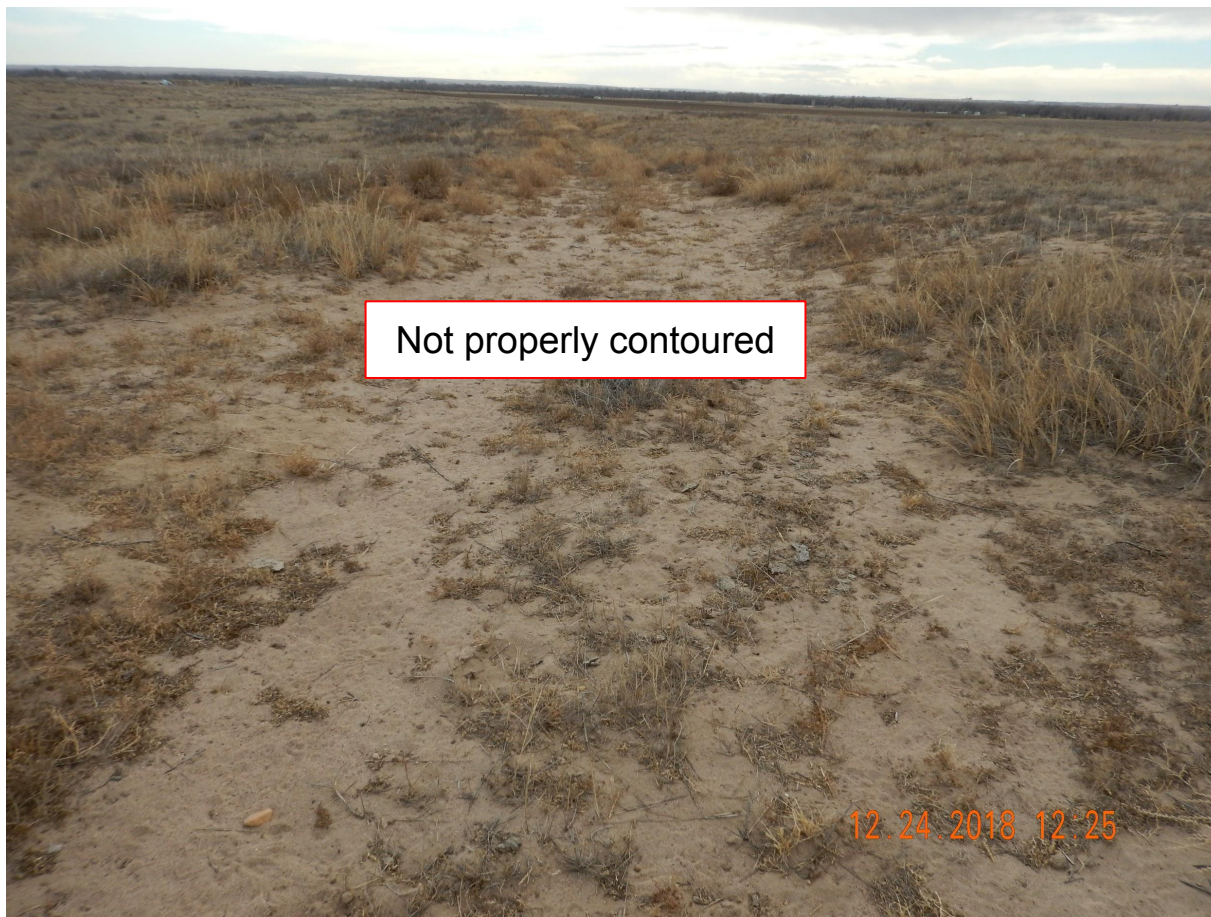
Photo 3. Photo taken from the northern well location access road, facing South. Operator has failed to reclaim the well location access road per Rule 1004 standards (e.g., recontour). Patches of Russian thistle were observed along portions of the access road and bare patches with no vegetation.

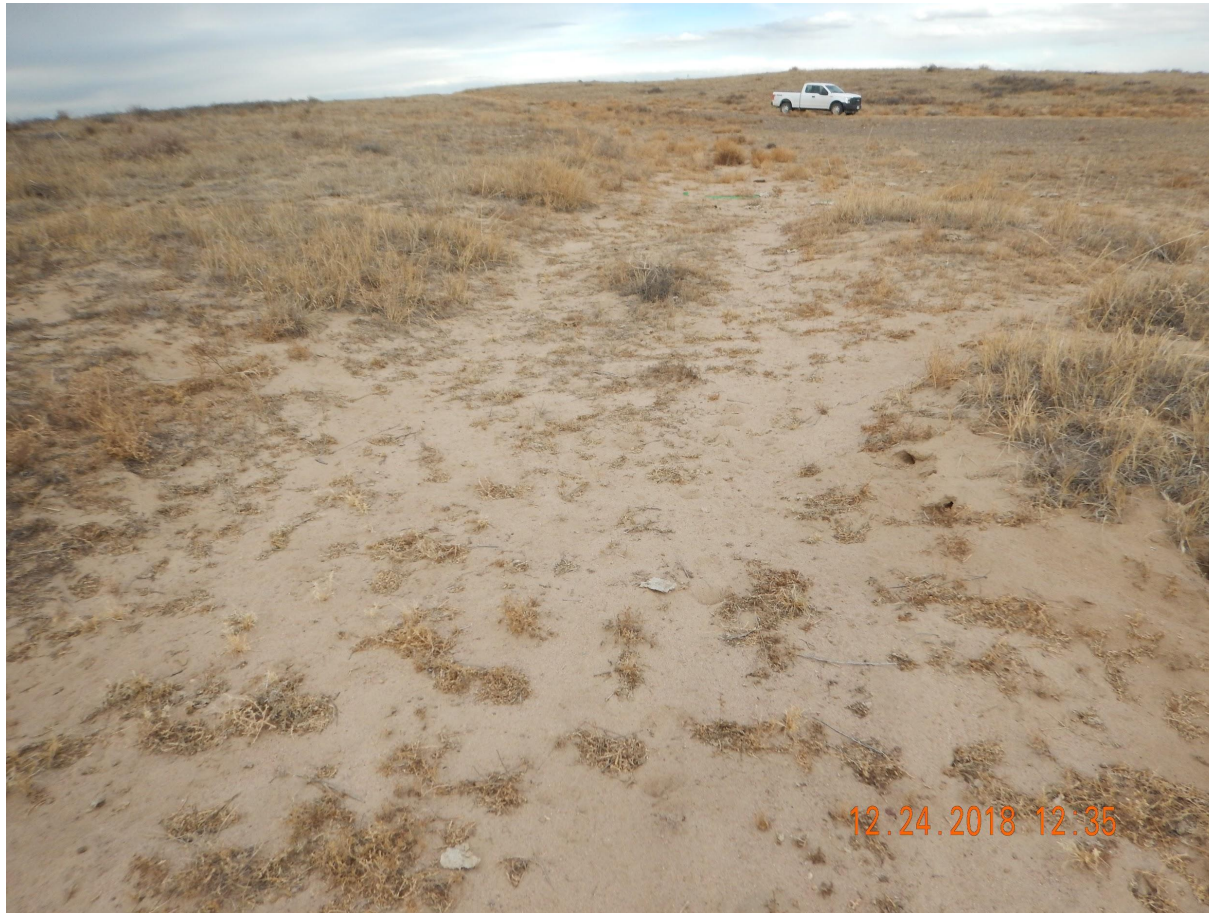
Photo 4. Photo taken from the northern well location access road, facing North.
See comments under Photo 3.

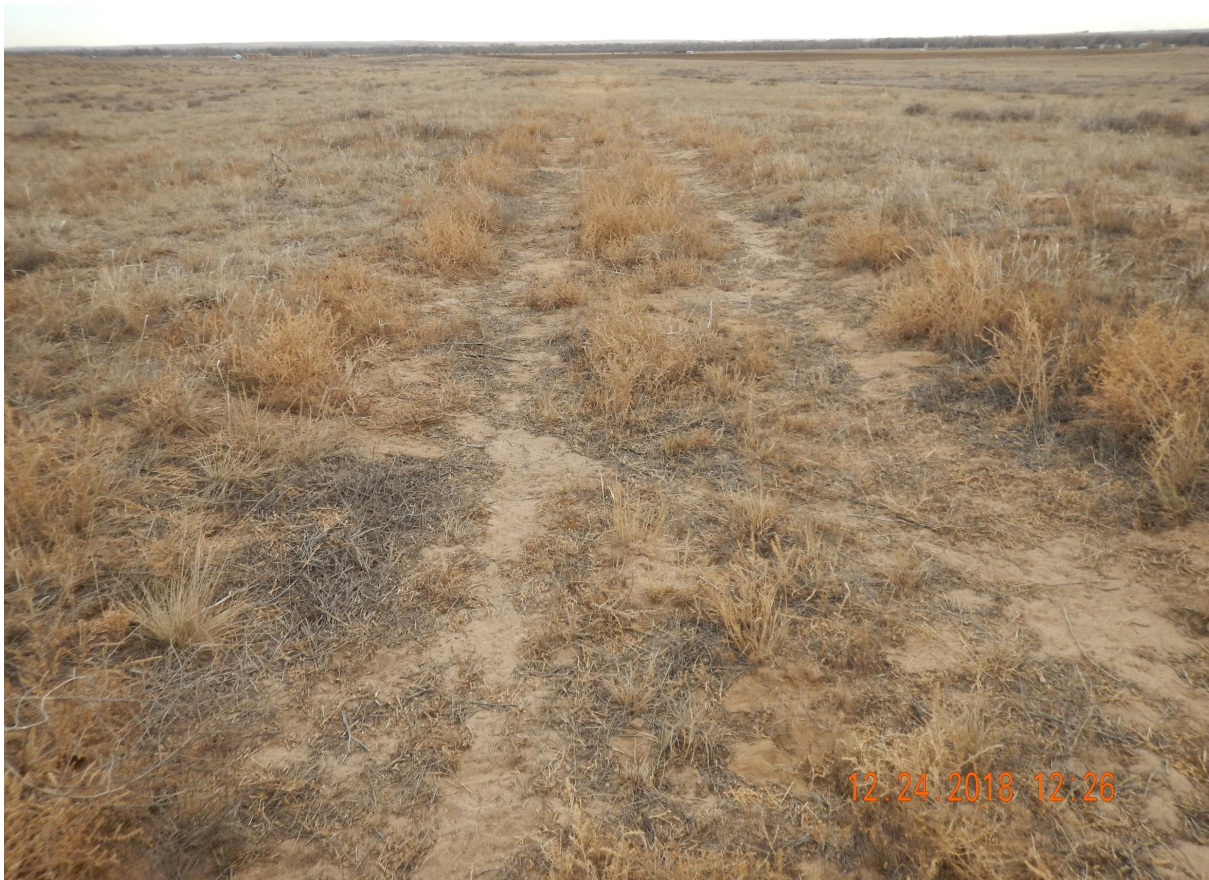
Photo 5. Photo taken from the central well location access road, facing South. See comments under Photo 3.

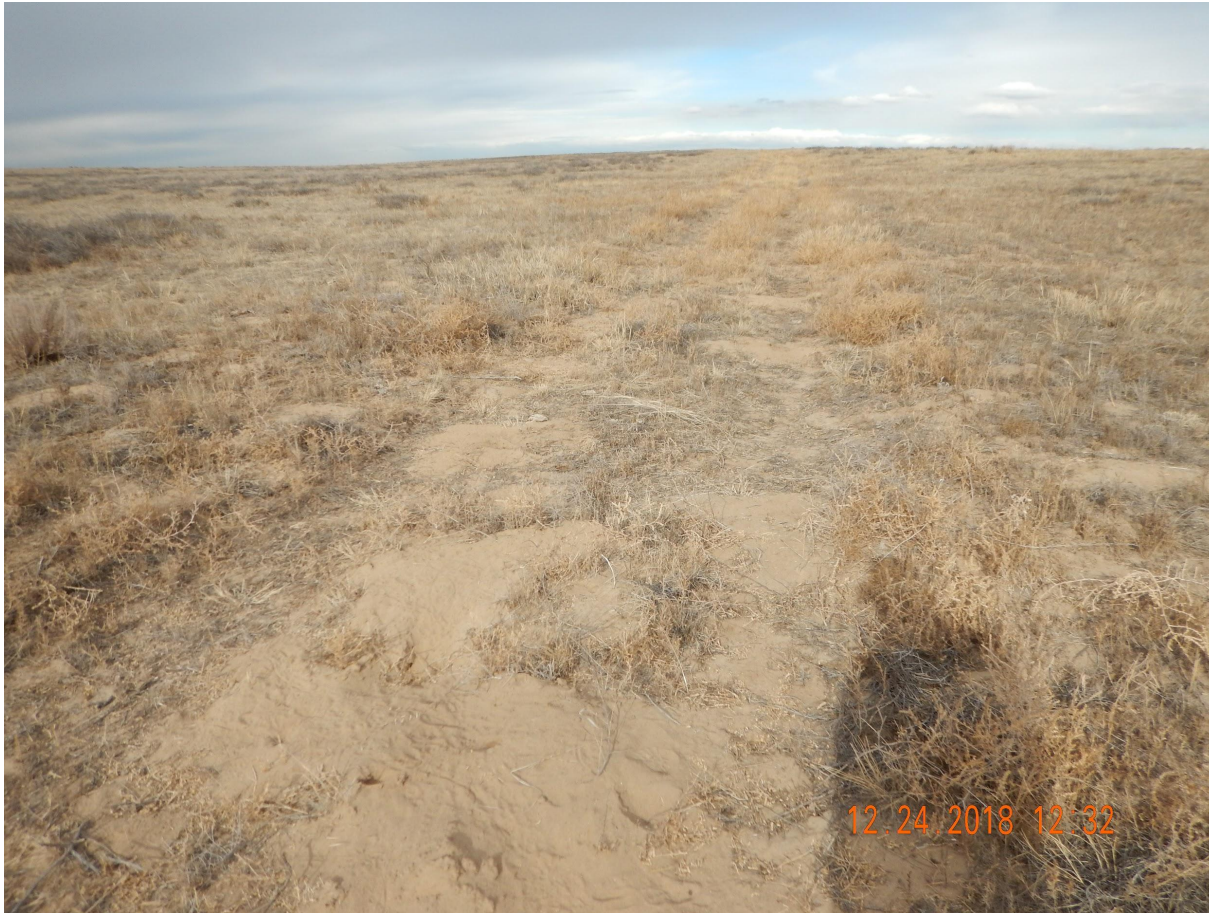
Photo 6. Photo taken from the southern well location access road, facing North.
See comments under Photo 3.

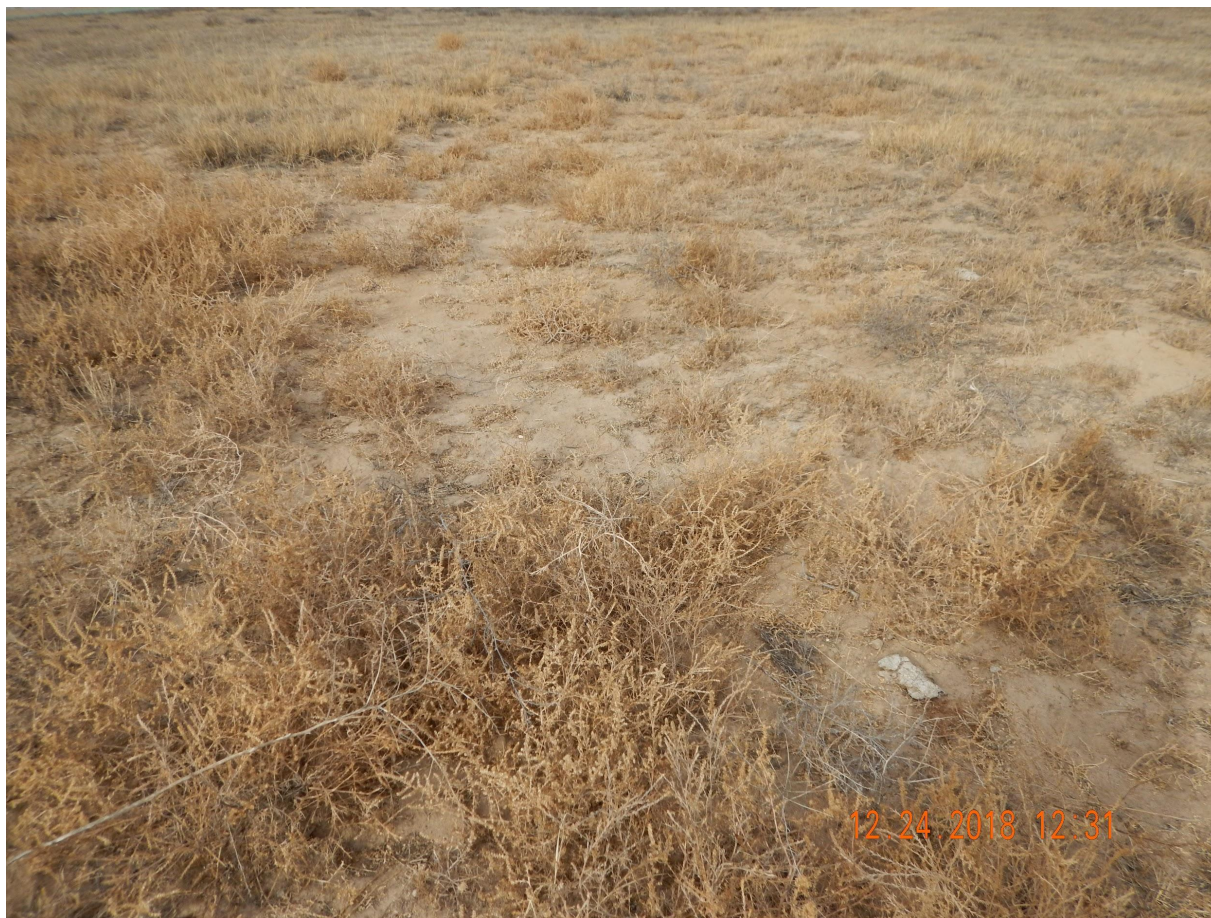
Photo 7. Photo taken from a portion of the well location, facing North. Patches of Russian thistle were observed, shown above, and vegetation is not reflective of reference area vegetation.

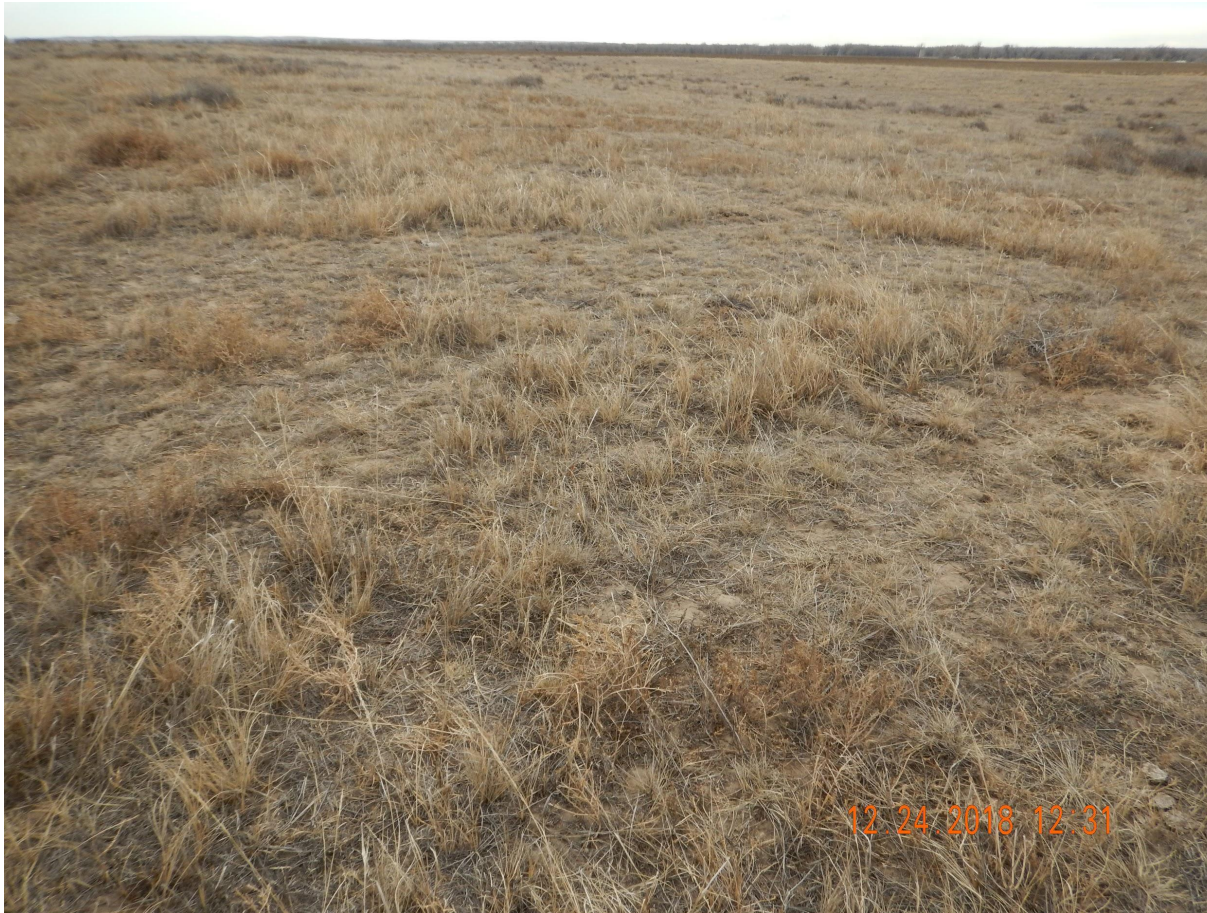
Photo 8. Reference photo taken south of the location, facing Southwest. Reference area vegetation consists of the following, but not limited to, sand dropseed (*Sporobolus cryptandrus*), prairie sandreed (*Calamovilfa longifolia*), blue grama (*Bouteloua gracilis*) and sand sage (*Artemisia filifolia*).
