# Inspection Photos

API: 05-071-06356

Operator: PIONEER NATURAL RESOURCES

Inspection Date: 12/21/2017

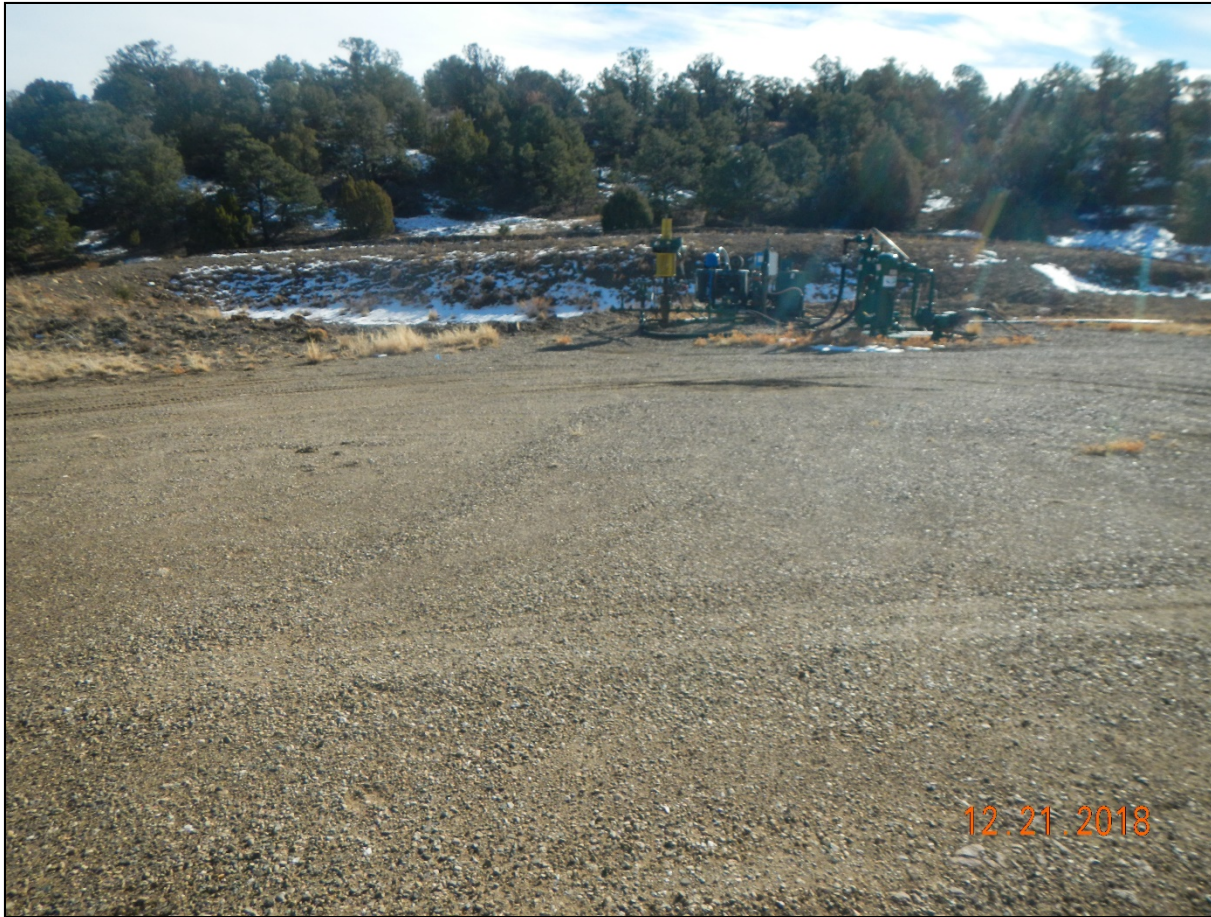
**Photo 1.** Facing south toward the location. Only one well appears at the location.

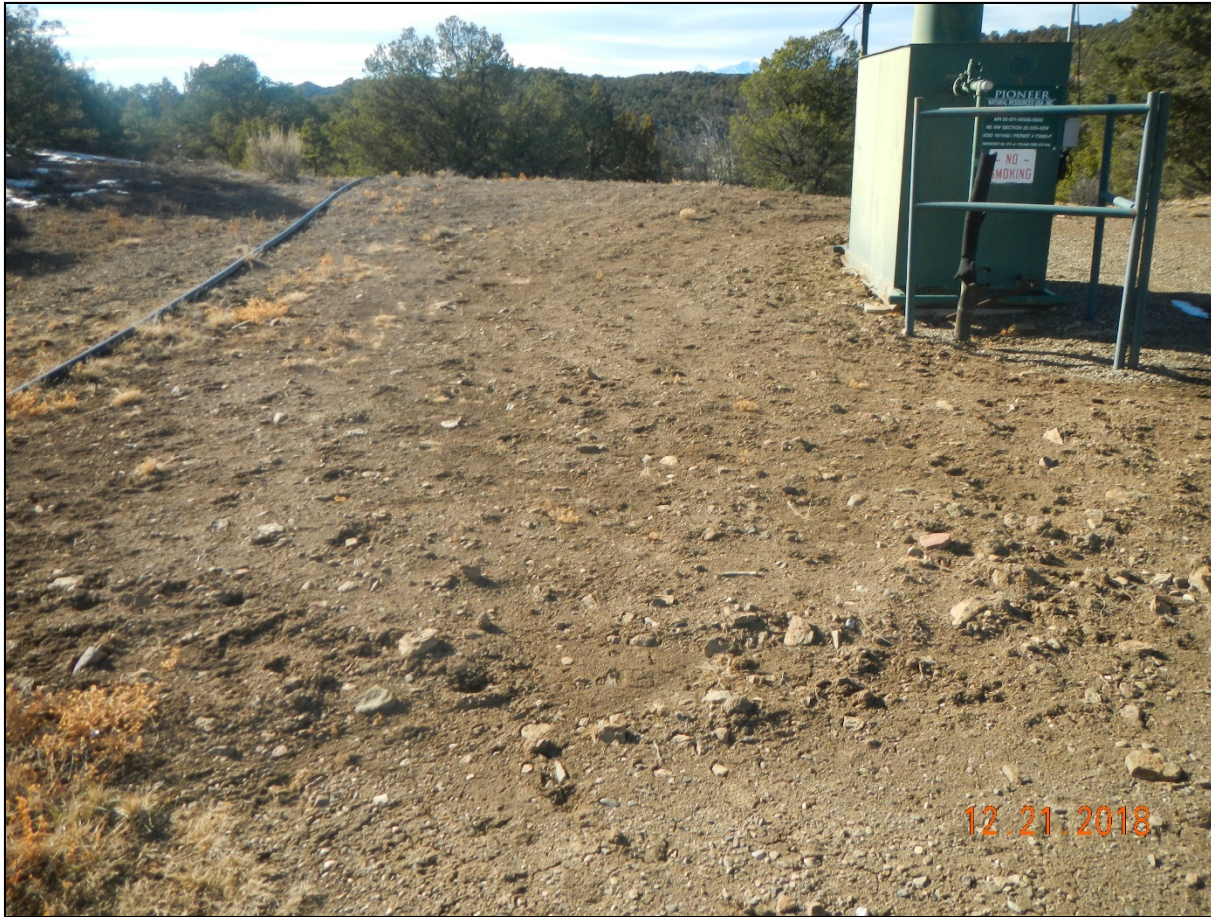
**Photo 2.** The west side of the location appears to have been disturbed and does not have adequate vegetation cover.

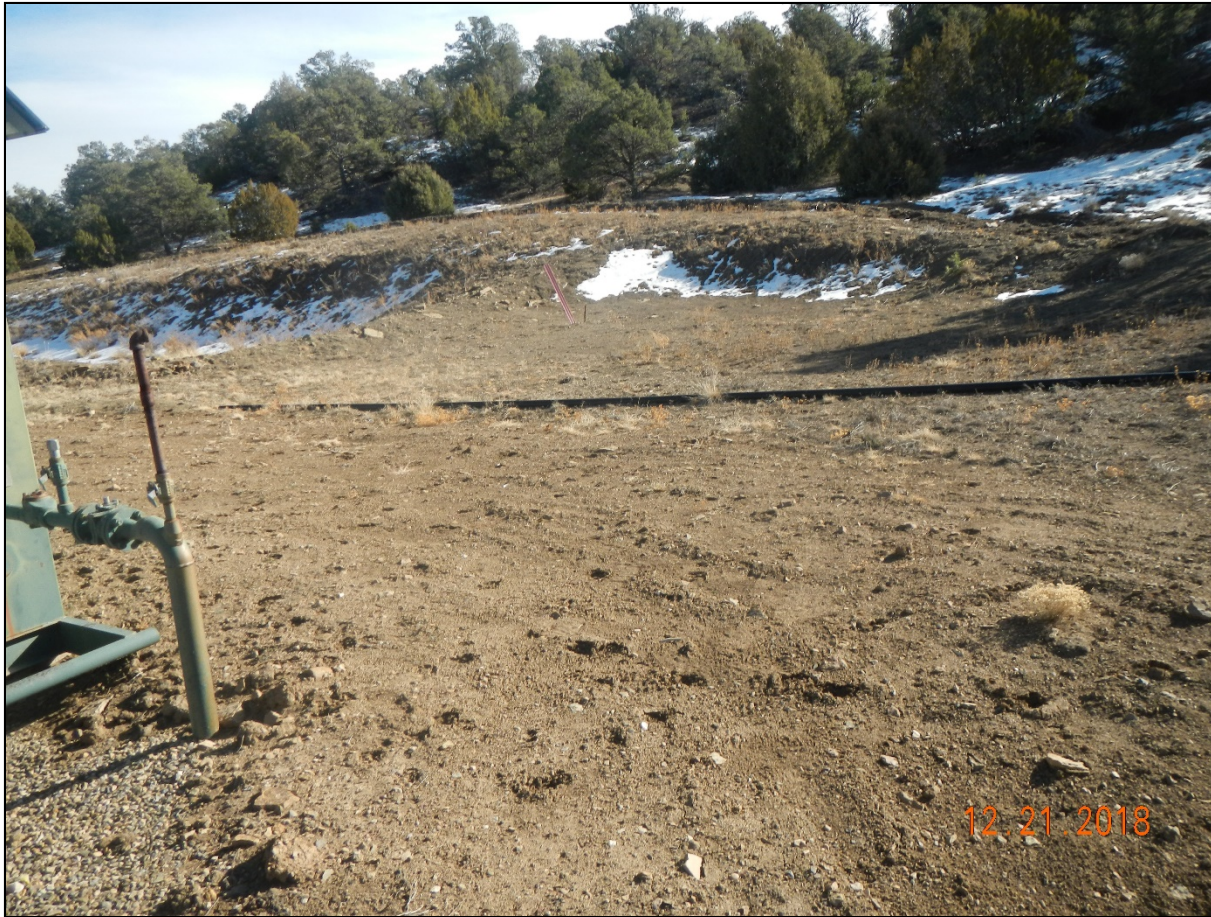
**Photo 3.** Facing southeast toward the cut slope. There is sparse vegetation and the soils are susceptible to erosion.

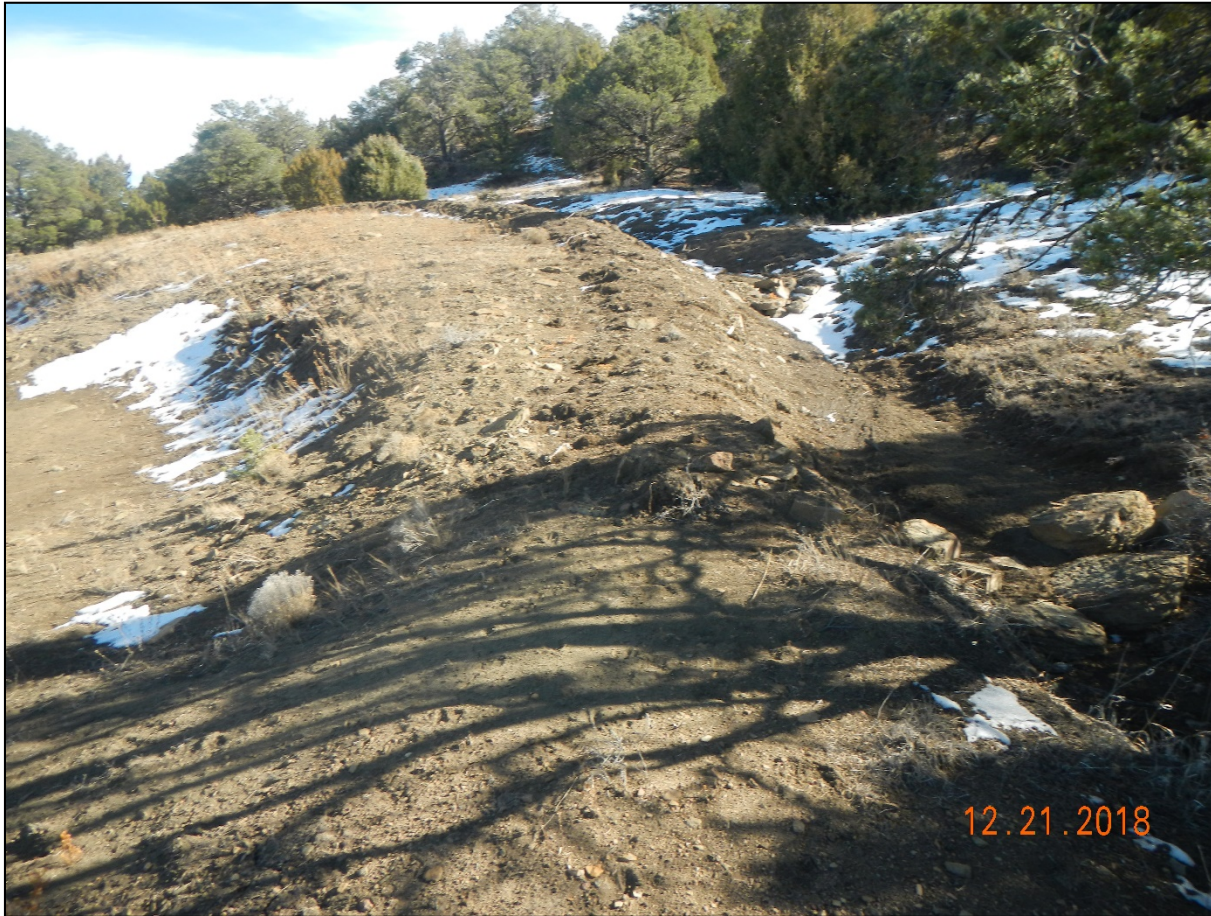
**Photo 4.** Facing southeast toward the cut slope.

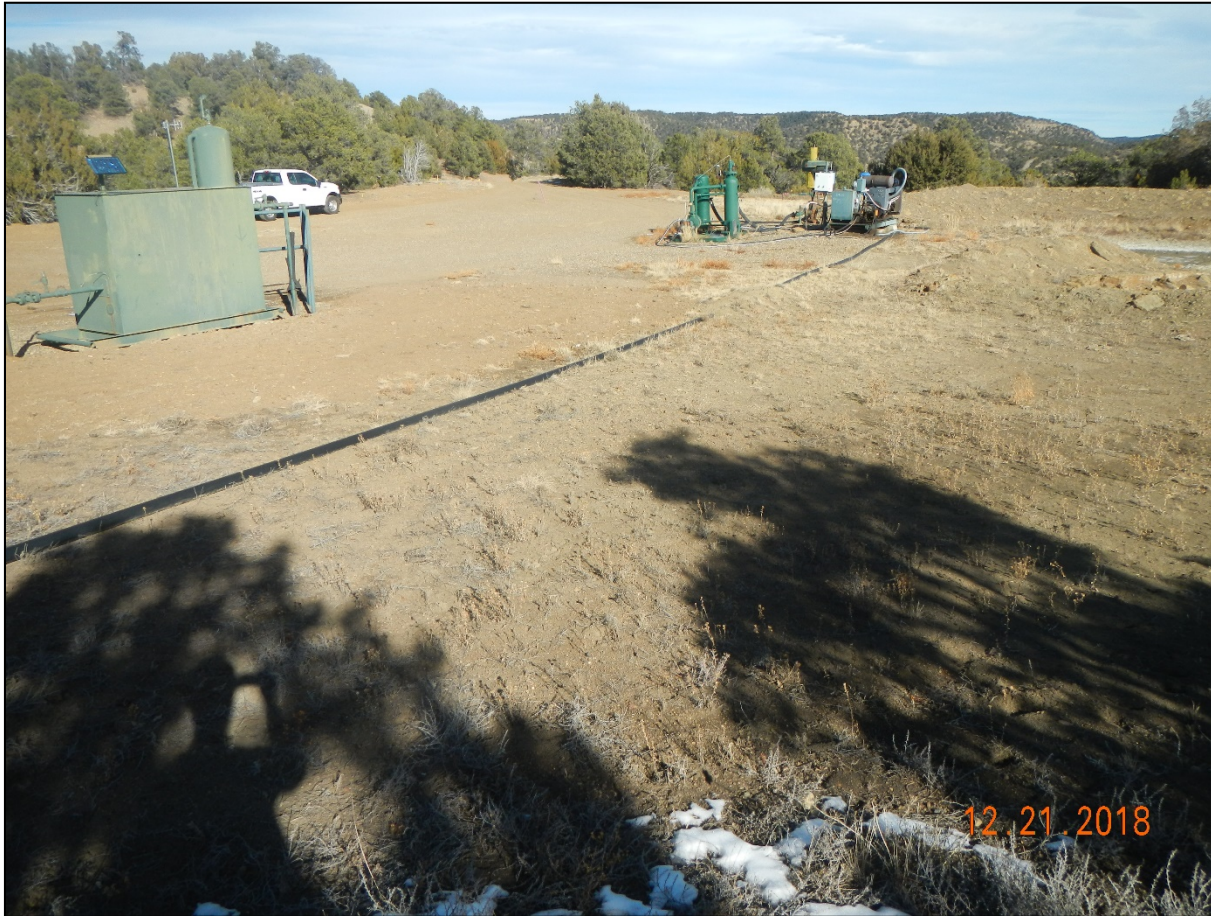
**Photo 5.** Facing east toward the location.
