# Inspection Photos

API: 05-071-06362

Operator: PIONEER NATURAL RESOURCES

Inspection Date: 12/21/2017

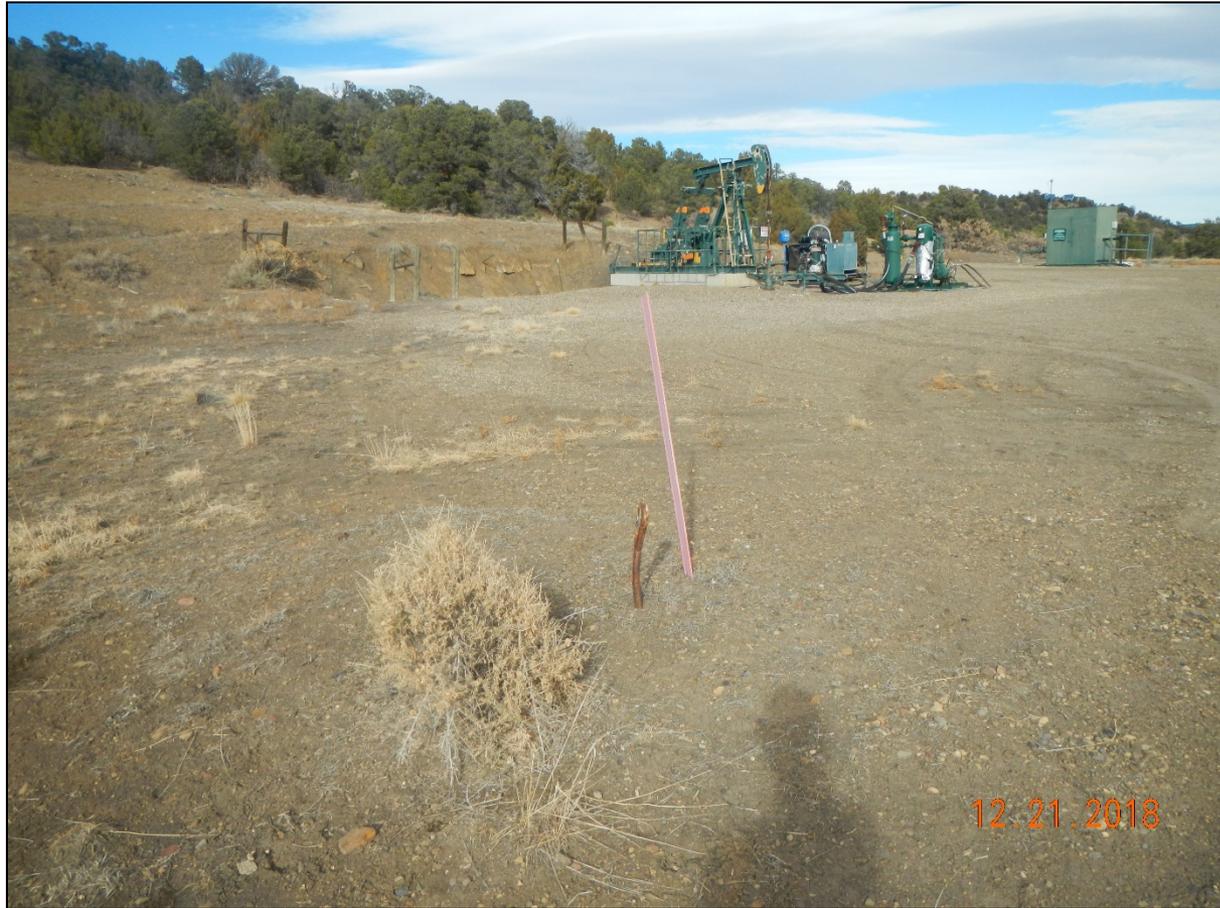
**Photo 1.** Facing south toward the location. Only one well appears at the location.

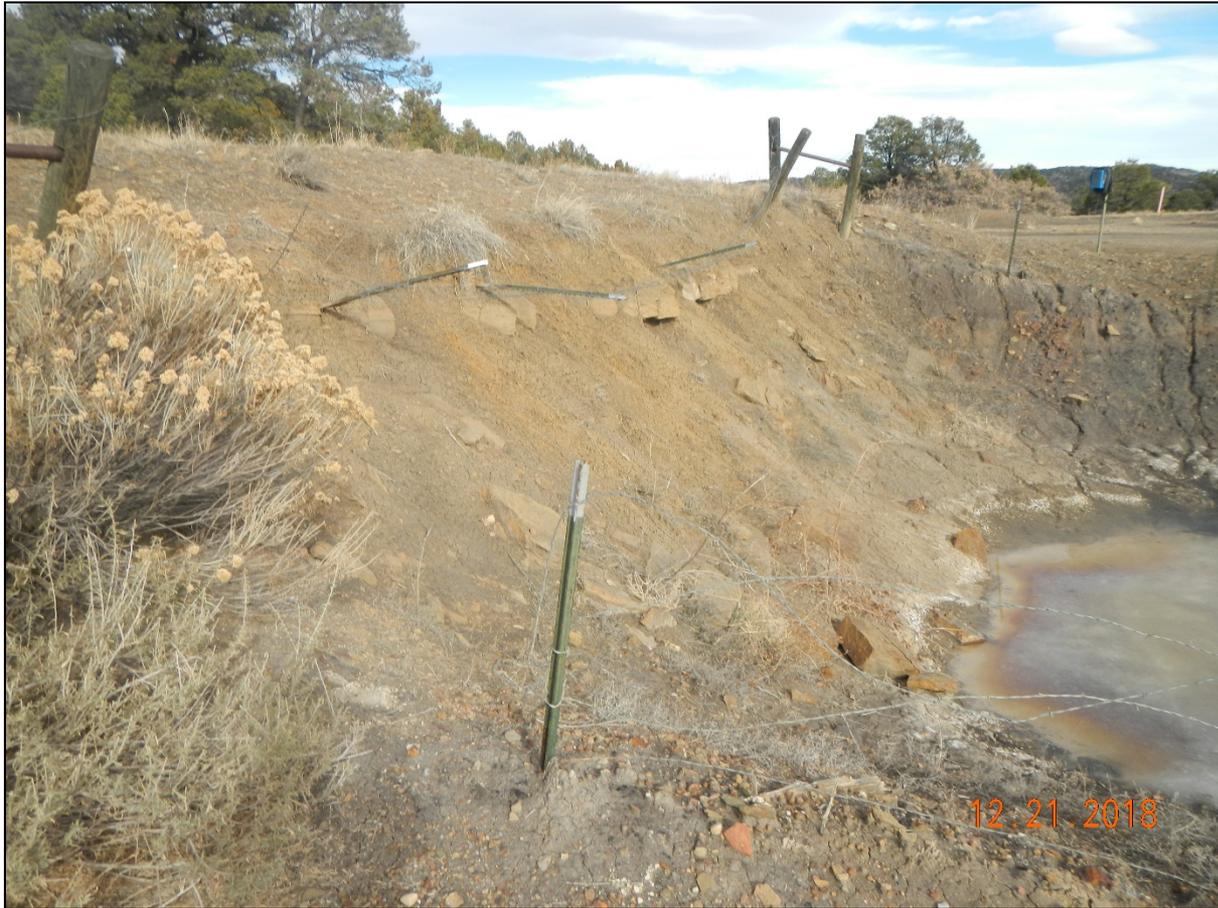
**Photo 2.** The west side of the location appears to have been disturbed and does not have adequate vegetation cover.

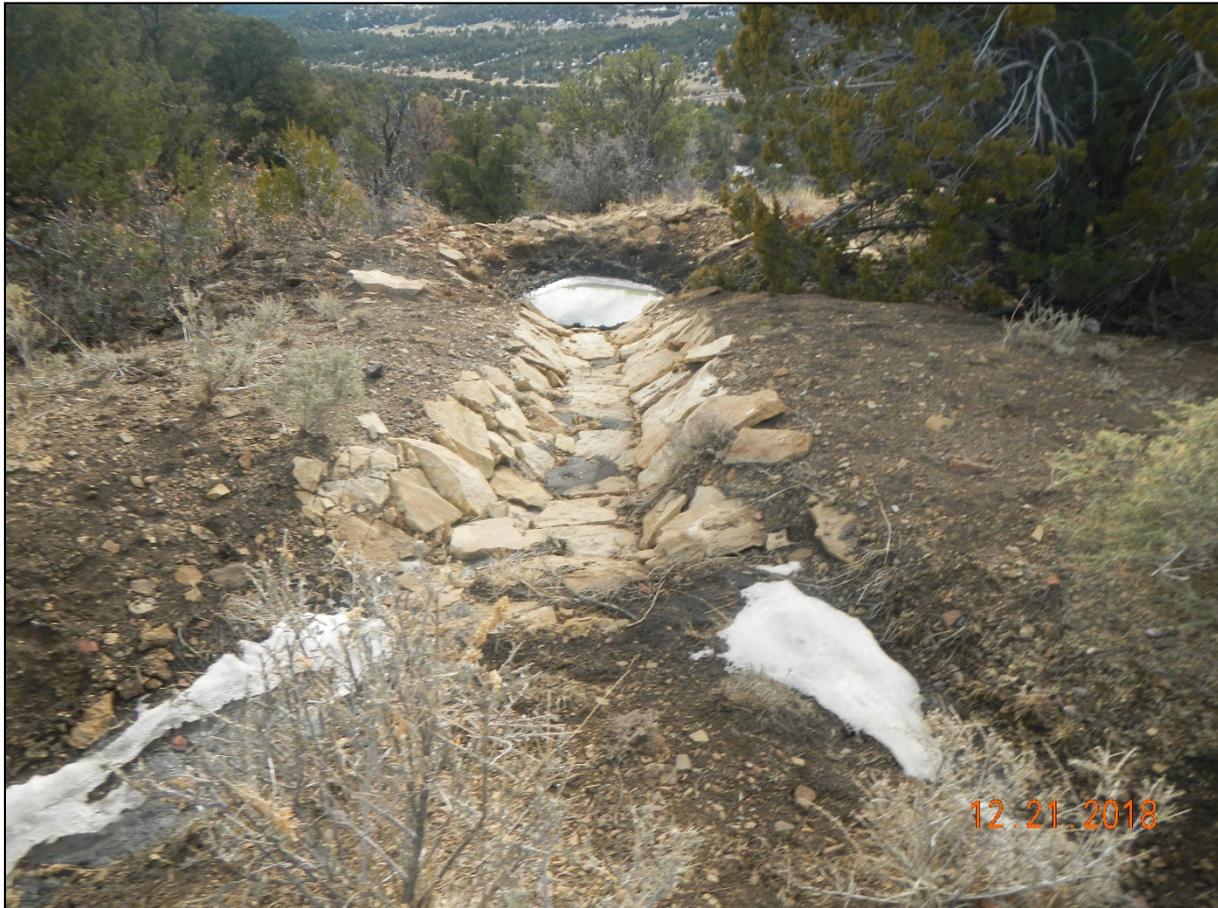
**Photo 4.** Facing southeast toward the cut slope.
