Inspection Photos
Location Name: AM Sprague A#1
Location ID:323132

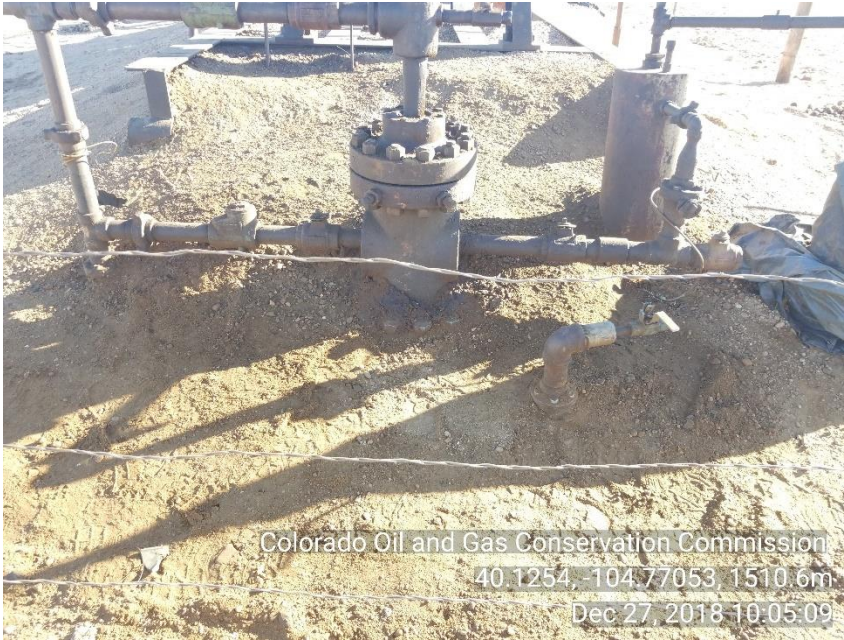
Photo 3 Stained soil WH

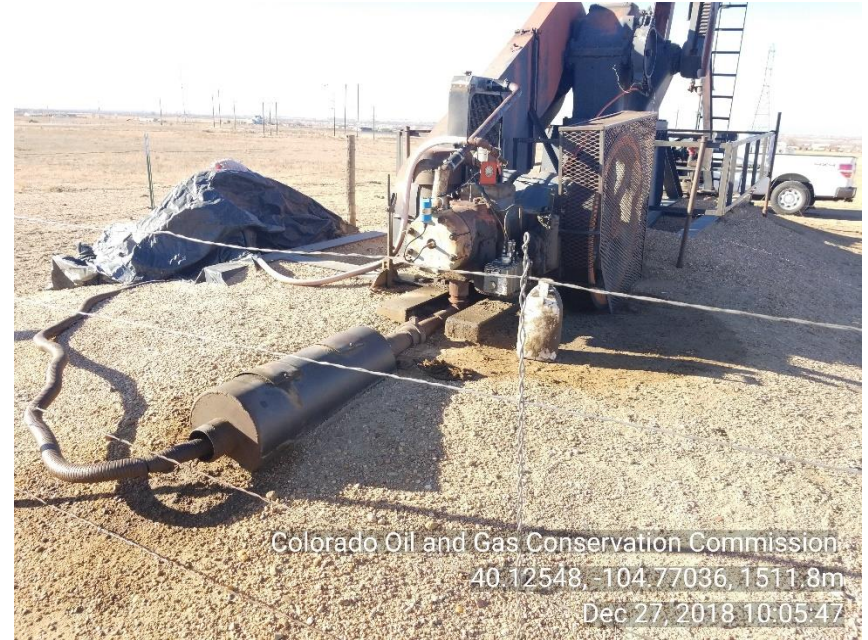
Photo 4 Stained soil PU motor and exhaust

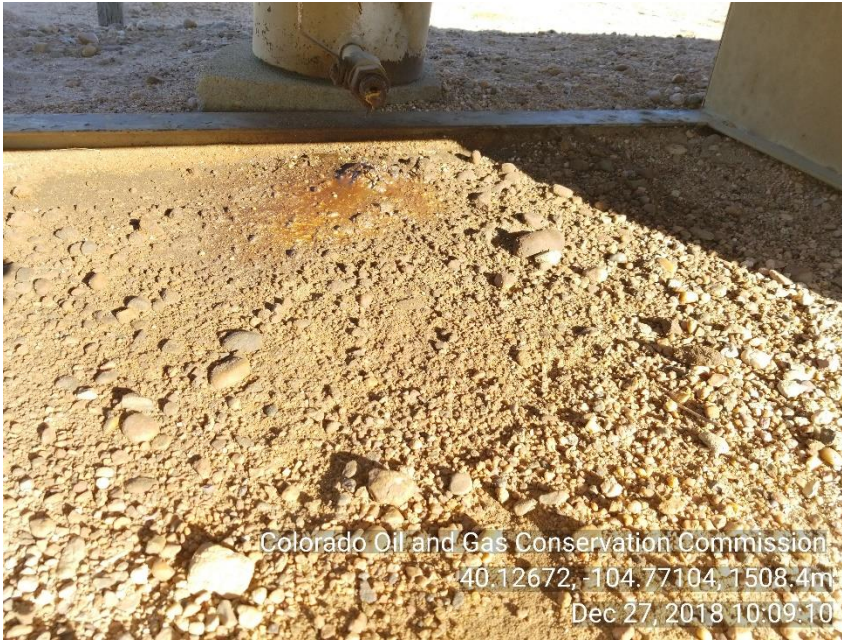
Photo 5 Stained soil under SEP

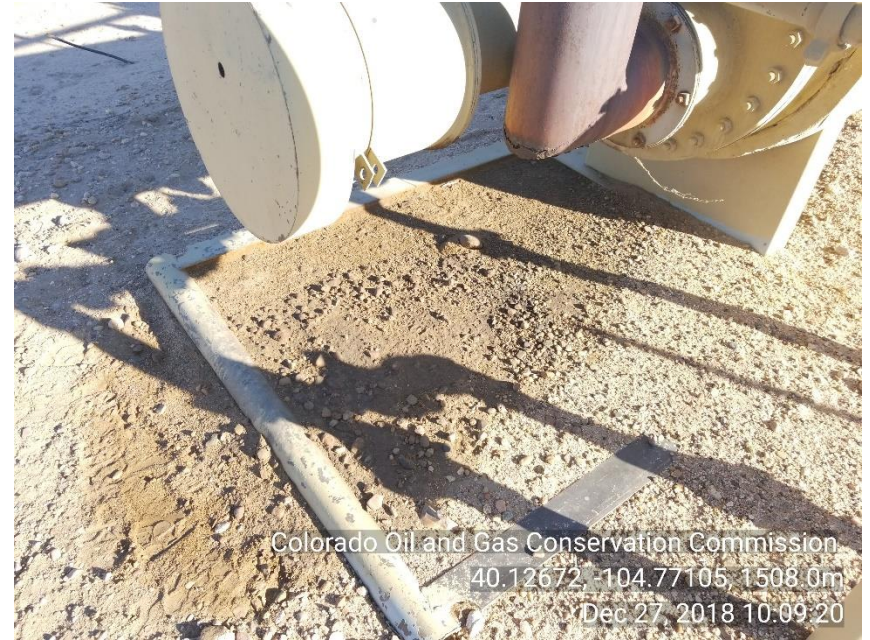
Photo 6 Stained soil under burner of sep

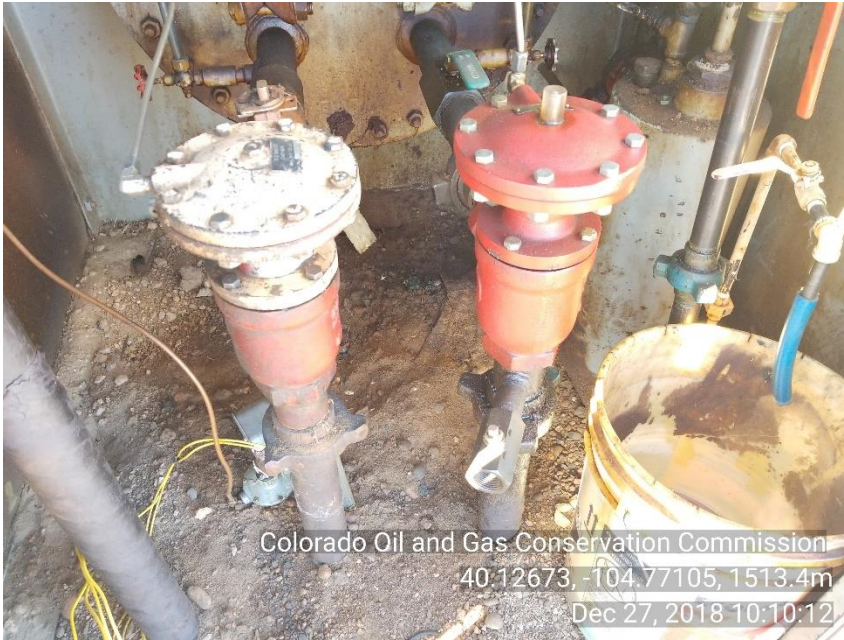
Photo 6 Stained soil Inside SEP
