Inspection Photos

Operator: Logos Operating

API: 05-067-05524

Date: 12/19/2018

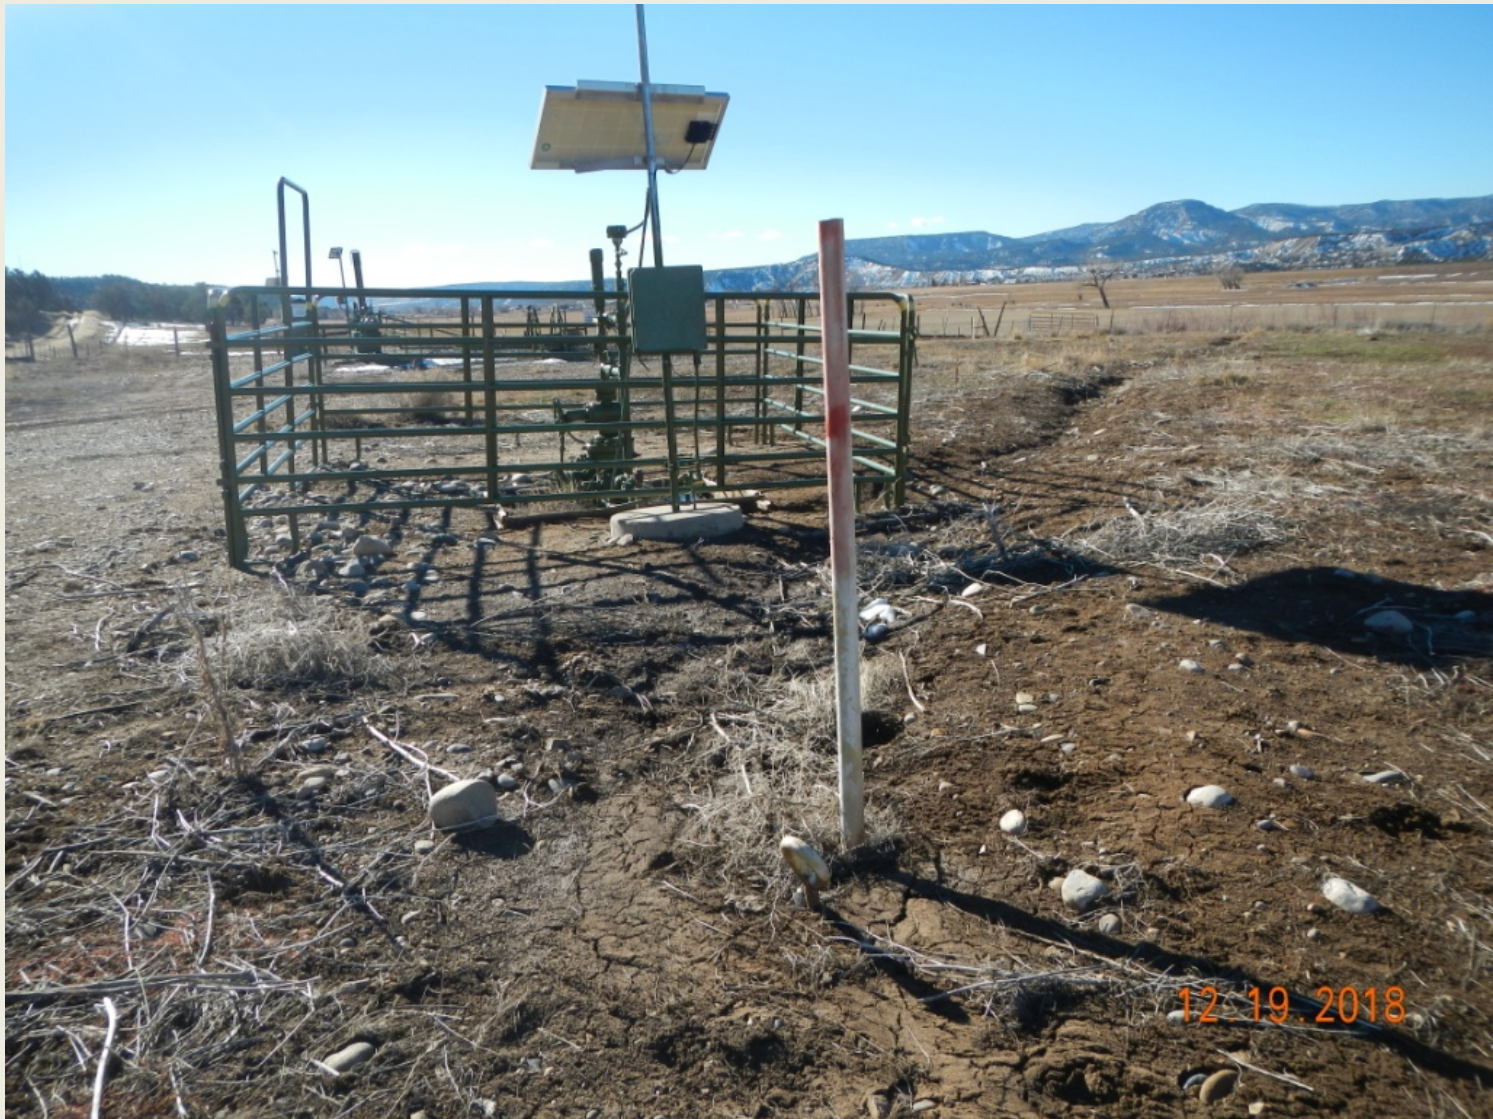
Photo 1. View of the project area from the western edge facing southwestward.

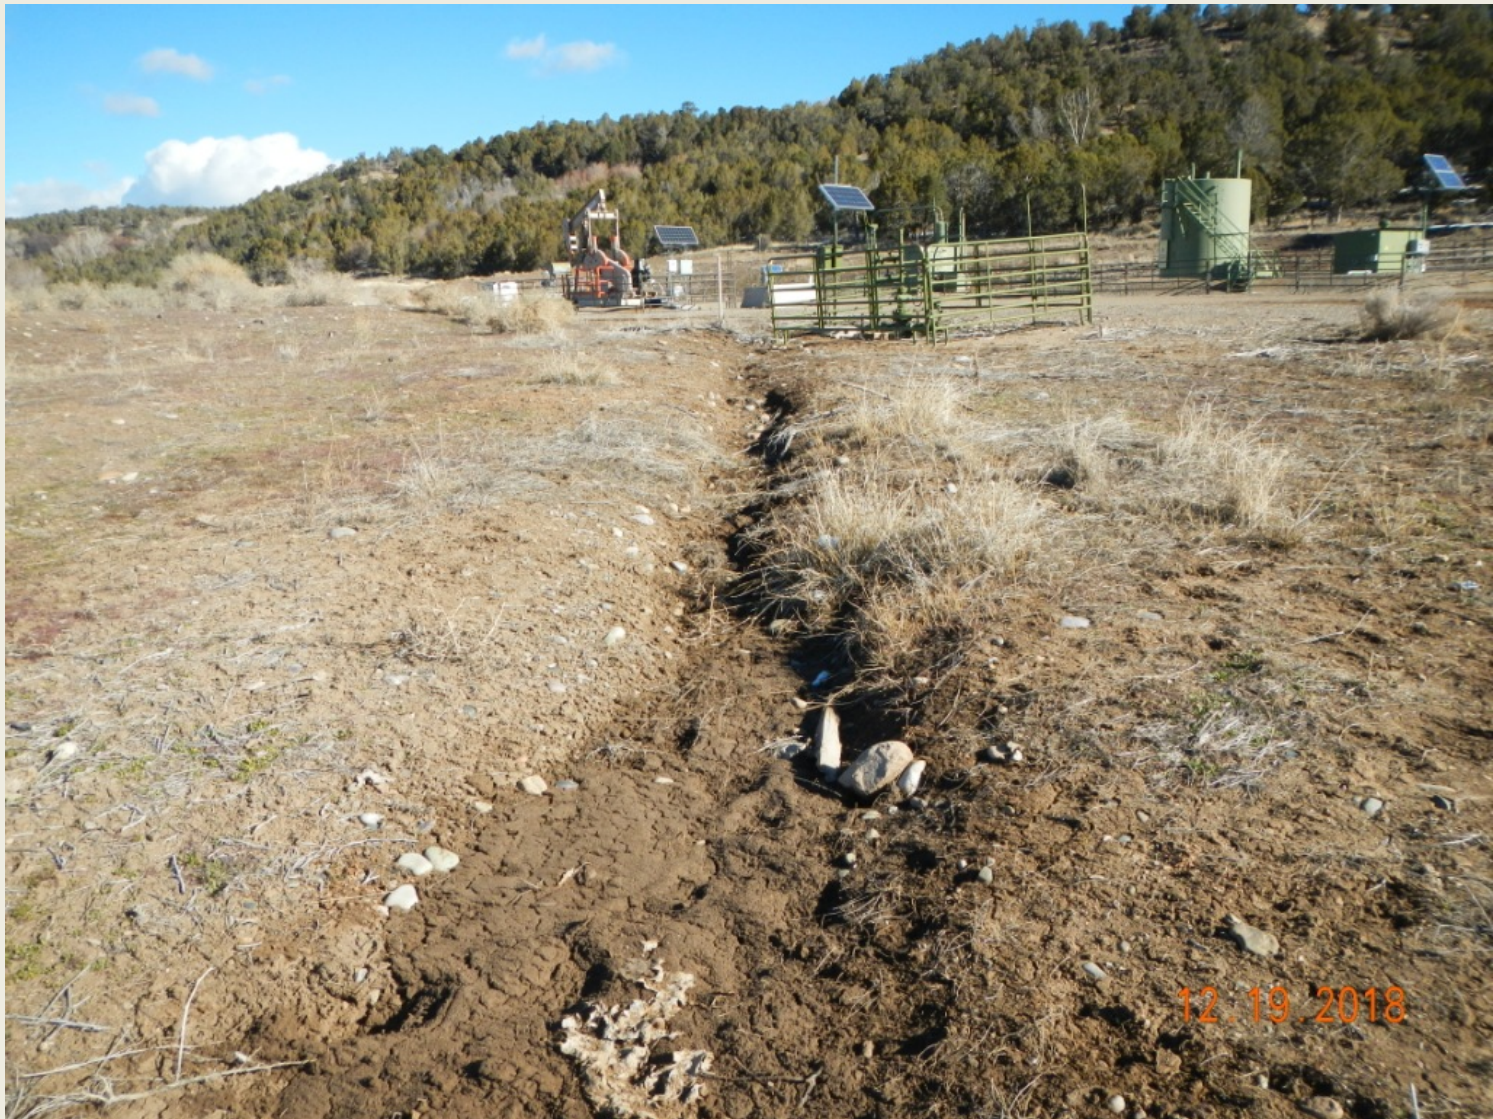
Photo 2. View of an erosional channel approximately 3 feet wide and 1 foot deep within the mid-western portion of the project area, downstream from the well.

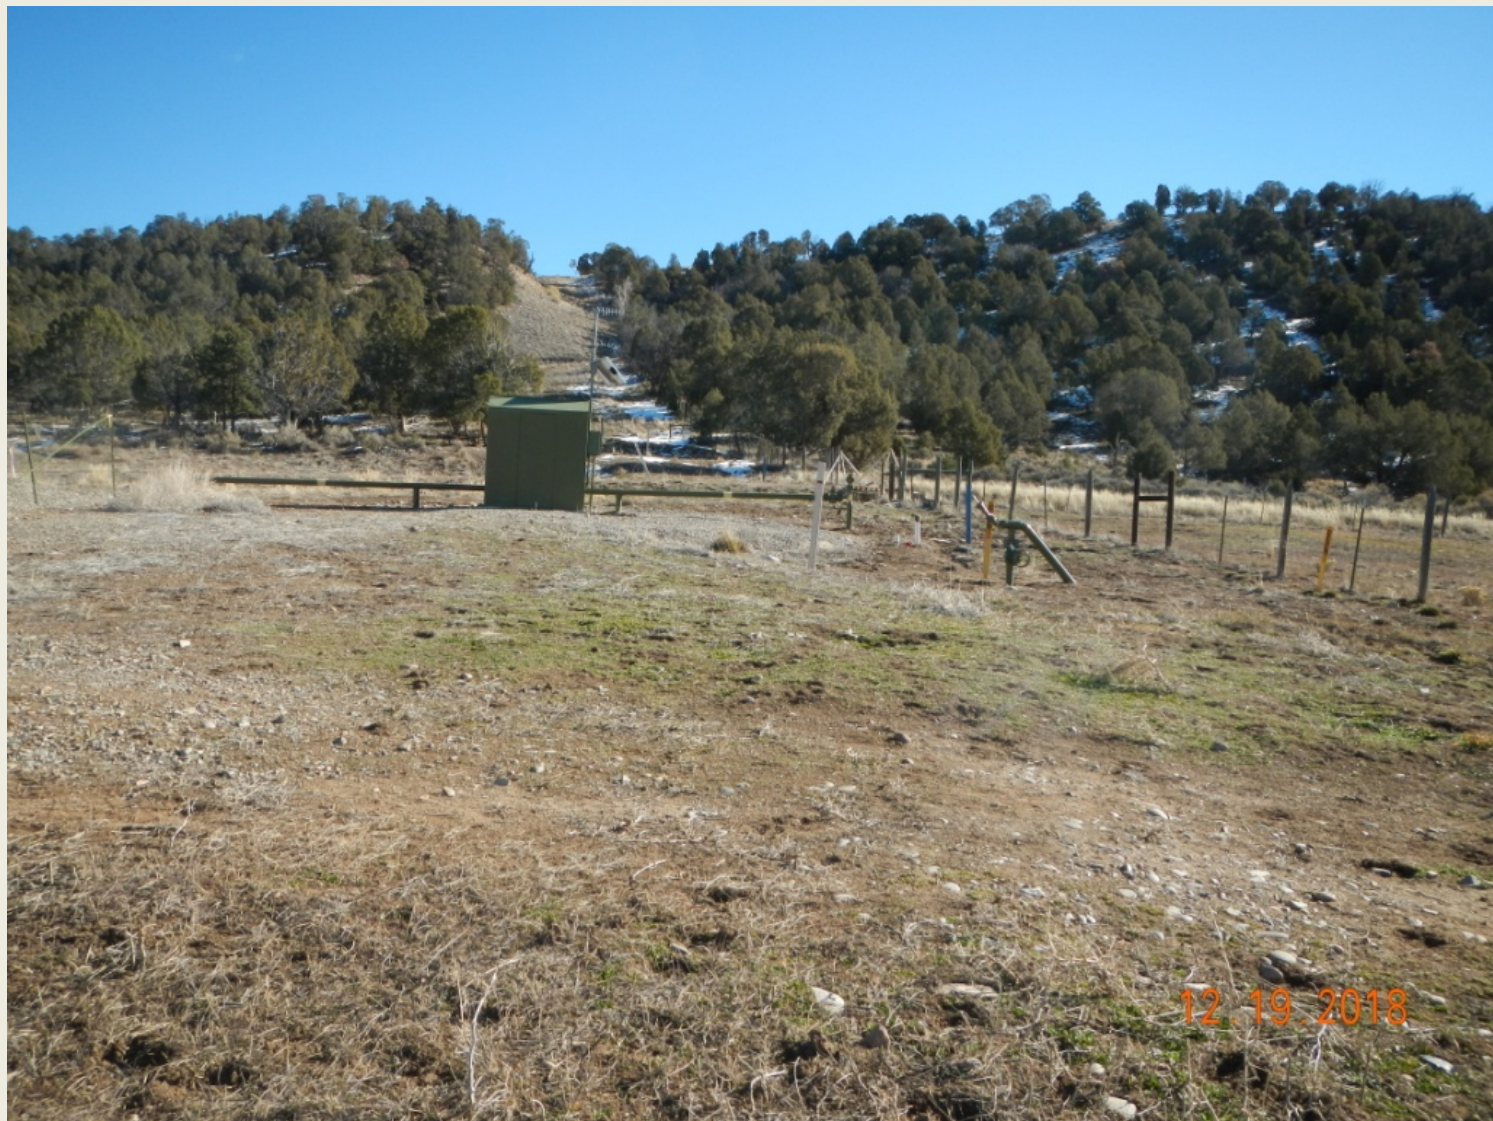
Photo 3. View of the southern project area from the southwestern corner facing eastward. Vegetation is grazed and not in identifiable condition.

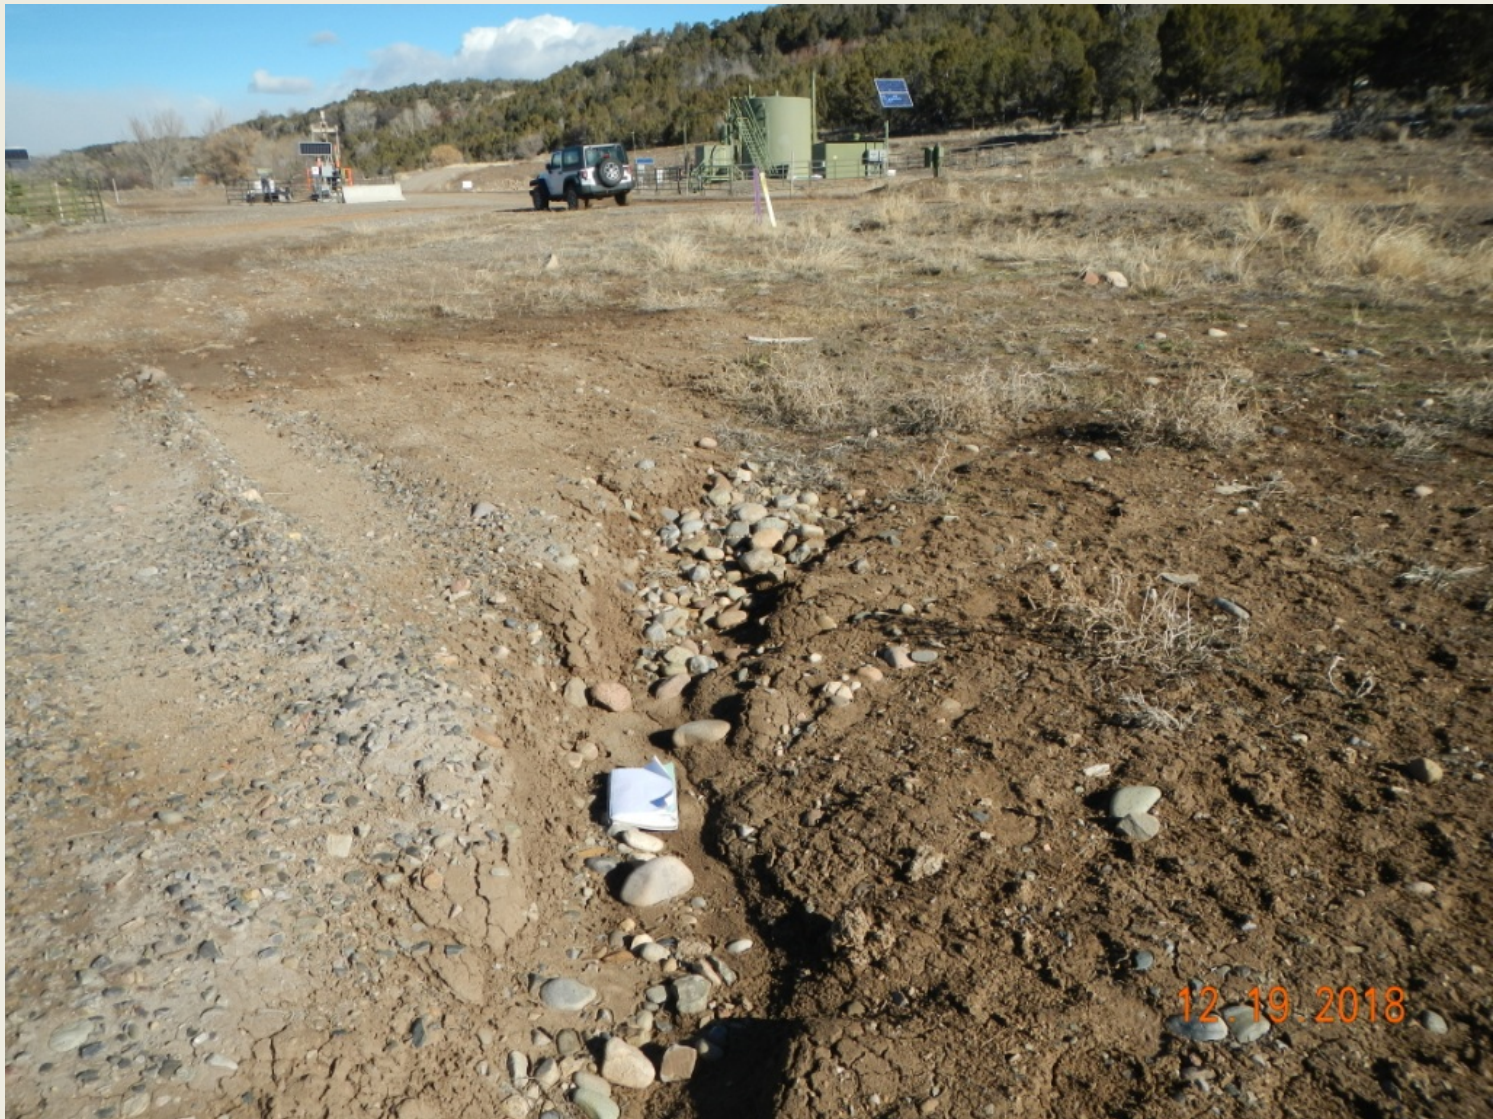
Photo 4. View of another erosional channel approximately 2 feet wide and 1 foot deep within the southwestern project area.
