Inspection Photos

Operator: BP America

API: 05-067-07595

Date: 12/19/2018

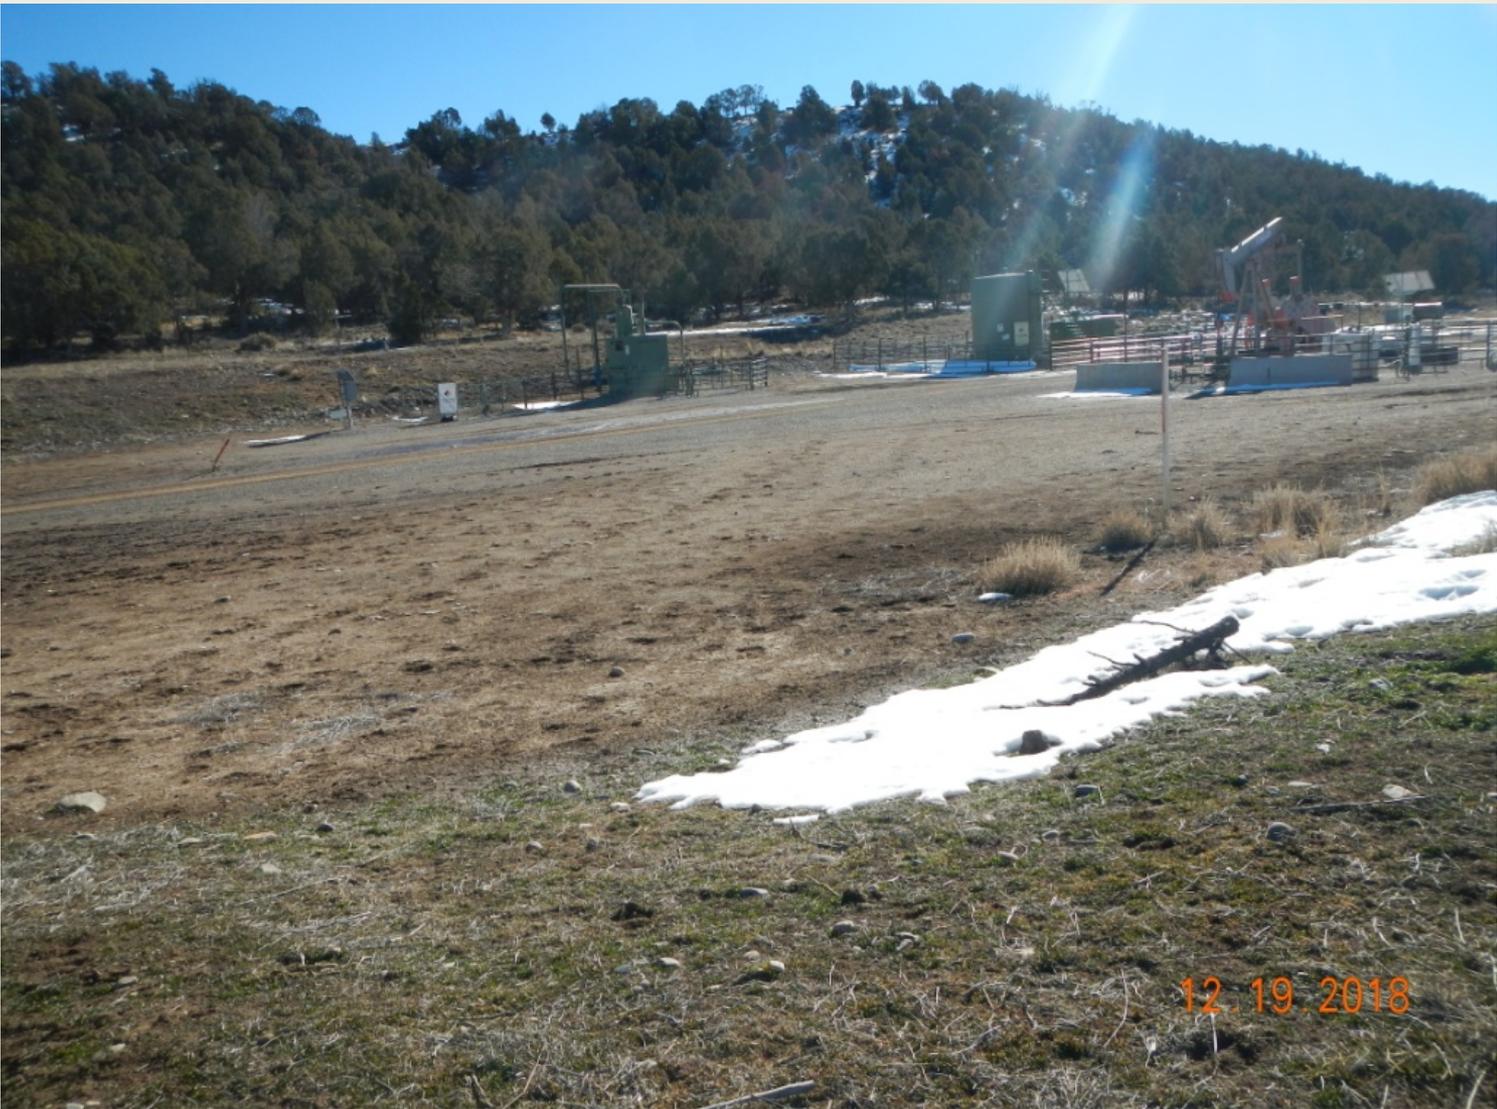
Photo 1. View of the northwestern project area from the well pad entrance facing eastward.

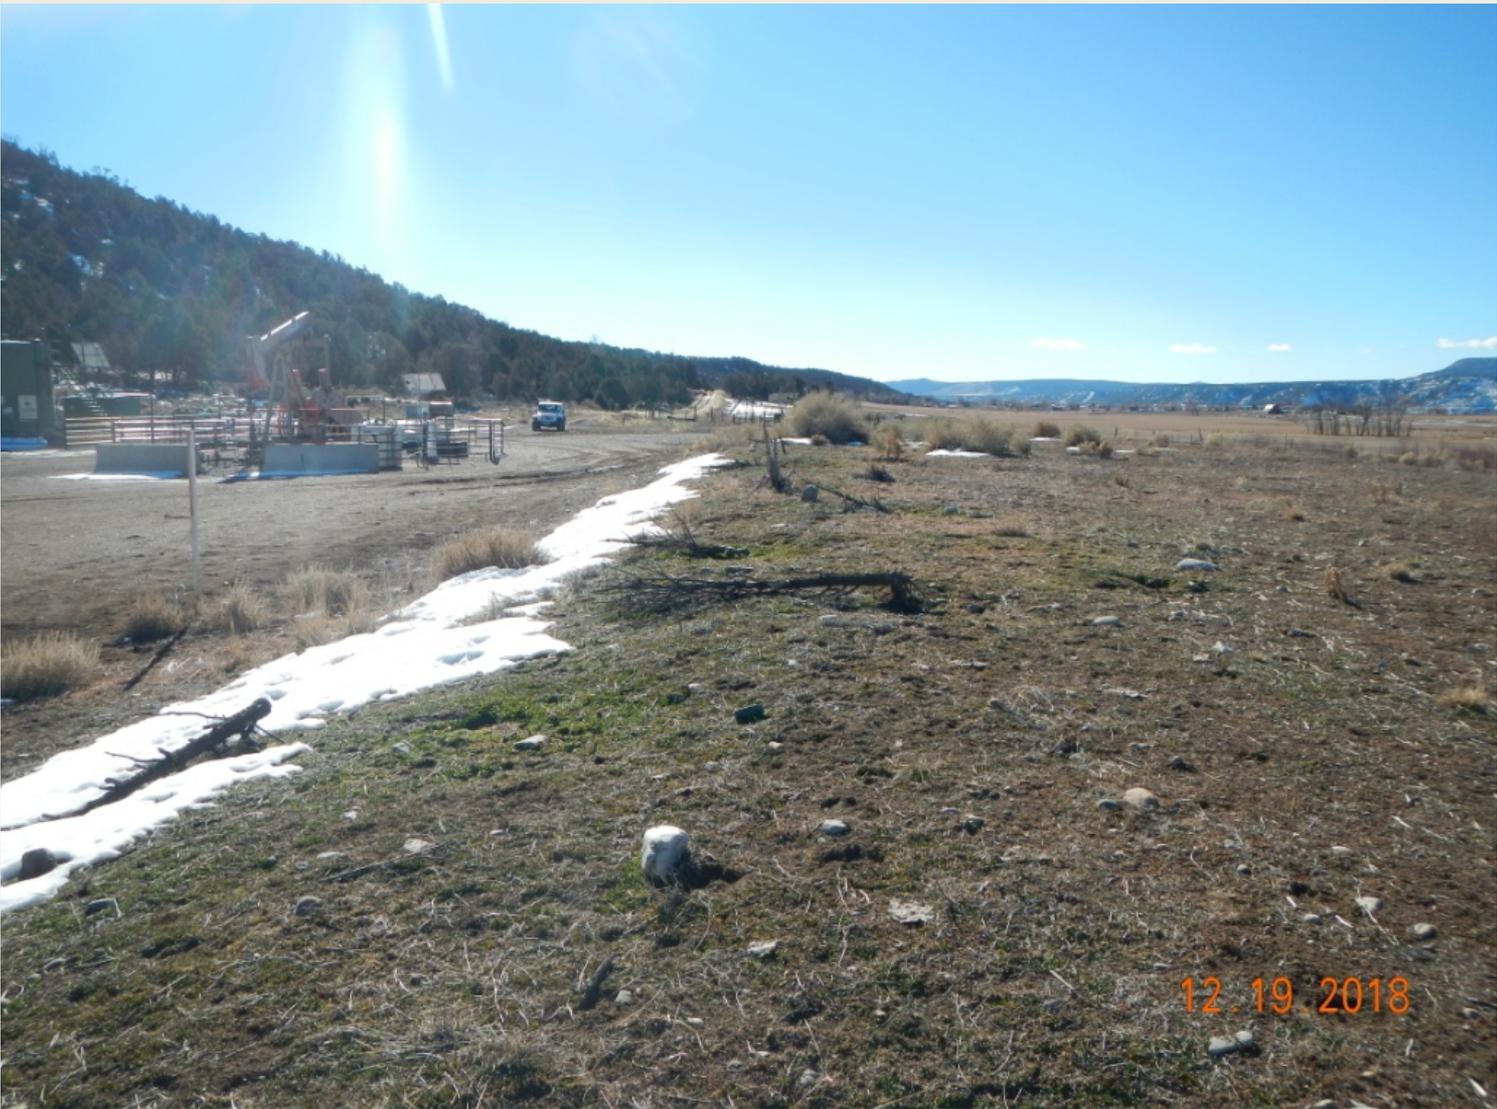
Photo 2. View the western project area from the northwestern corner facing southward.

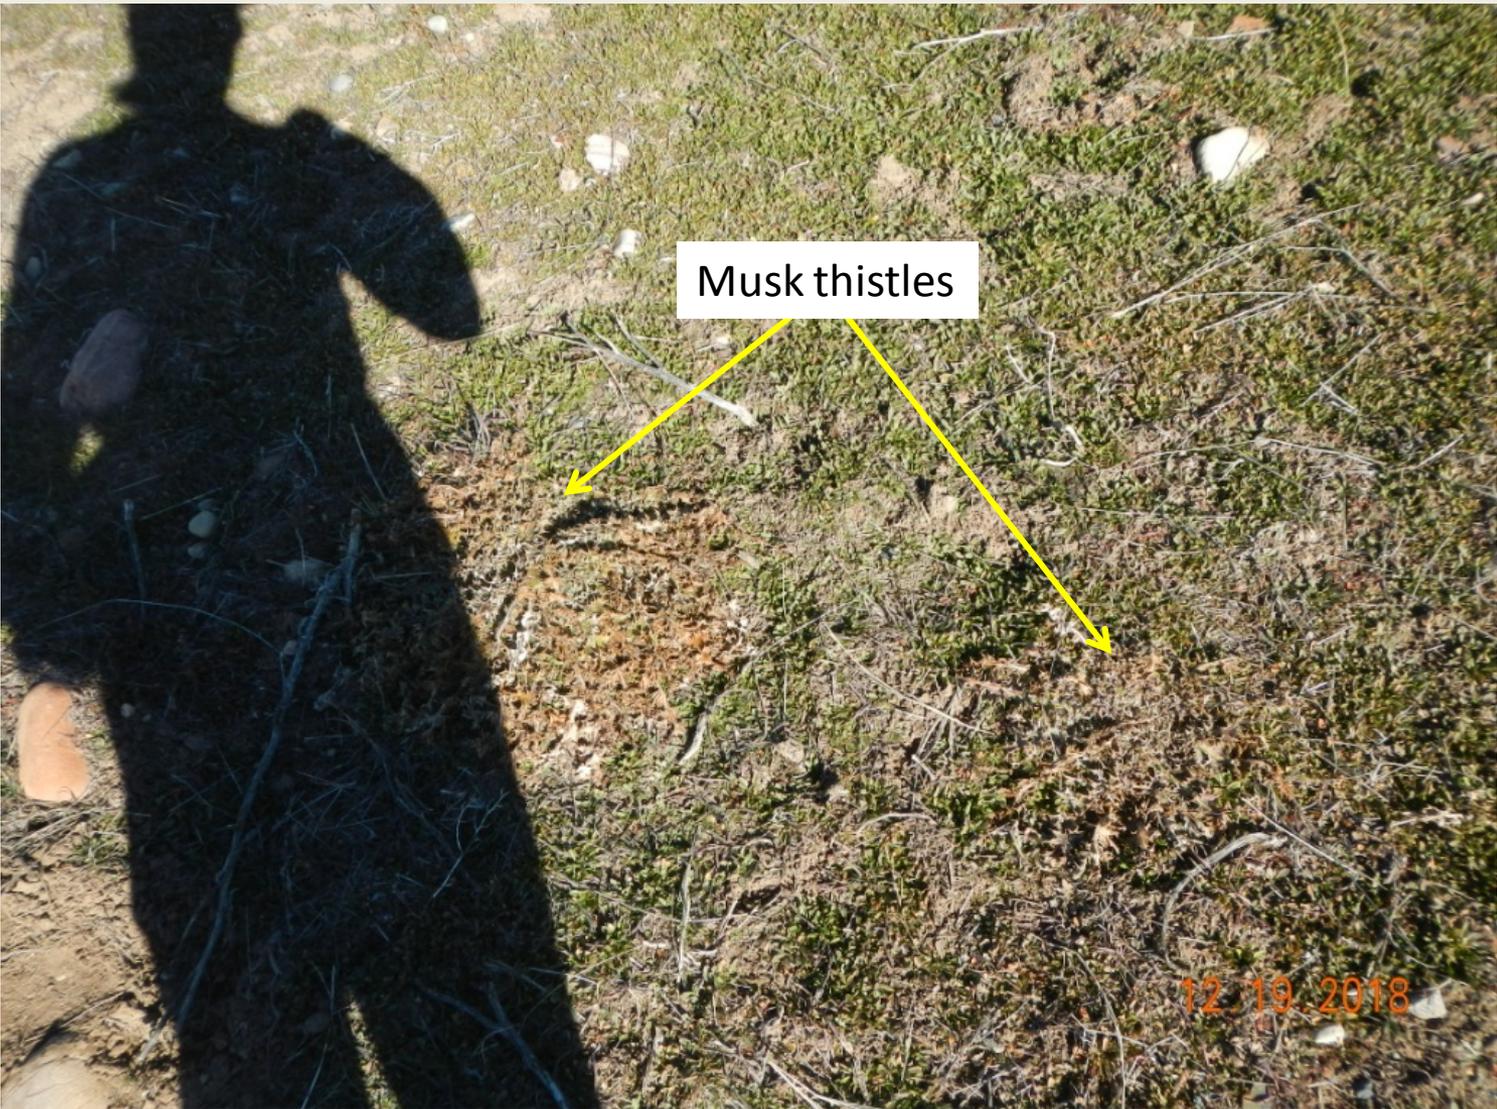
Photo 3. View of musk thistle rosettes within the northern project area. Musk thistle debris was observed throughout the revegetation area.

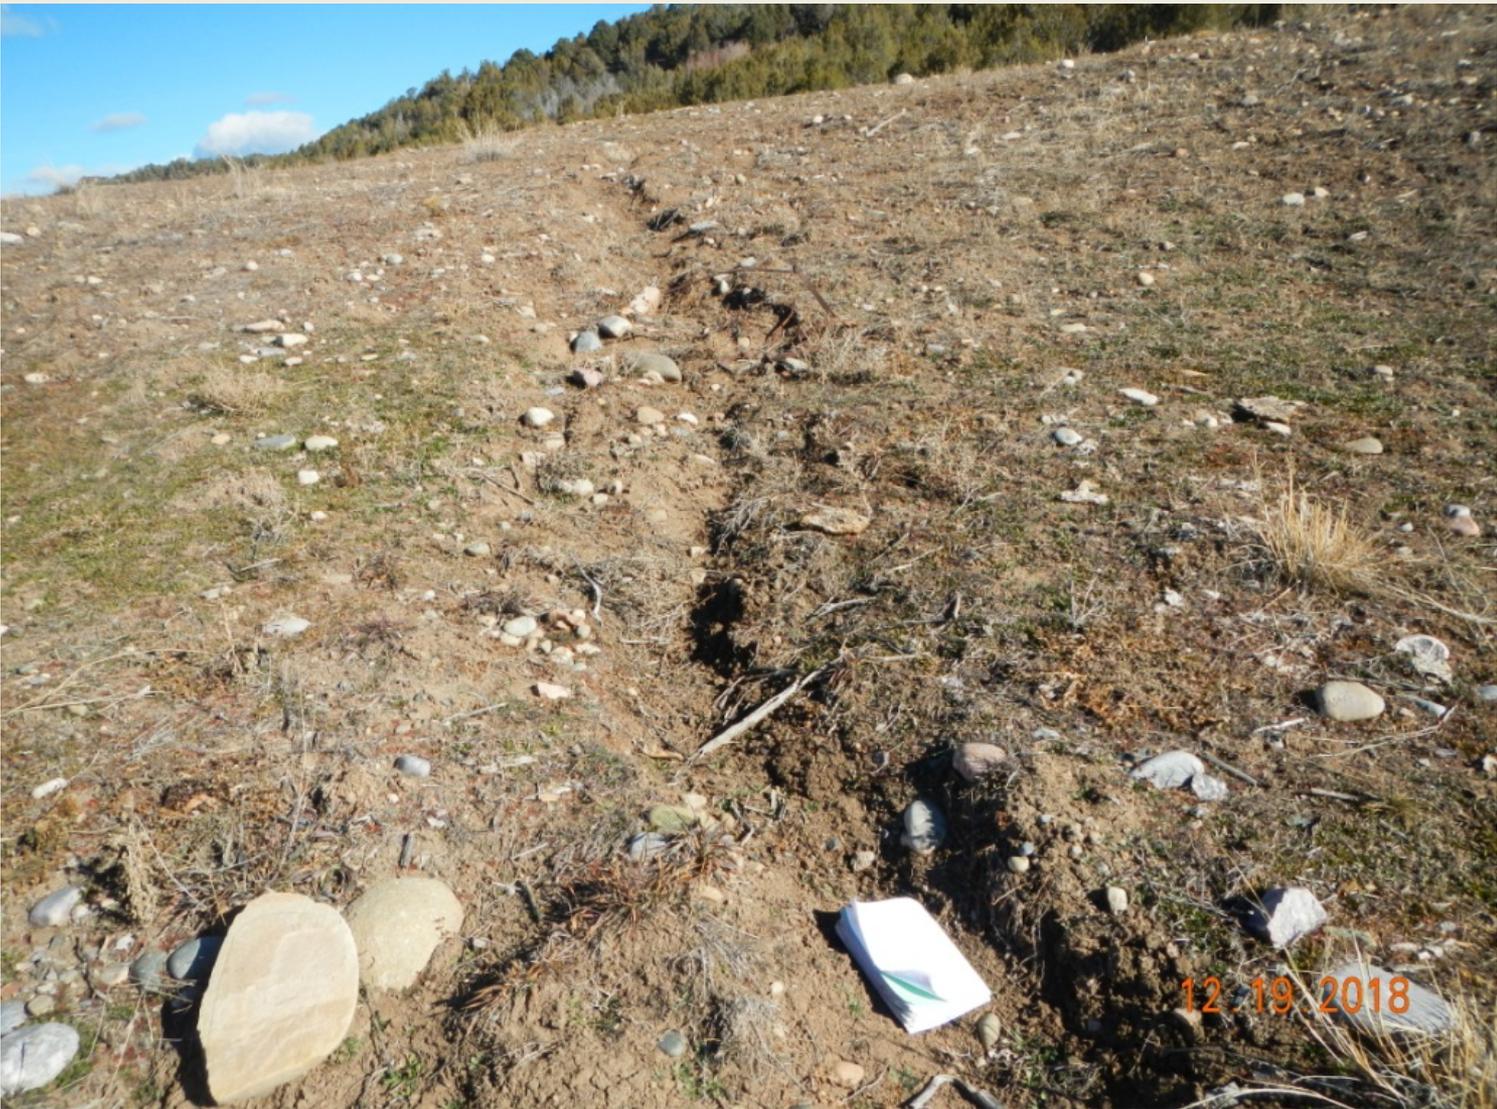
Photo 4. View of an erosional channel approximately 1.5 feet wide and 10 inches deep within the northeastern project area.

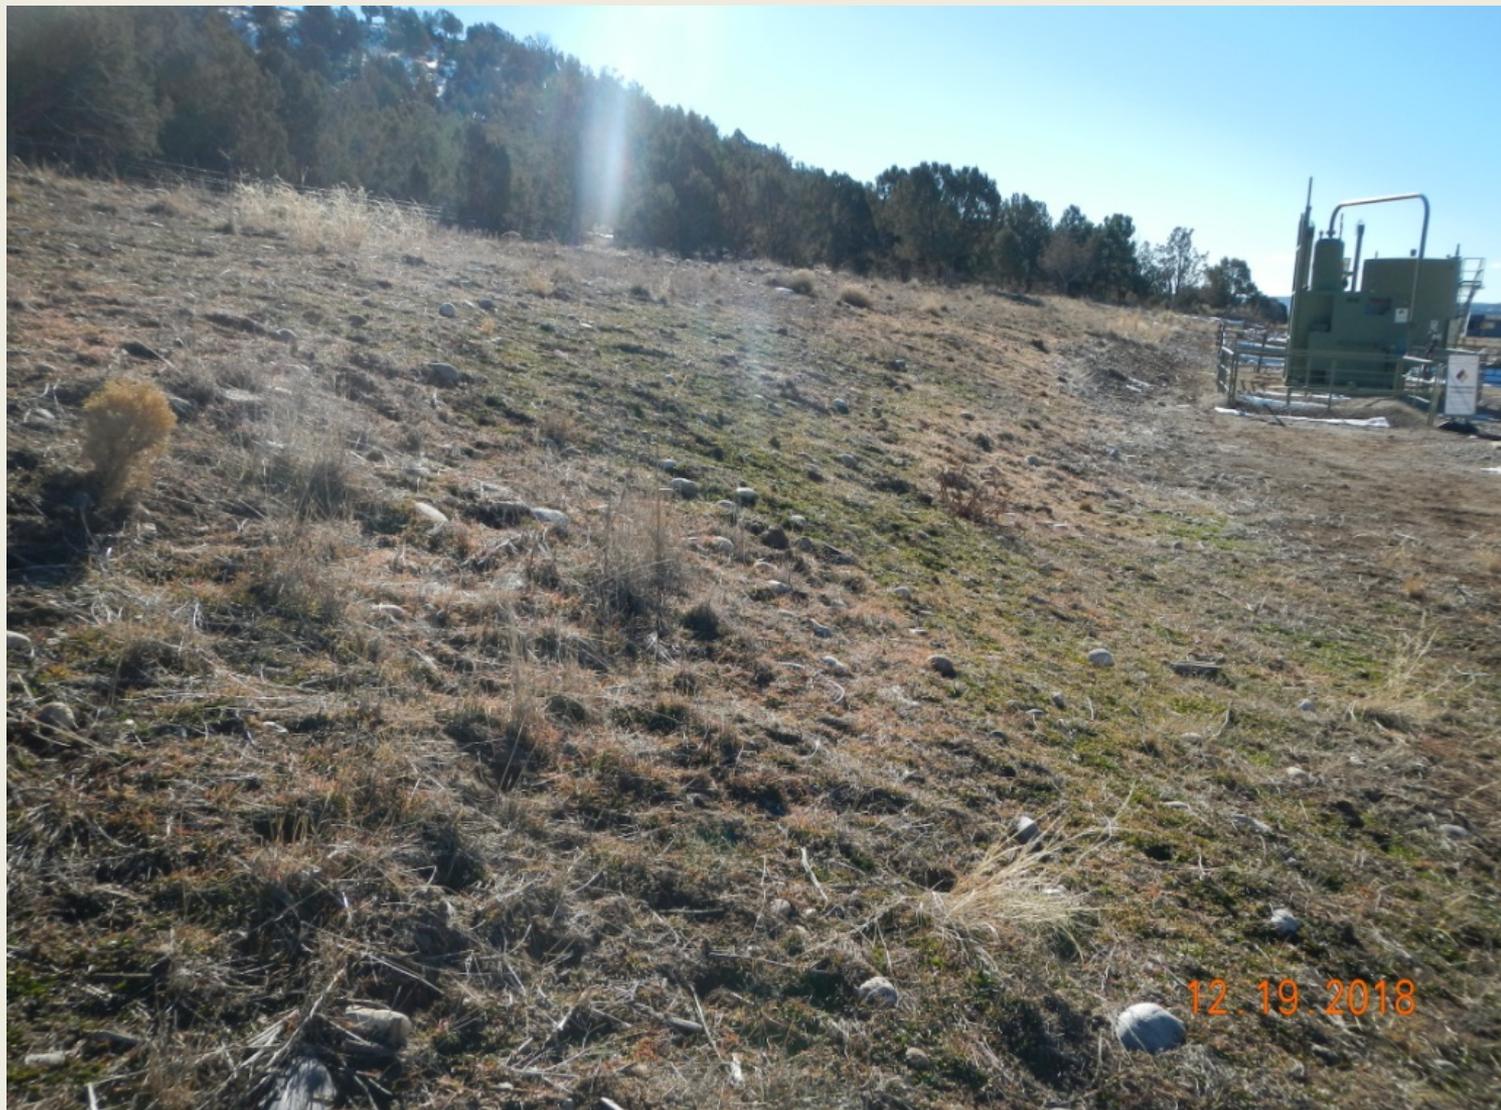
Photo 5. View of the eastern project area from the northeastern corner facing southward. Vegetation is grazed and largely comprised of weedy annuals.

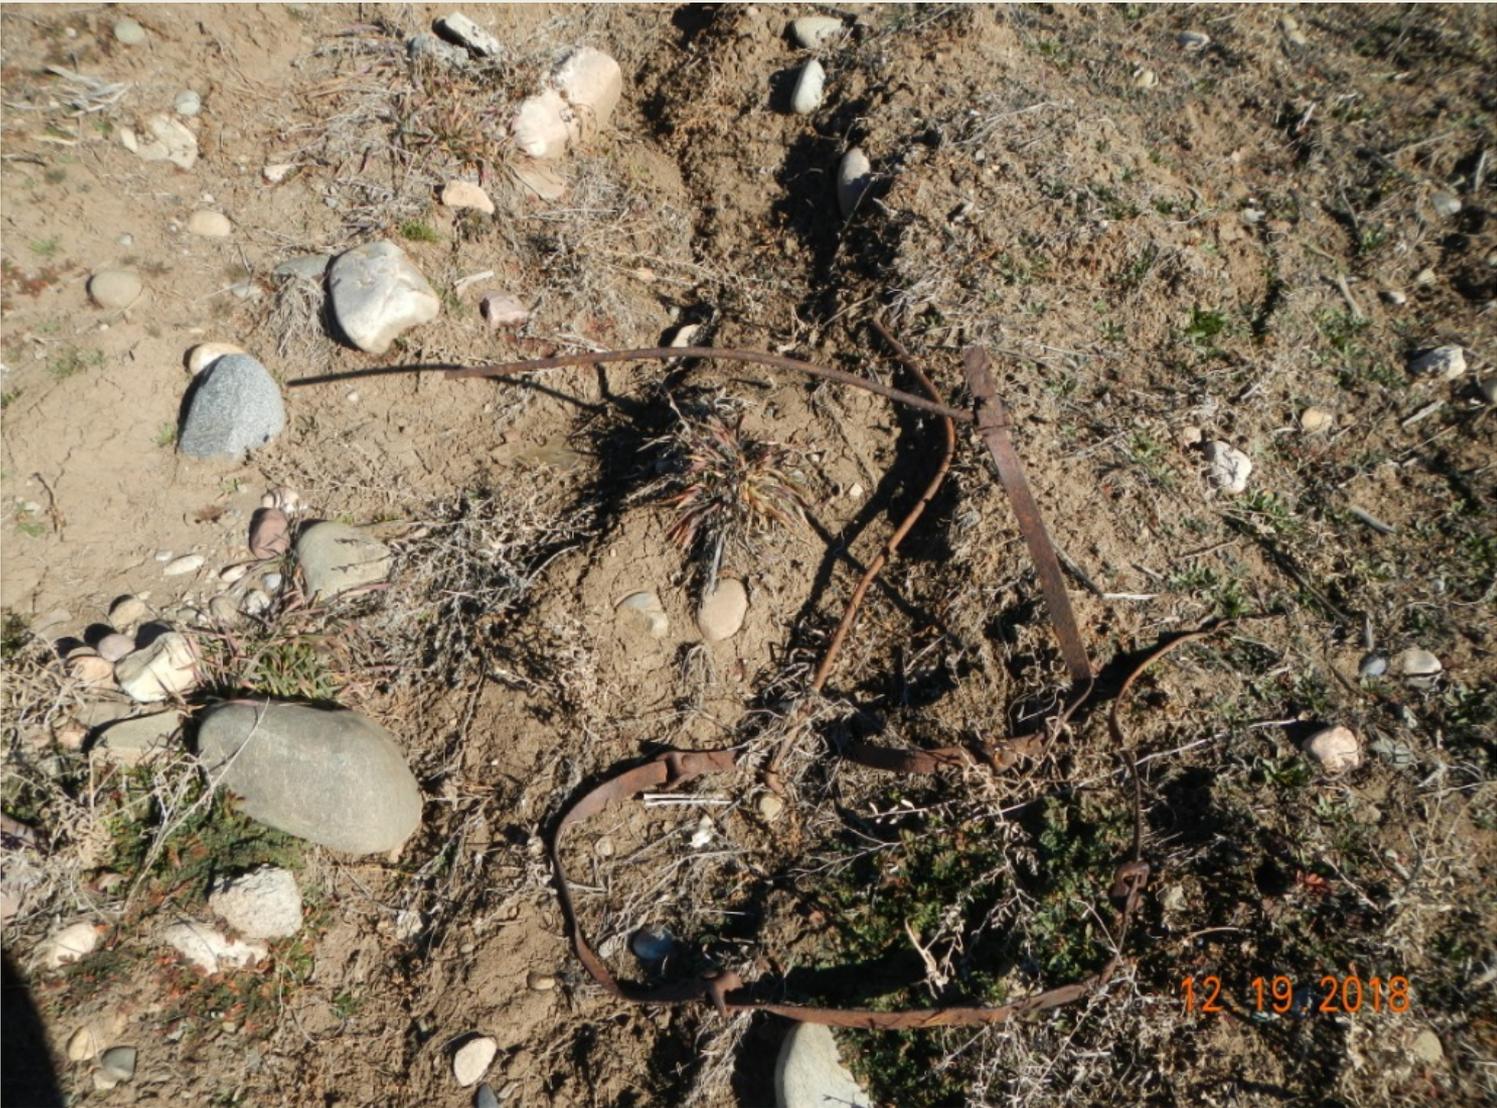
Photo 6. View of metal debris within the northeastern project area.
