# Construction and Storm Water Inspection

December 28, 2018

Operator: NOBLE ENERGY INC – 100322

Location ID: 458904

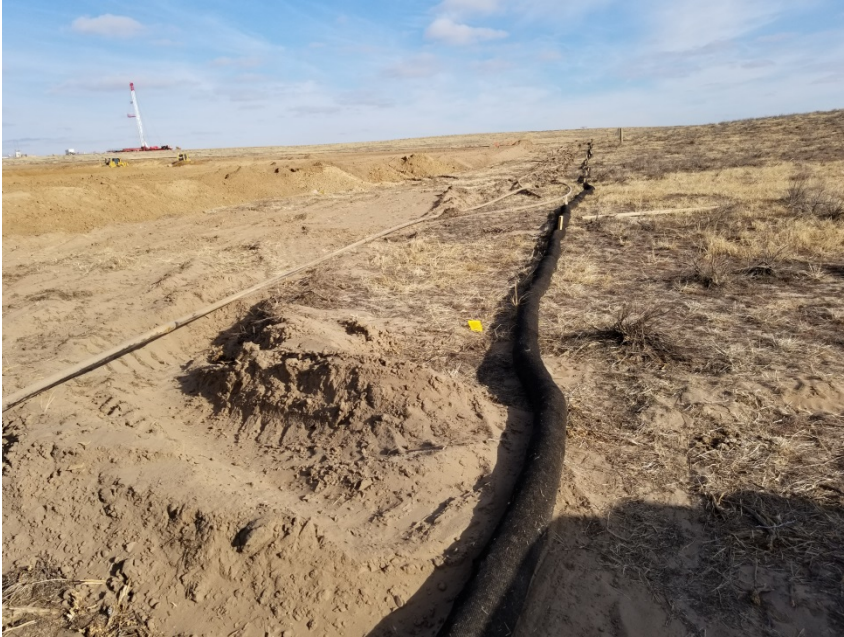
**Photo 1.** Photo taken from the southern perimeter of the location, facing East. Photo illustrates a filterxx BMP that has been installed around the perimeter of the location.

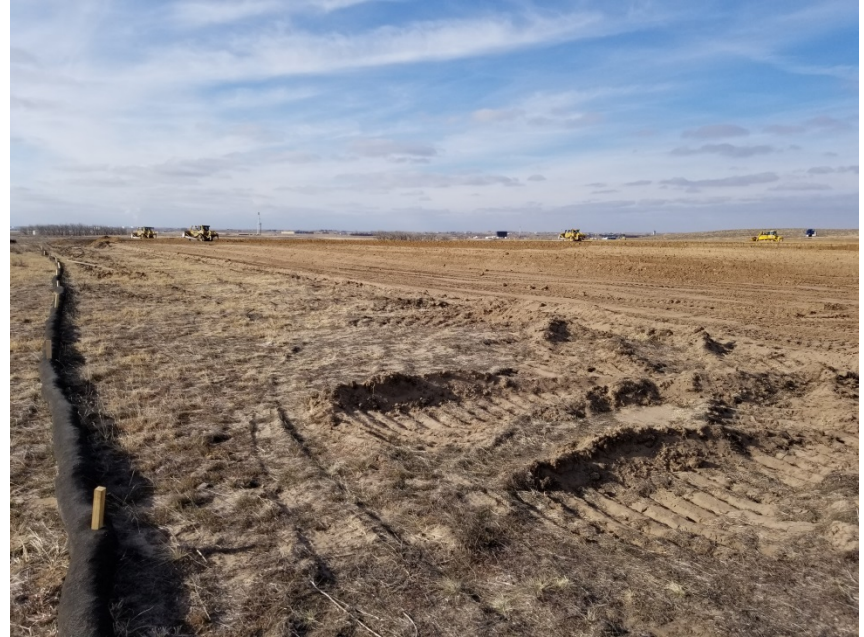
**Photo 2.** Photo taken from the southeastern perimeter of the location, facing West. See comments from Photo 1.

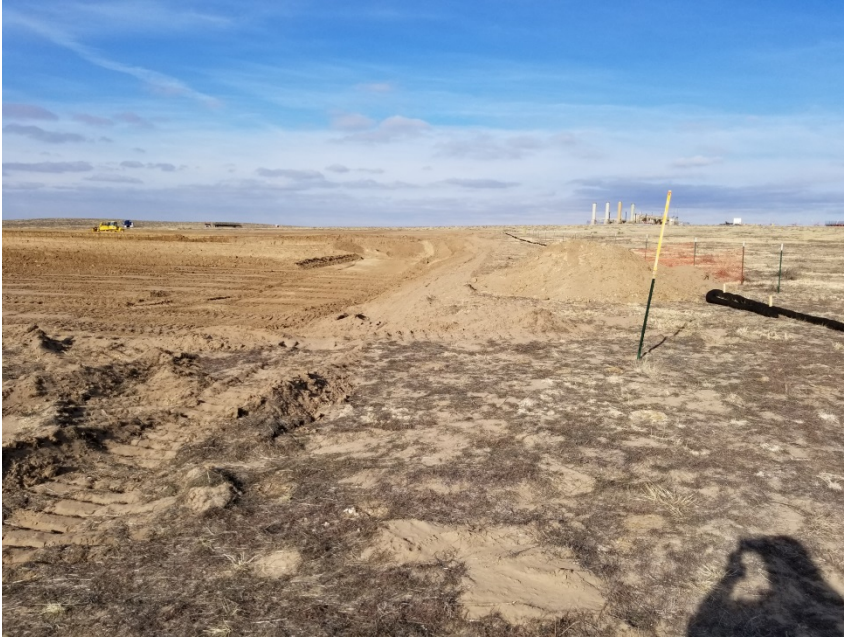
**Photo 3.** Photo taken from the southeastern perimeter of the location, facing North. Photo depicts breaks in the perimeter of the filtrex BMP .

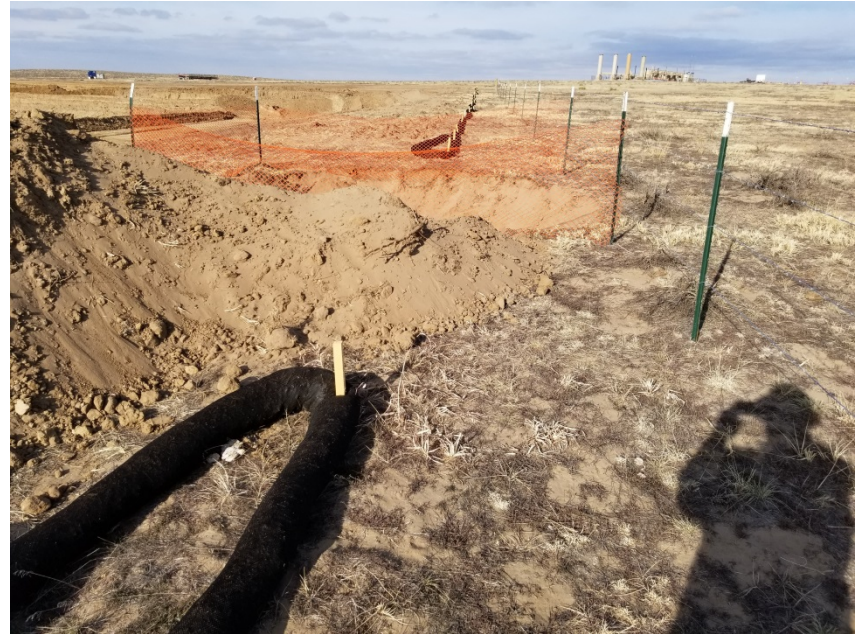
**Photo 4.** Photo taken from the Eastern perimeter of the location, facing North. Photo depicts breaks in the perimeter of the filtrex BMP adjacent to open fenced pothole.

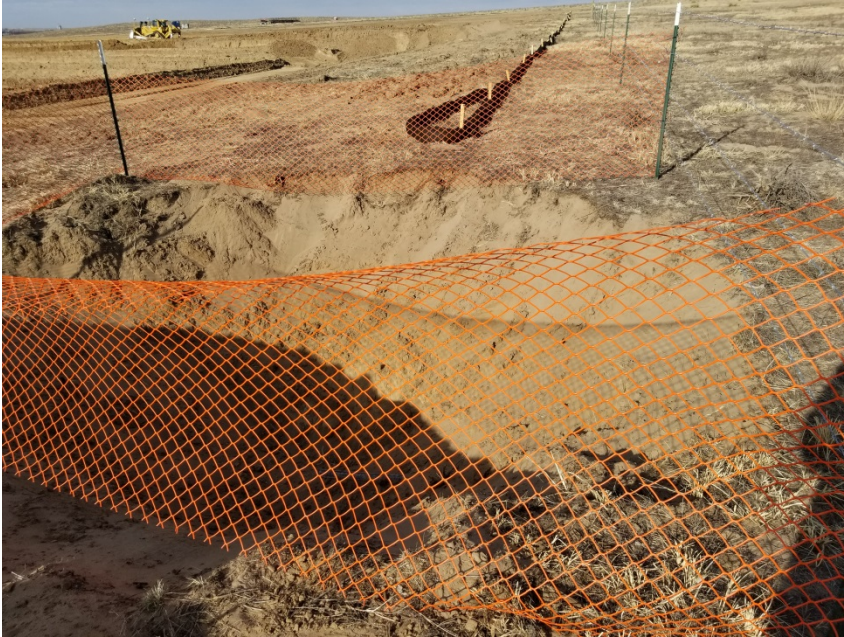
**Photo 5.** Photo taken from the Eastern perimeter of the location, facing North. See comments from Photo 4.

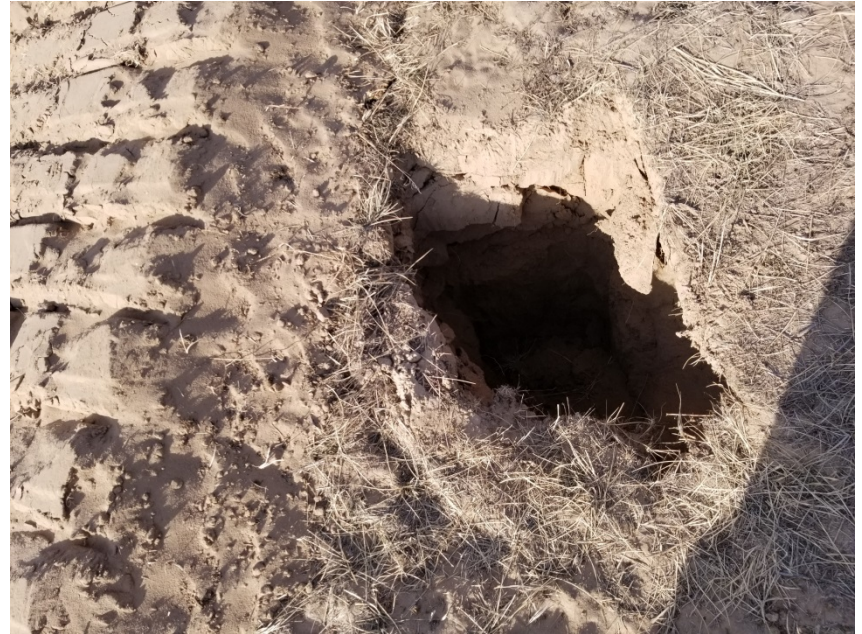
**Photo 6.** Photo taken from the Eastern perimeter of the location, adjacent to the fenced pothole. The unfenced hole appeared to be greater than 3 feet depth.

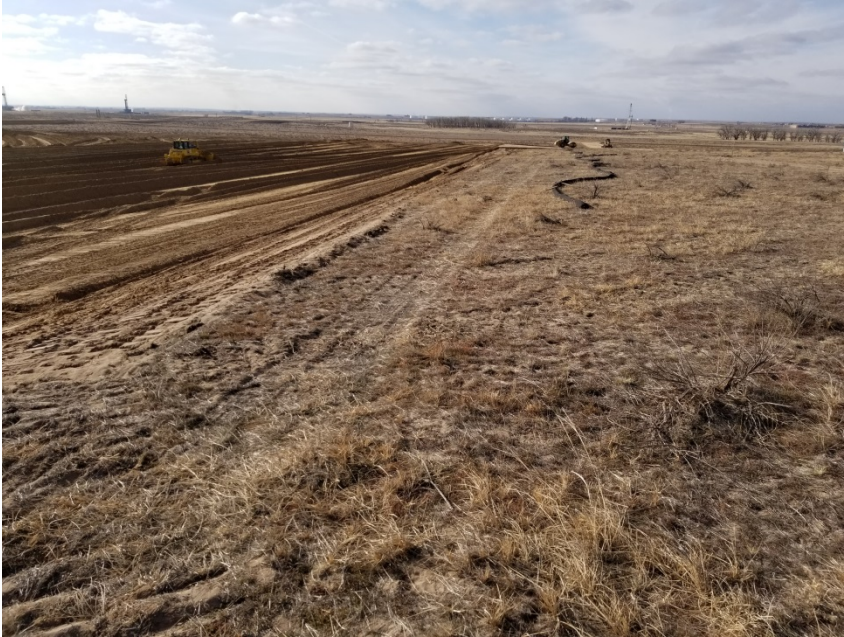
**Photo 7.** Photo taken from the northeastern perimeter of the location, facing West. See comments under Photos 3.

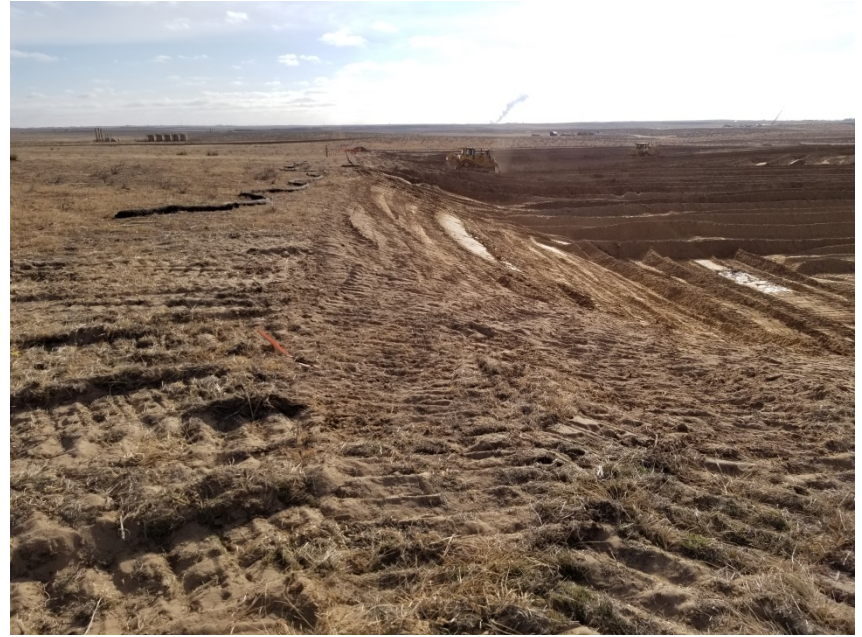
**Photo 8.** Photo taken from the northeastern perimeter of the location, facing South. See comments under Photos 3.

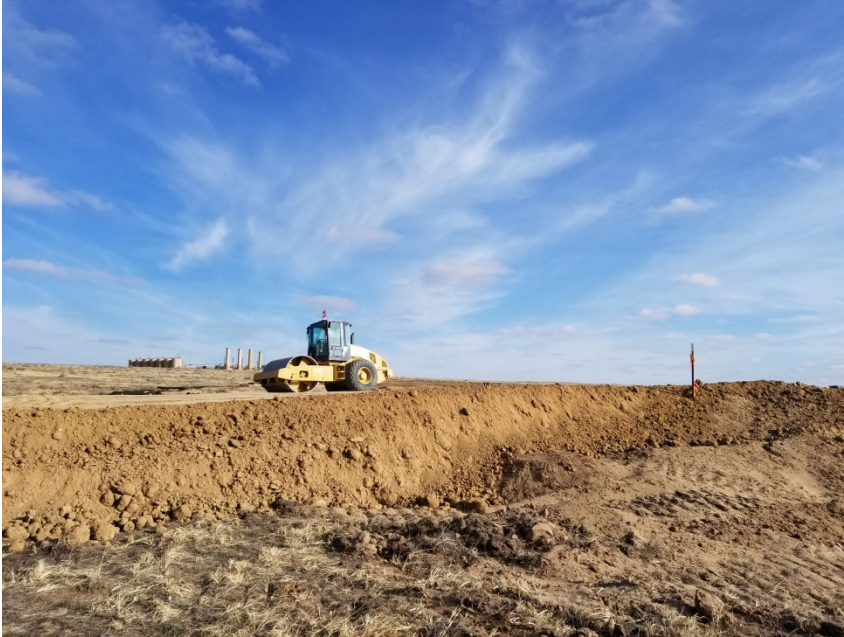
**Photo 9.** Photo taken from the northwestern perimeter of the location, facing East. See comments under Photos 3.

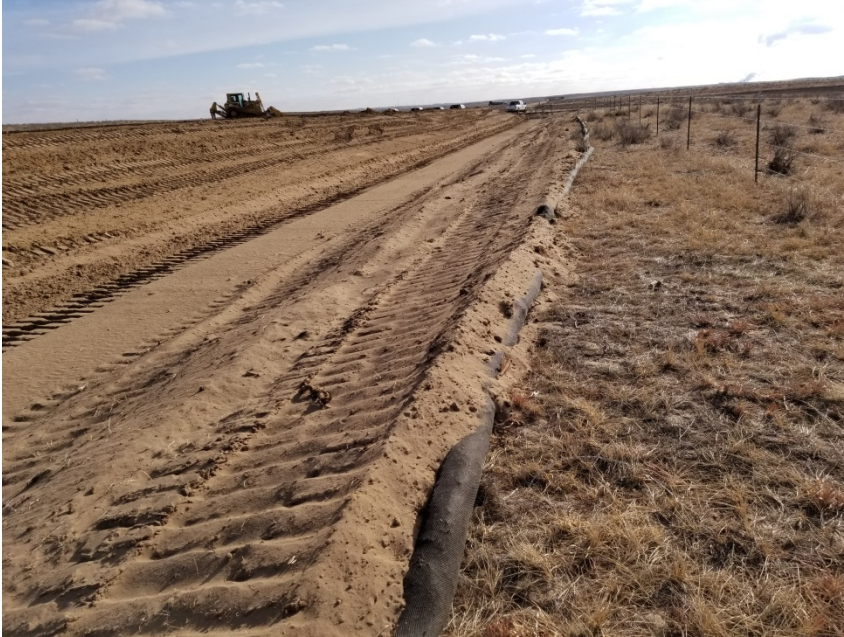
**Photo 11.** Photo taken from the Western perimeter of the location, facing South. Photo depicts soil placed over Filtrexx BMPs.

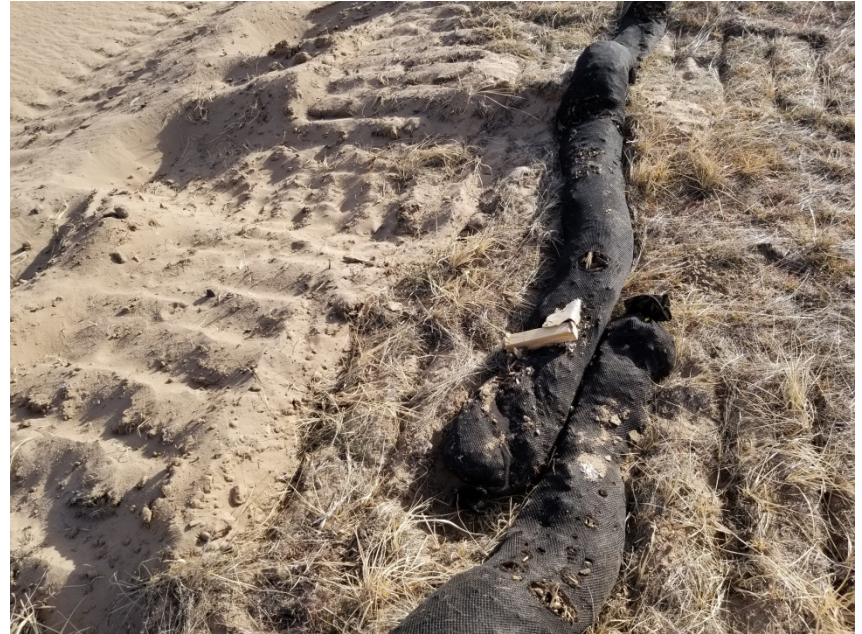
**Photo 12.** Photo taken from the Western perimeter of the location, facing South. Photo depicts soil Filtrexx BMPs apparently ran over by equipment.

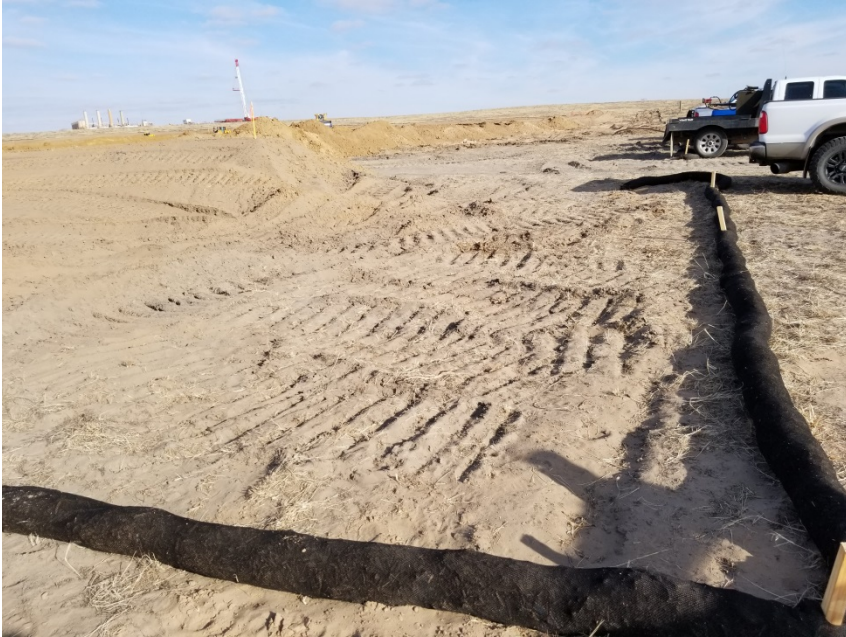
**Photo 13.** Photo taken from the southwestern perimeter of the location, facing East. See comments from Photo 1.

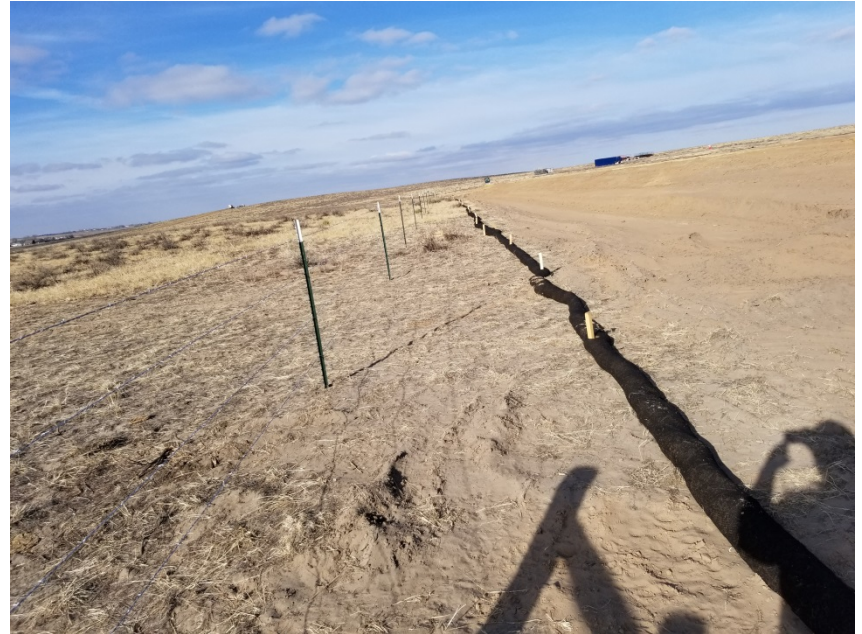
**Photo 14.** Photo taken from the southwestern perimeter of the location, facing North. See comments from Photo 1.
