# Inspection Photos

Operator: Hilcorp Energy

API: 05-067-08111

Date: 12/19/2018

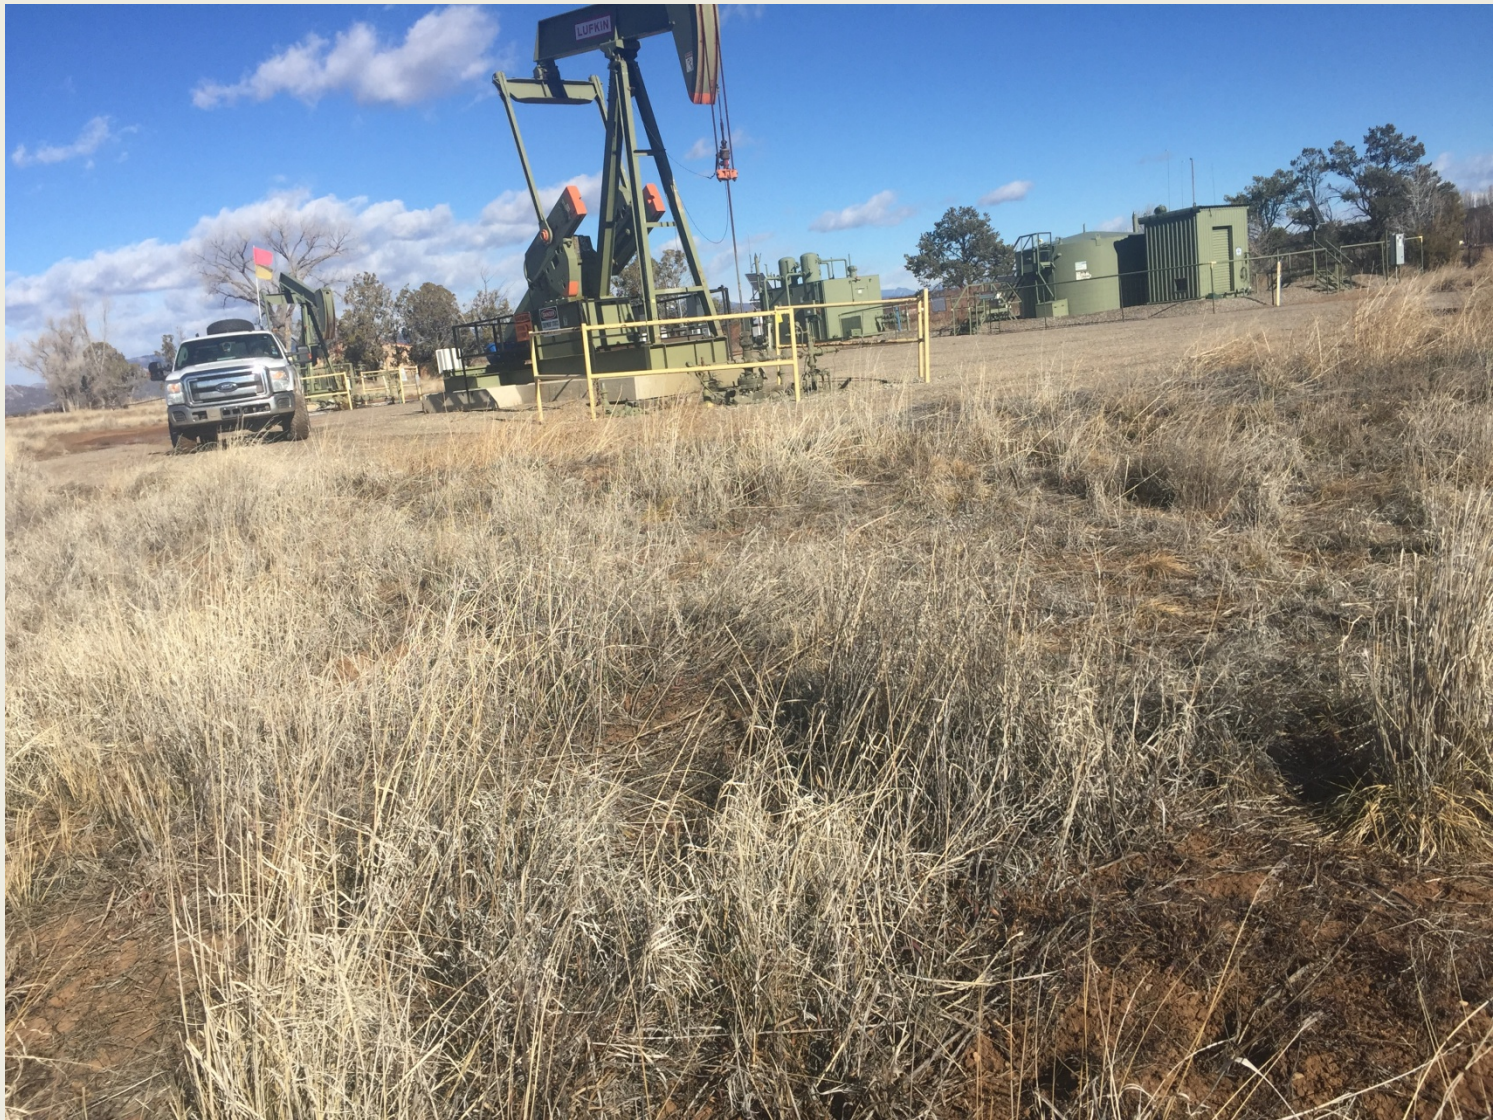
**Photo 1. View of the southern project area from the southwestern corner facing eastward.**

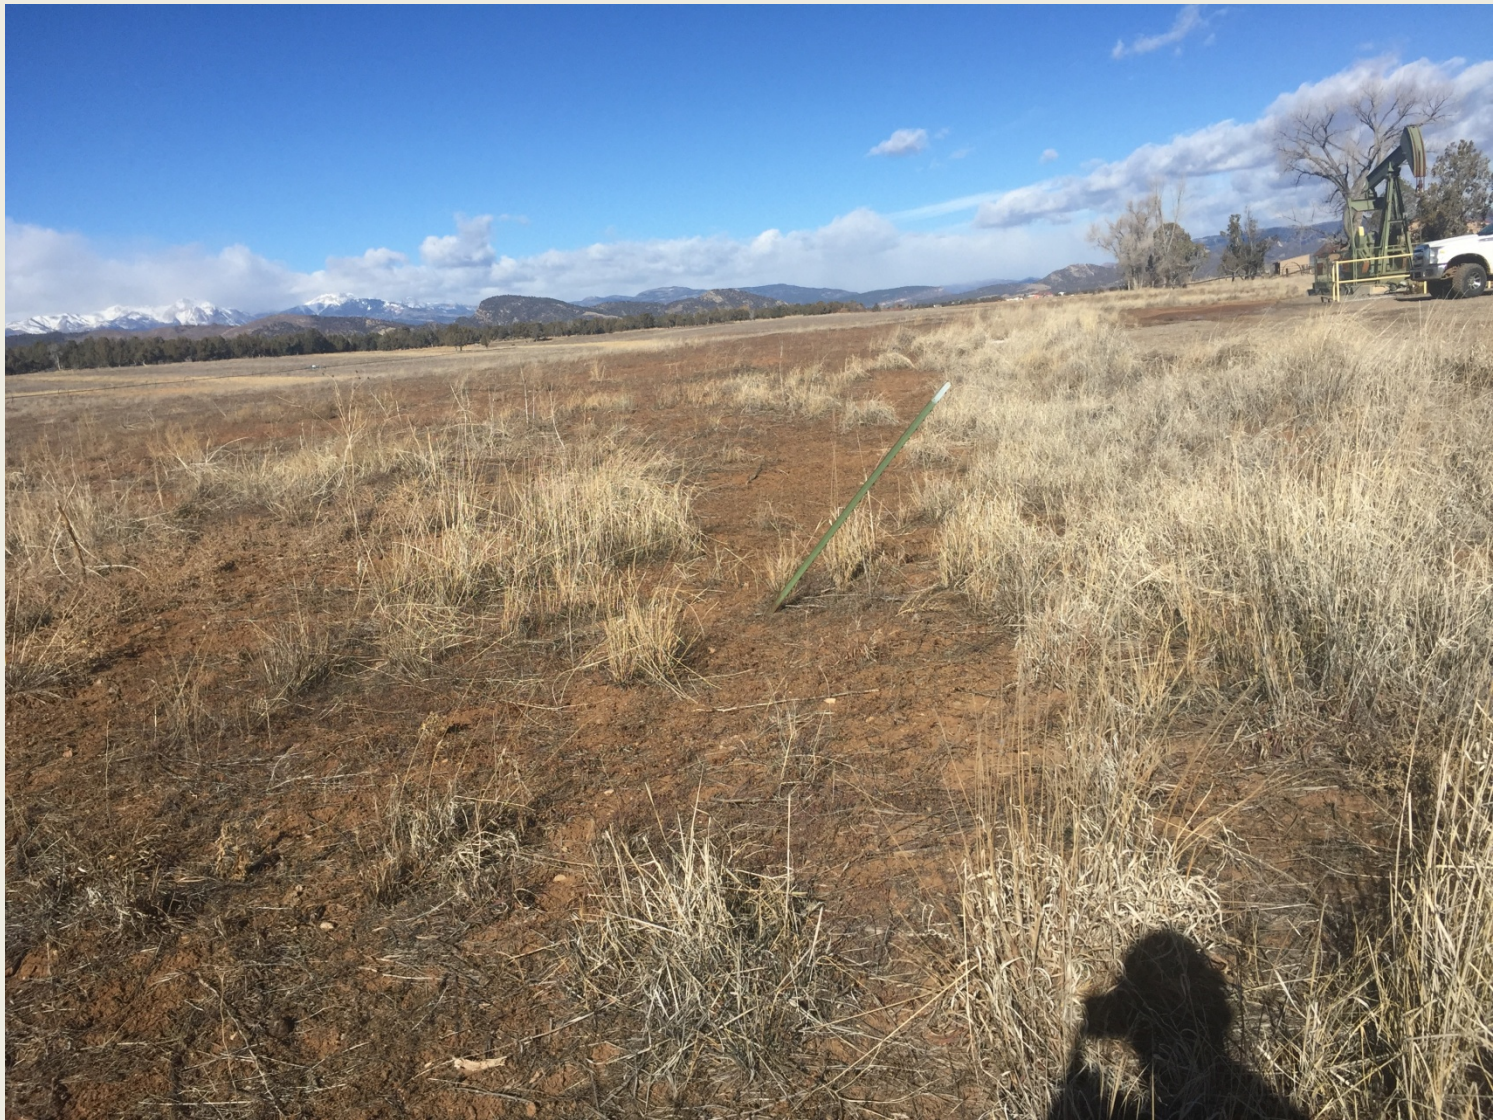
**Photo 2. View the western project area from the southwestern corner facing northward.**

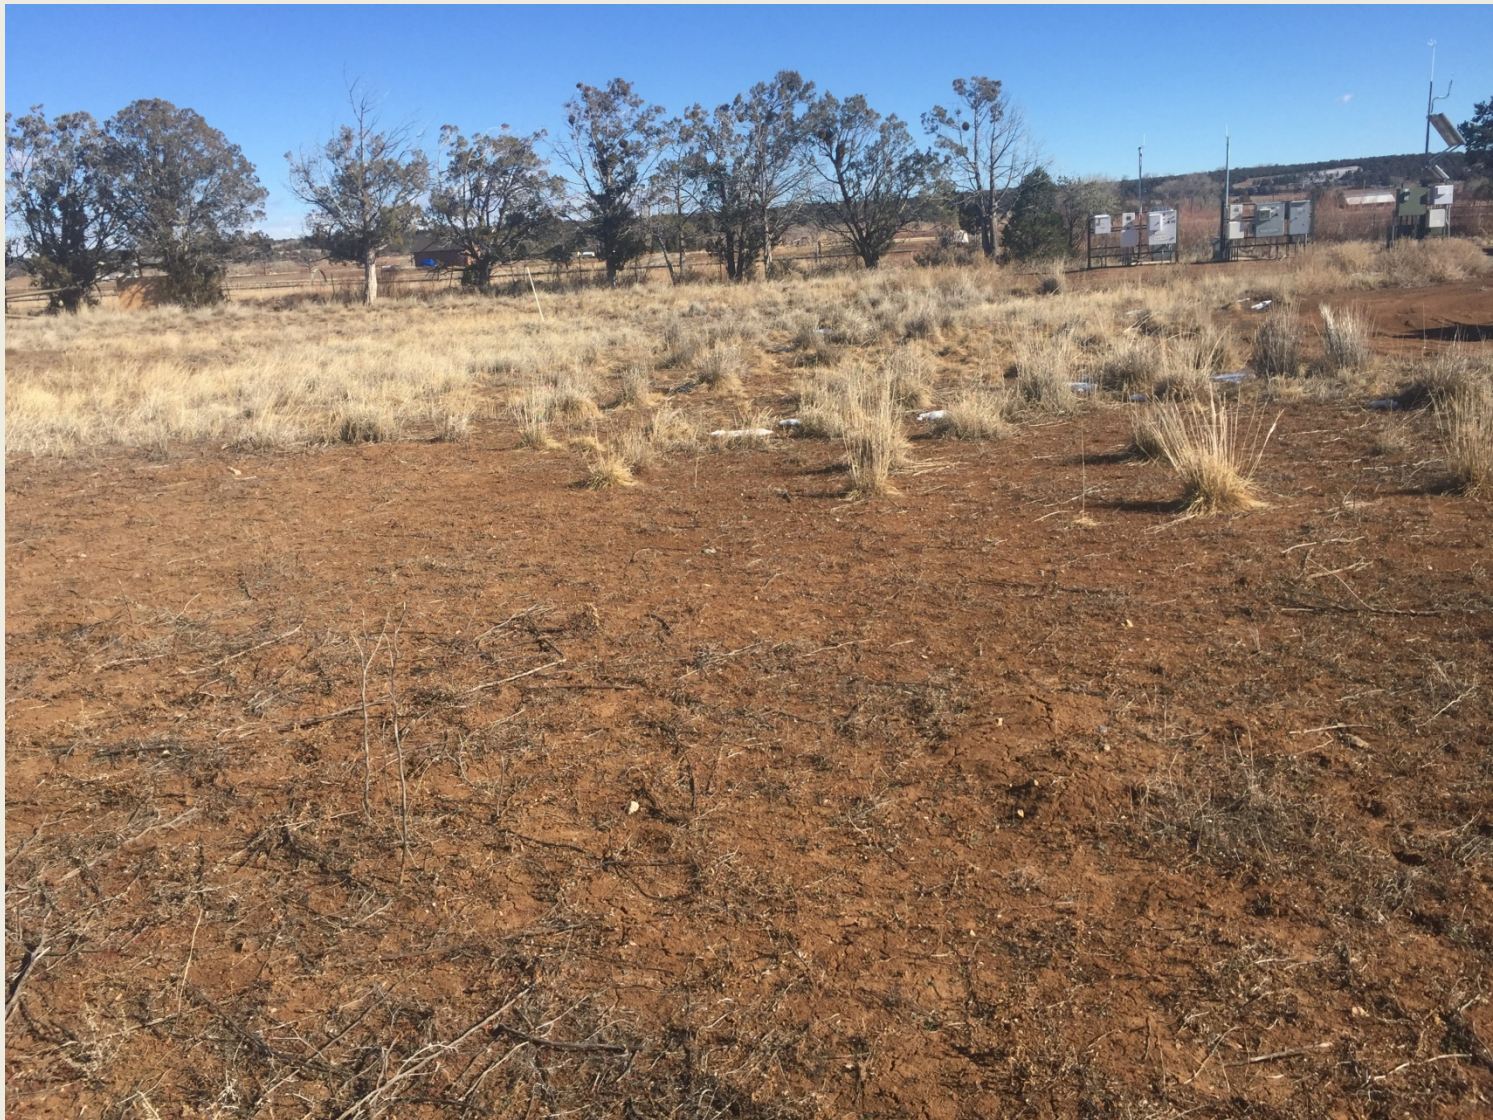
**Photo 3. View of northern project area from the northwestern corner facing eastward.**

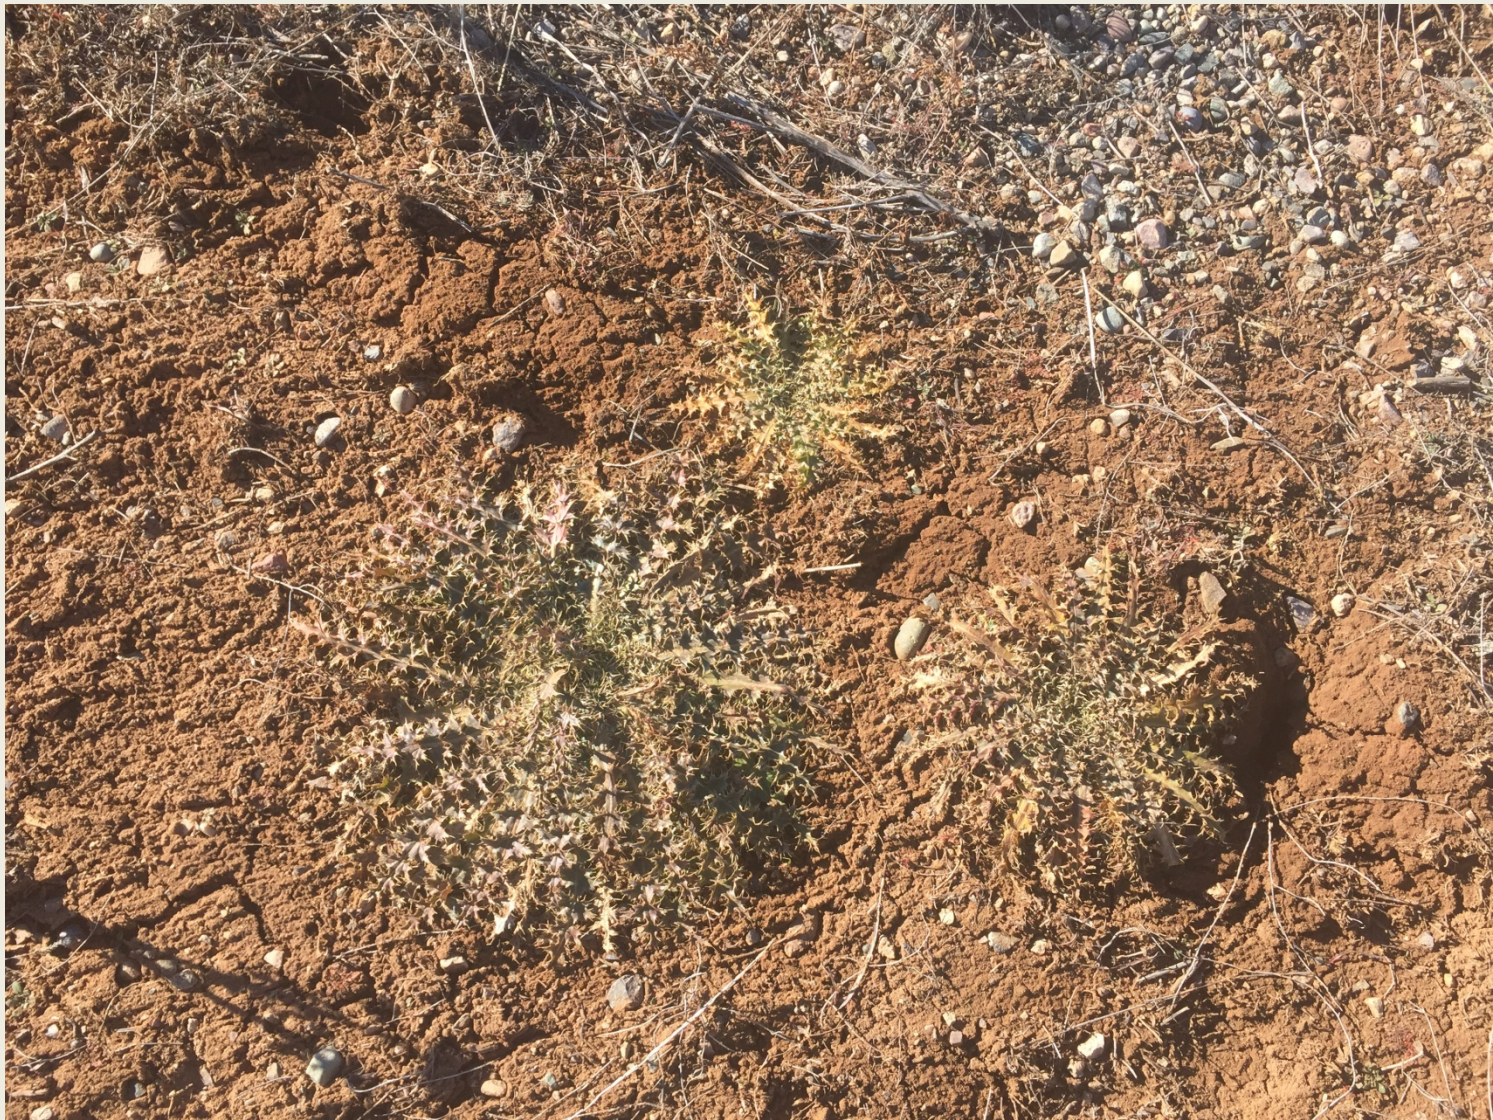
**Photo 4. View of musk thistles (*Carduus nutans*) within the interim reclamation area.**

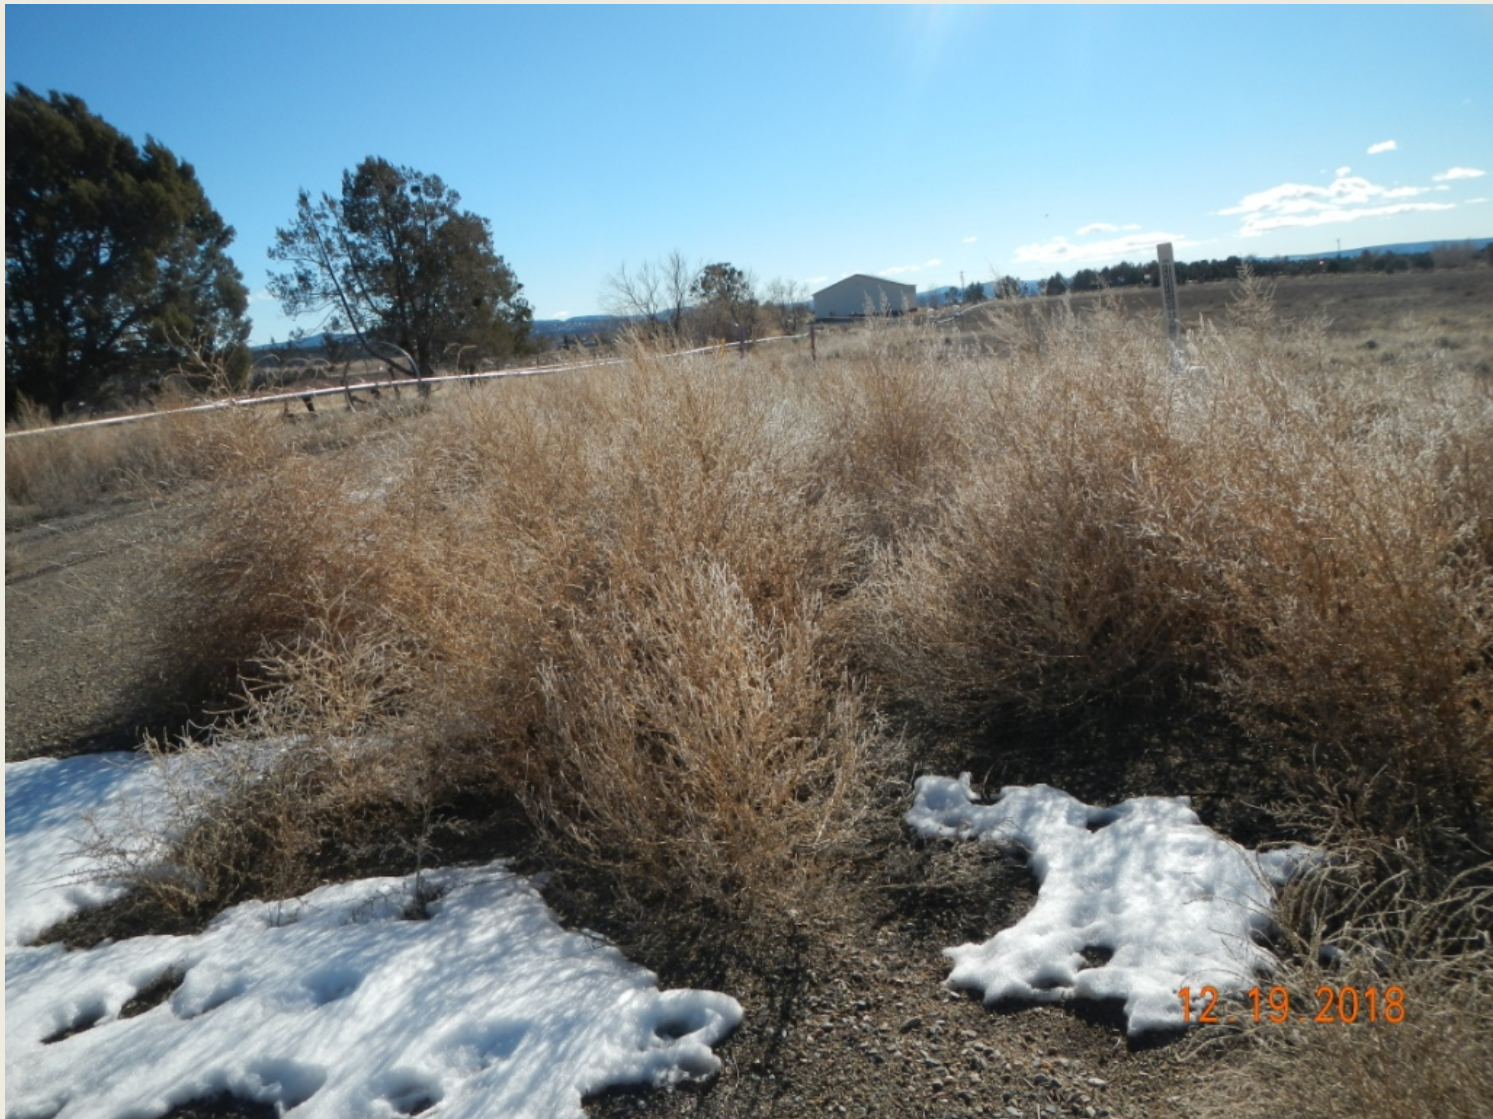
**Photo 5. View of kochia debris up to 4 feet tall at the entrance to the well pad.**
