Inspection Photos

Operator: Hilcorp Energy

API: 05-067-08106

Date: 12/19/2018

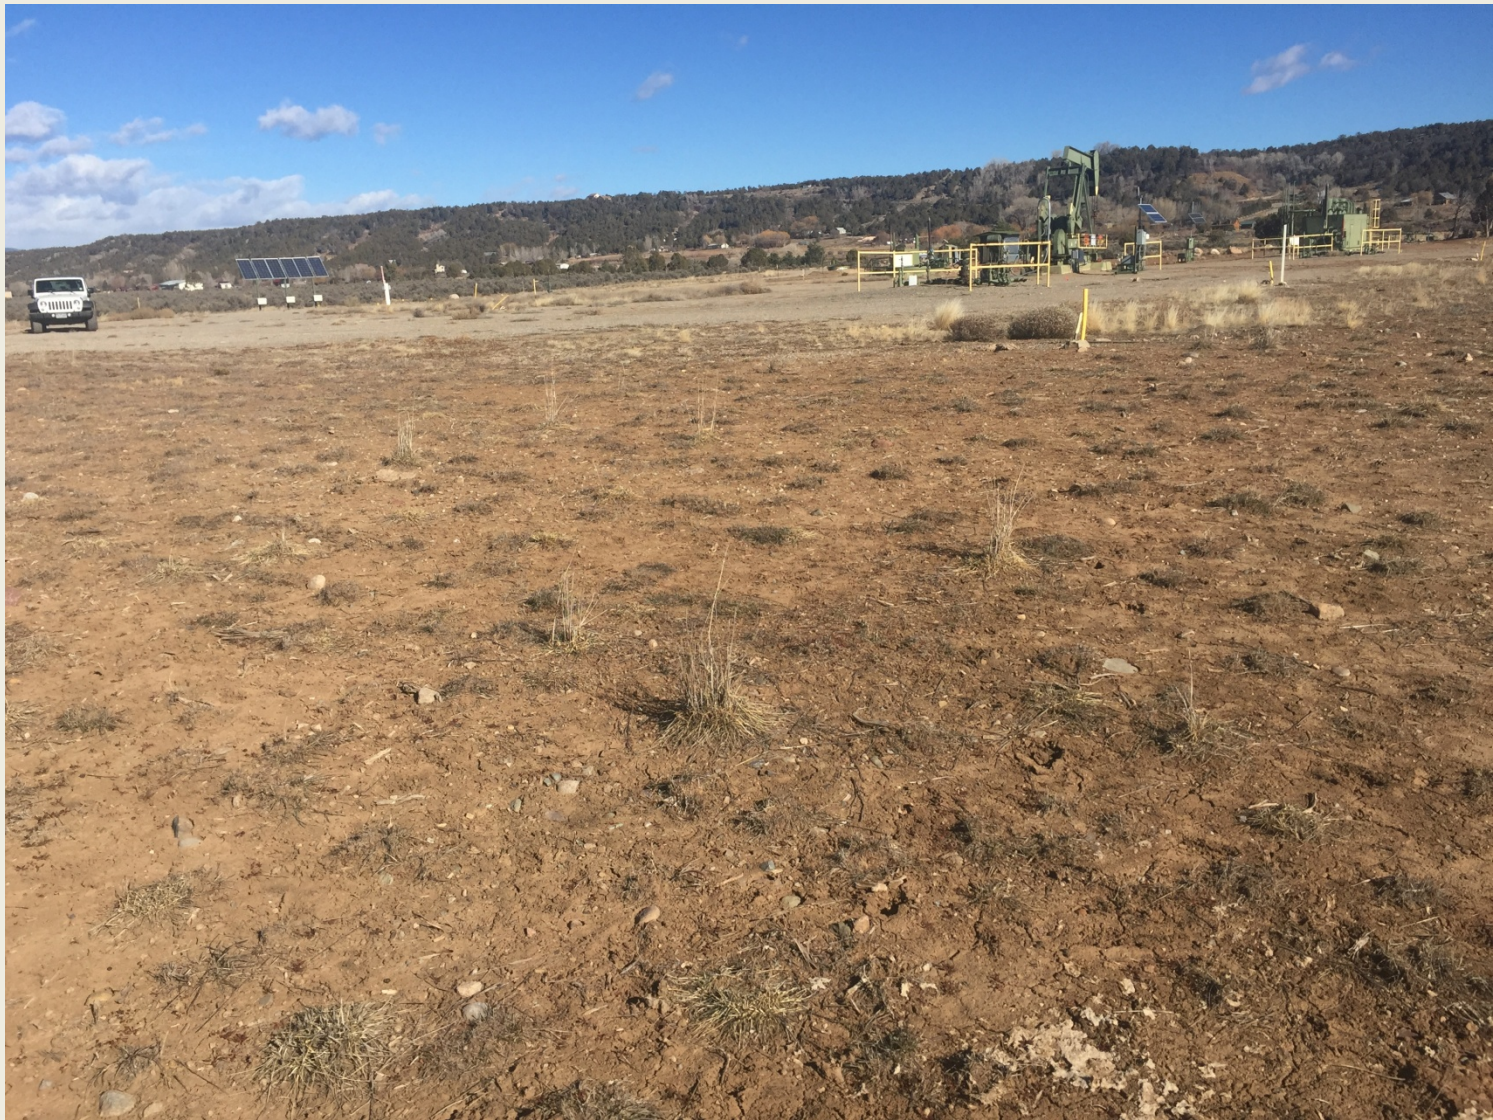
Photo 1. View of the project area from the southwestern corner facing center.

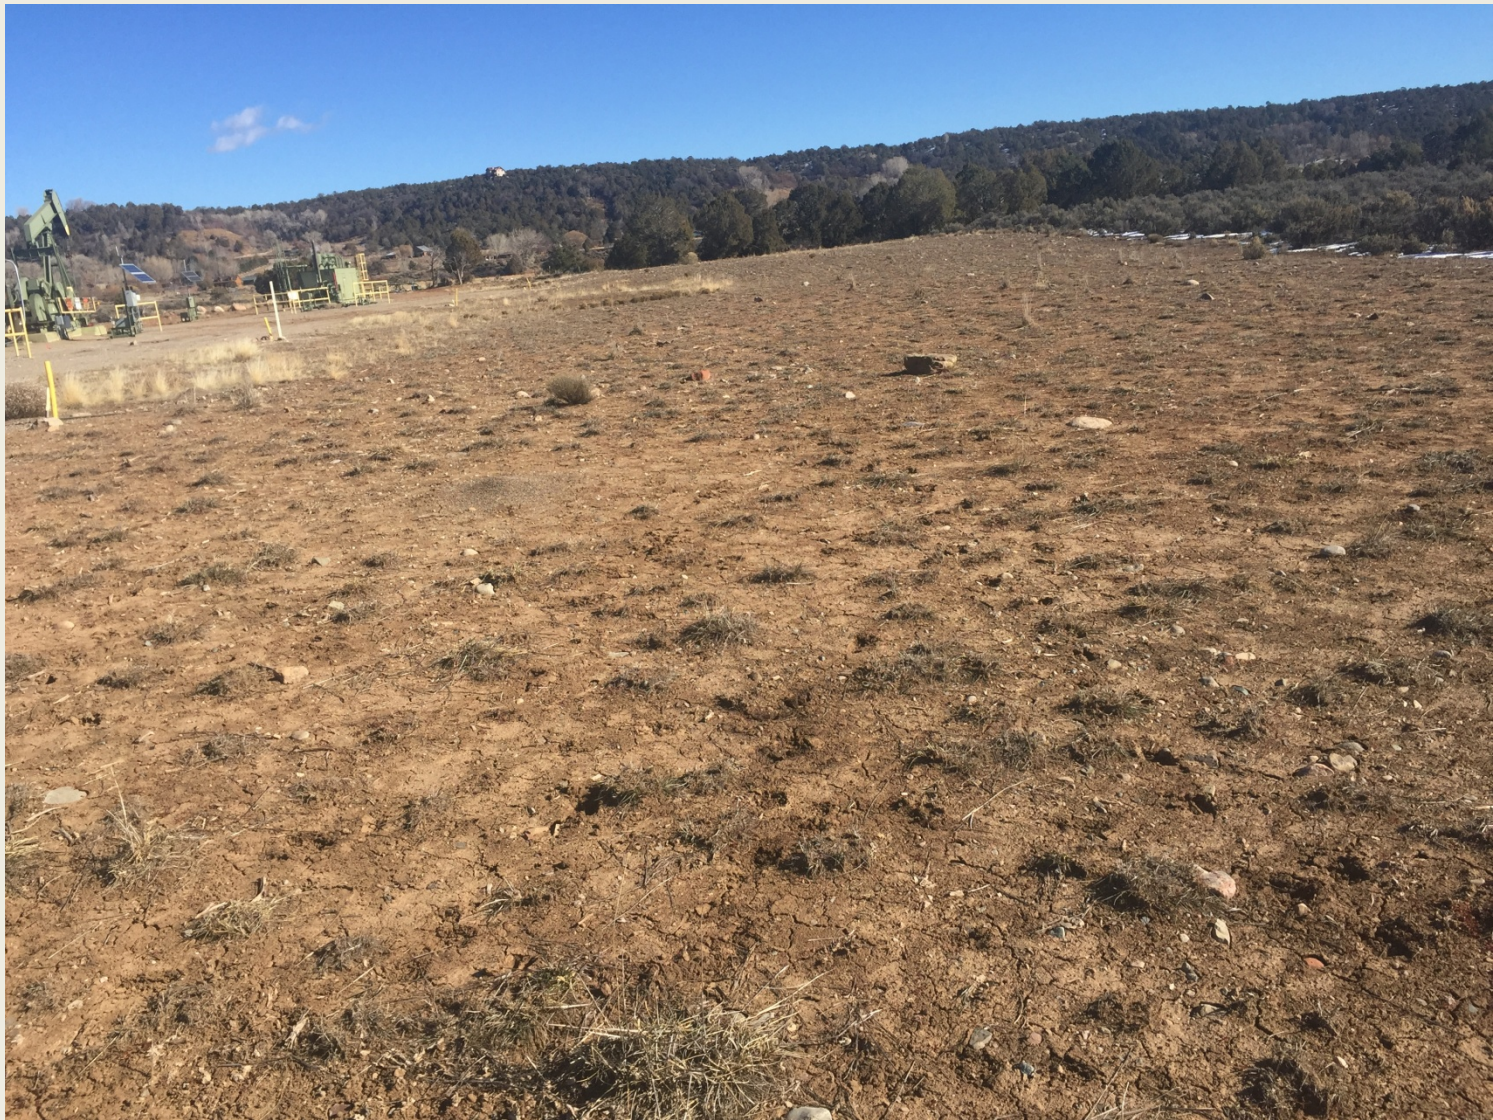
Photo 2. View the southern project area from the southwestern corner facing eastward. Revegetation is progressing, although grazed.

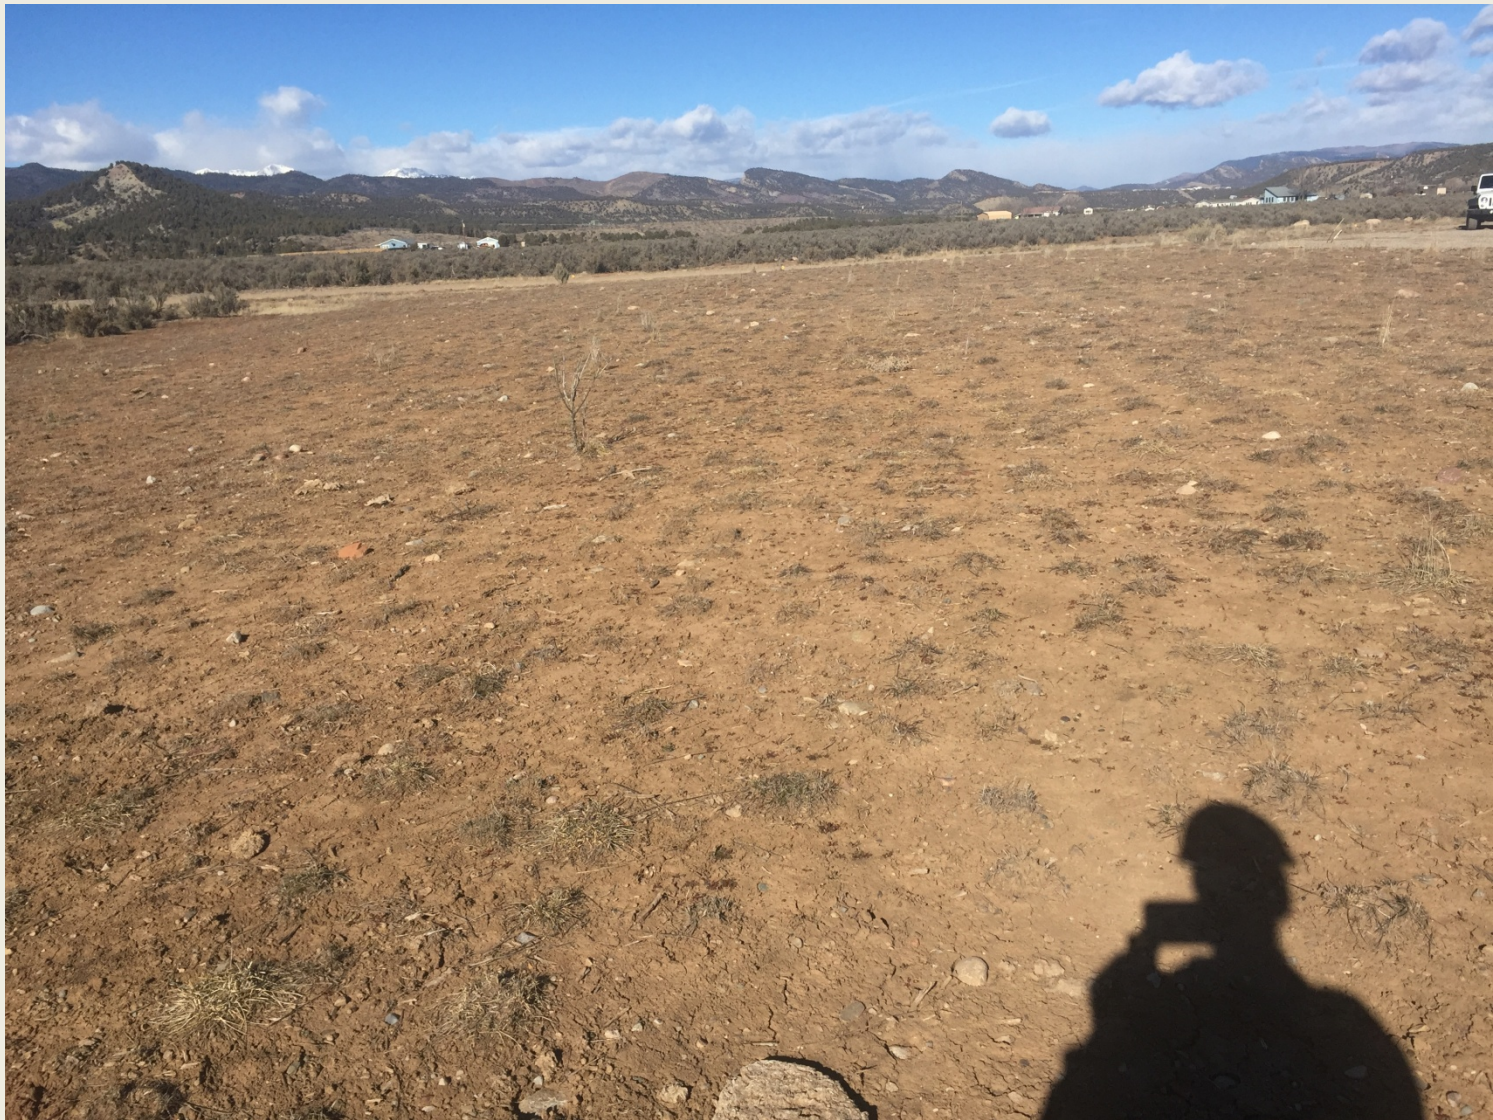
Photo 3. View of western project area from the southwestern corner facing northward.
