Inspection Photos

Operator: Enervest Operating

API: 05-067-05614

Date: 12/19/2018

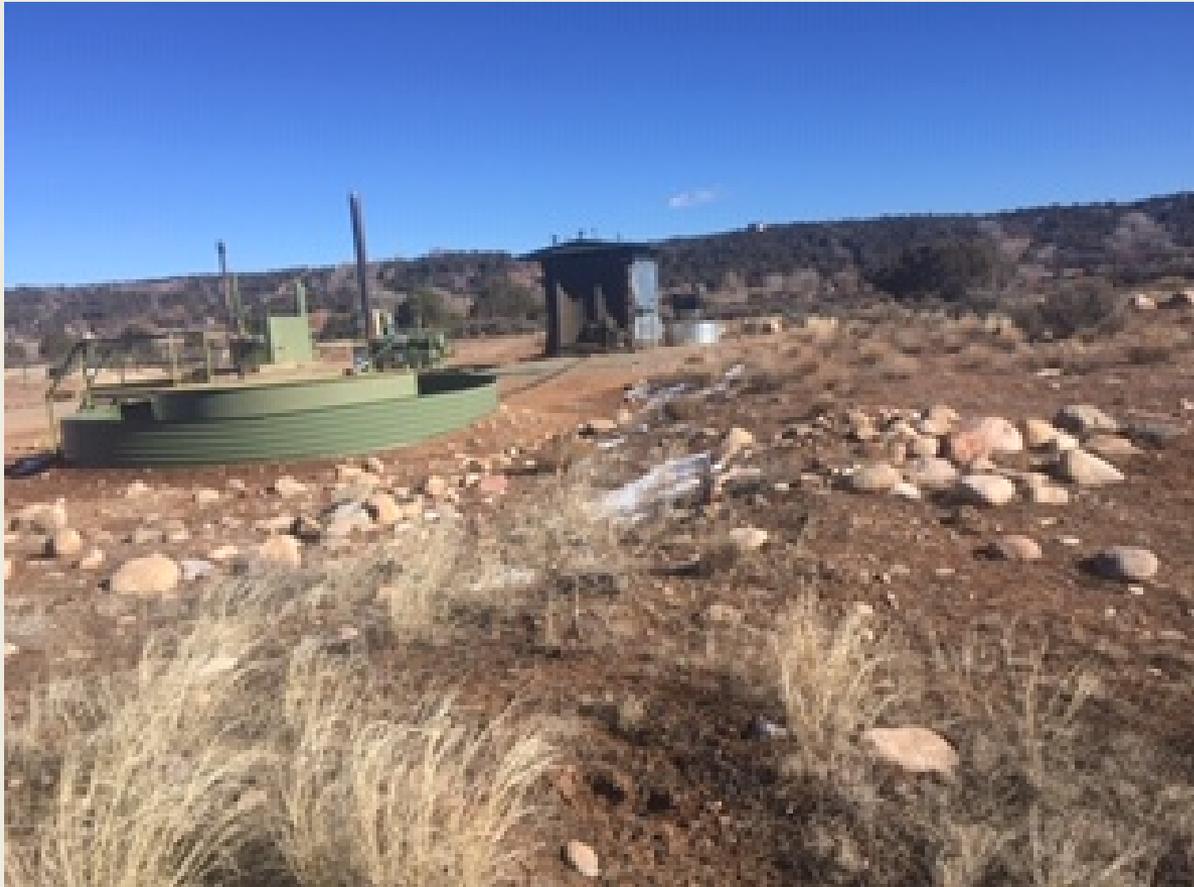
Photo 1. View of the southern project area from the southwestern corner facing eastward. Revegetation is progressing within the interim reclamation areas.
