Inspection Photos

Operator: BP America

API: 05-067-09727

Date: 12/21/2018

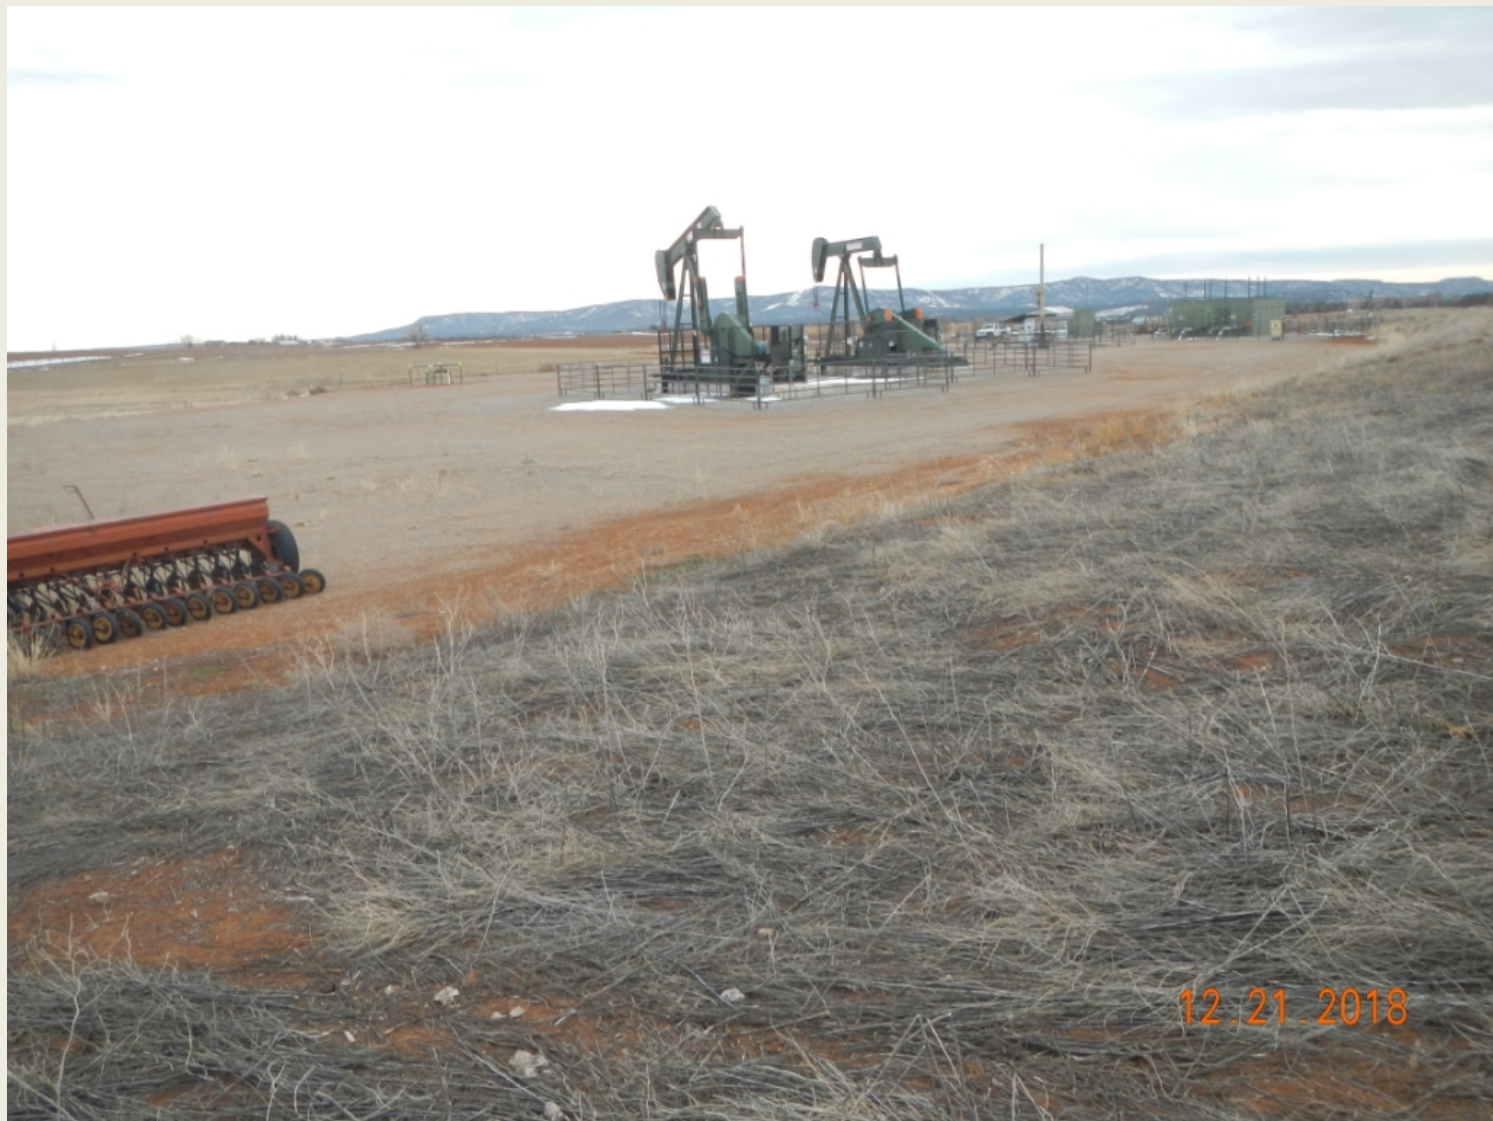
Photo 1. View of the project area from the northwestern corner facing center. Plow is stored in the northwestern corner of the working area.

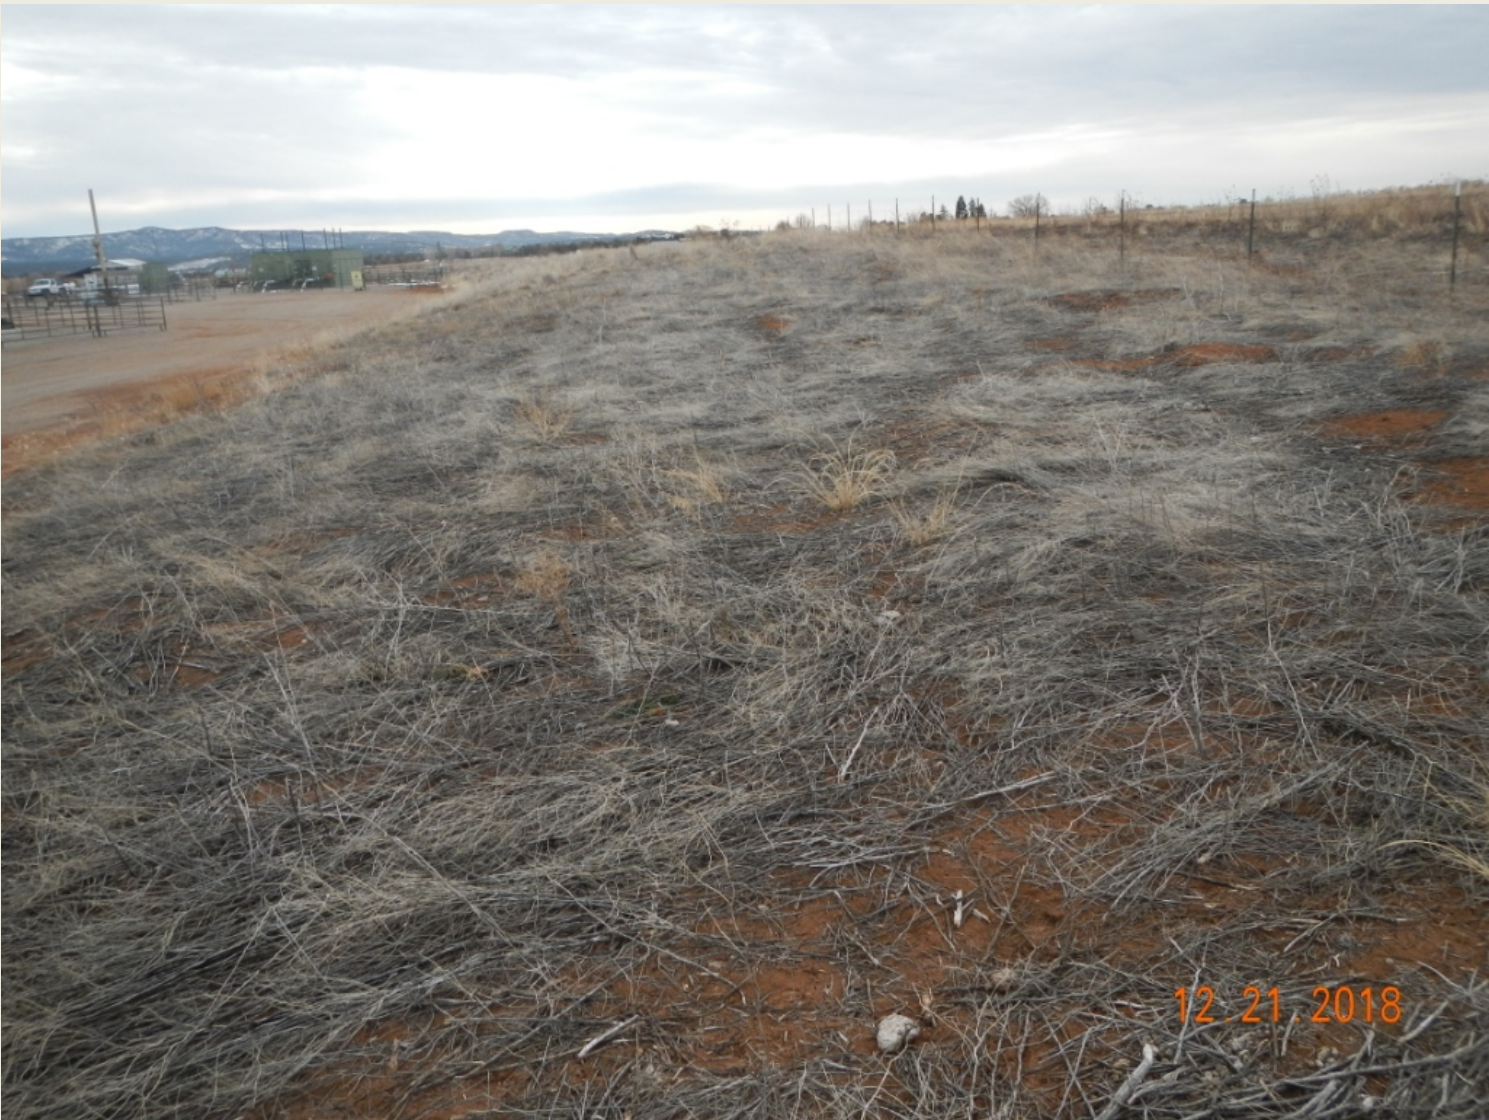
Photo 2. View the western project area from the northwestern corner facing southward.

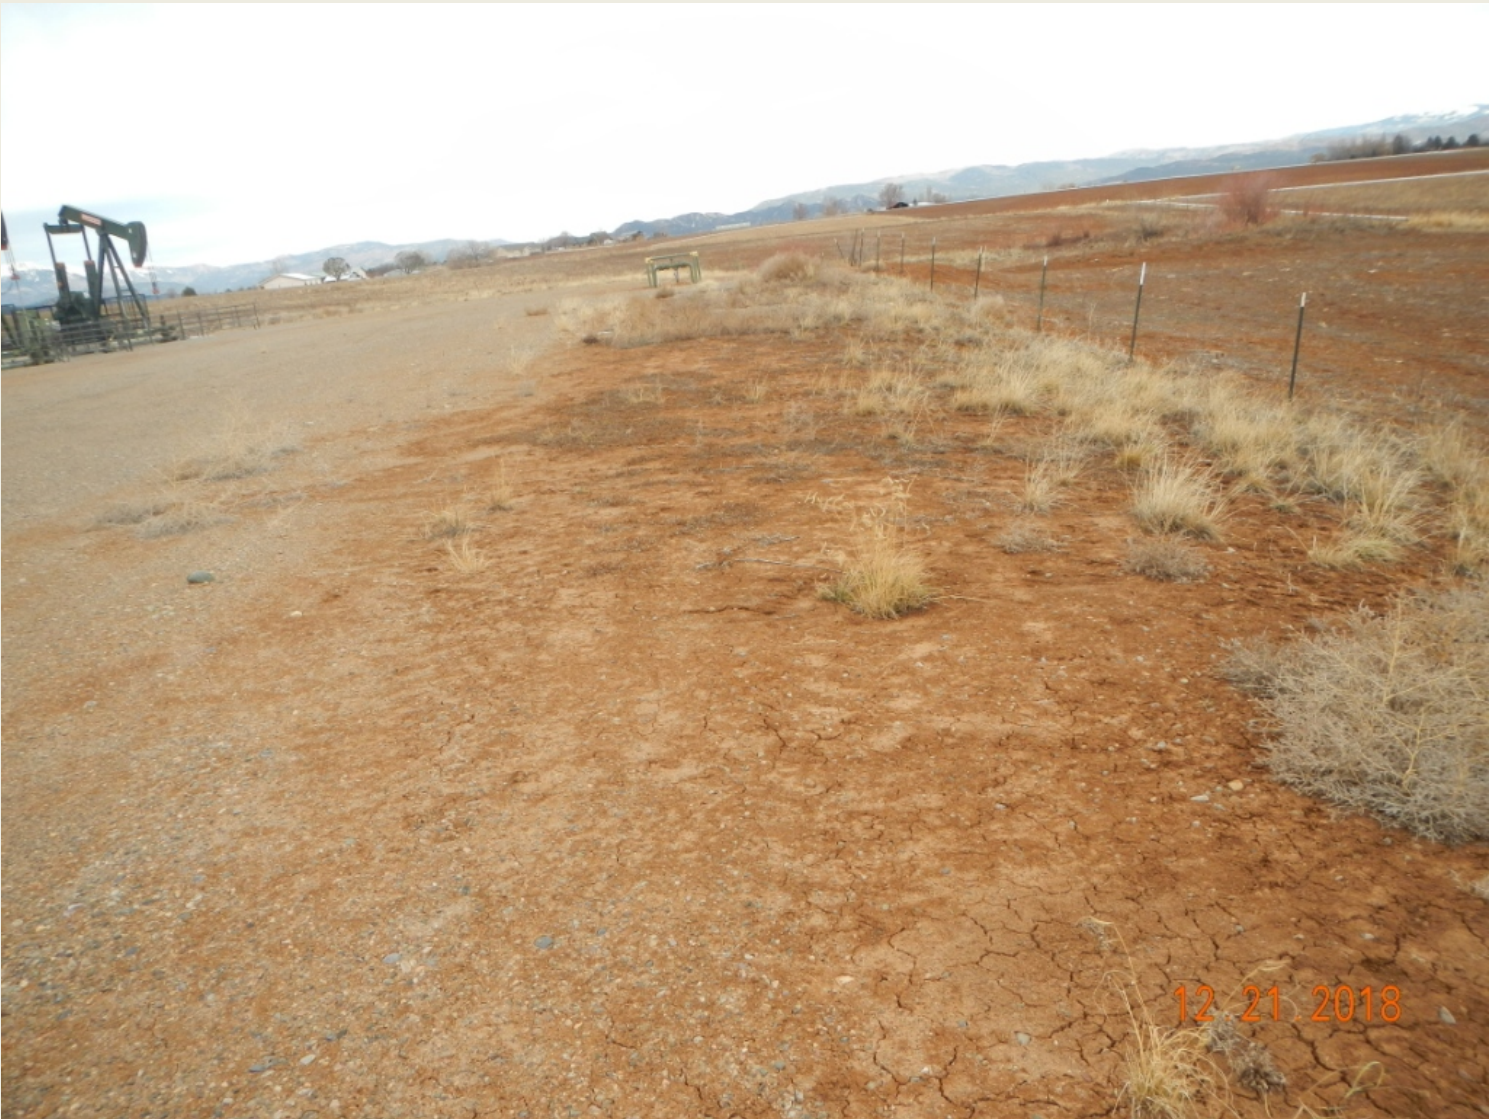
Photo 3. View of the eastern project area from the southeastern corner facing northward.

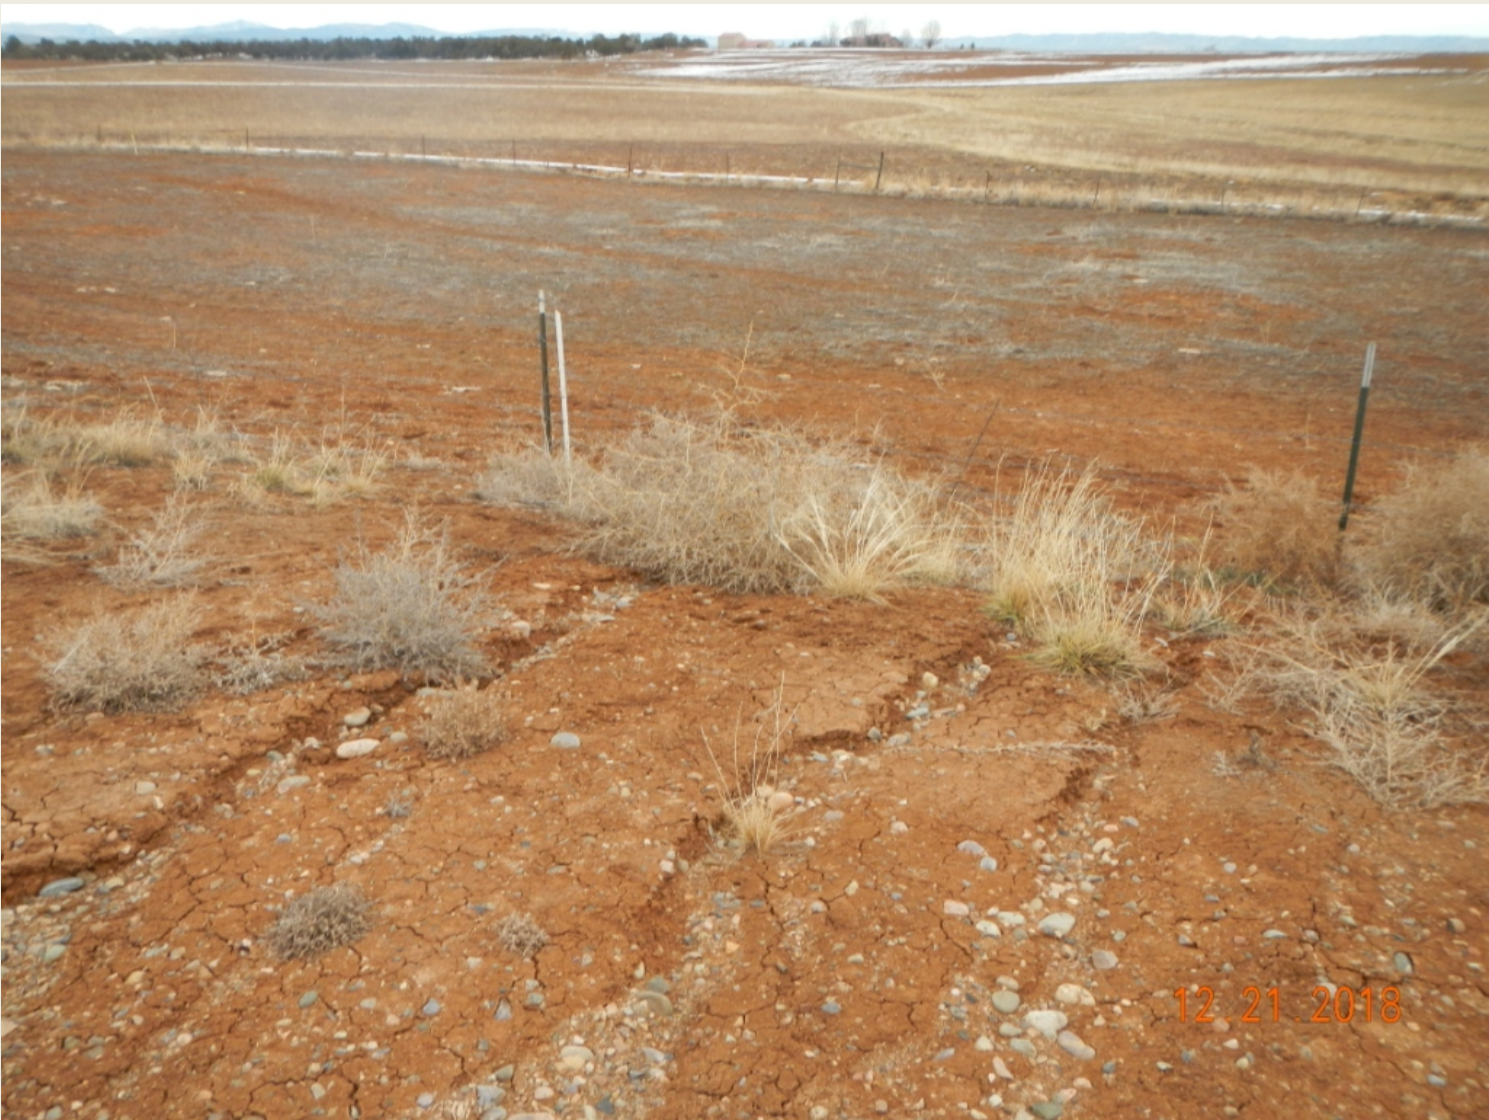
Photo 4. View of erosional rilling within the eastern project area.

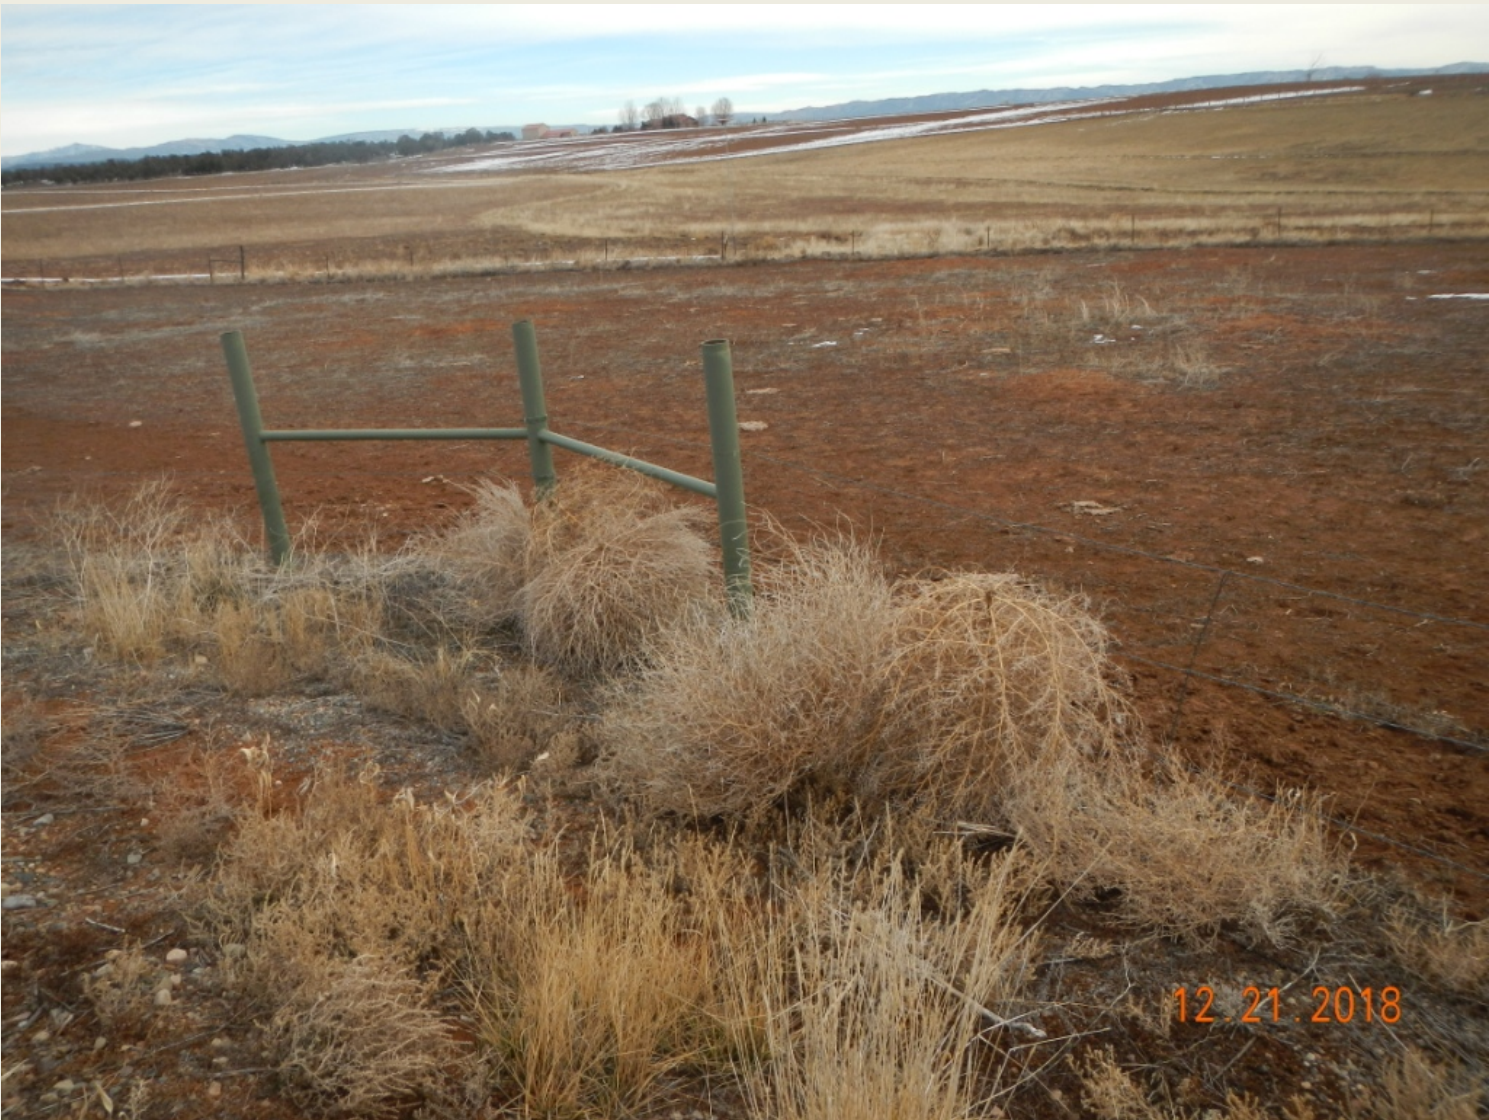
Photo 5. View of kochia and Russian thistle debris along the eastern fenceline. Needs removal.
