Inspection Photos
Location Name: UPRR Kalcevic #22-3
Location ID: 320190

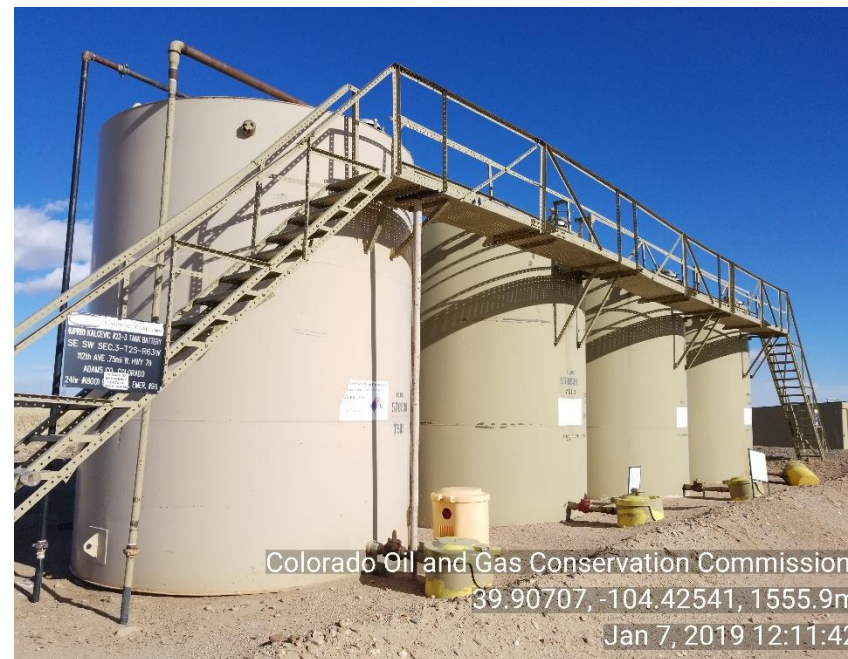
Photo 2 TNK BTRY Signs on tanks not current operator

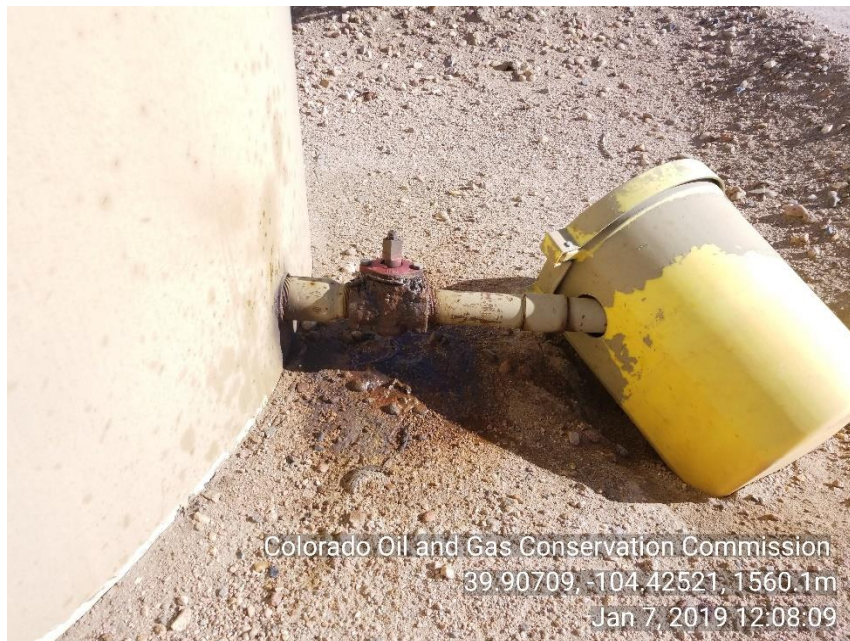
Photo 3 leaking VLV and stained soil crude oil tank #75110

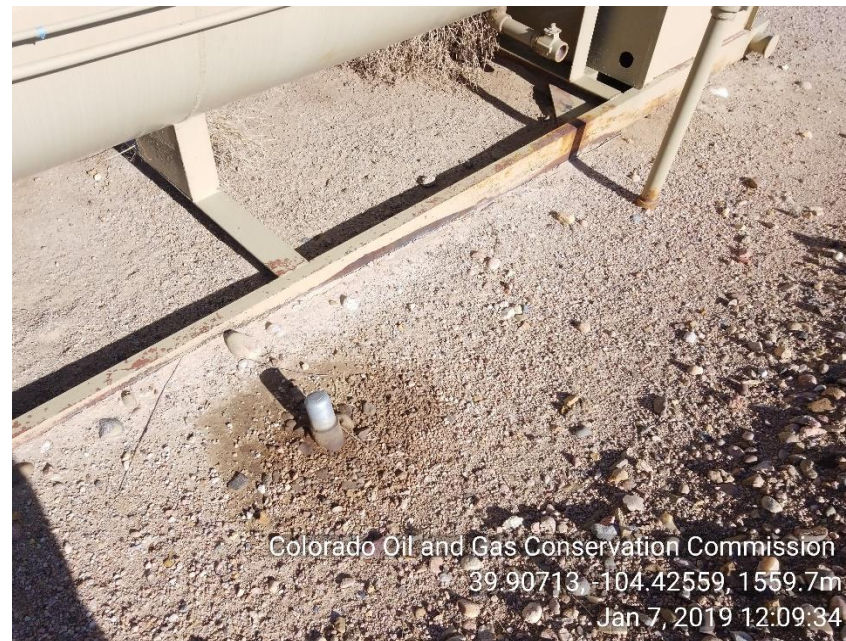
Photo 4 Stained soil 2" line next to separator

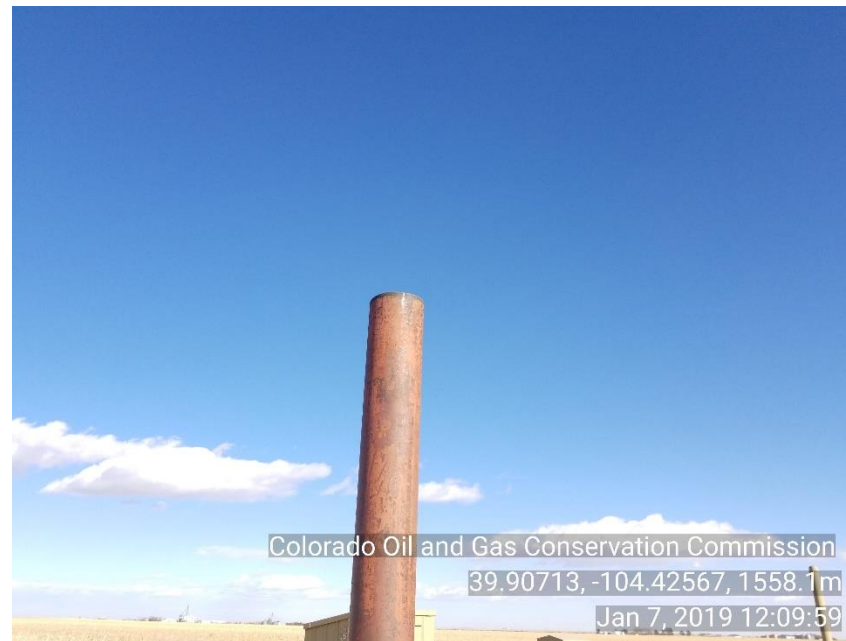
Photo 6 not bird netting on sep stack

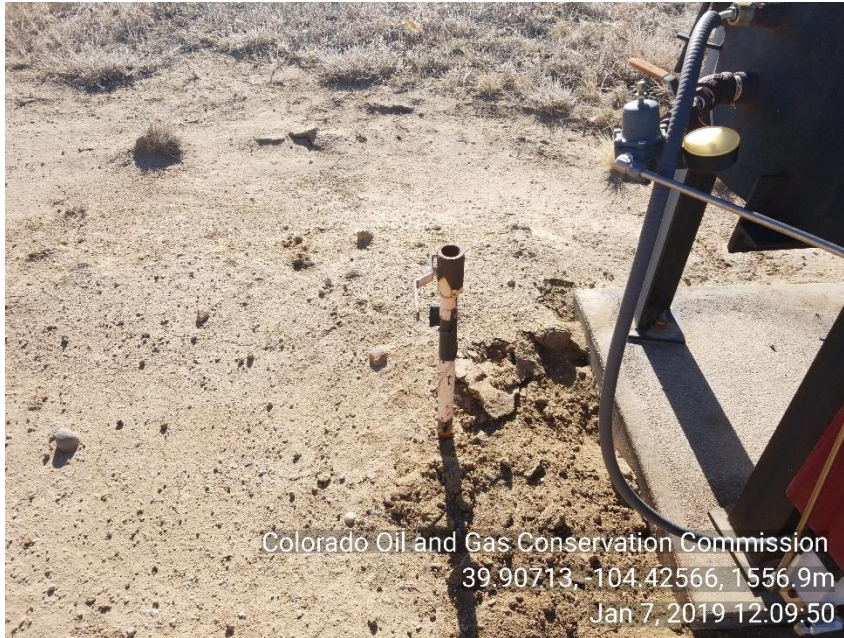
Photo 7 unmarked riser by ECD

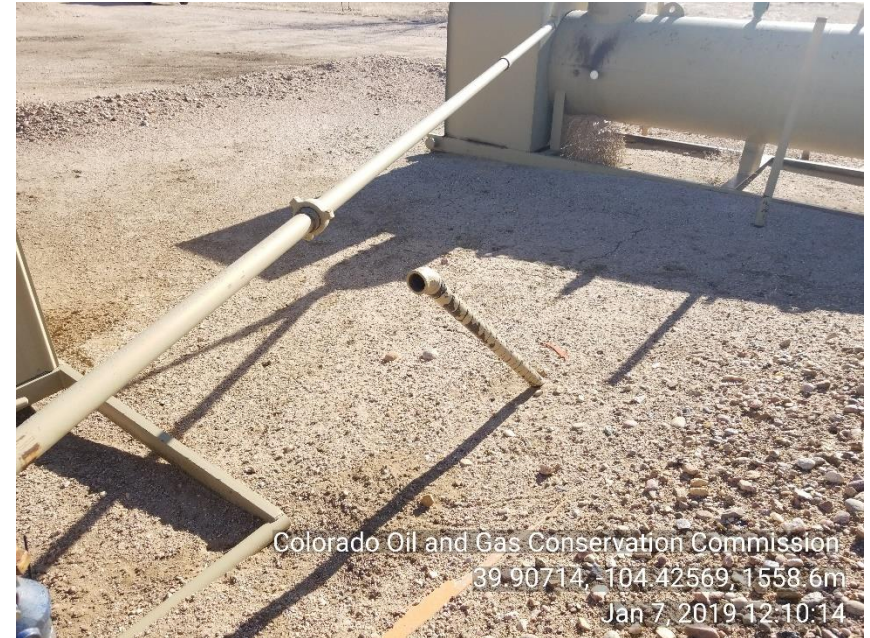
Photo 8 unmarked riser between sep and meter house
