Inspection Photos
Location Name: Champlin Danford #44-32
Location ID: 320609

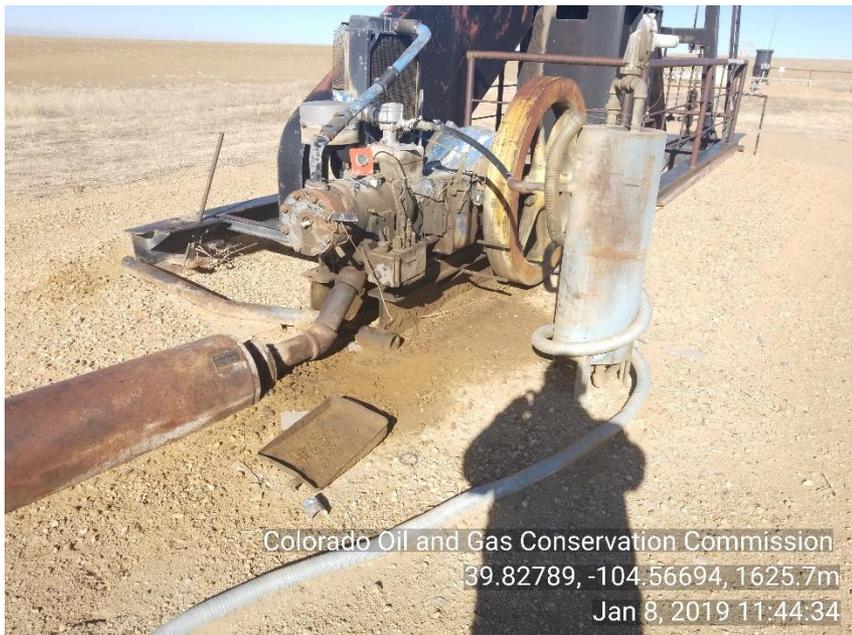
Photo 3 Stained soil/trash PU

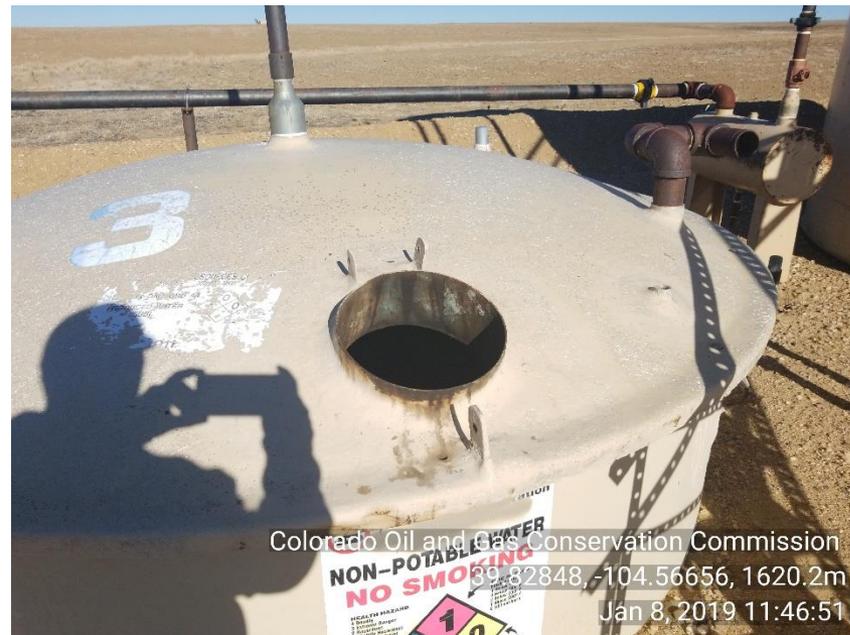
Photo 4 Gauge Hatch missing H2O tank
