# Construction and Storm Water Inspection

Operator: KERR MCGEE OIL & GAS ONSHORE LP – 47120

Location ID: 460006

Inspection Document #: 674902400

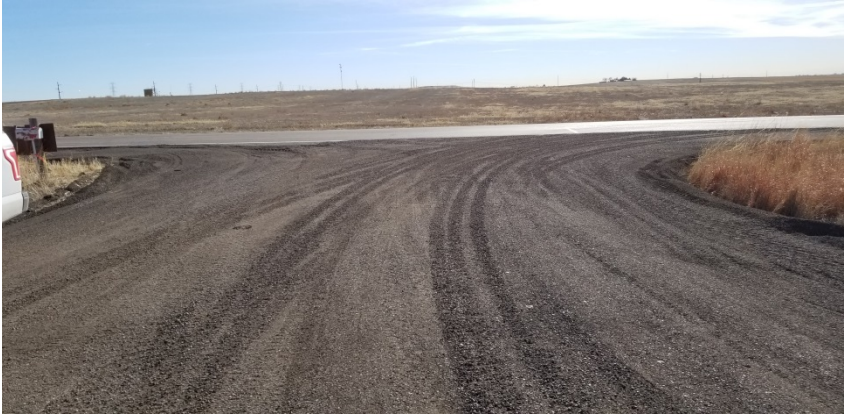
**Photo 1.** Photo taken from the entrance of the location off CR 8, facing South. Operator has installed gravel potentially to limit tracking onto the county road. BMPs in proper functioning condition at the time of this inspection.

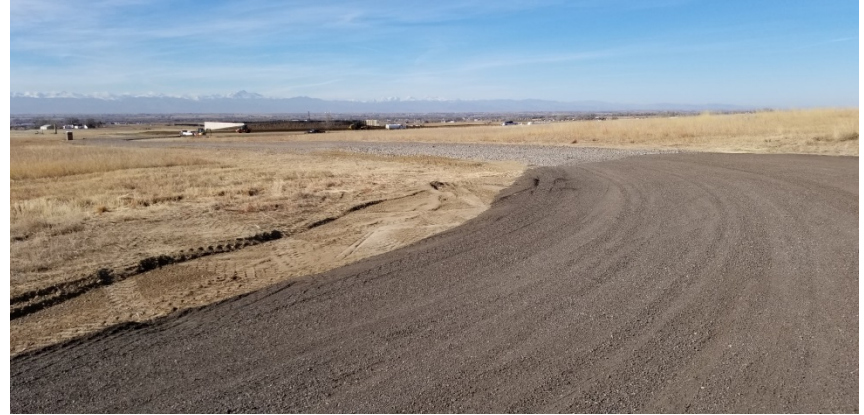
**Photo 2.** Photo taken from the entrance of the location off CR 8, facing Northwest. See comments from Photo 1.

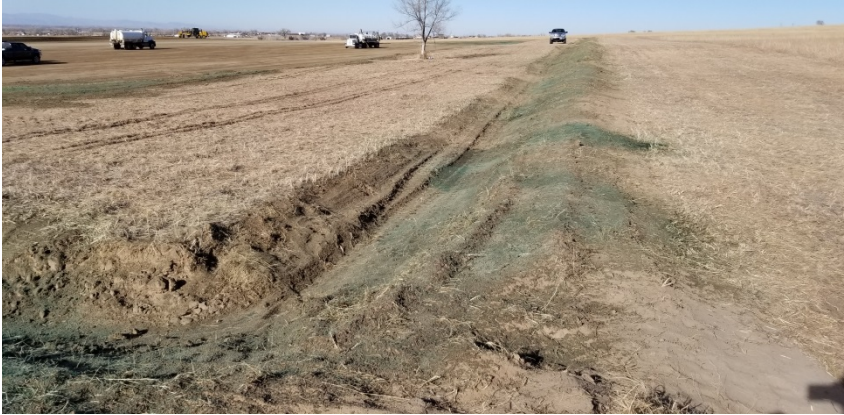
**Photo 3.** Photo taken from the southeastern perimeter of the location, facing North. Photo illustrates the ditch and berm BMP that has been installed around the perimeter of the location.

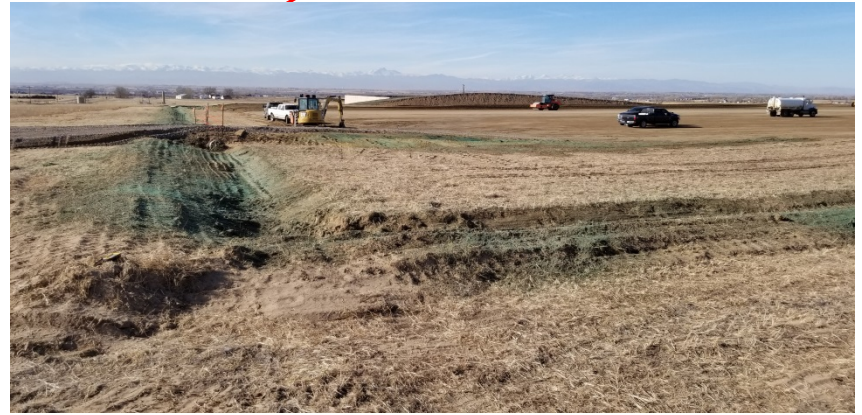
**Photo 4.** Photo taken from the southeastern perimeter of the location, facing West. See comments from Photo 1.

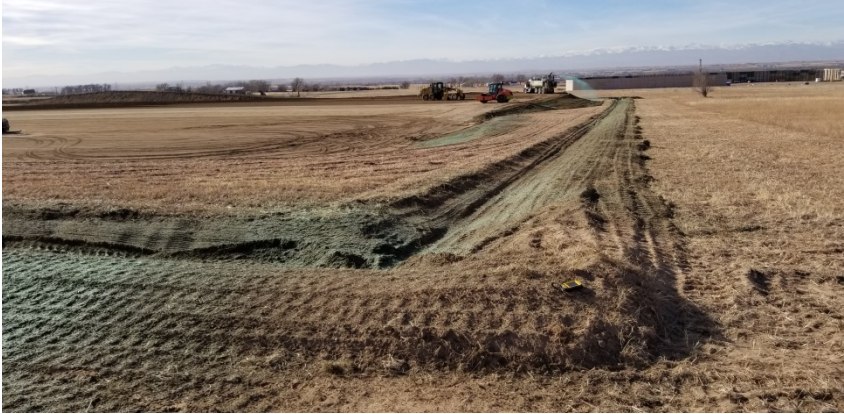
**Photo 5.** Photo taken from the northeastern perimeter of the location, facing West. See comments from Photo 1.

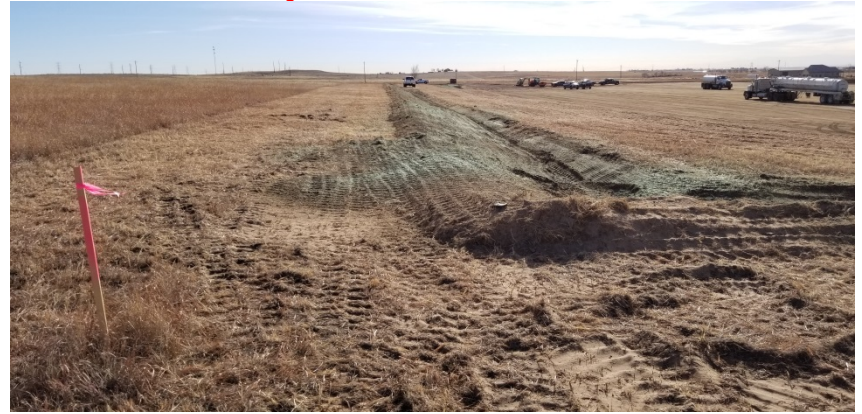
**Photo 6.** Photo taken from the northeastern perimeter of the location, facing South. See comments from Photo 1.

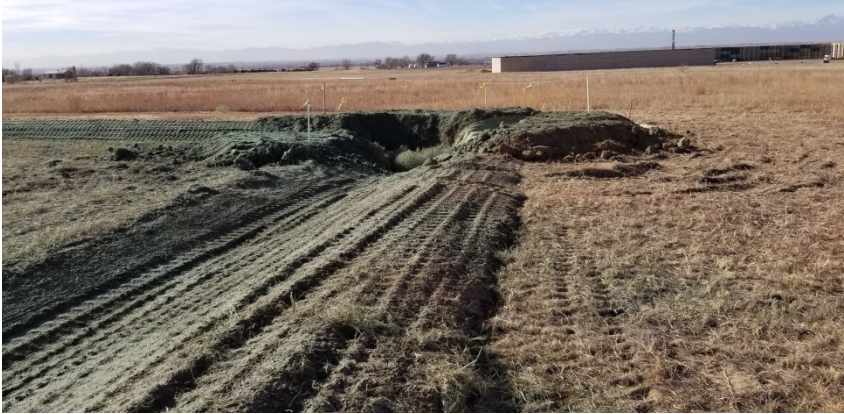
**Photo 7.** Photo taken from the northwestern perimeter of the location, facing West. Operator has installed a sediment trap with a temporarily stabilized outlet.

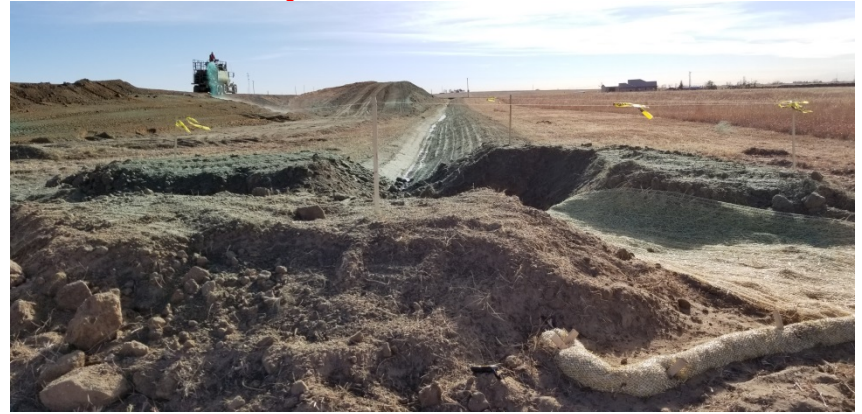
**Photo 8.** Photo taken from the northwestern perimeter of the location, facing South. See comments from Photo 7.

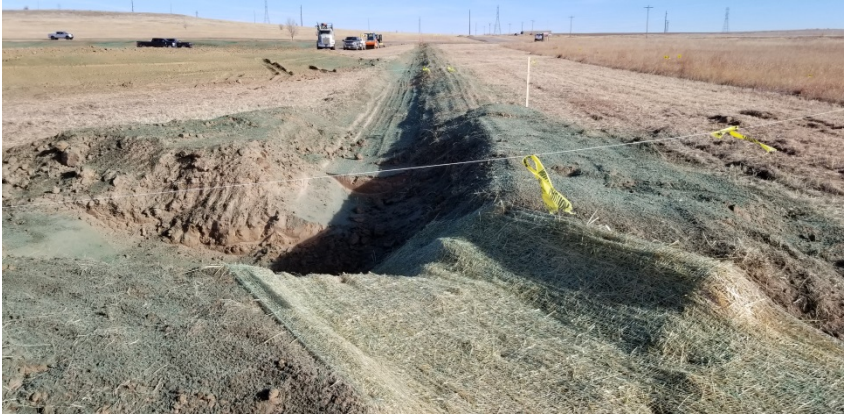
**Photo 9.** Photo taken from the southwestern perimeter of the location, facing East. See comments from Photos 1 and 7.

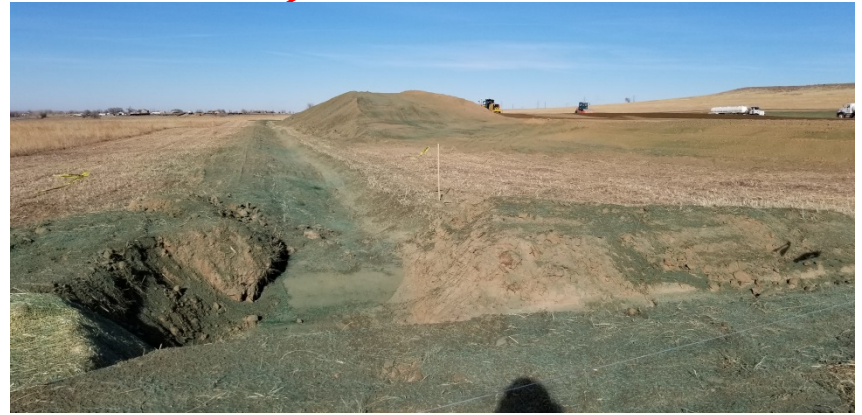
**Photo 10.** Photo taken from the southwestern perimeter of the location, facing North. See comments from Photos 1 and 7.

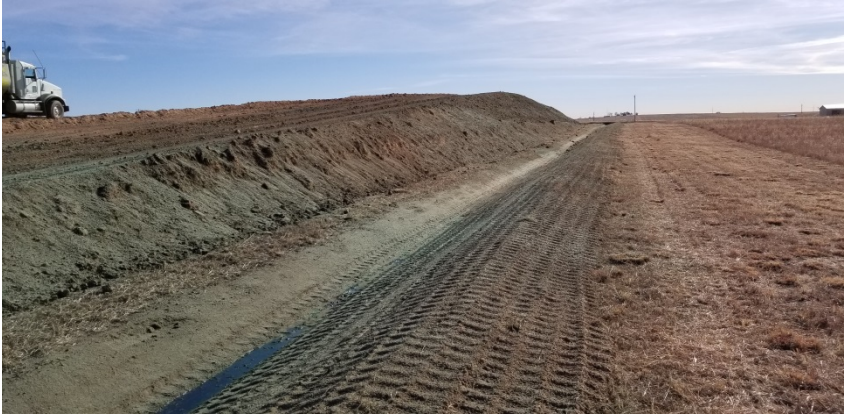
**Photo 11.** Photo taken from the Western perimeter of the location, facing South. The topsoil stockpile being stored along the western area has been temporarily stabilized with equipment tracking and hydroseed.

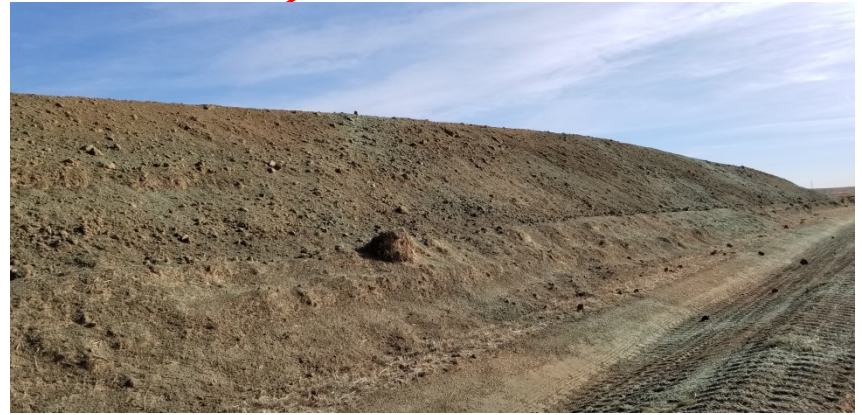
**Photo 12.** Photo taken from the Western perimeter of the location, facing South. See comments from Photo 11.
