Inspection Photo (s)
Shideler 19-7B
API # 05-045-09452
Inspection # 689302942

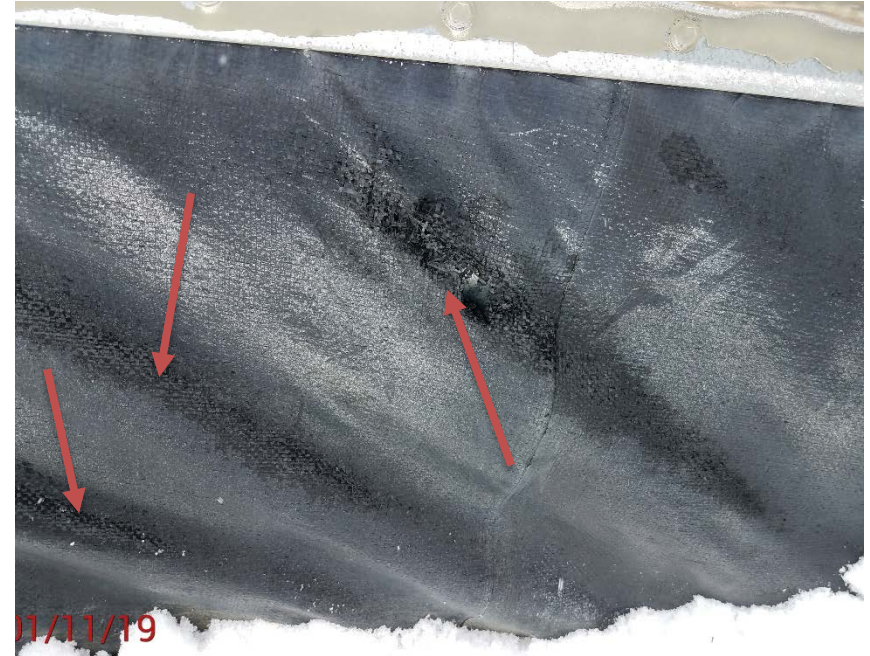
**Location Photo #4, Holes in secondary liner,
near the stair access point.**

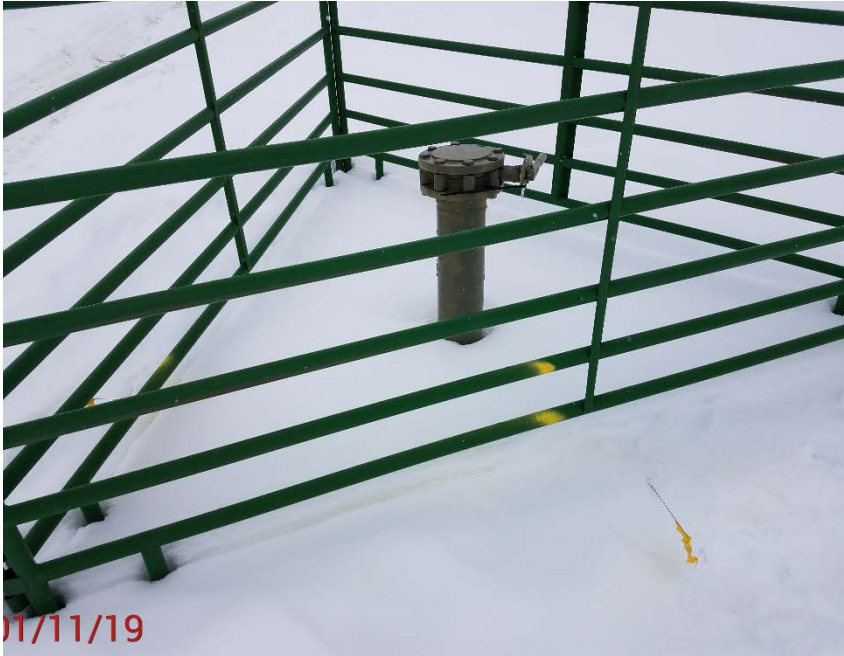
Location Photo #5, Unmarked/unused flowline.

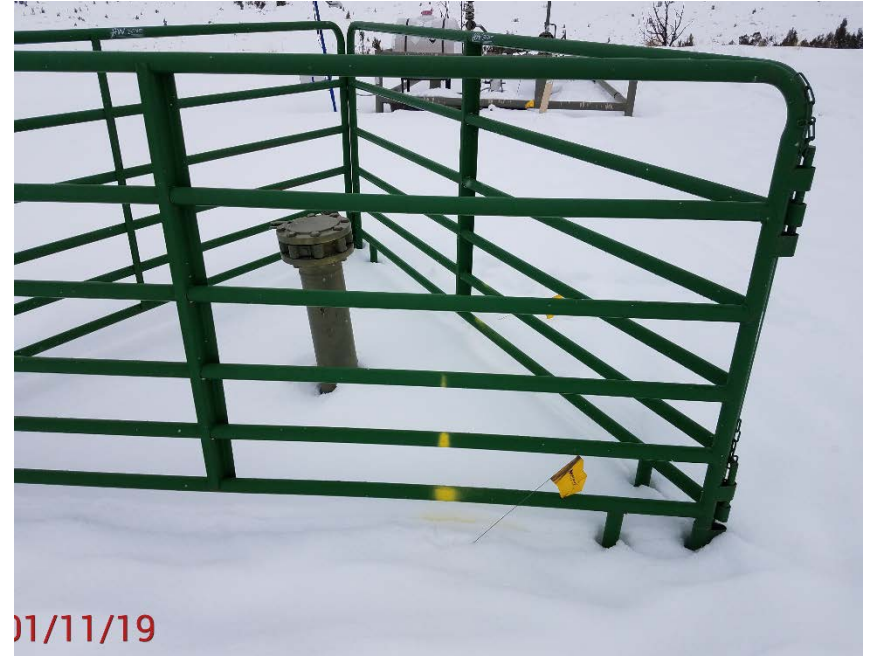
Location Photo #6, Unmarked/unused flowline.
