**Inspection Photo (s)**  
**ALP 25-16**  
**API # 05-045-09180**  
**Inspection # 689302952**

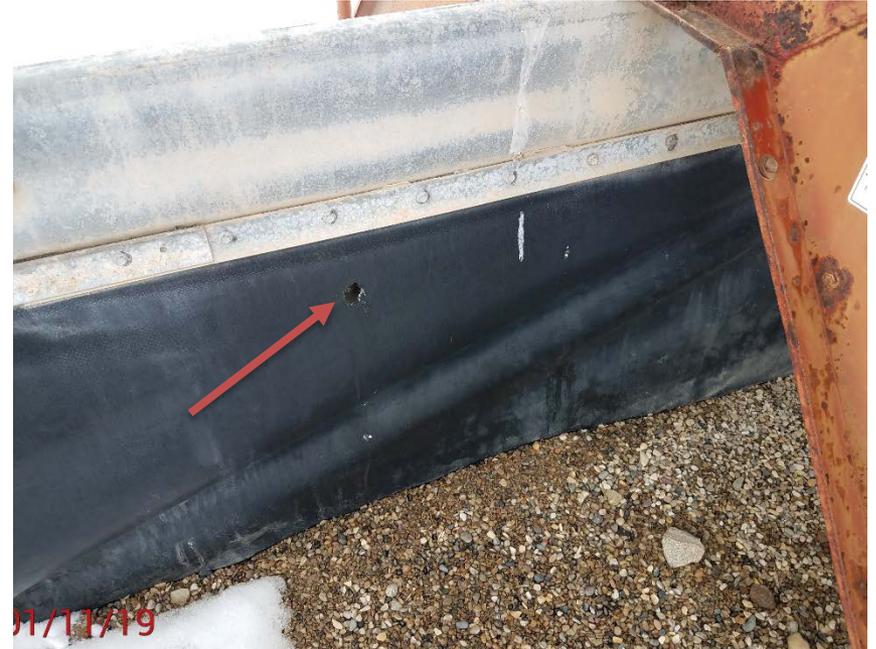
**Location Photo #2, Hole in secondary  
containment liner.**
