Inspection Photos
Location Name: Boies Ranch C-240 Pad
Location ID: #335678
Inspection Date: January 11, 2019

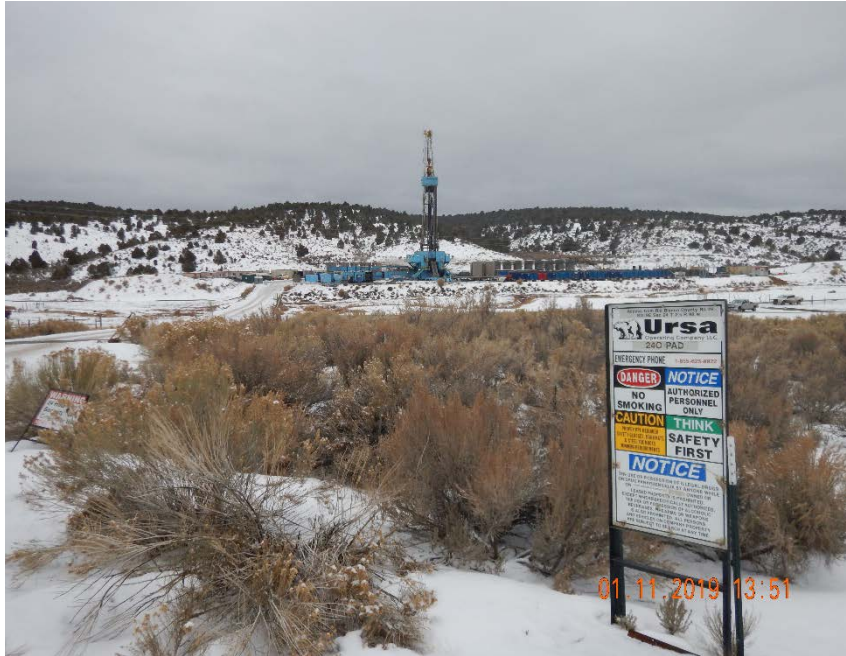
Photo #1 – View of facility sign and active drilling rig from the north.

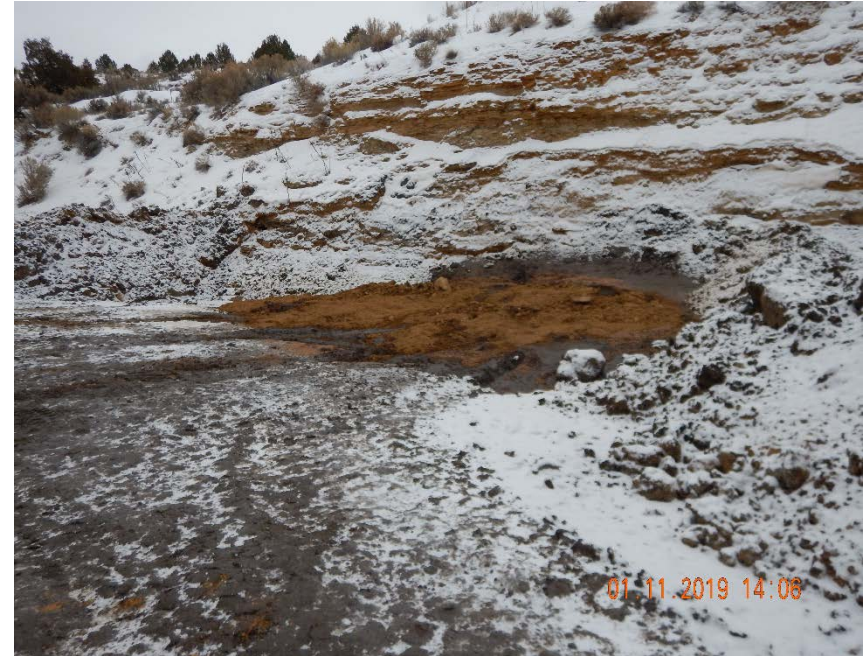
Photo #2 – East bermed drill cuttings storage area. Operator indicated that surface cuttings had been moved from storage area to make room for additional production zone cuttings.

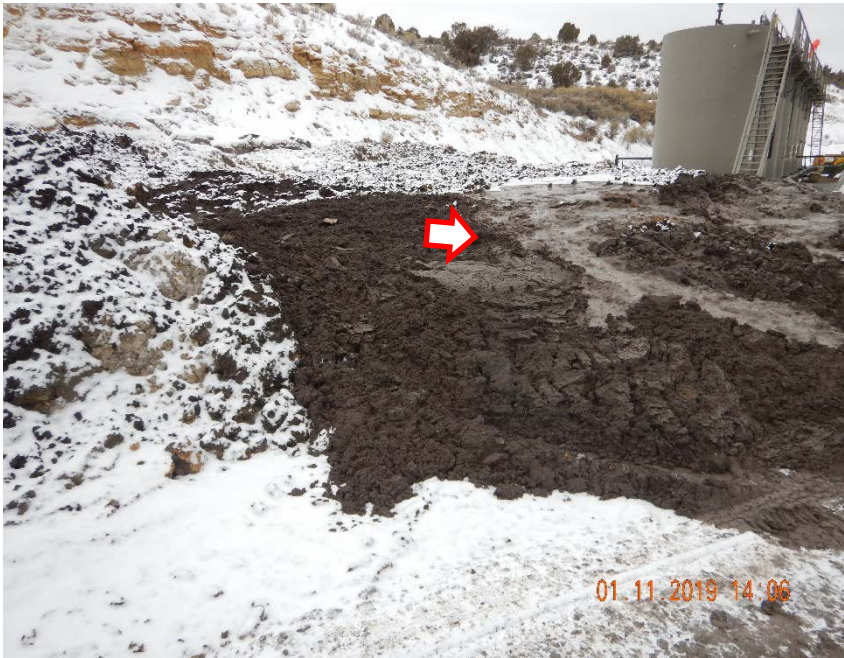
Photo #3 – West bermed drill cuttings area (view from NE) had production zone cuttings on inspection date. Note fluids accumulation on top of cuttings (red arrow).

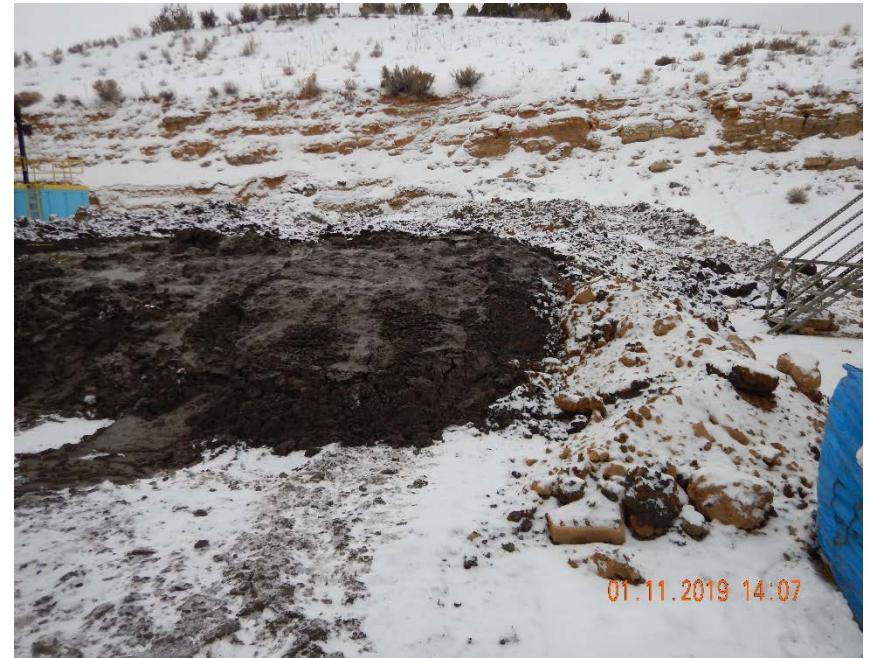
Photo #4 – West bermed drill cuttings area (view from NW)

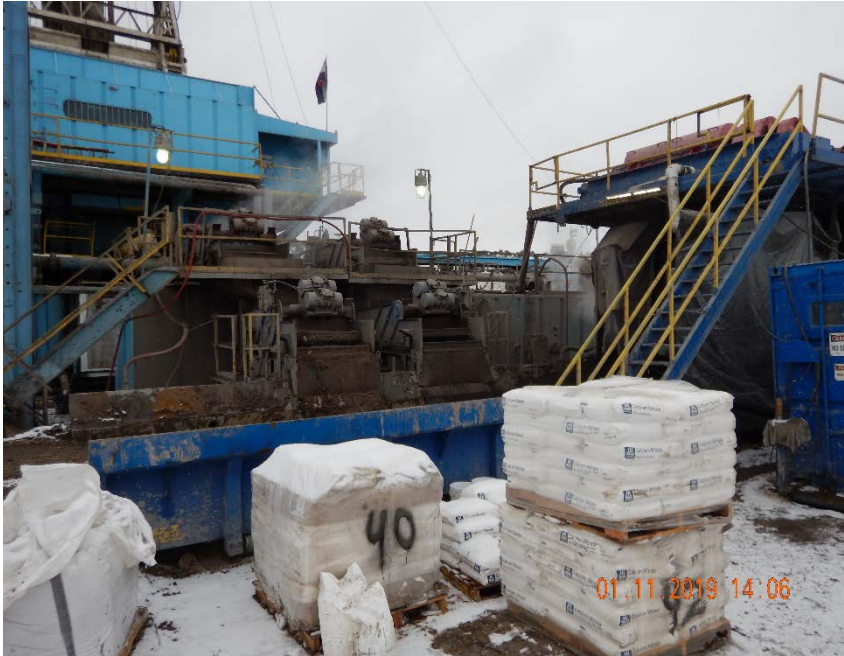
Photo #5 – View of drilling rig and cuttings shaker from south.

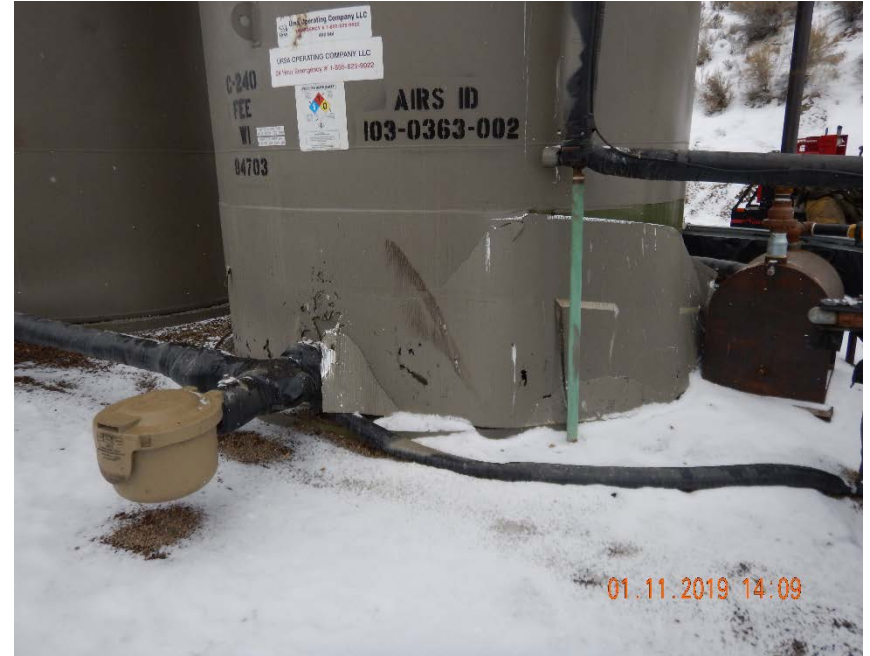
Photo #6 – Western produced water tank had damaged insulation on inspection date.
