Inspection Photos
Operator Name: Caerus Piceance LLC
Location ID: 312691

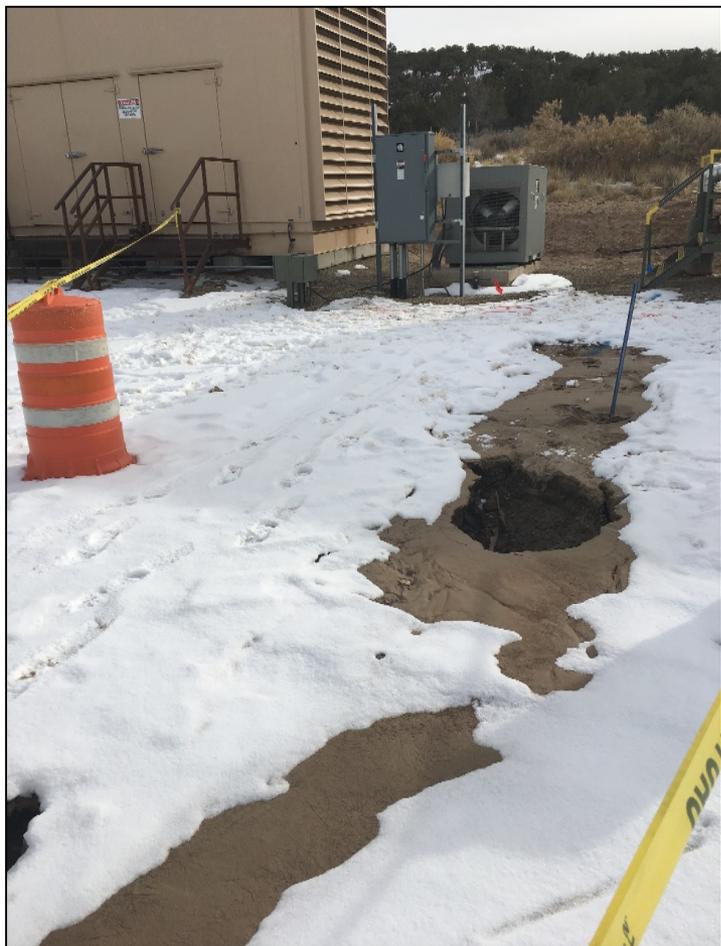
Sink hole looking west

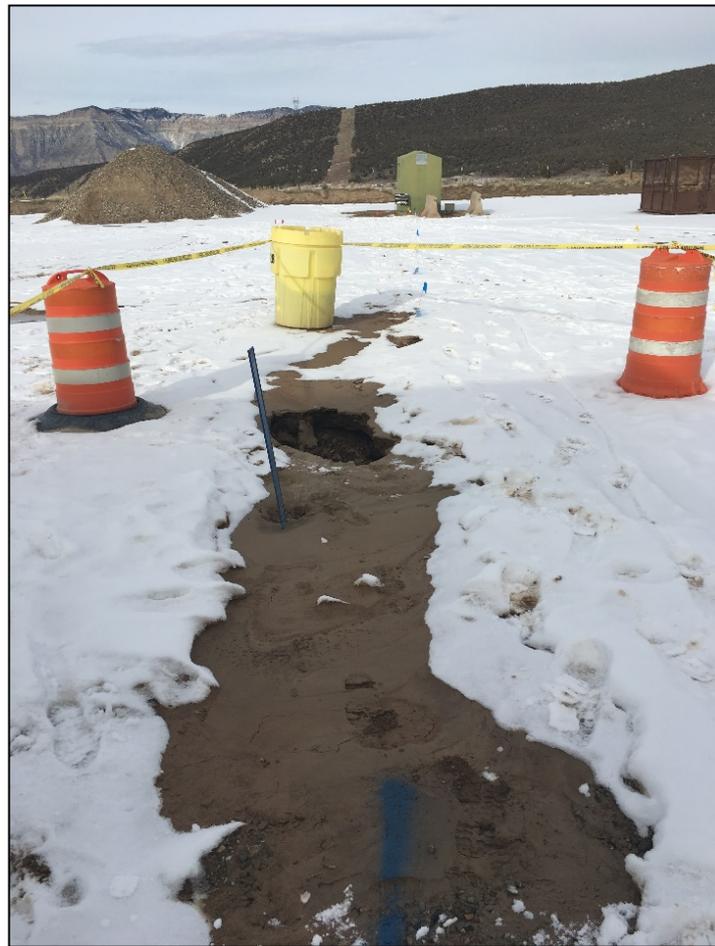
Sink hole looking east

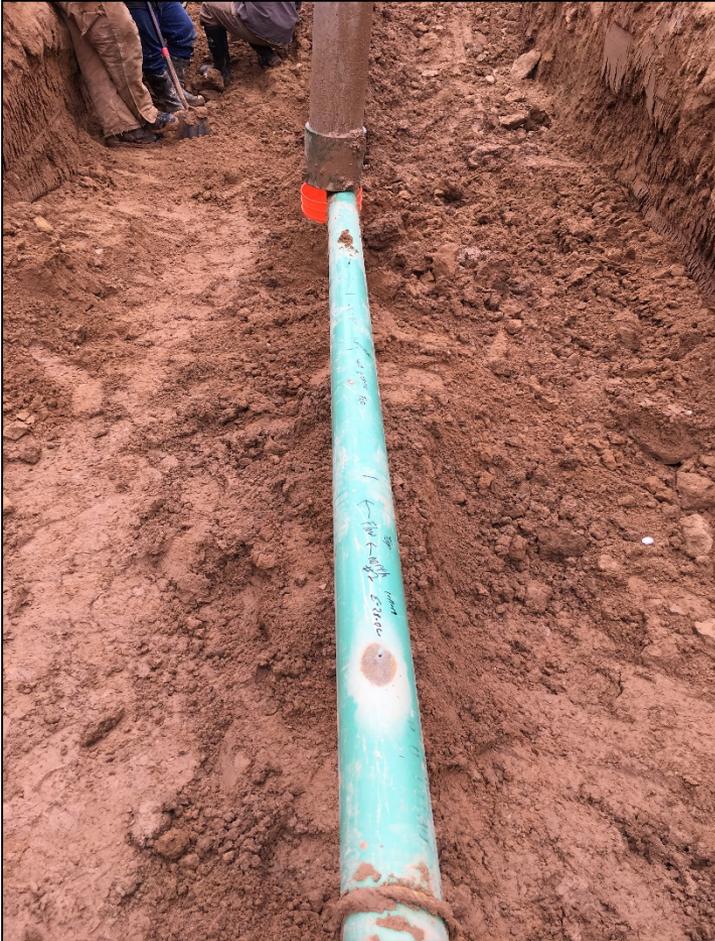
Holes in pipe, 2nd hole under vac truck hose. Looking east

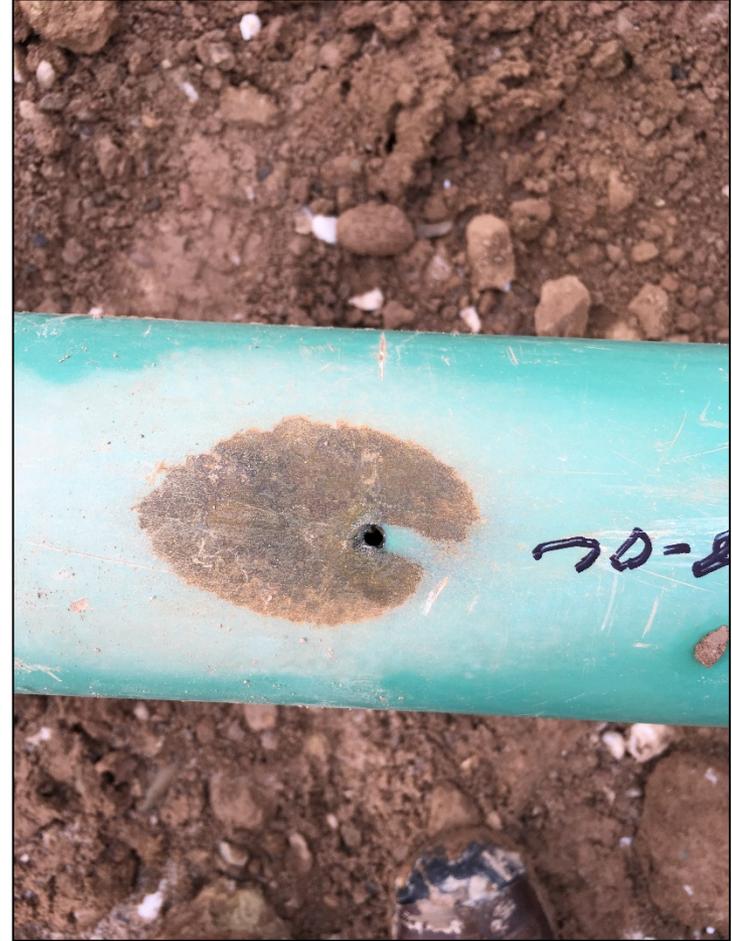
1st hole on west side
