Interim Reclamation and Stormwater Inspection

January 8, 2019

Operator: KERR MCGEE OIL & GAS ONSHORE LP – 47120

Location ID: 451781

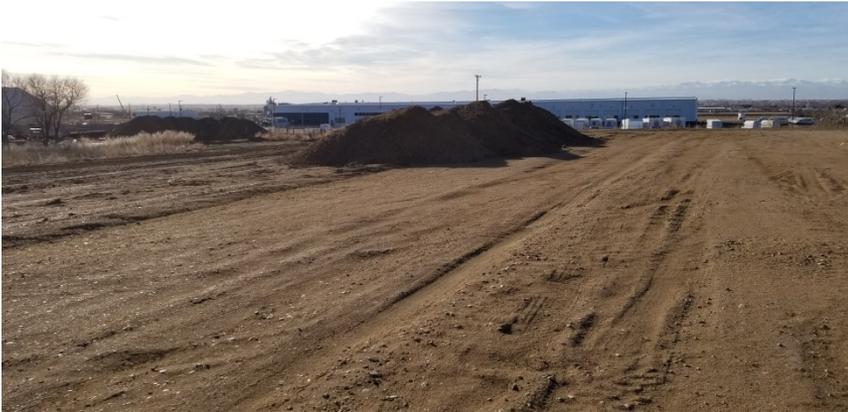
Photo 1. Photo taken from the location, facing East. Appears the Operator has started interim reclamation activities to reduce disturbance areas only needed for production operations at the location. However, no evidence of drilling rows and straw crimped mulch were observed.

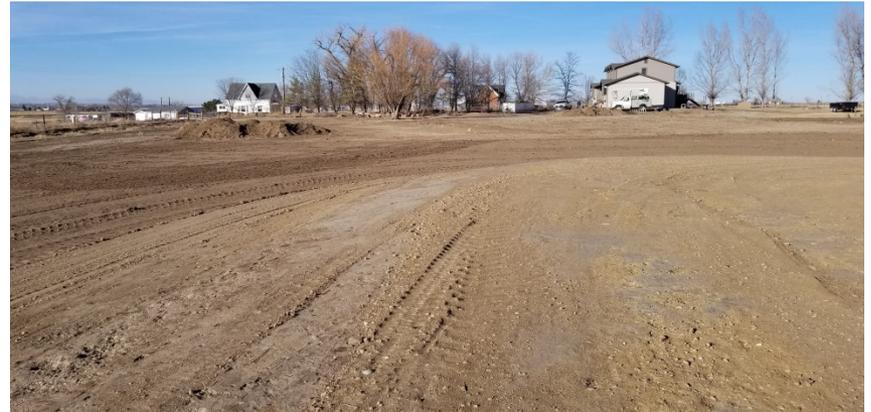
Photo 2. Photo taken from the location, facing North. See comments from Photo 1.

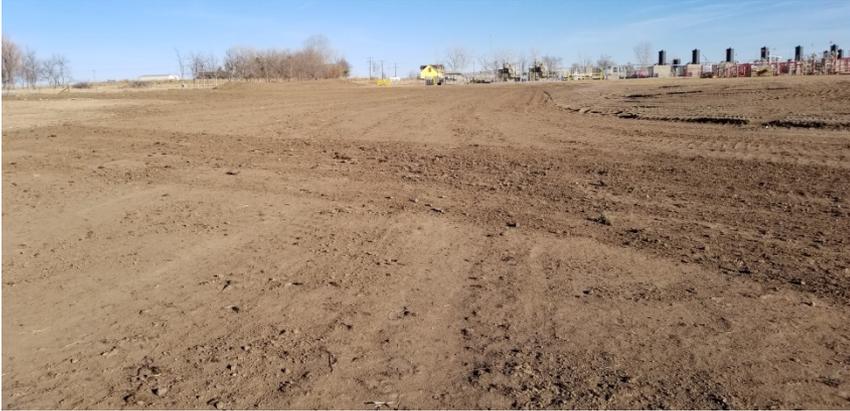
Photo 3. Photo taken from the location, facing East. See comments from Photo 1.

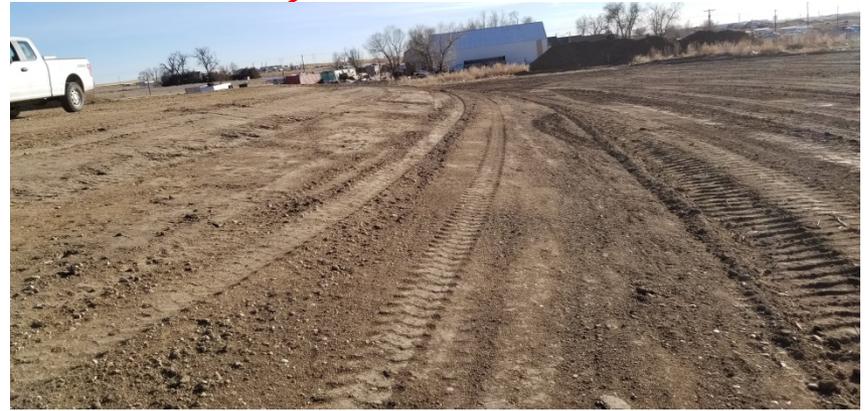
Photo 4. Photo taken from the location, facing South. See comments from Photo 1.

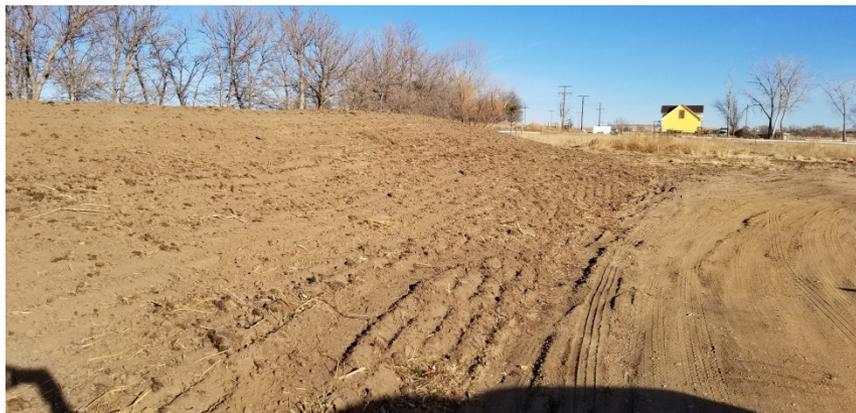
Photo 5. Photo taken from the location, facing East. See comments from Photo 1.

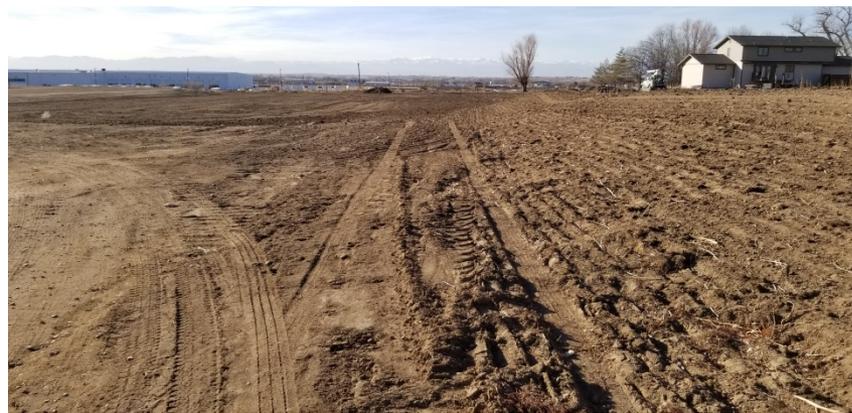
Photo 6. Photo taken from the location, facing West. See comments from Photo 1.

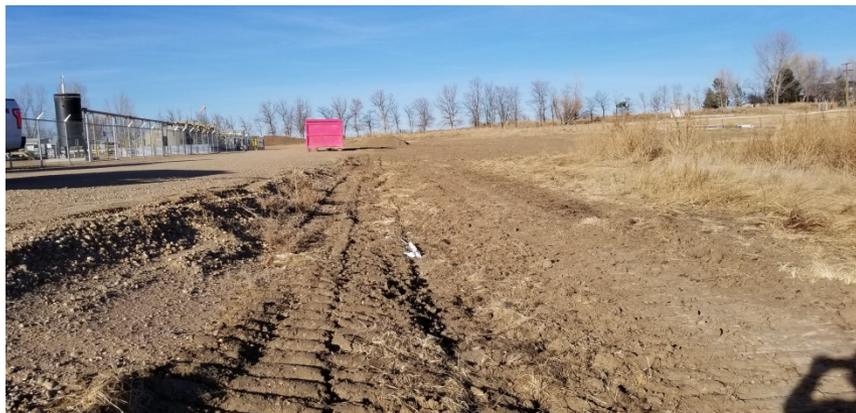
Photo 7. Photo taken from the location, facing North.
See comments from Photo 1.

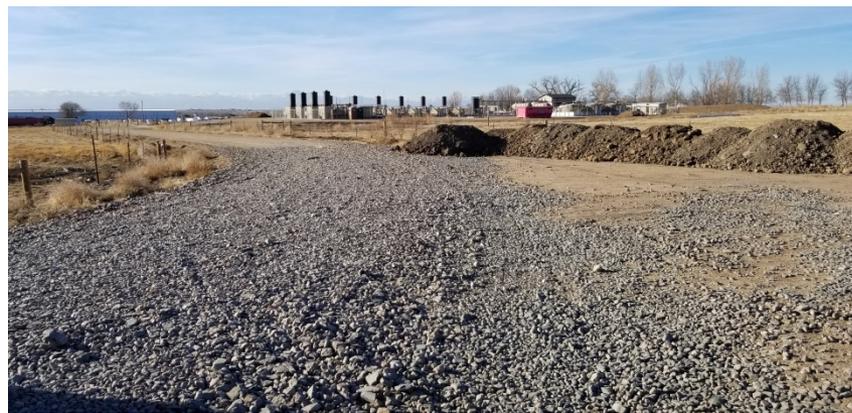
Photo 8. Photo taken from the access road, facing West.
See comments from Photo 1.
