Interim Reclamation and Stormwater Inspection

January 9, 2019

Operator: BONANZA CREEK ENERGY OPERATING COMPANY LLC - #8960

Location ID: 453242

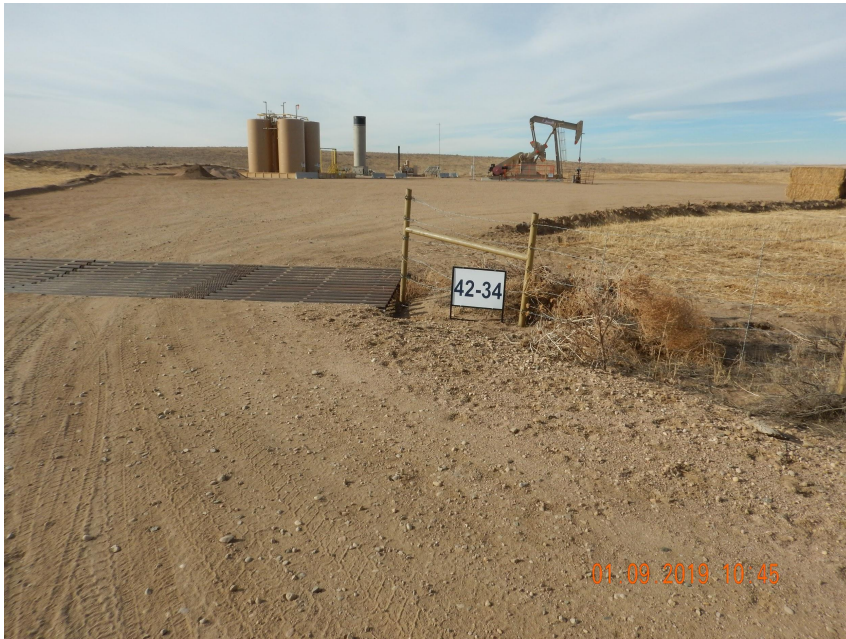
Photo 1. Photo taken from the entrance of the location, facing West. Photo illustrates Operator sign. Another Operator sign was located next to the pumpjack. Appears the Operator has performed interim reclamation activities to reduce disturbance areas only needed for production operations.

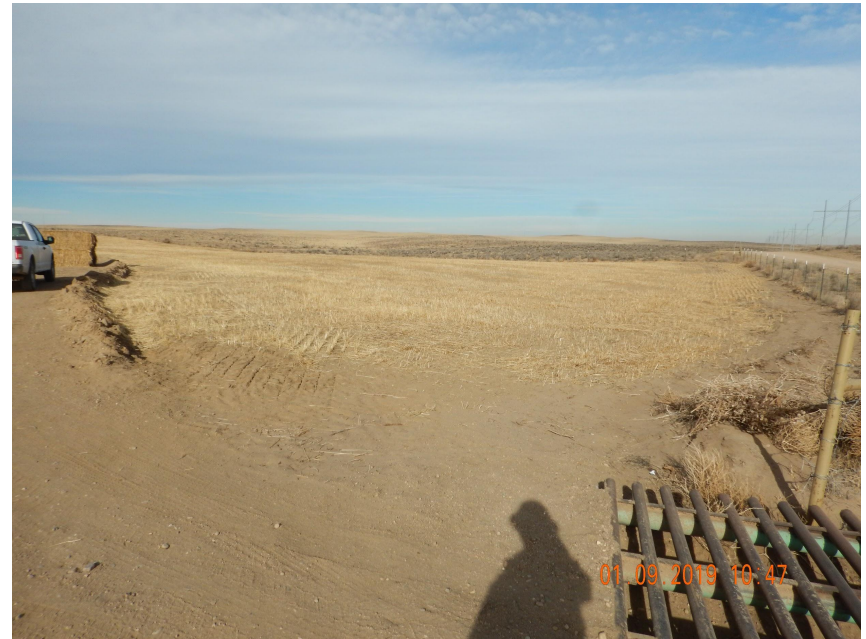
Photo 2. Photo taken from the entrance of the location, facing North. Operator has performed interim reclamation activities with the evidence of drilling rows and straw crimped mulch. Interim areas appear to be properly contoured to the surrounding landscape.

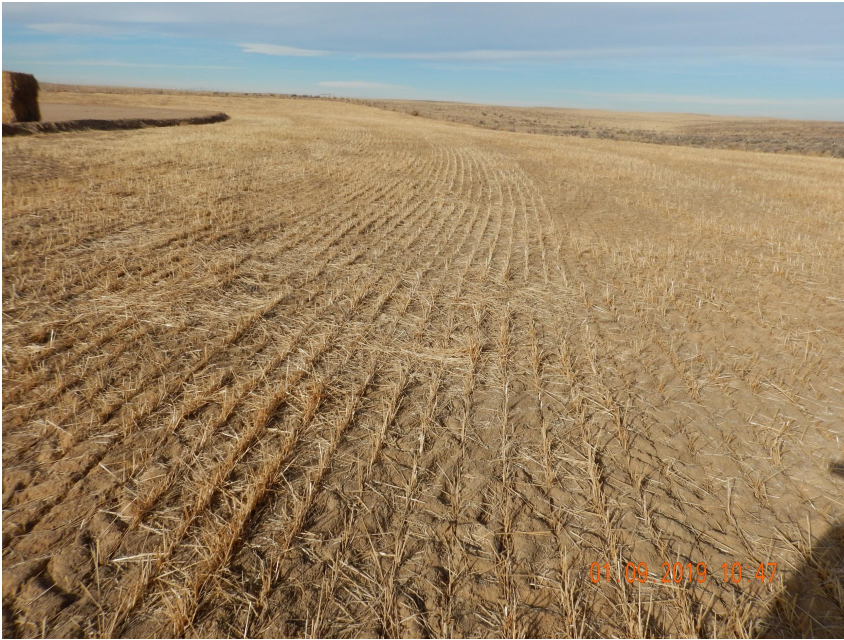
Photo 3. Photo taken from the northeastern interim reclamation area, facing West. See comments under Photo 2.

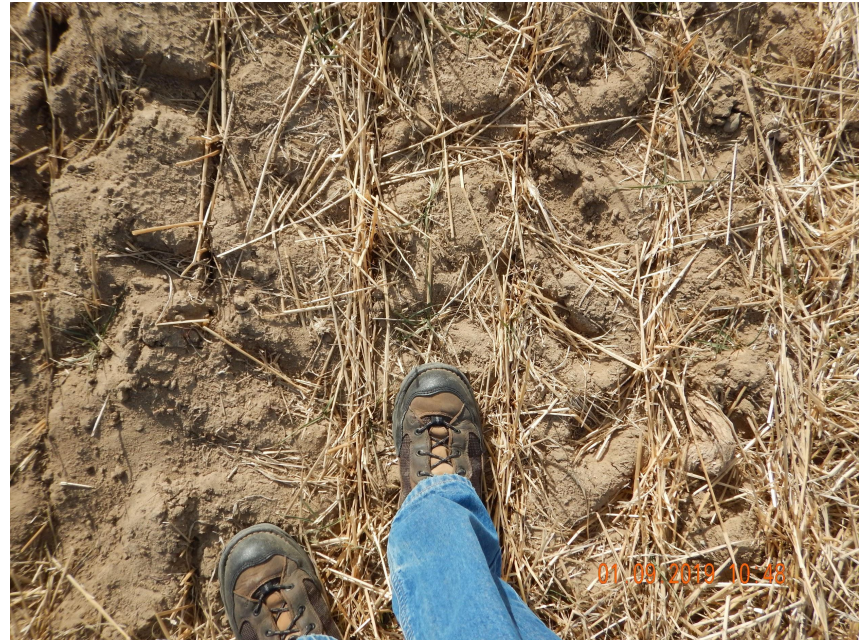
Photo 4. Close up photo taken from the northern interim reclamation area. Some germination was observed throughout portions of the interim area.

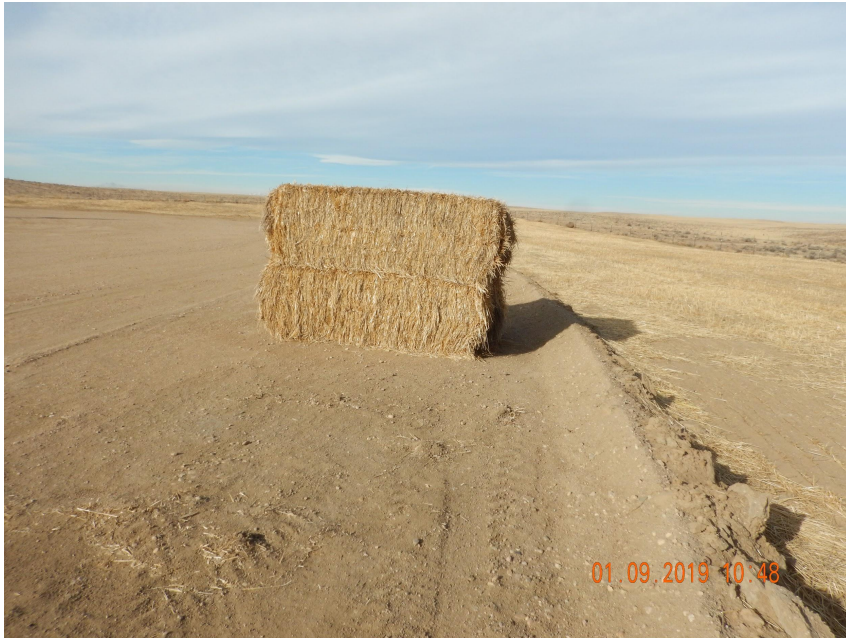
Photo 5. Photo taken from the northern production area, facing West. All locations shall be kept free of supplies not necessary for use on that lease per Rule 603.f.

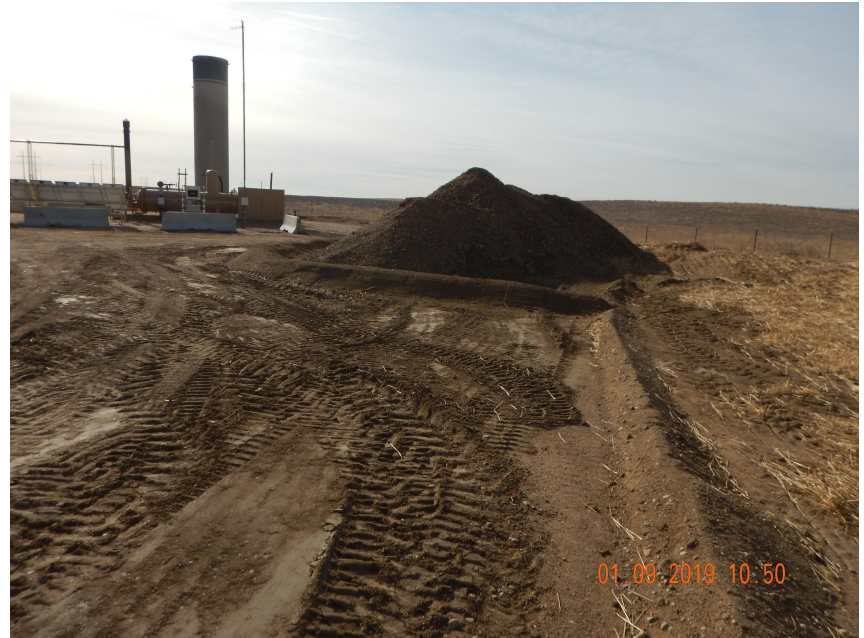
Photo 6. Photo taken from the western production area, facing Southwest. See comments under Photo 5.

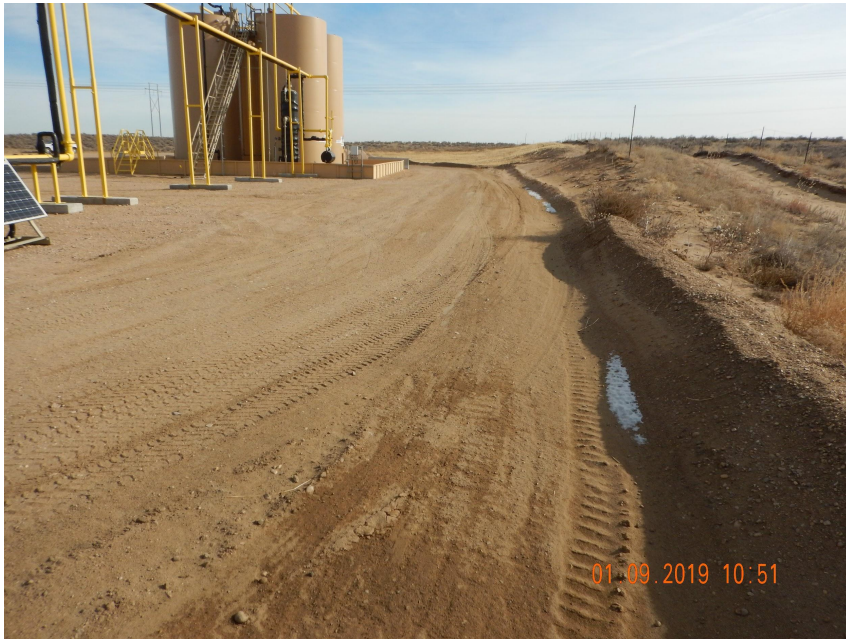
Photo 7. Photo taken from the western production area, facing South. See comments under Photo 1.

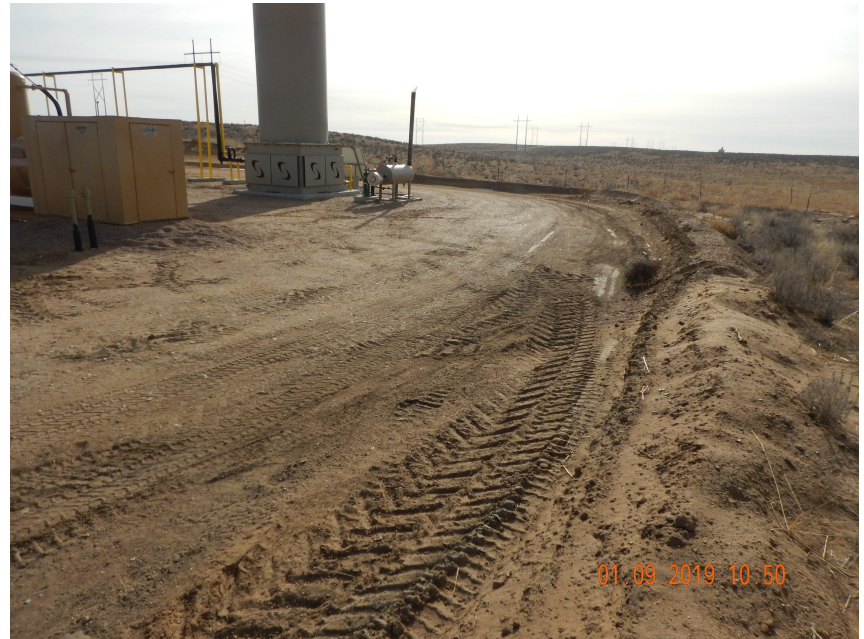
Photo 8. Photo taken from the southwestern production area, facing South. See comments under Photo 1.

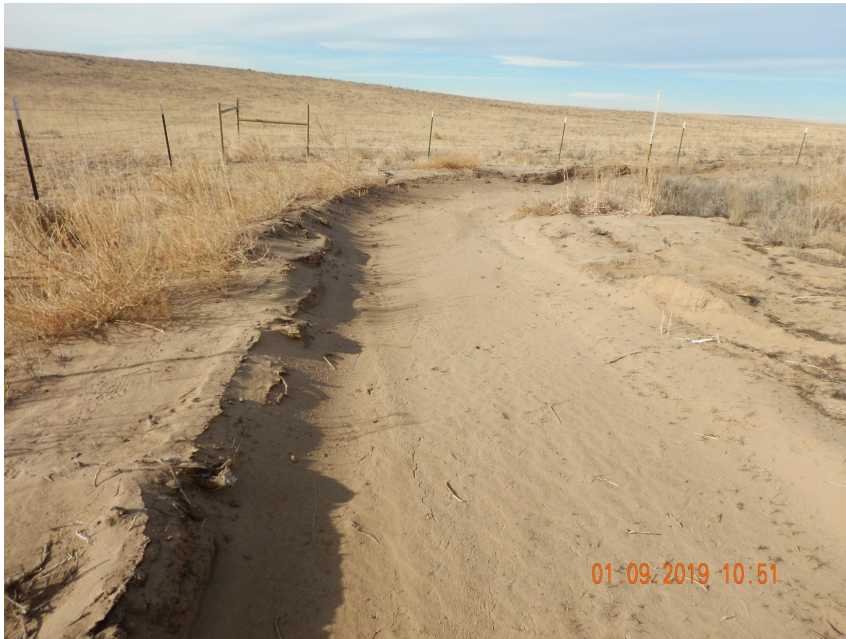
Photo 9. Photo taken from the southwestern perimeter of the location, facing West. Appears to be a relic ditch BMP that needs to be stabilized, as this is unconsolidated material that is susceptible to wind and water erosion. Wind erosion soil particle deposition was observed off Location at other nearby locations.

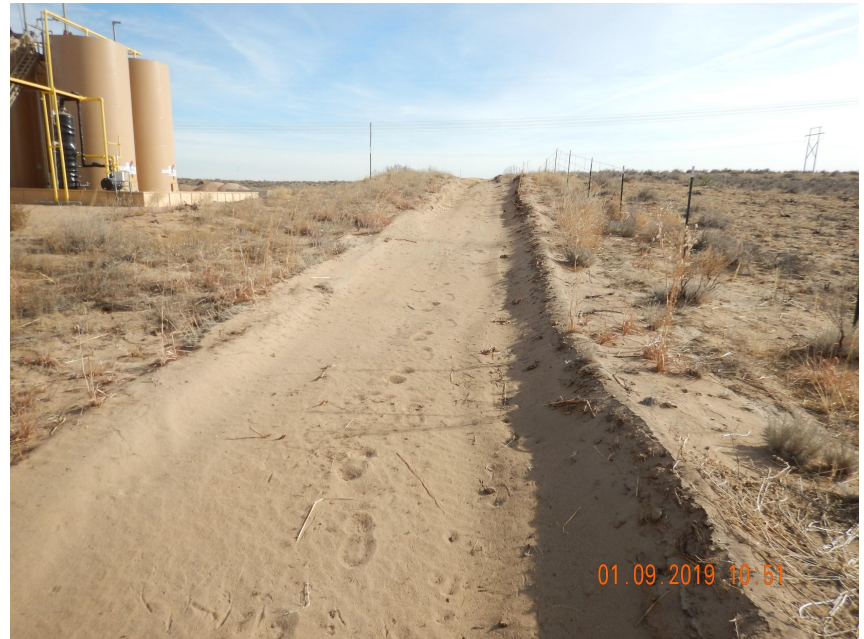
Photo 10. Photo taken from the southwestern perimeter of the location, facing East. See comments under Photo 9.

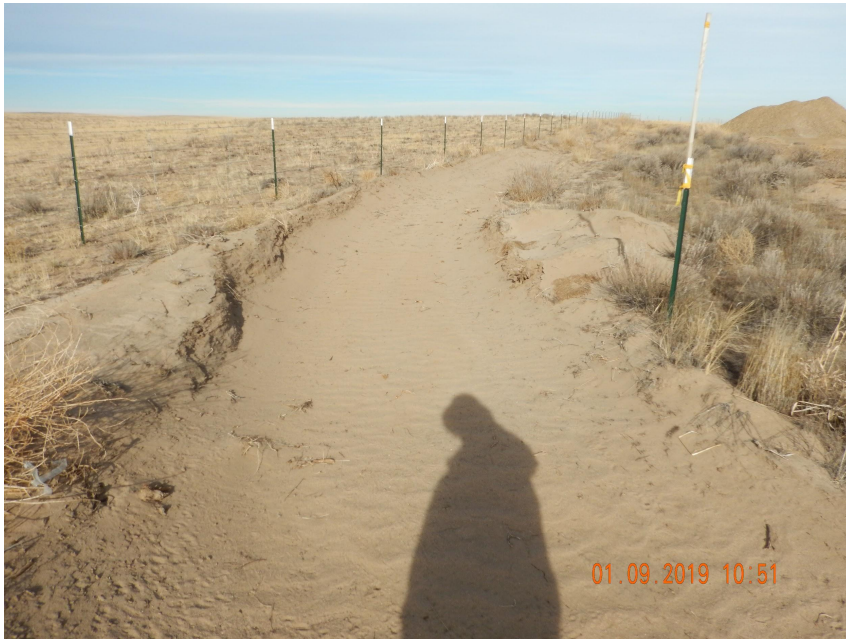
Photo 11. Photo taken from the southwestern perimeter of the location, facing North. See comments under Photo 9.

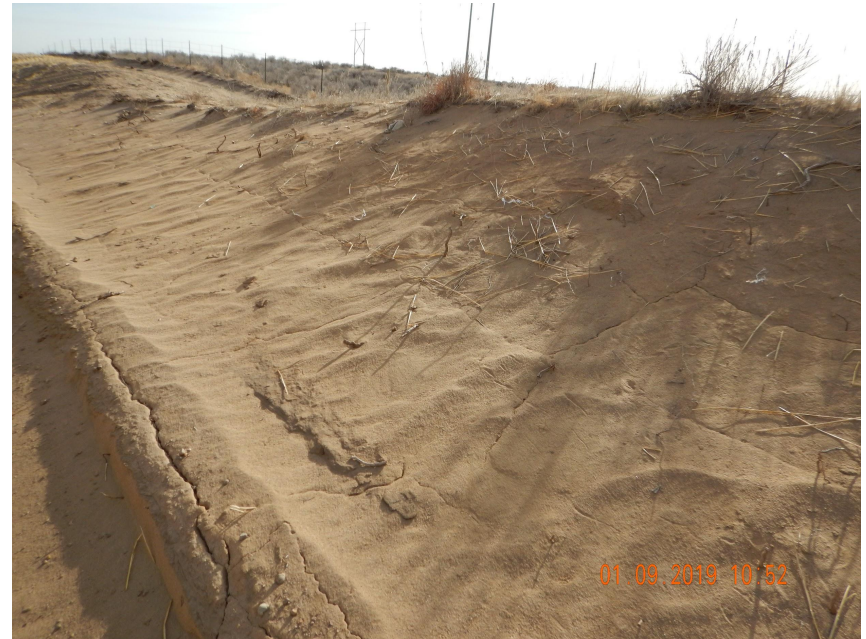
Photo 12. Photo taken from the southern cut slope of the location, facing East. See comments under Photo 9.

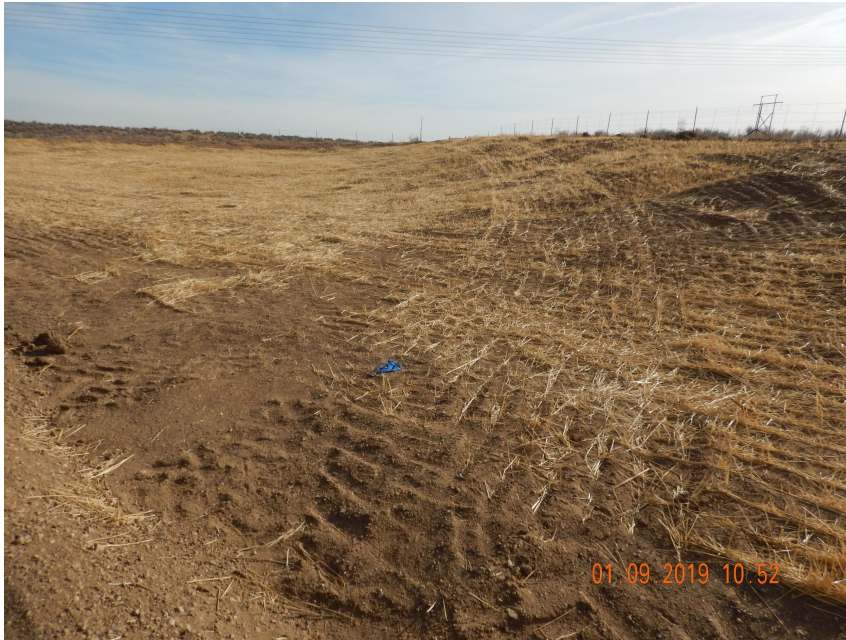
Photo 13. Photo taken from the southeastern interim reclamation area, facing East. See comments under Photo 2.

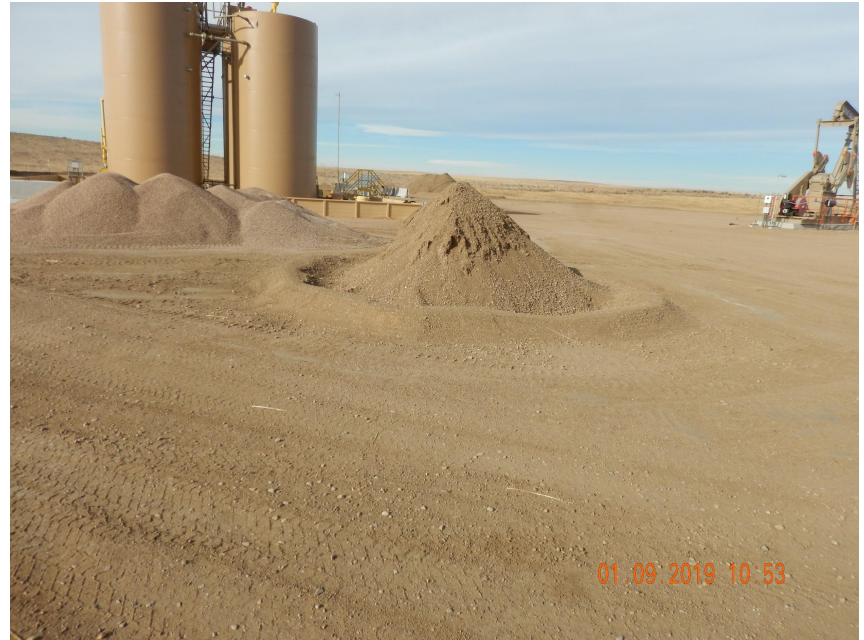
Photo 14. Photo taken from the southern production area, facing West. See comments under Photo 5.
