Inspection Photos

Operator: SWN PRODUCTION COMPANY LLC -
10396

Location ID: 427955

Inspection Doc. Number: 682504411
Adams County, CO

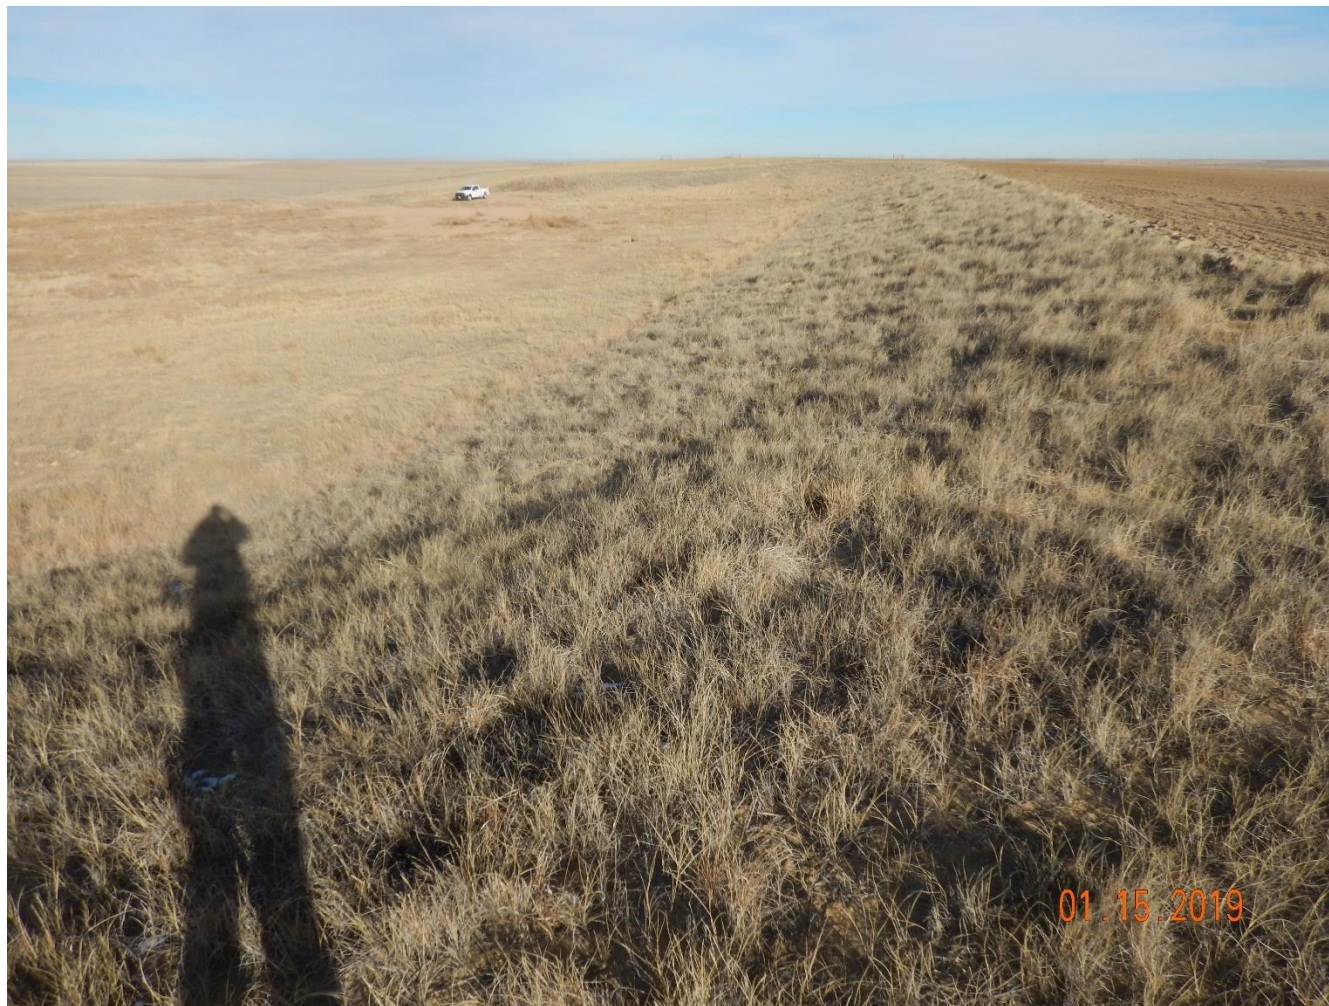
Photo 1: Photo taken from the southeast corner of the location, facing north. Photos 1-3 provide an overview of the location from north, northwest to east. Corrective actions and COAs required operator to conduct reclamation and reduce the location's disturbance area to 0.92 acres. Photos show reclamation has not been conducted; disturbance area has not been reduced.

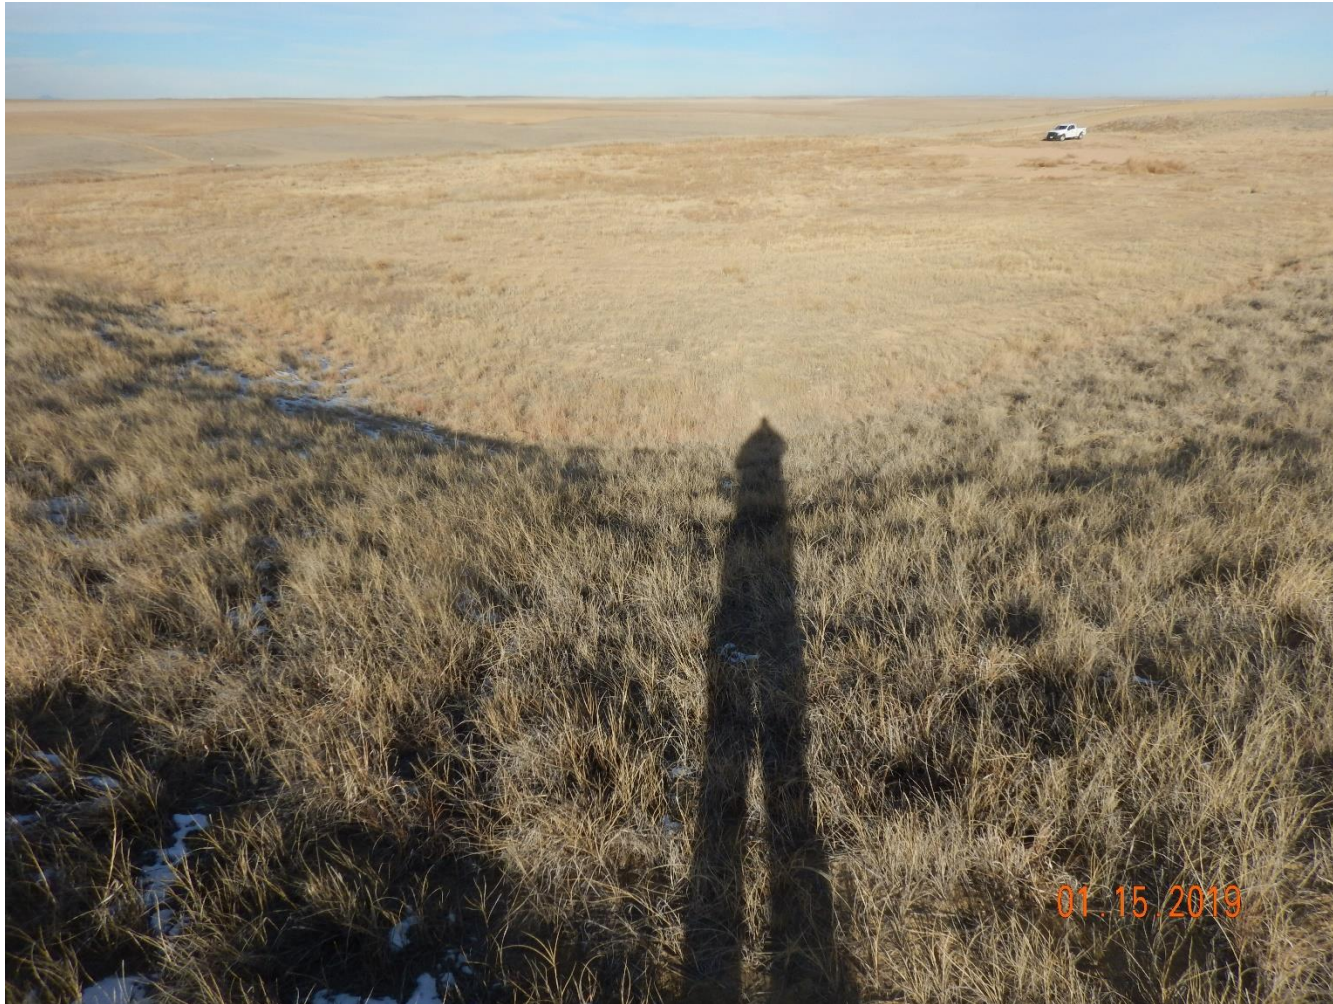
Photo 2: Photo taken from the southeast corner of the location, facing northwest. See comments under photo 1.

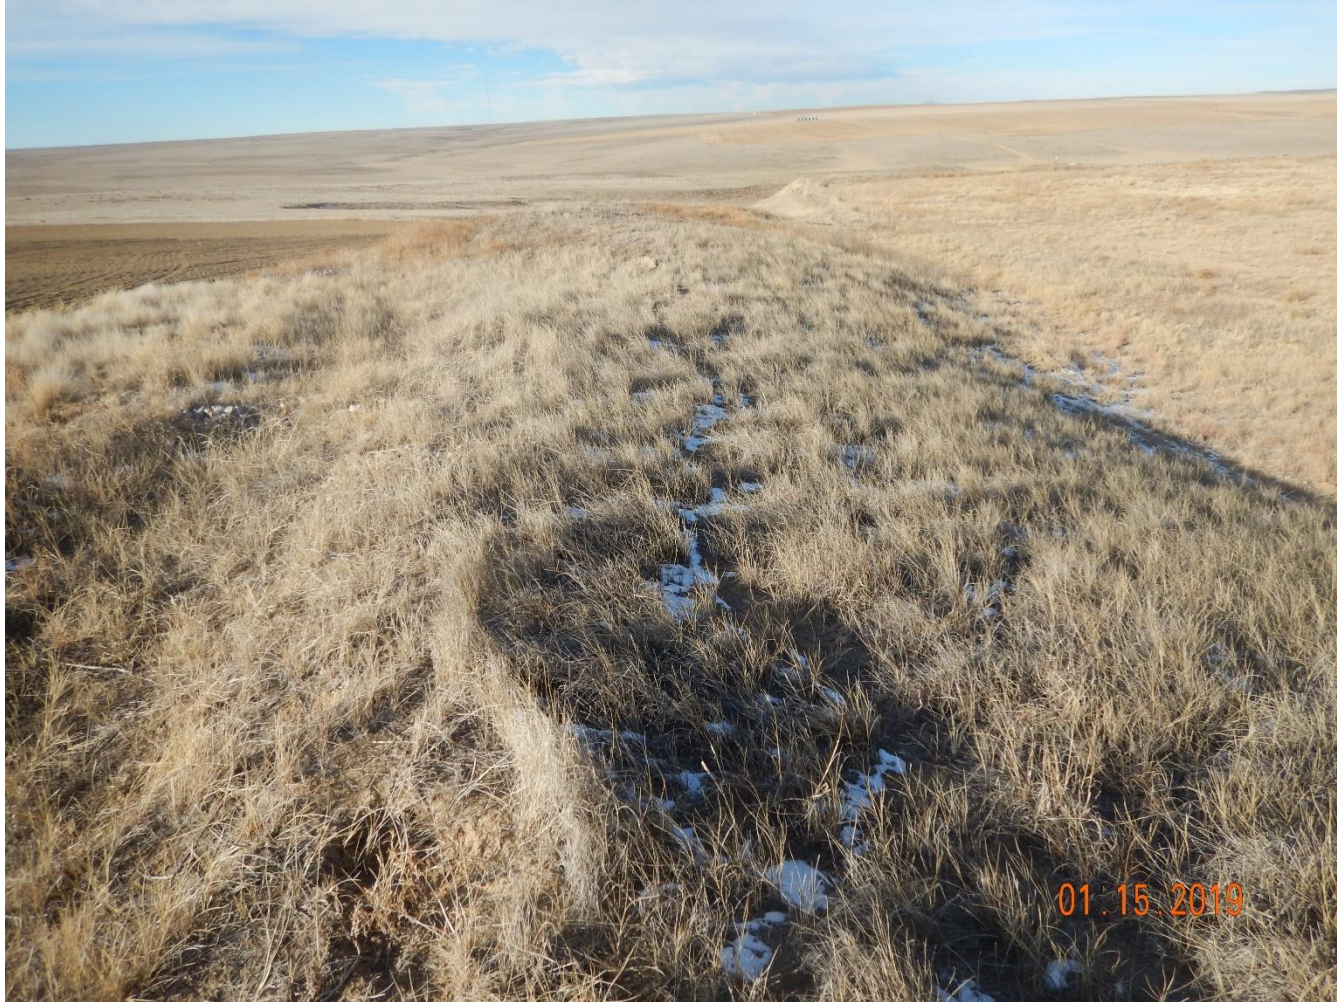
Photo 3: Photo taken from the southeast corner of the location, facing west. See comments under photo 1.

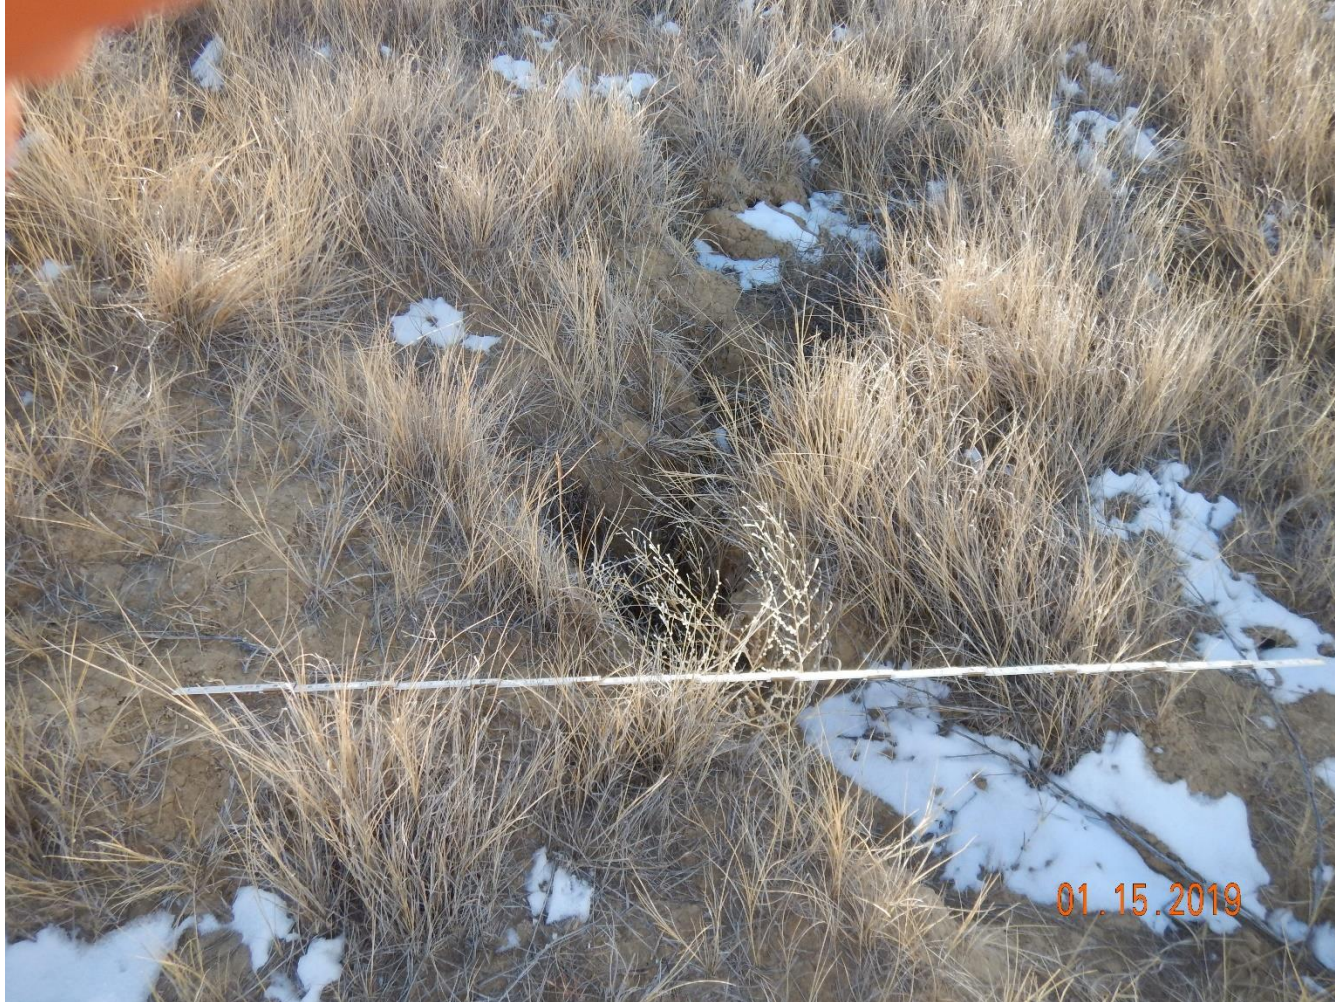
Photo 4: Photo taken from the cut slopes on the southeast corner of the location. Corrective actions required operator to repair erosion degradation and conduct revegetation activities on the cut slopes of the location. Photo shows stormwater erosion has not been repaired/stabilized, and BMPs have not been installed/maintained. Stormwater has been allowed to continue, and has continued to degrade the location. Photo also shows additional revegetation activities to stabilize slope has not been conducted. 6 foot measuring stick for reference.

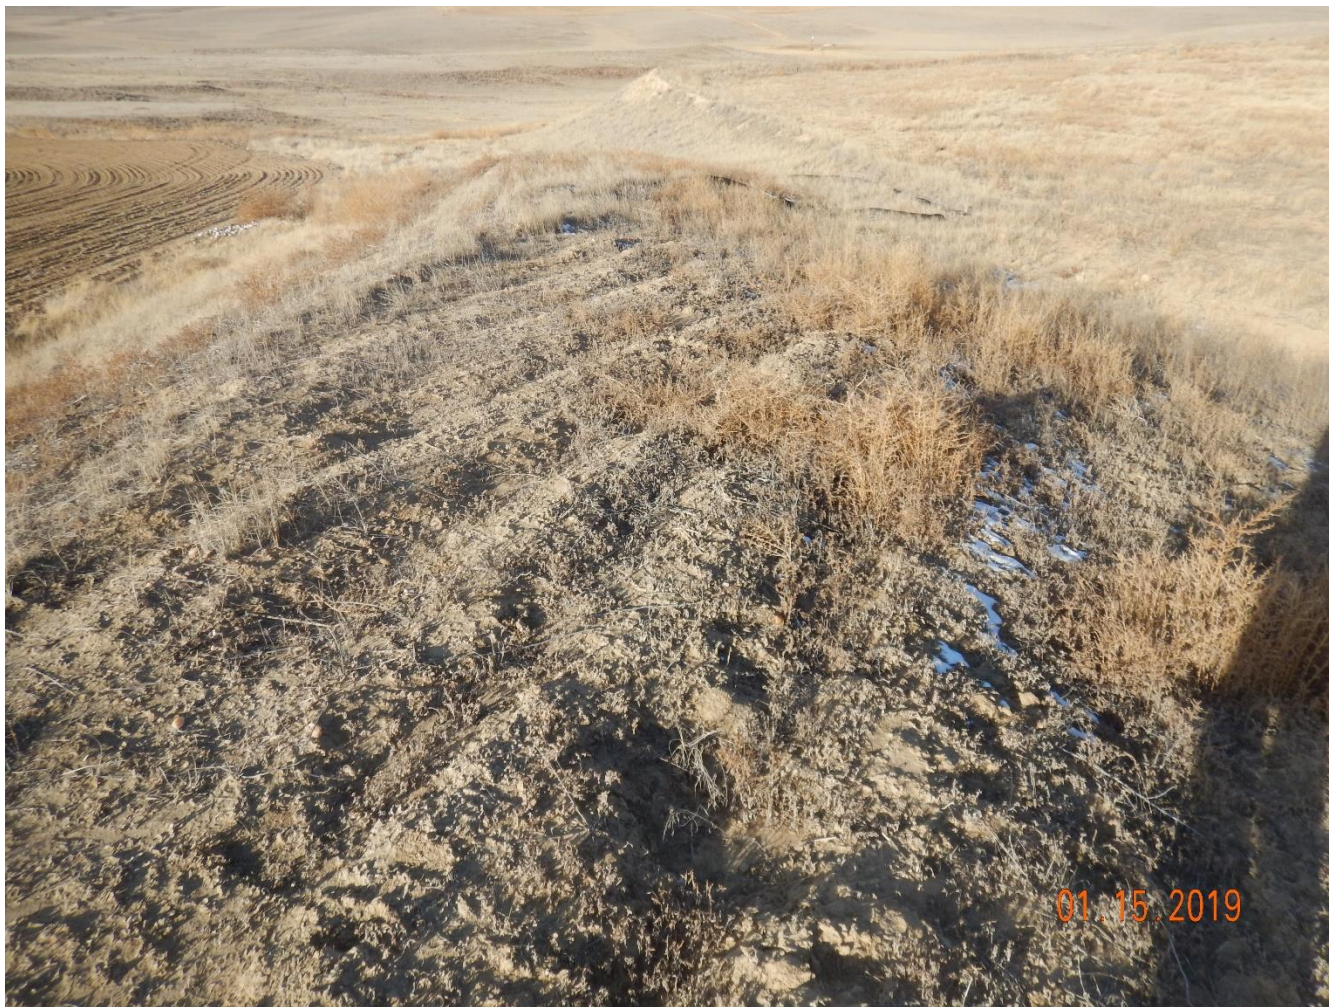
Photo 6: Photo taken from area of the “spoils” stockpile on the south end of the location, facing west. Photo shows areas of bare and exposed soil with large furrows. Previous inspections required operator to repair erosion and stabilize slopes. Photo shows erosion has not been repaired and BMPs have not been installed. Photo also show reclamation activities do not appear to have been conducted per CAs and COAs

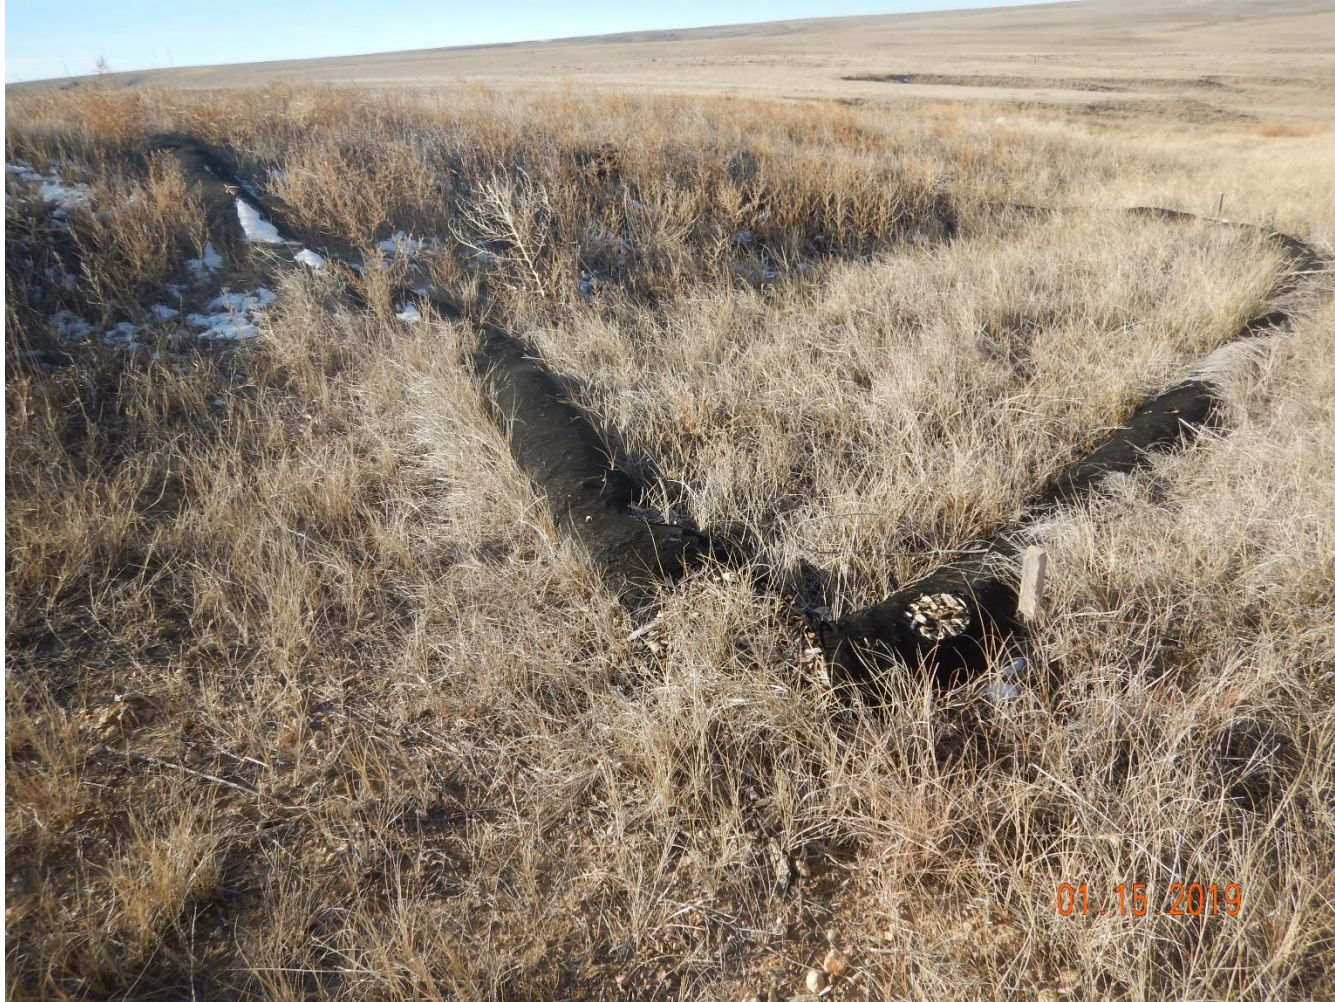
Photo 7: Photo taken from the south end of the location, facing southwest. Photo shows wood-mulch wattle stormwater ponding BMP. Previous inspection documented BMP was degrading. Photo shows BMP has not been maintained/repaired.

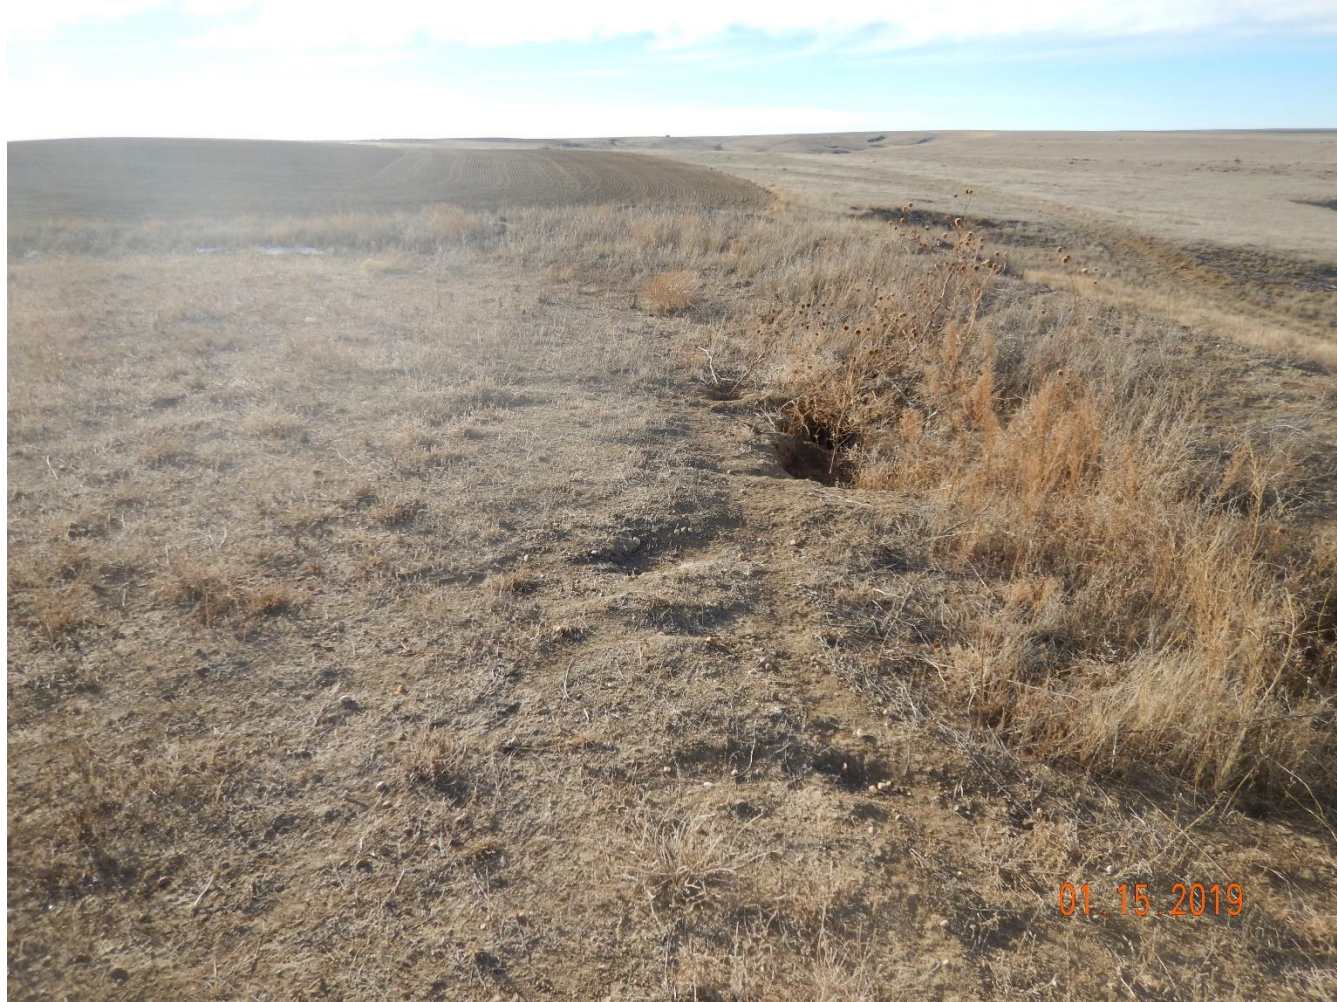
Photo 8: Photo taken from the ditch on the southwest corner of the location, facing south. Previous inspections documented that stormwater runoff has incised the ditch along the west end of the pad and created sinkholes within the ditch. Photo shows a new sinkhole has developed within the ditch.

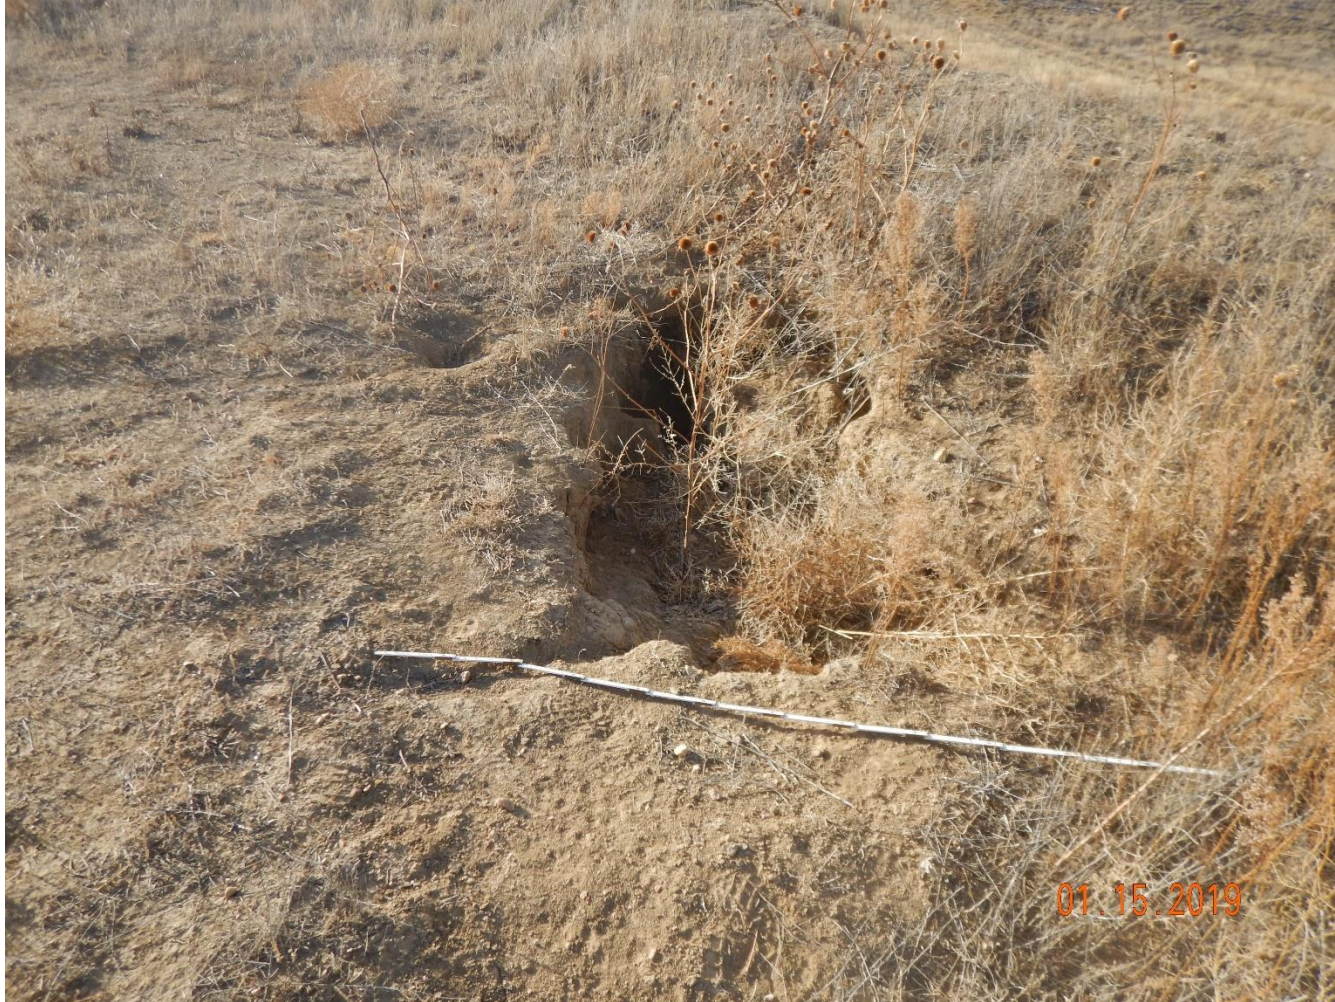
Photo 9: See comments under photo 8. 6 foot measuring stick for reference.

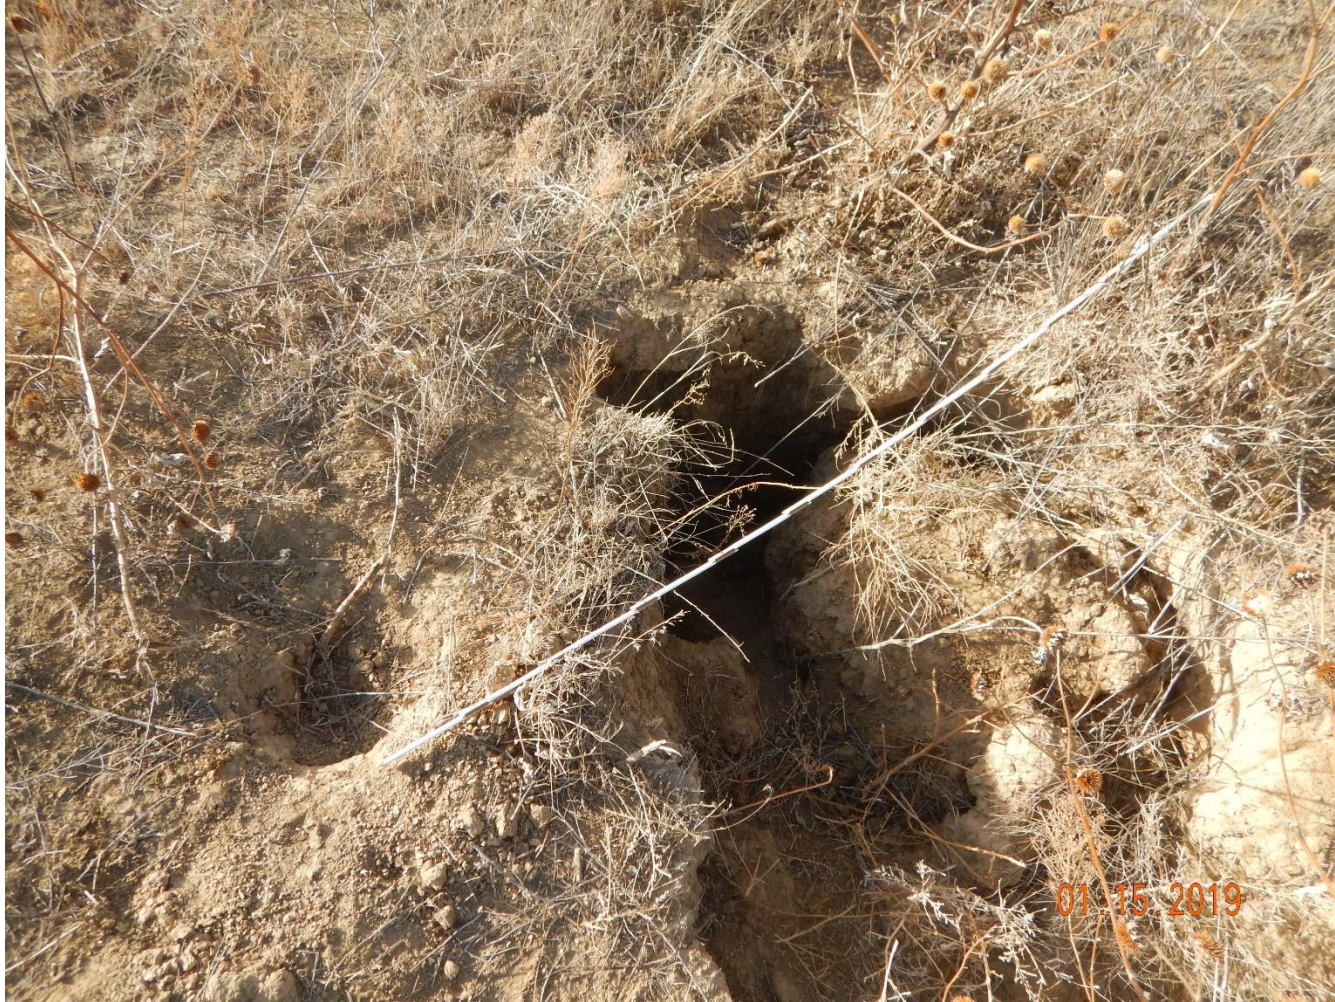
Photo 10: See comments under photo 8. 6 foot measuring stick for reference.

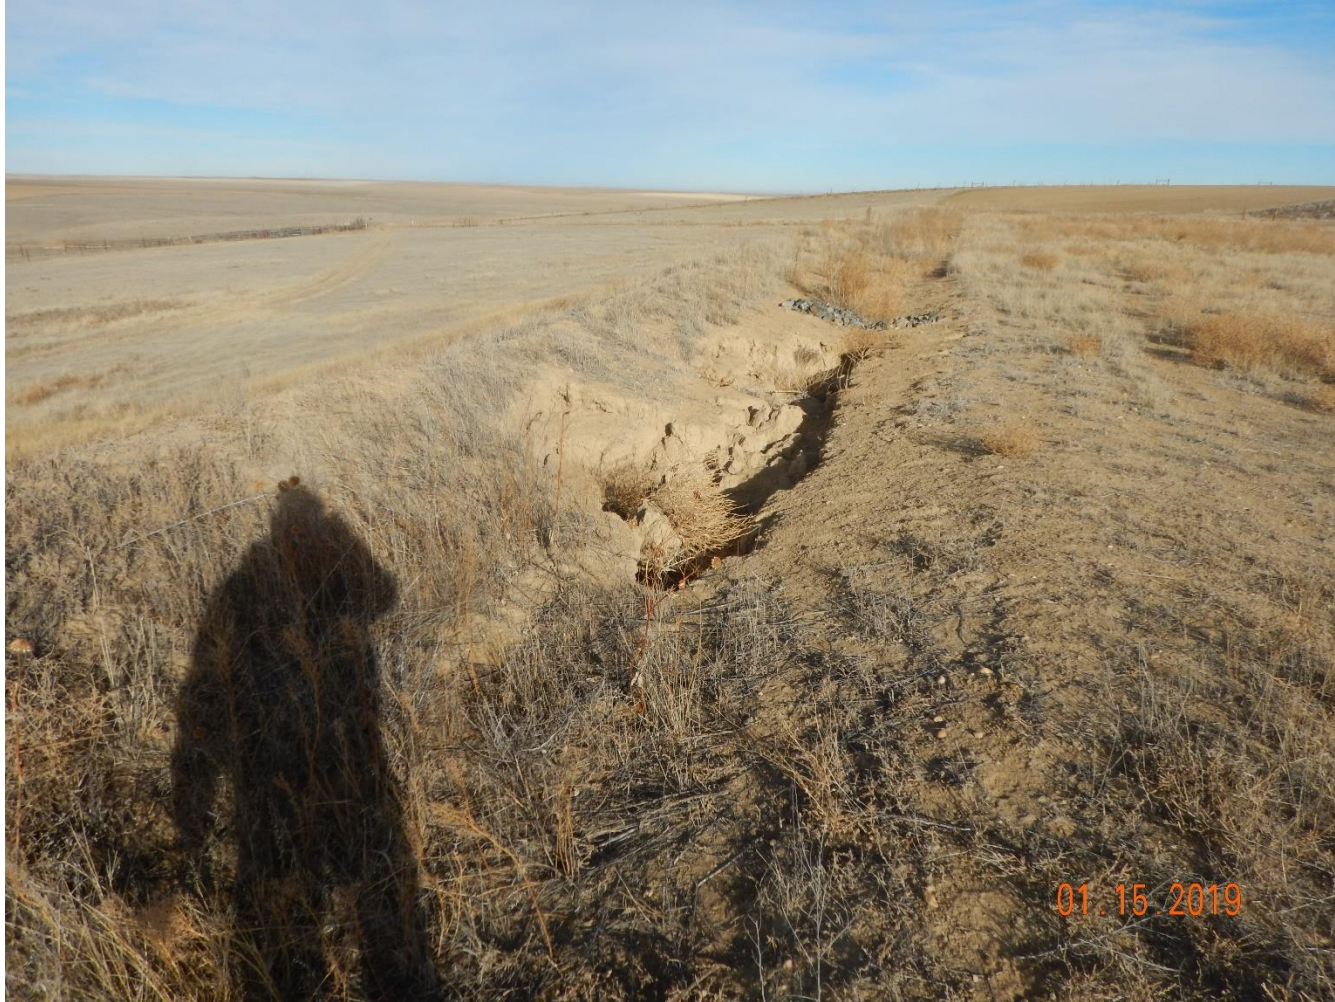
Photo 11: Photo taken from the west end of the location, facing north. Photo shows stormwater degradation within the ditch has not been repaired and stabilized. Stormwater has continued to incise within the ditch and sinkhole appears to have expanded.

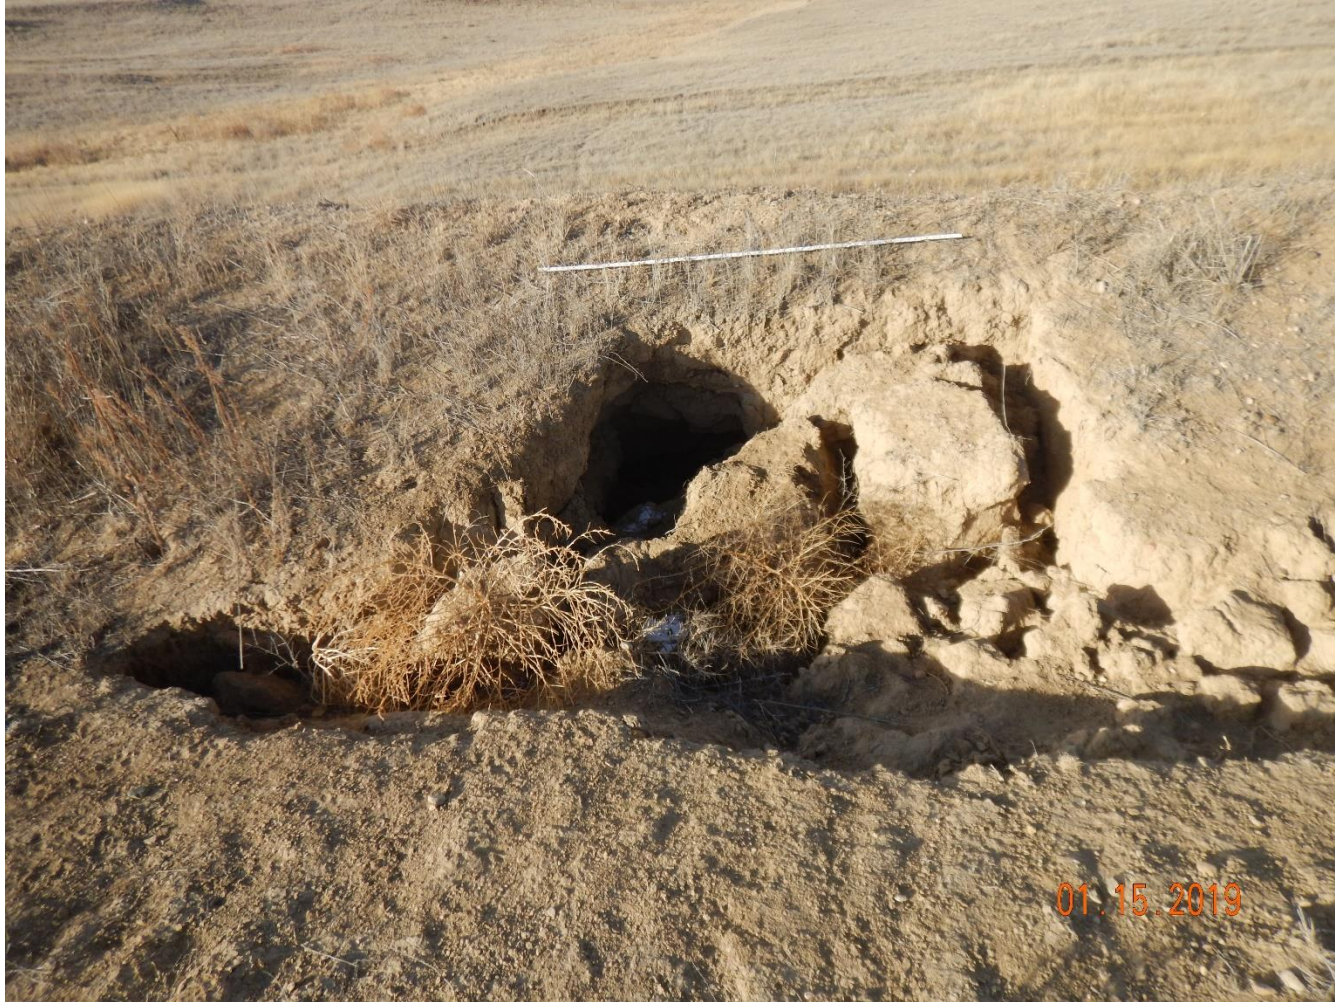
Photo 12: Photo taken from the west end of the location, facing west. See comments under photo 11. 6 foot measuring stick for reference.

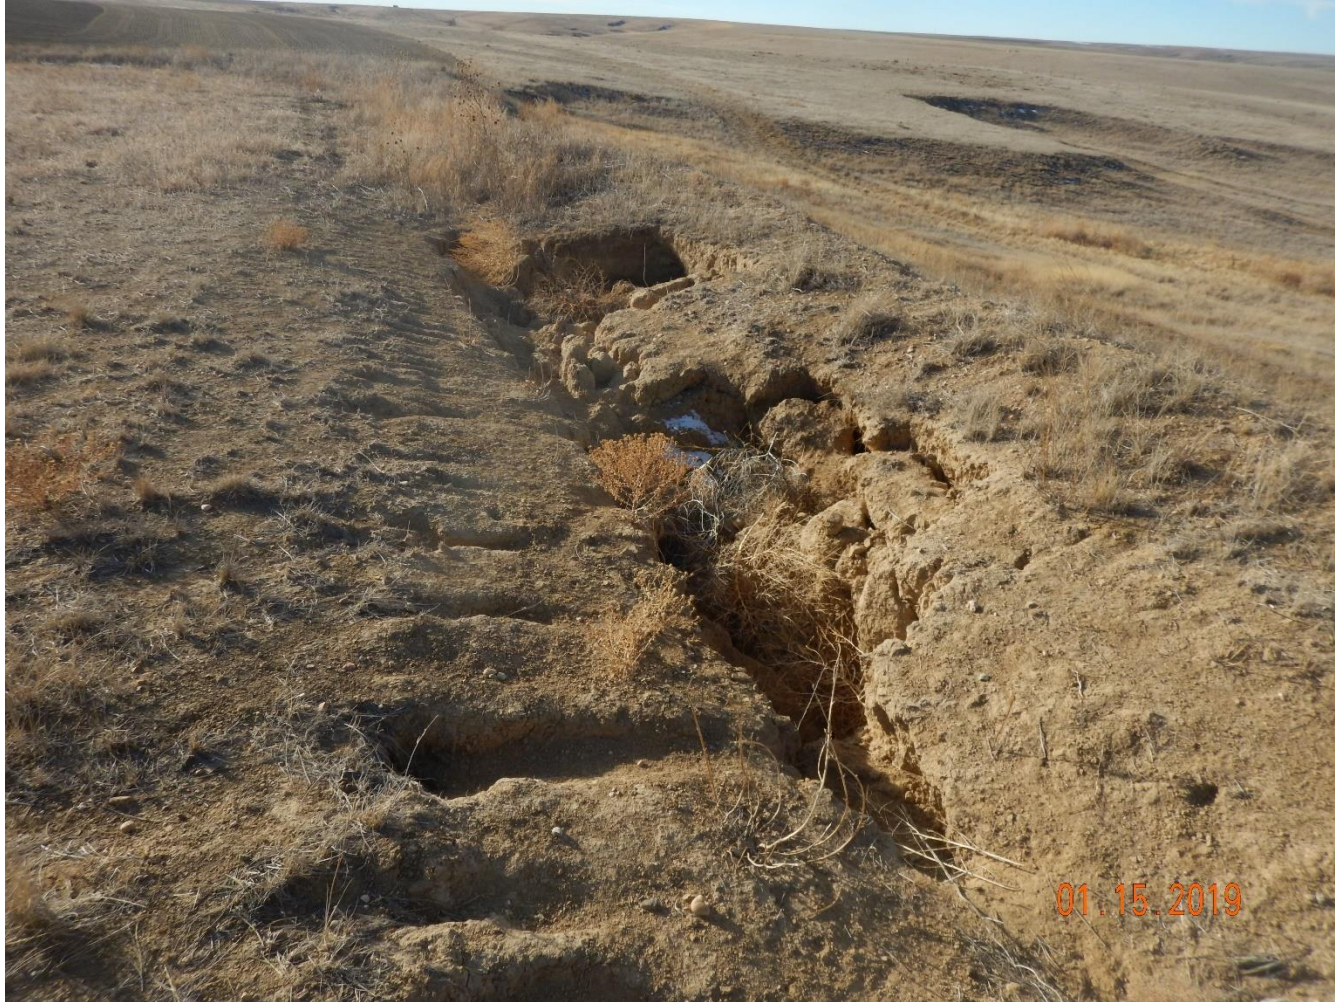
Photo 13: Photo taken from the west end of the location, facing south. See comments under photo 11.

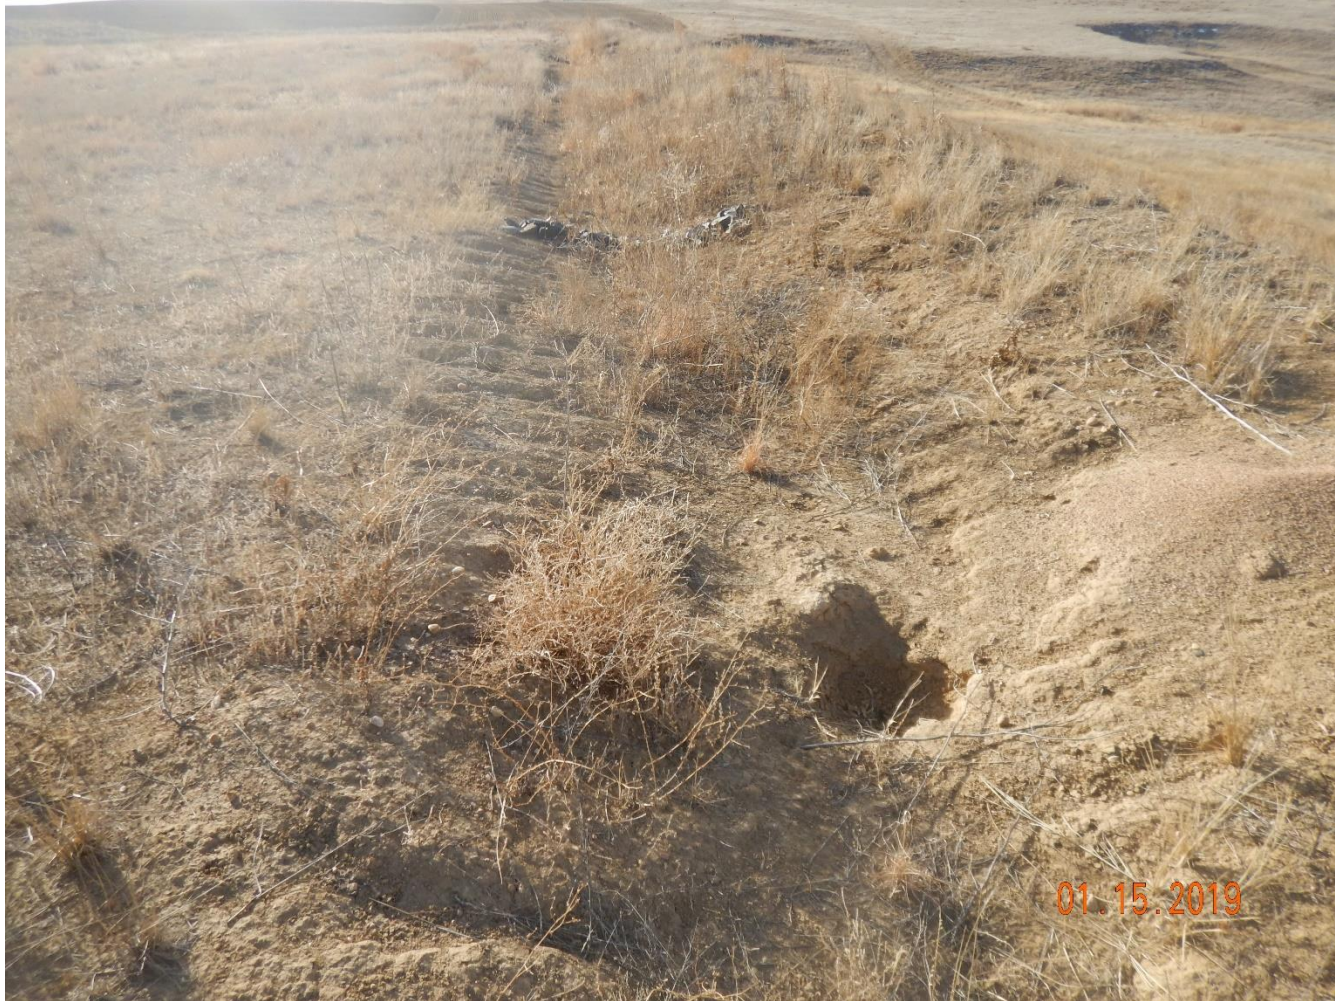
Photo 14: Photo taken ~100 feet north from photo 13. Photo shows a third sinkhole appears to be forming within the ditch along the west end of the location.

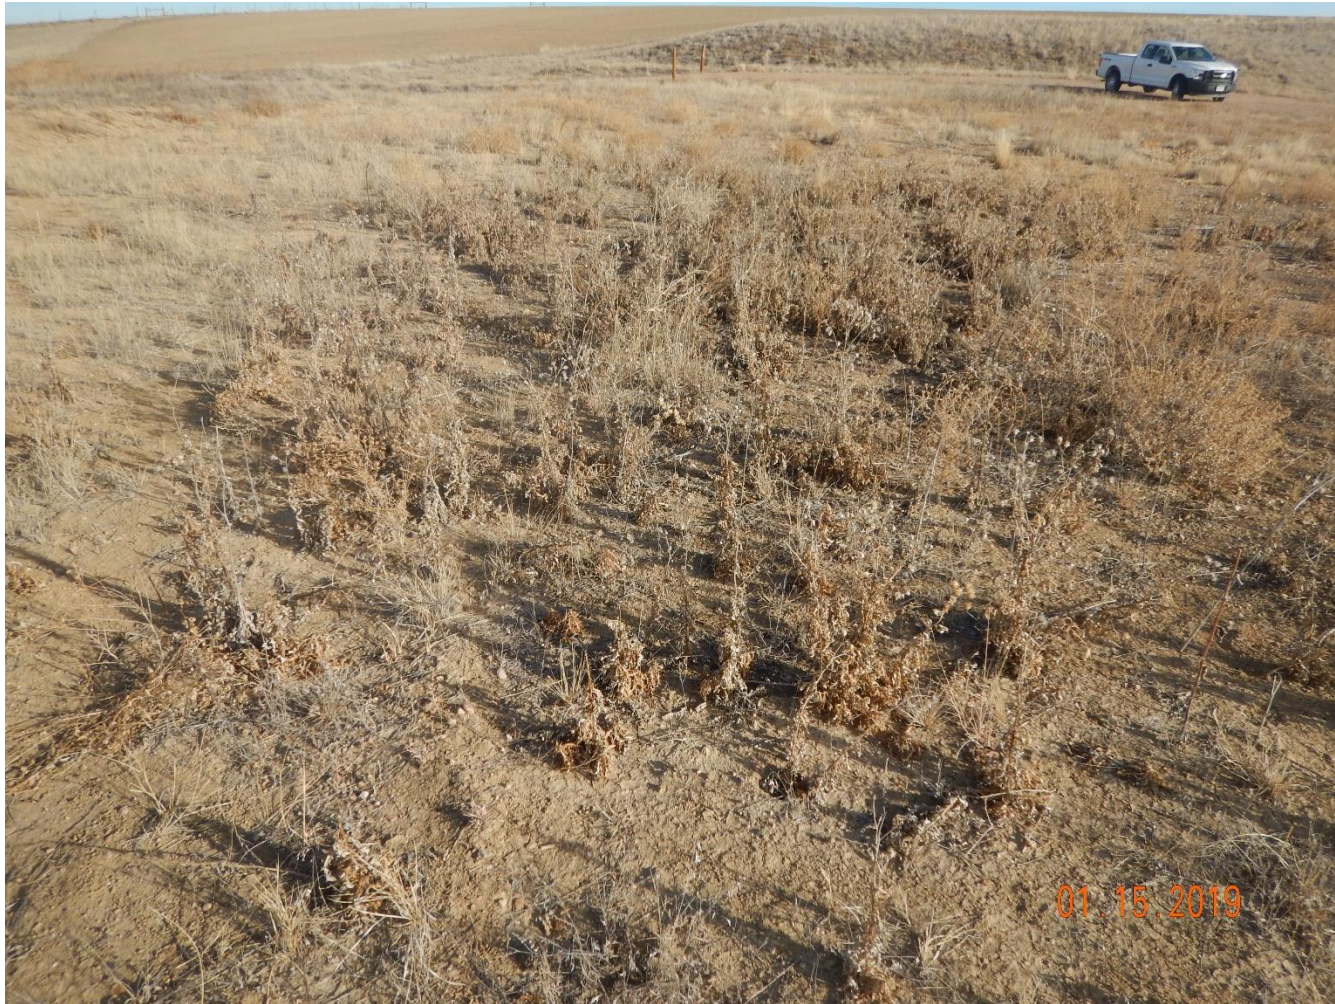
Photo 15: Photo taken from the northwest end of the location, facing northeast. Photo shows a patch of Canada thistle.

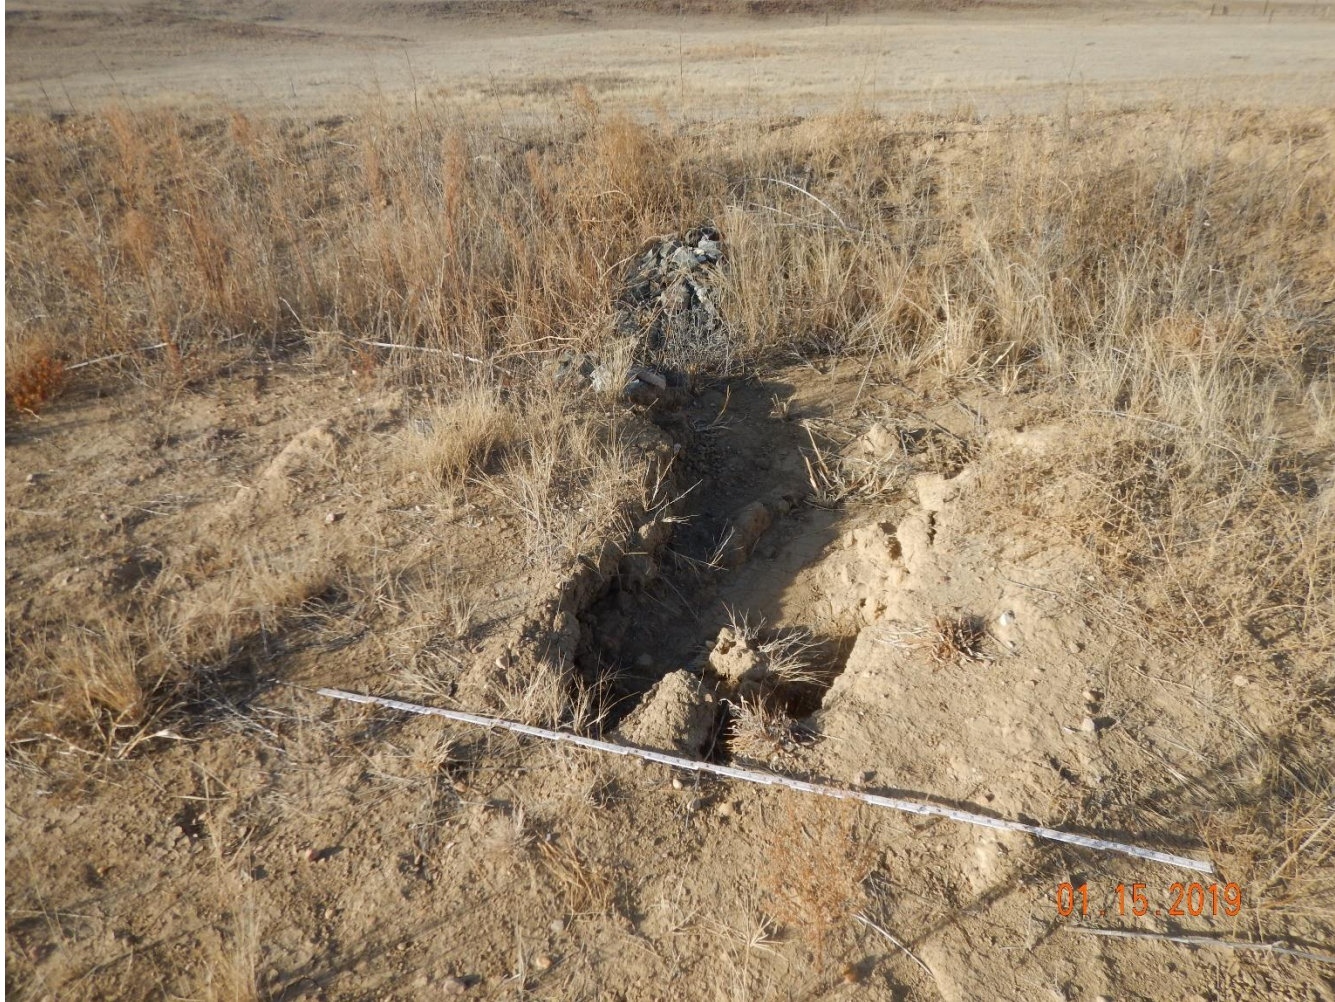
Photo 16: Photo taken from the ditch on the northwest end of the location, facing west. Photo shows erosion degradation cutting eastward into the pad has not been repaired or stabilized. 6 foot measuring stick for reference.

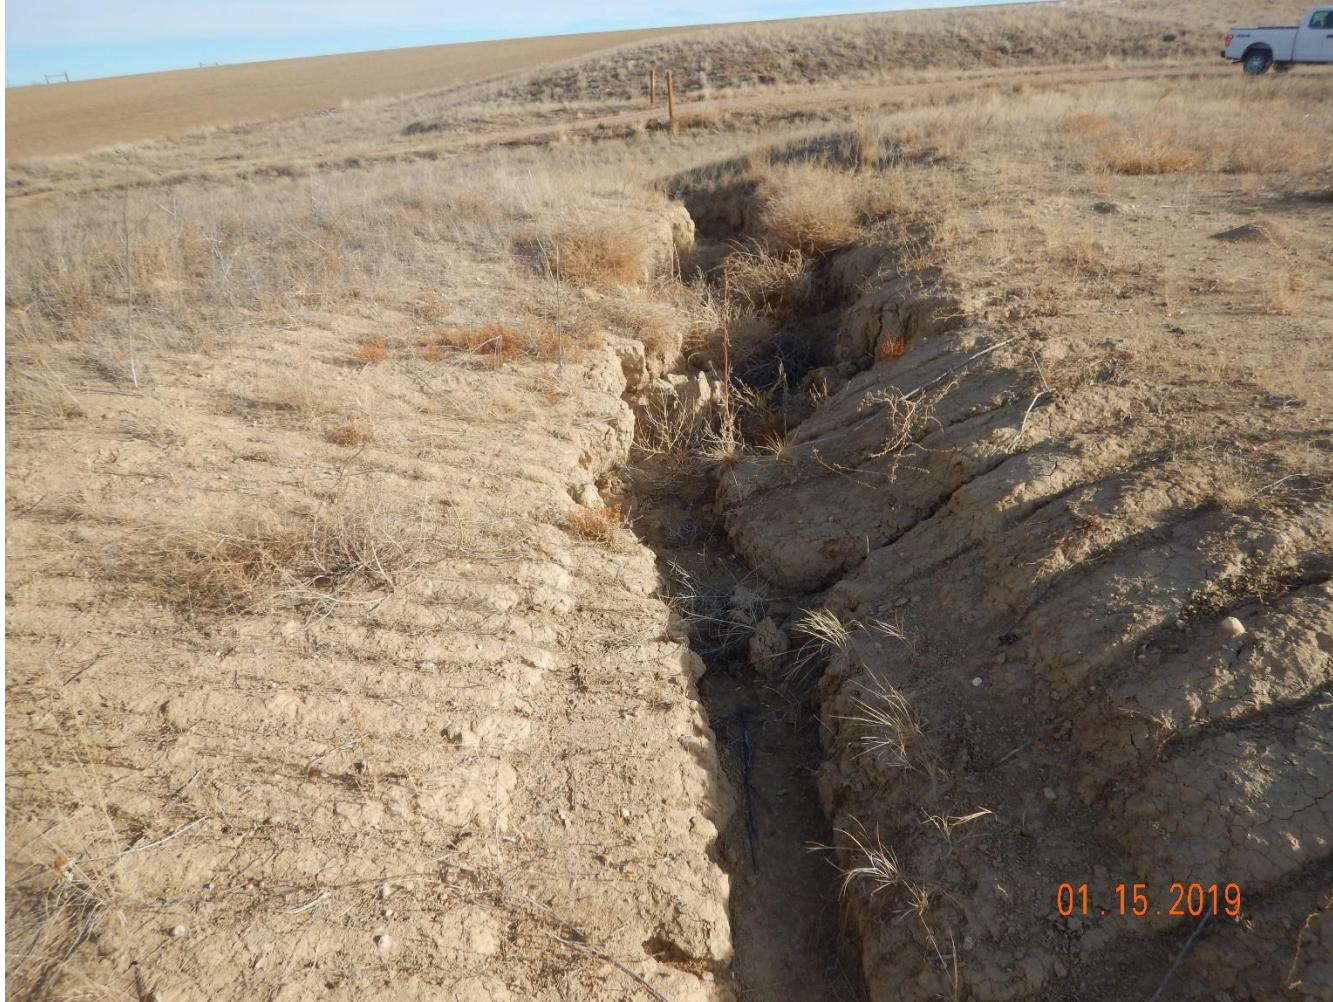
Photo 17: Photo taken from the north end of the location, facing northeast. Photo shows unused equipment not needed for production remains on location. Photo shows gully erosion has not been repaired/stabilized.
