Inspection Photos

Operator: SWN PRODUCTION COMPANY LLC -
10396

Location ID: 427955

Inspection Doc. Number: 682504411
Adams County, CO

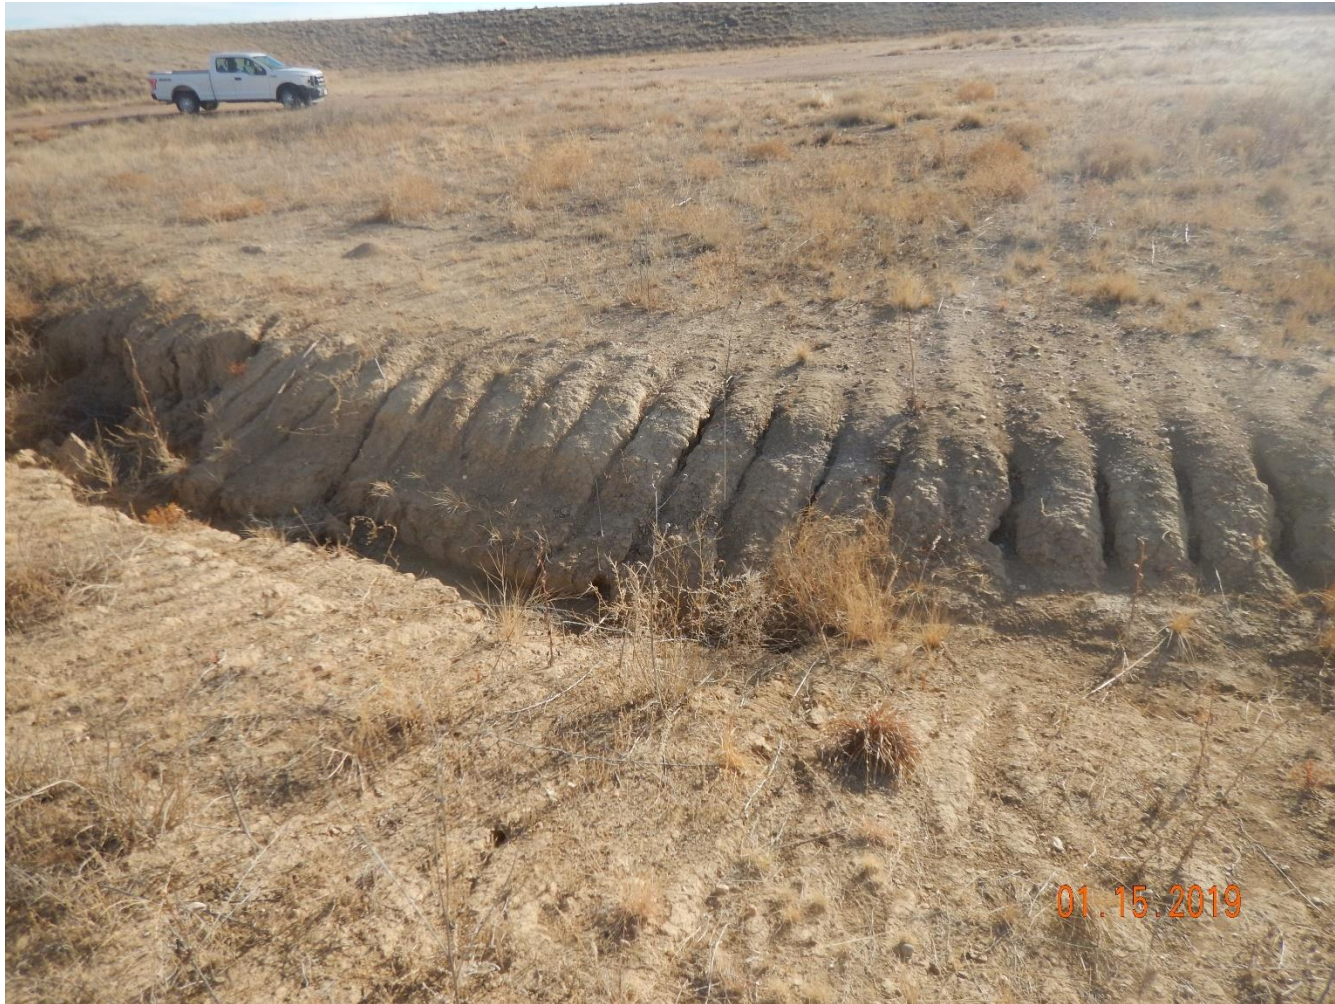
Photo 18: Photo taken from the ditch on the northwest end of the pad. Photos show stormwater runoff from the pad into the ditch has created rill erosion. Stormwater degradation has not been repaired or stabilized.

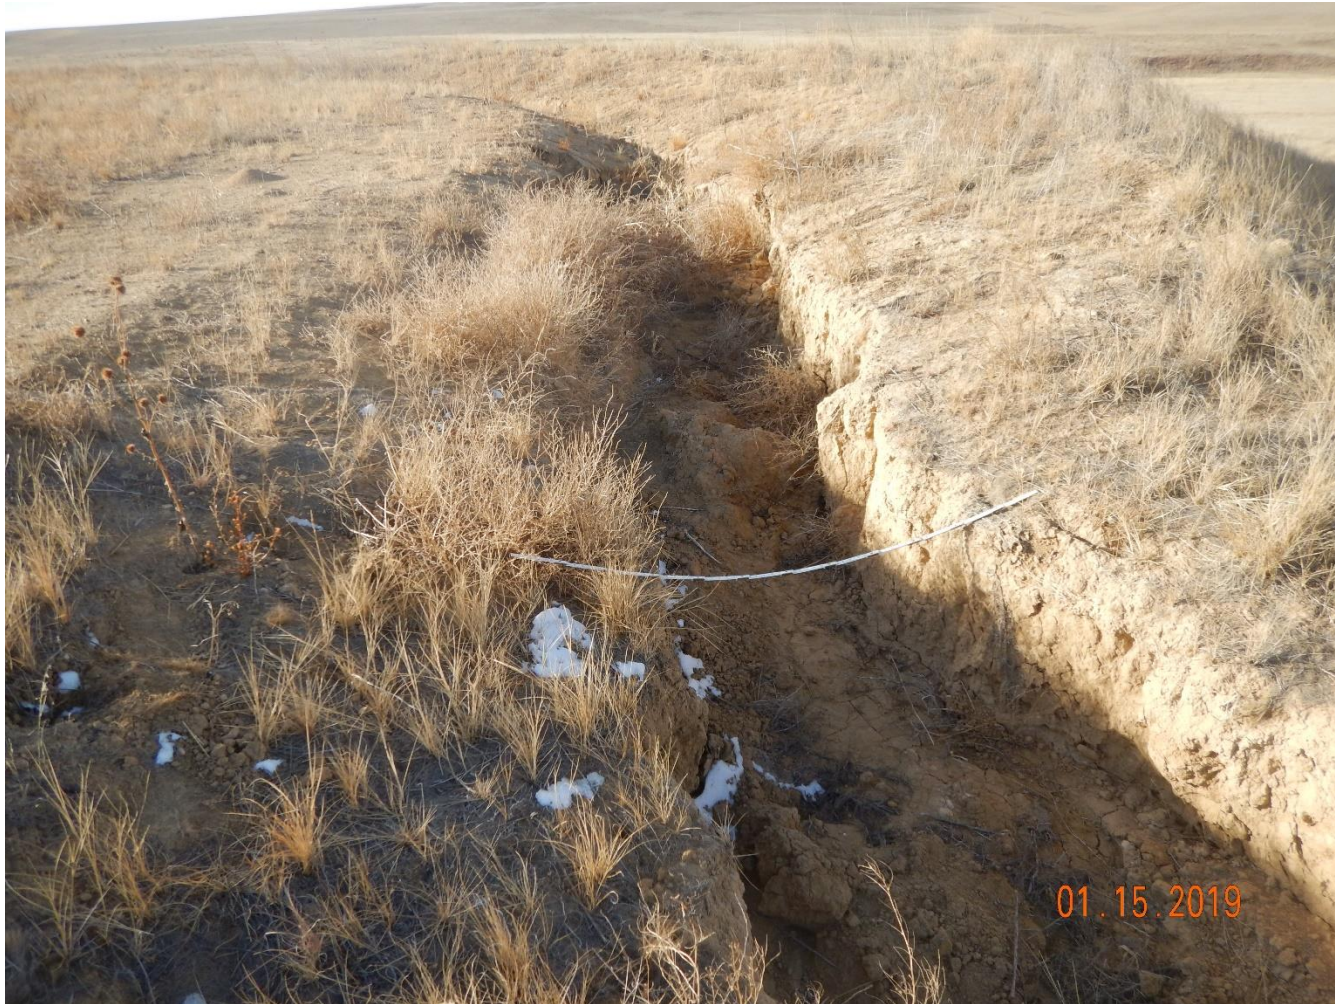
Photo 19: Photo taken from the gully on the northwest end of the pad, facing southwest. Photo shows gully erosion has not been repaired/stabilized. 6 foot measuring stick for reference.

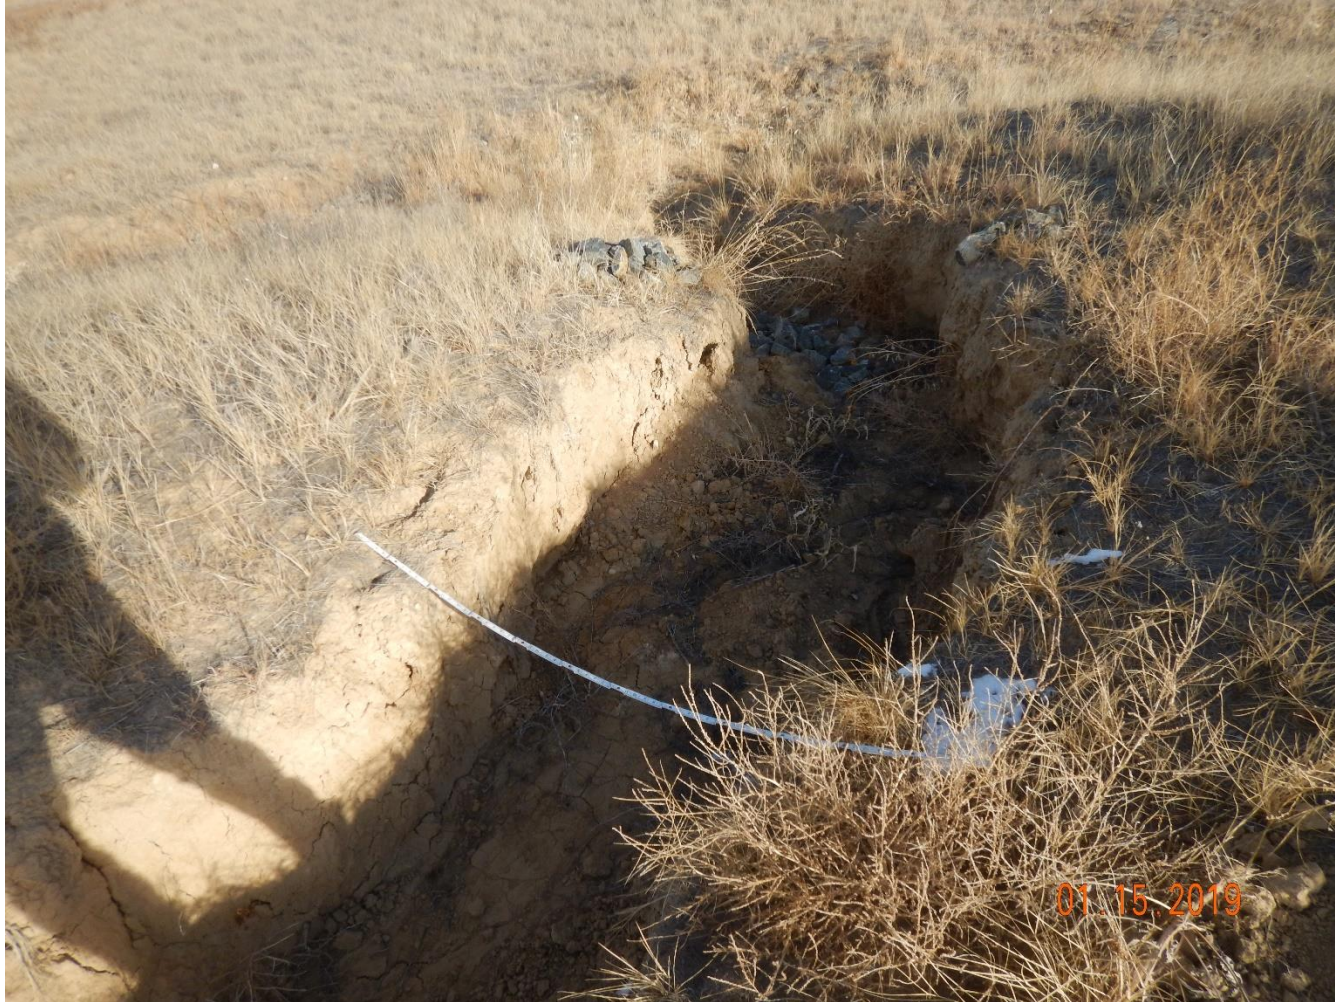
Photo 20: Photo taken from the gully on the northwest end of the pad, facing north. Photo shows gully erosion has not been repaired/stabilized. 6 foot measuring stick for reference.

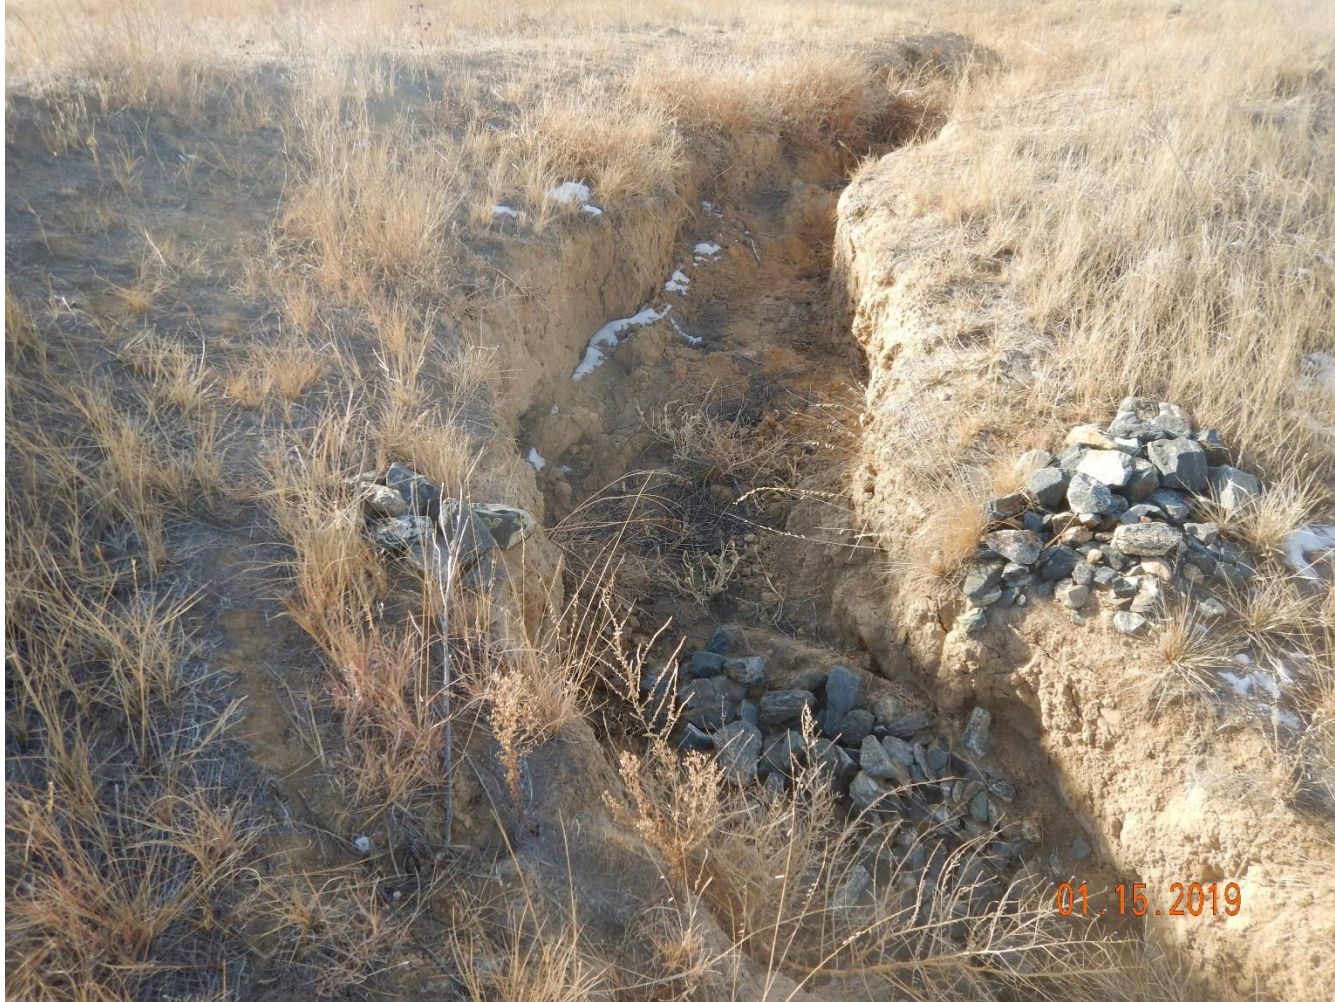
Photo 21: Photo taken from the gully on the northwest end of the pad, facing southwest. Photo shows gully erosion has not been repaired/stabilized.

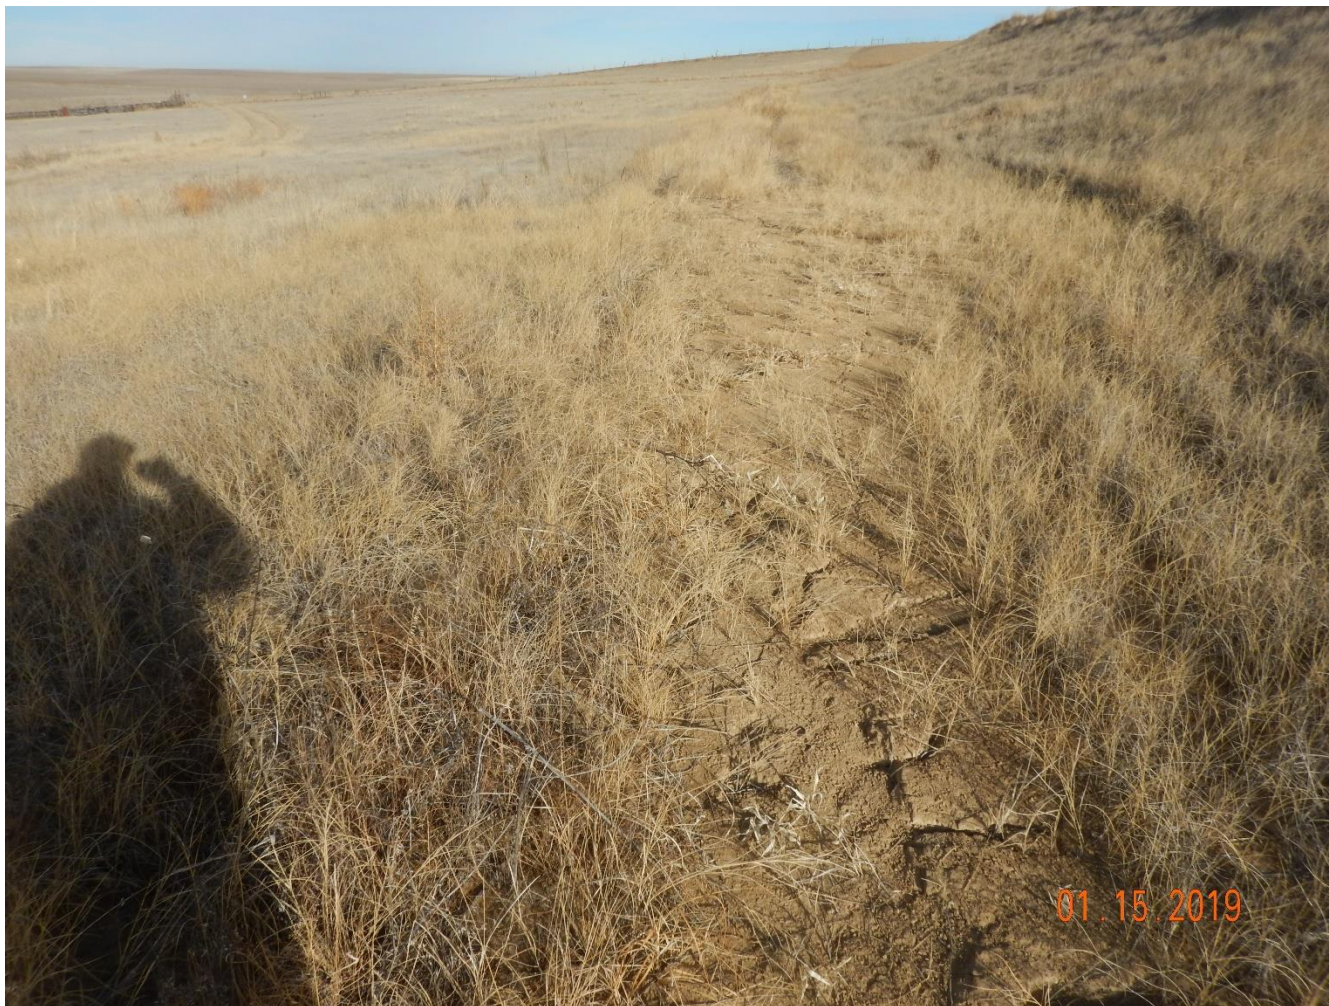
Photo 22: Photo taken from the stormwater ditch along the perimeter of the west end of the location. Previous inspection documented that ditch BMP has filled with sediment and is not longer in proper functioning condition. BMP should have been reclaimed during interim reclamation. Photo shows BMP remains filled with sediment. Photo also shows interim reclamation to reduce the area of disturbance has not been conducted.

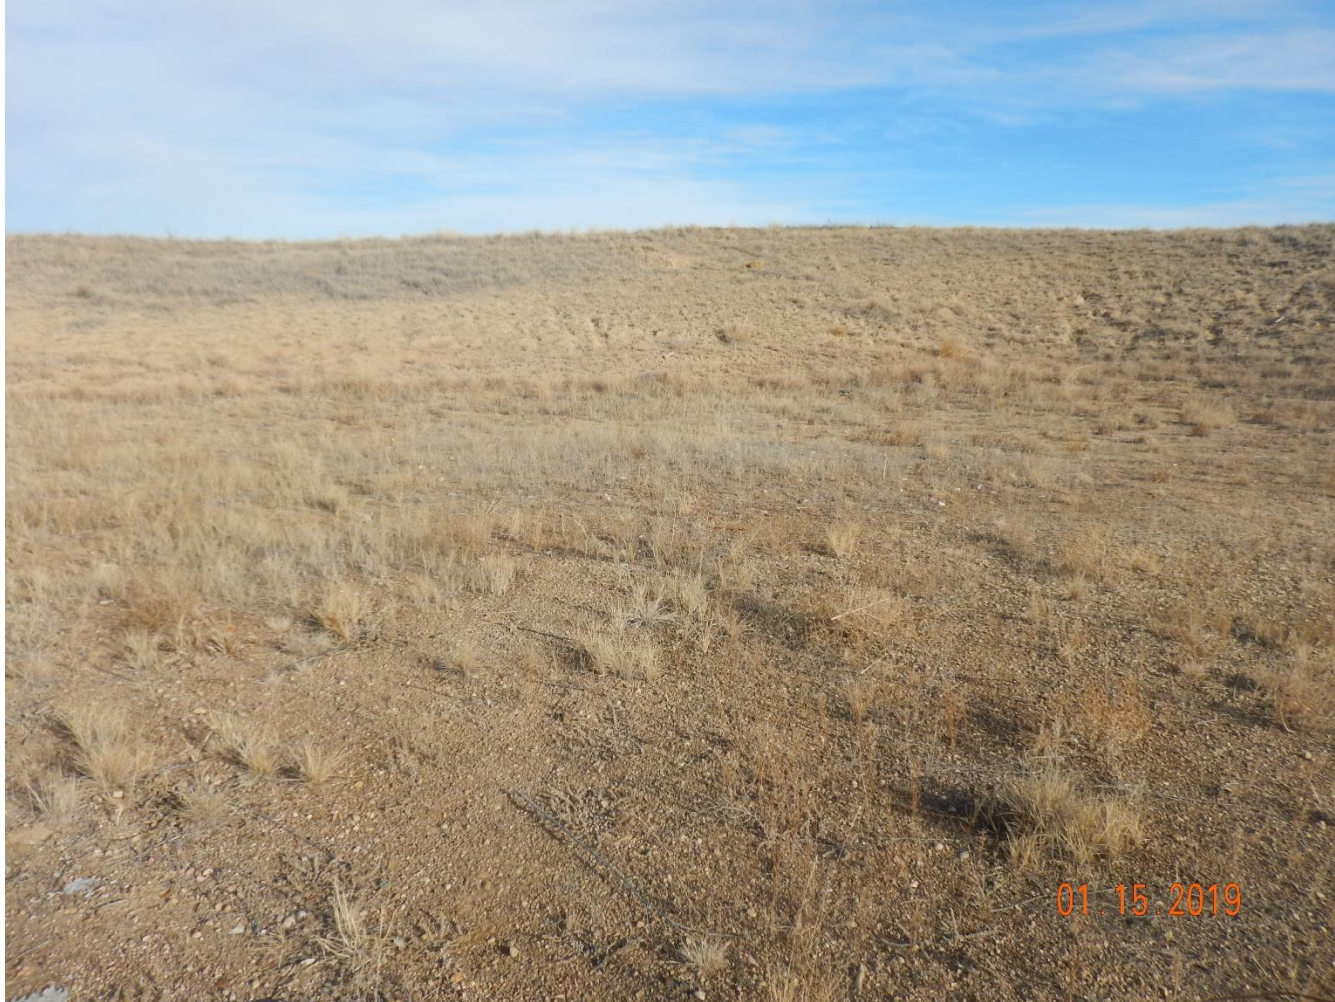
Photo 23: Photo taken from the northeast end of the location, facing northeast. Previous inspection documented that the cut slopes on the east end of the location remains predominantly bare and exposed soil and with erosion degradation evident. Inspection required operator to repair erosion, stabilize the slopes and conduct revegetation activities. Photos 23-27 show erosion degradation has not been repaired, no BMPs have been installed, and no revegetation activities appear to have been conducted.

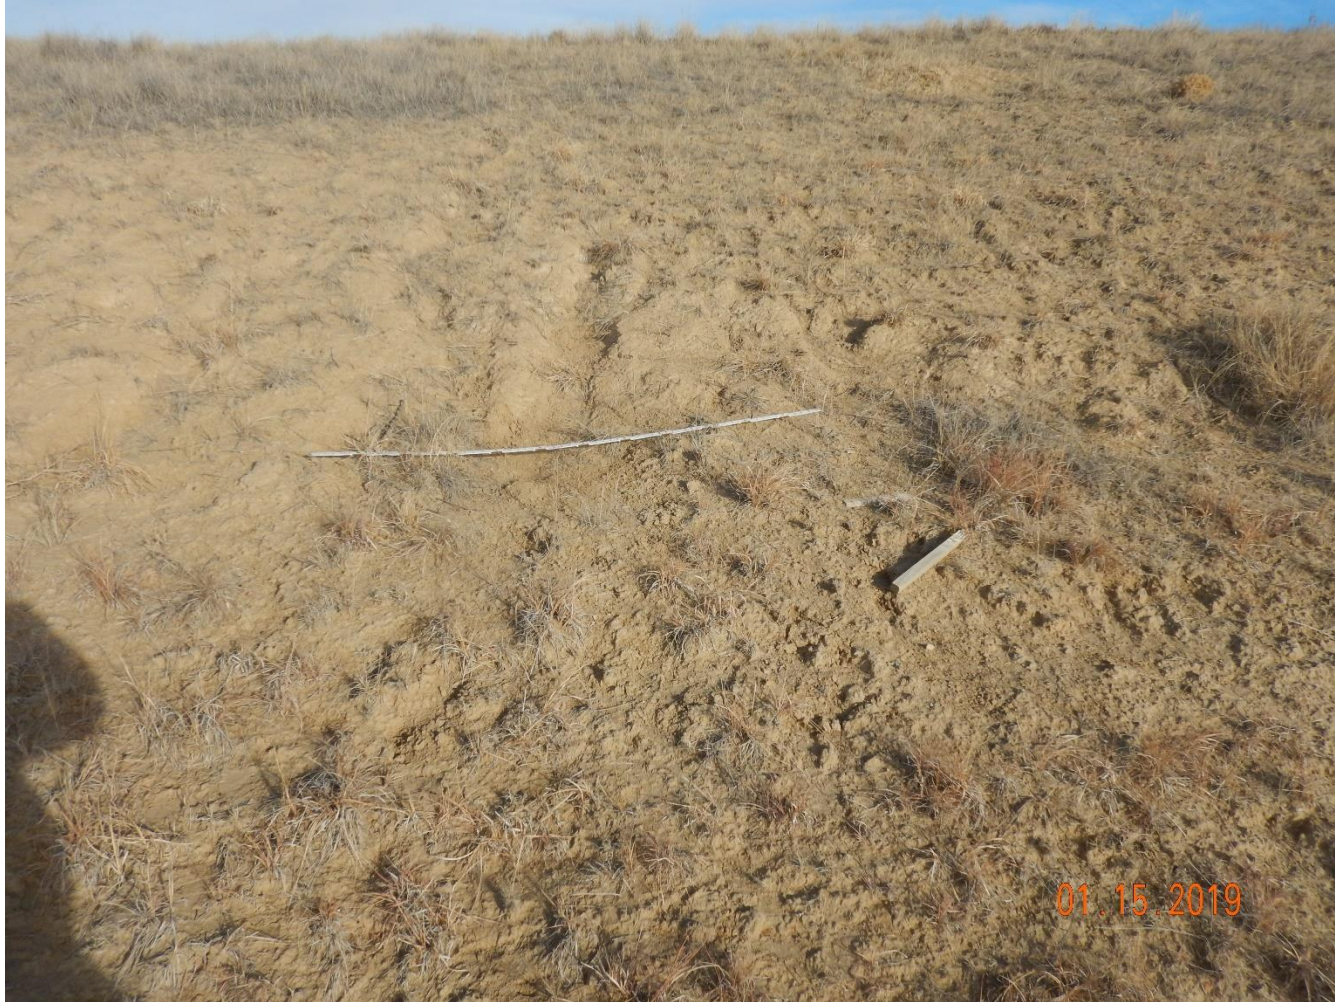
Photo 25: Photo taken from the northeast end of the location, facing north. See comments under photo 23. 6 foot measuring stick for reference.

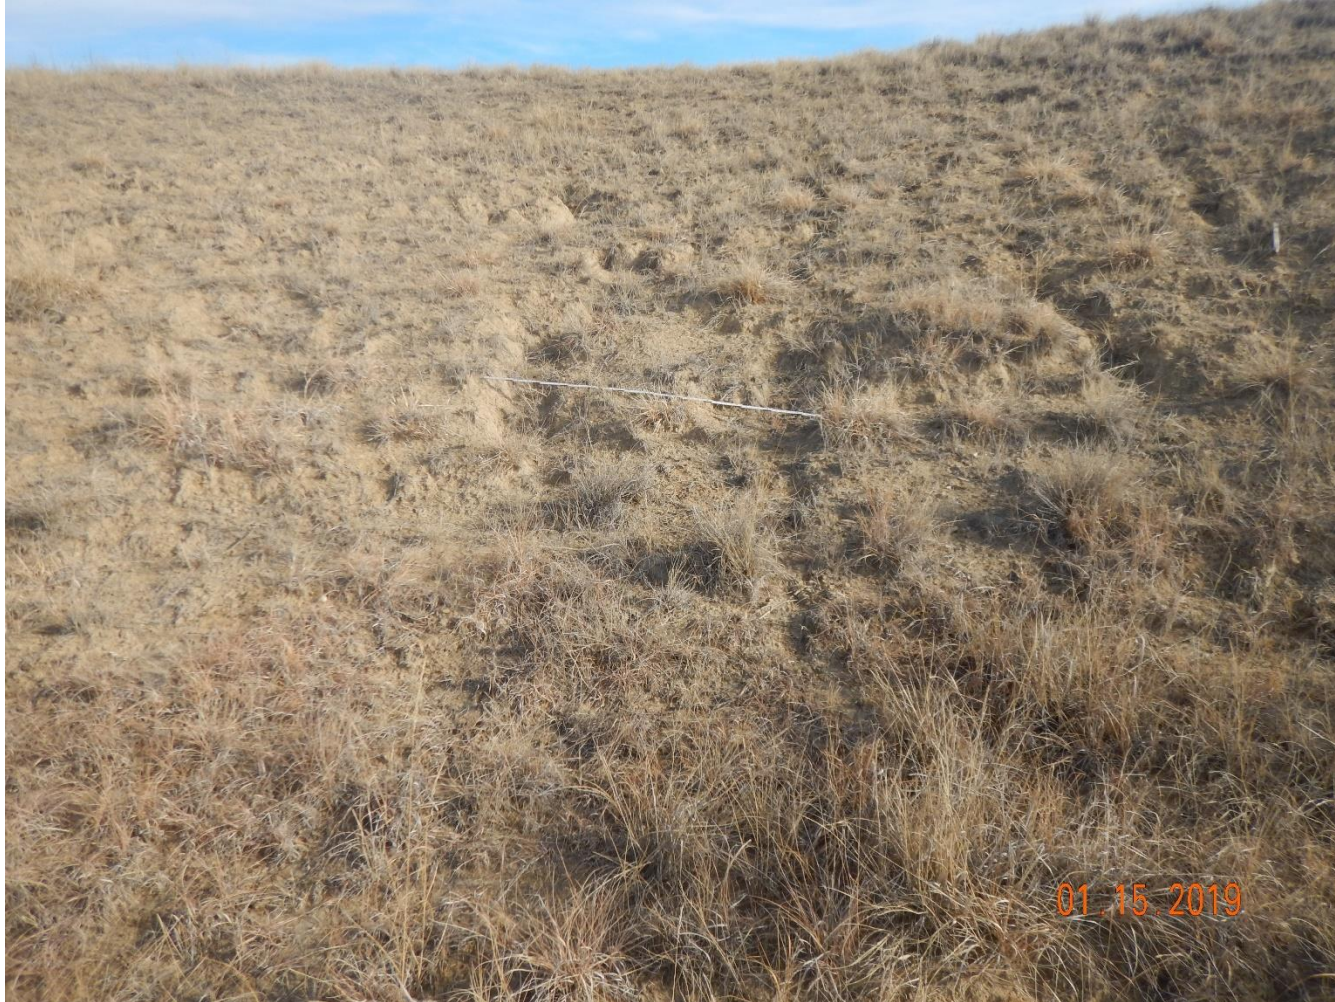
Photo 26: Photo taken from the northeast end of the location, facing northeast. See comments under photo 23. 6 foot measuring stick for reference.

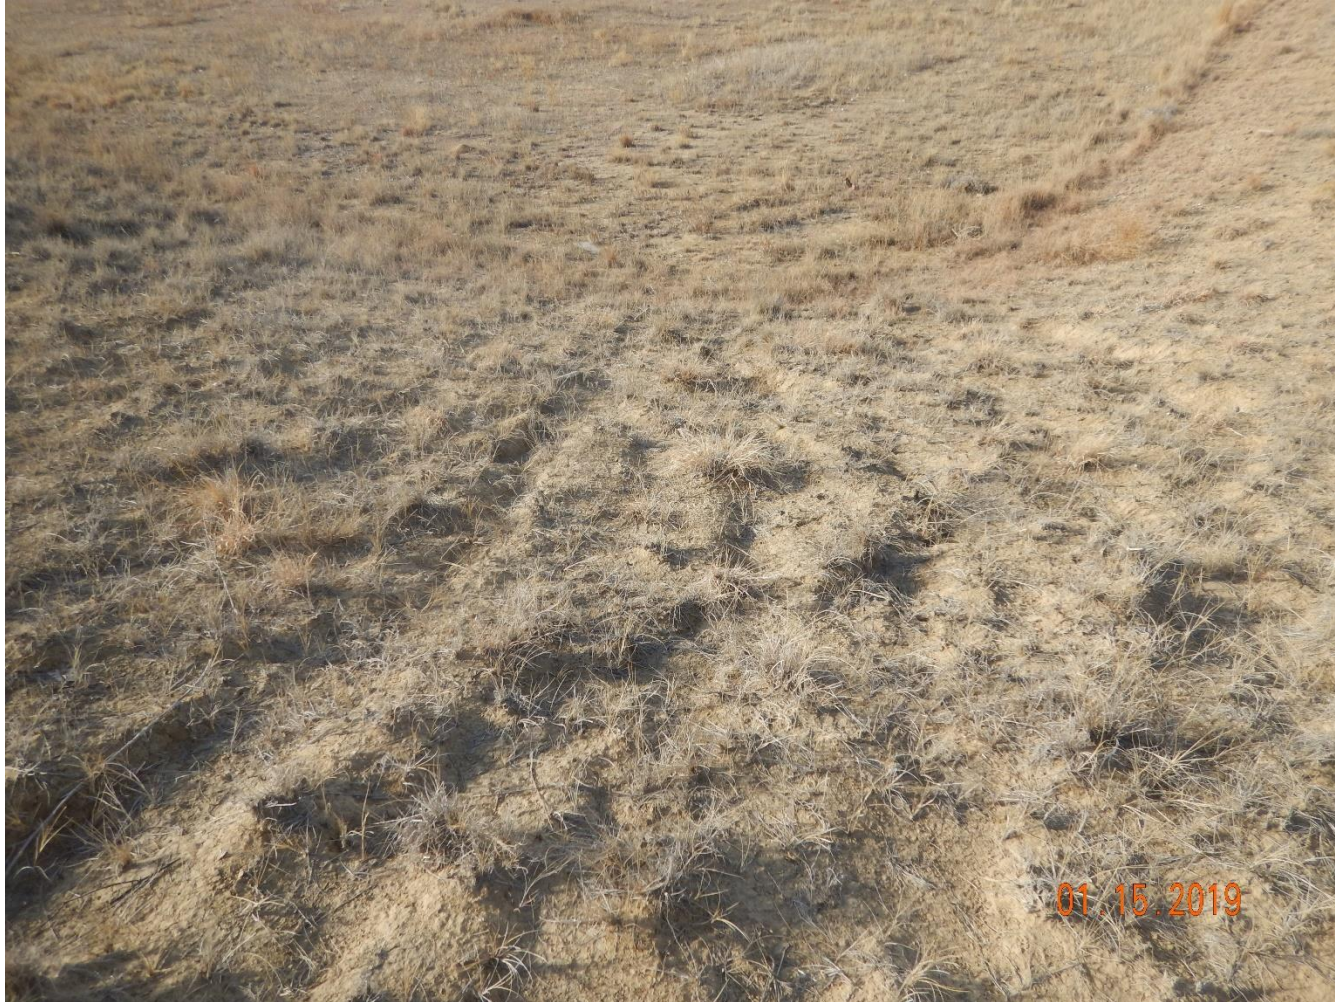
Photo 27: Photo taken from the northeast end of the location, facing southwest. See comments under photo 23. 6 foot measuring stick for reference.

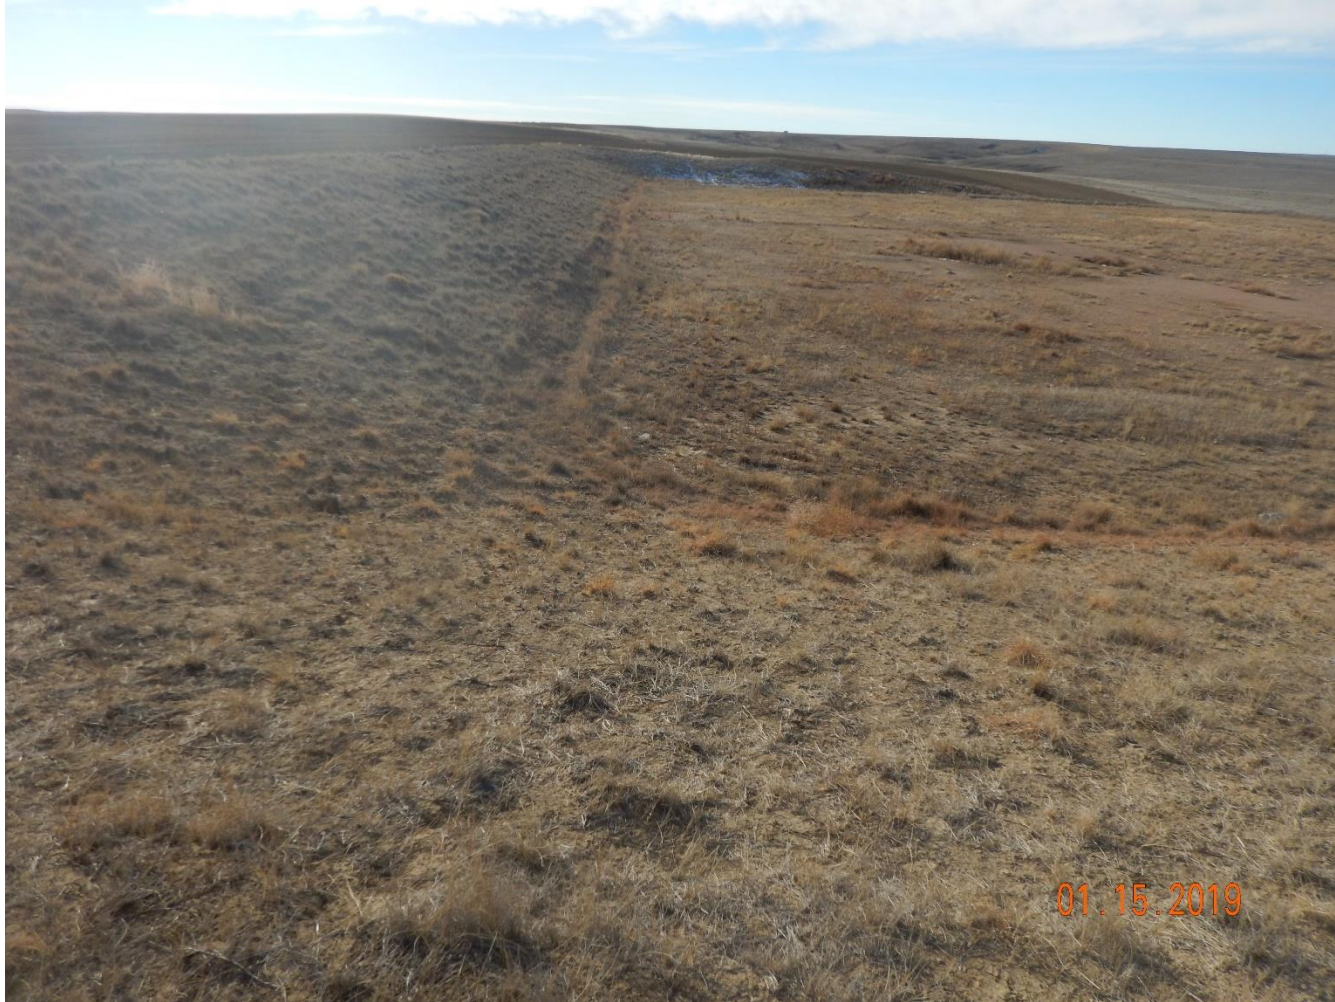
Photo 28: Photo taken from the northeast corner of the location, facing south. Photos 28-29 provide an overview of the location from south to west. Corrective actions and COAs required operator to conduct reclamation and reduce the location's disturbance area to 0.92 acres. Photos show reclamation has not been conducted; disturbance area has not been reduced.
