**Response to December 31, 2018 Inspection
Document Number: 674902382**

COGCC conducted an inspection of the D21-13 pad (Location ID 458904) on December 31, 2018 (Document 674902382).

Name: D21-13 Pad
Location ID: 458904

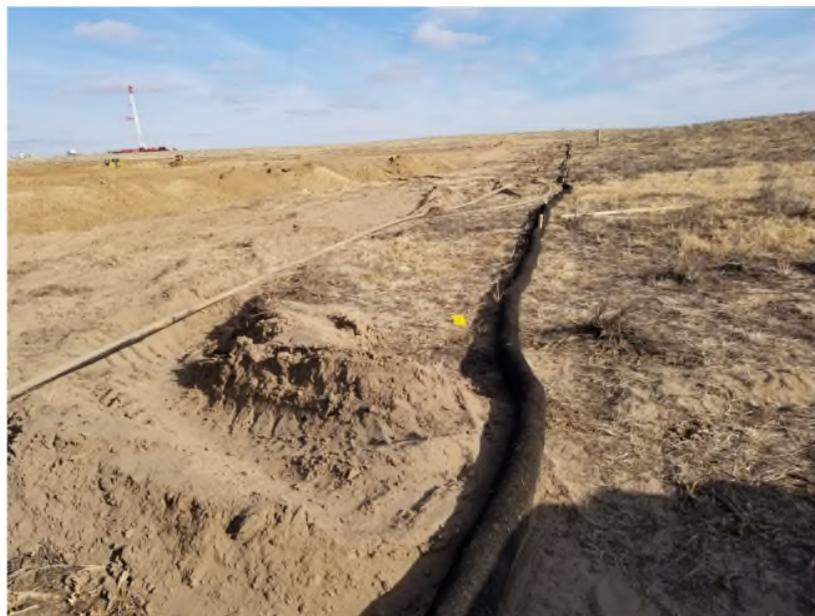
Stormwater comment: Operator does not appear to have implemented and maintained Best Management Practices (BMPs) to control stormwater runoff in a manner that minimizes erosion, transport of sediment offsite, and site degradation per Rule 1002.f.(2). Operator does not appear to have implemented BMPs in accordance with good engineering practices per Rule 1002.f.(2). See attached inspection photos for more details.

Photo 1. Photo taken from the southern perimeter of the location, facing East. Photo illustrates a filtrex BMP that has been installed around the perimeter of the location.

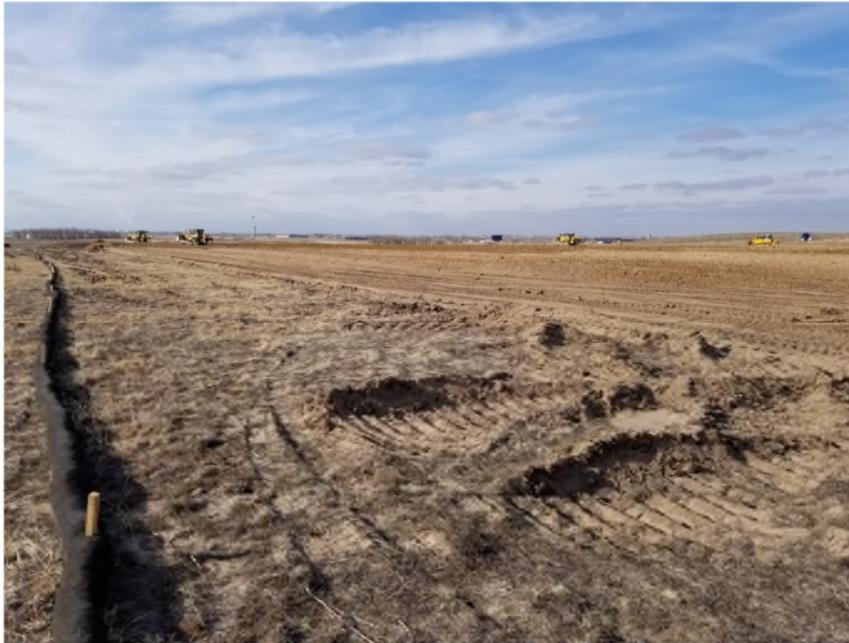
Photo 2. Photo taken from the southeastern perimeter of the location, facing West. See comments from Photo 1.

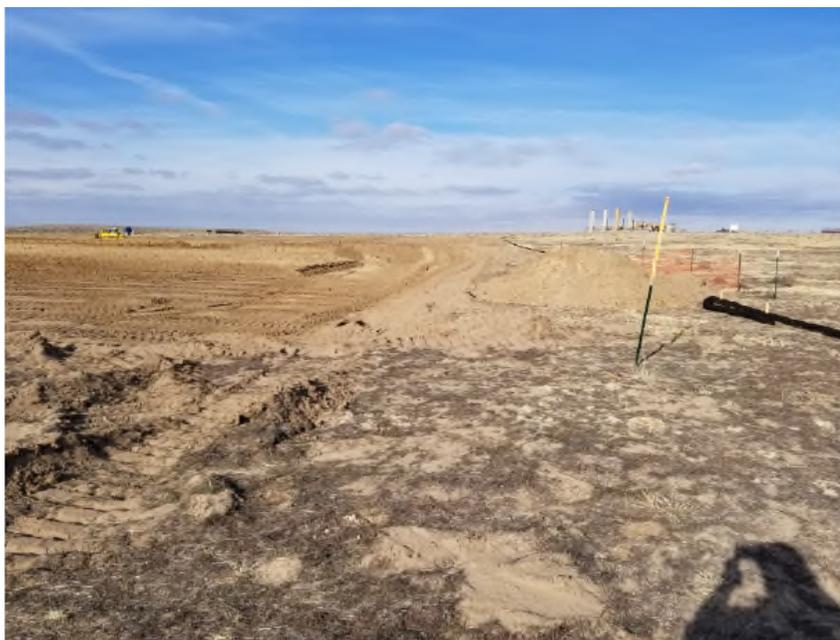
Photo 3. Photo taken from the southeastern perimeter of the location, facing North. Photo depicts breaks in the perimeter of the filtrex BMP.

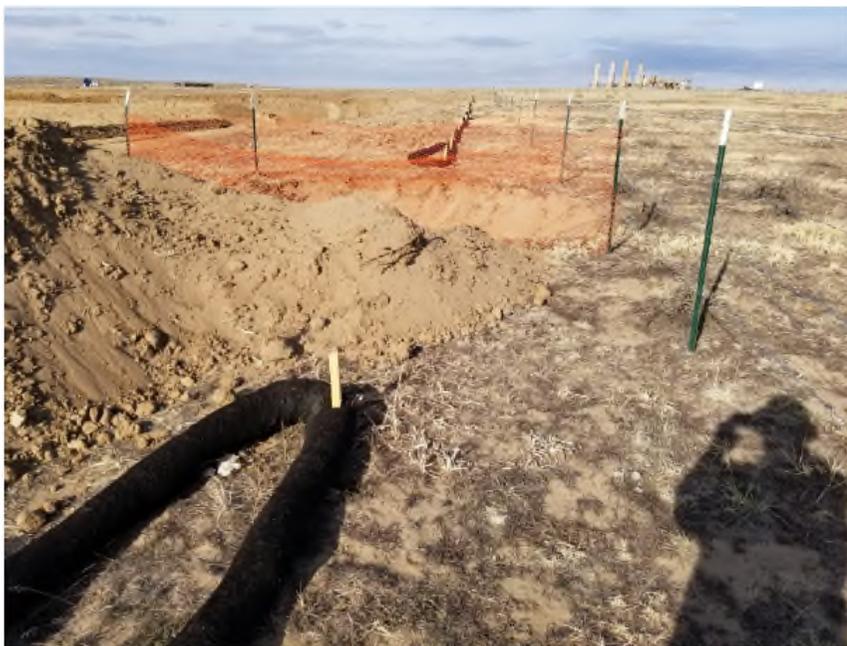
Photo 4. Photo taken from the Eastern perimeter of the location, facing North. Photo depicts breaks in the perimeter of the filtrex BMP adjacent to open fenced pothole.

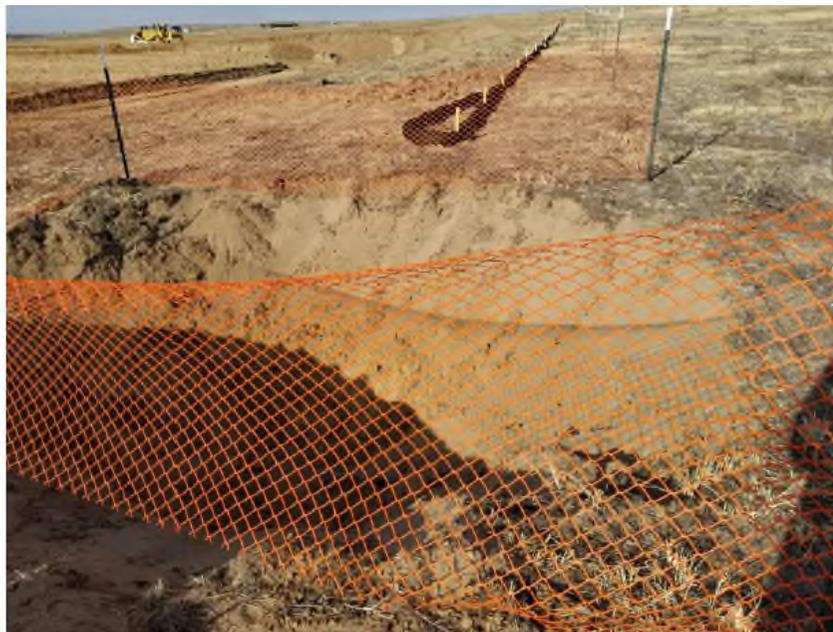
Photo 5. Photo taken from the Eastern perimeter of the location, facing North. See comments from Photo 4.

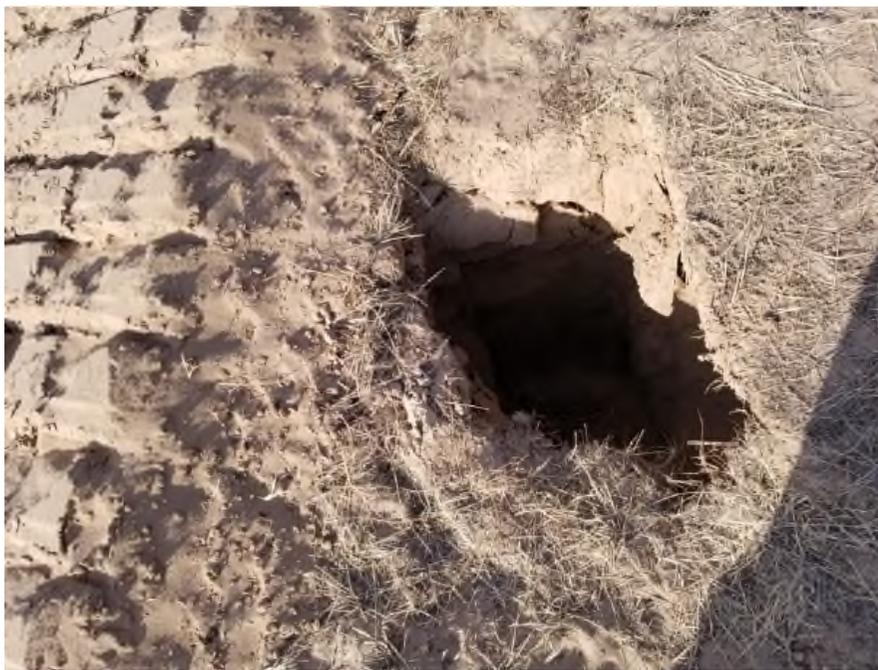
Photo 6. Photo taken from the Eastern perimeter of the location, adjacent to the fenced pothole. The unfenced hole appeared to be greater than 3 feet depth.

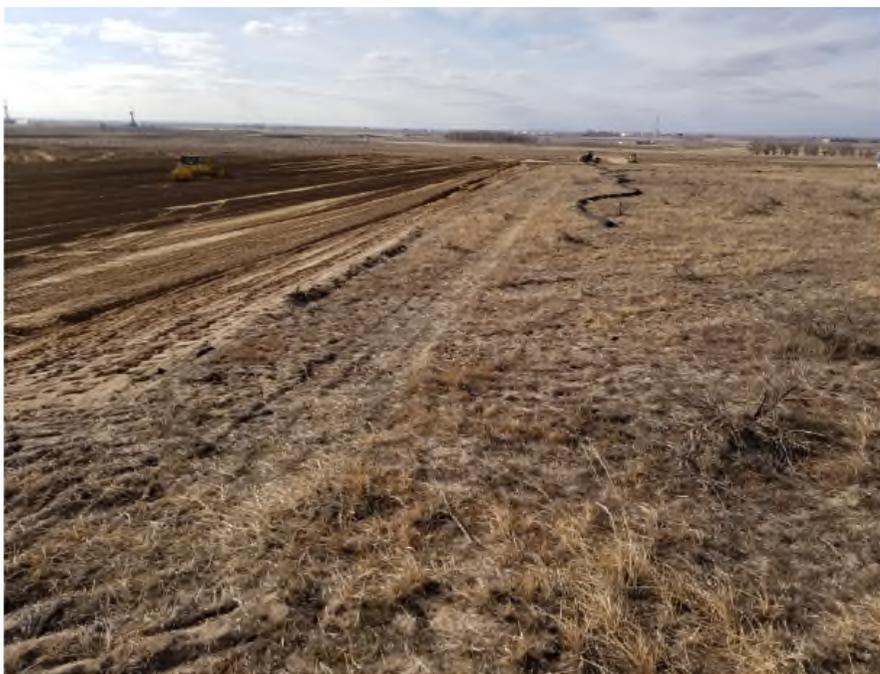
Photo 7. Photo taken from the northeastern perimeter of the location, facing West. See comments under Photos 3.

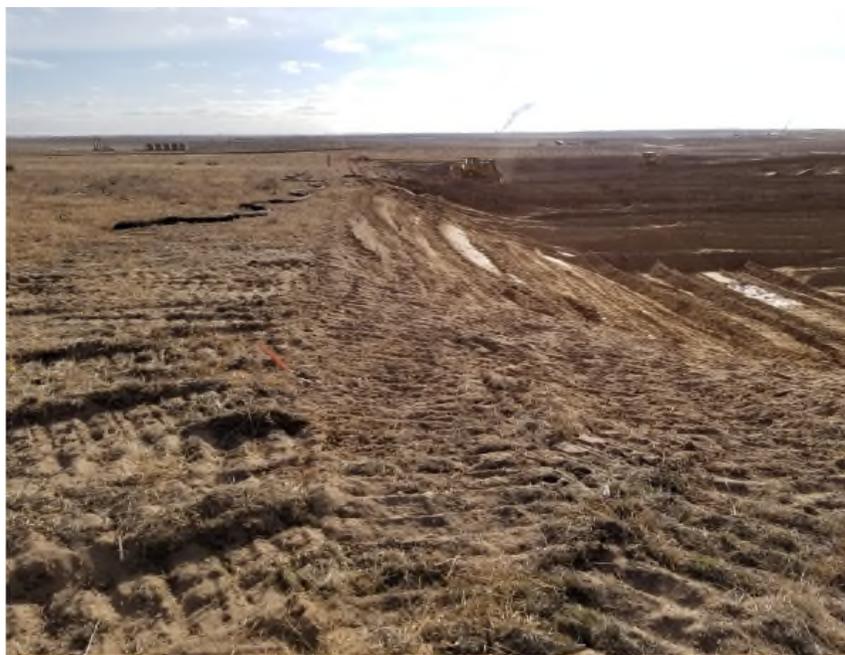
Photo 8. Photo taken from the northeastern perimeter of the location, facing South. See comments under Photos 3.

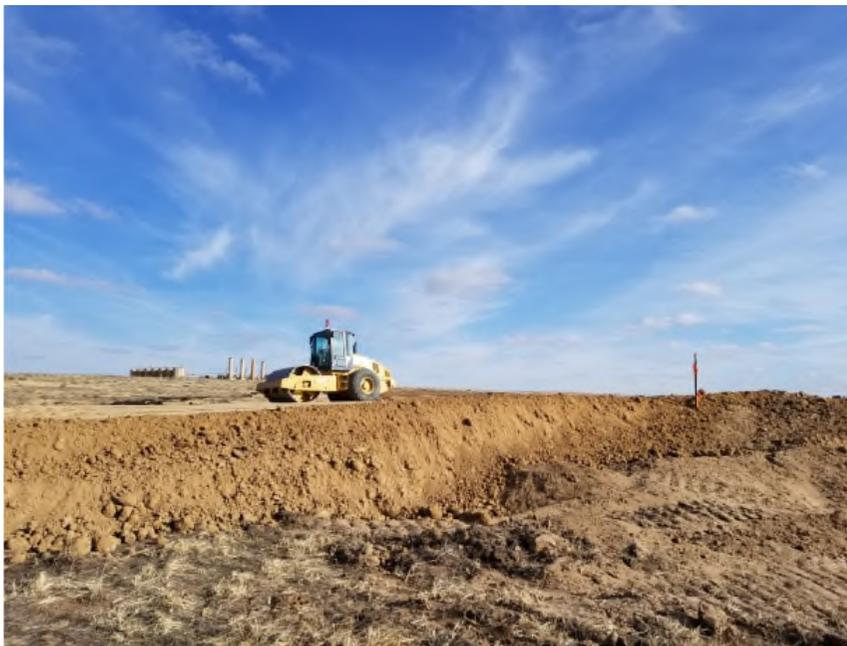
Photo 9. Photo taken from the northwestern perimeter of the location, facing East. See comments under Photos 3.

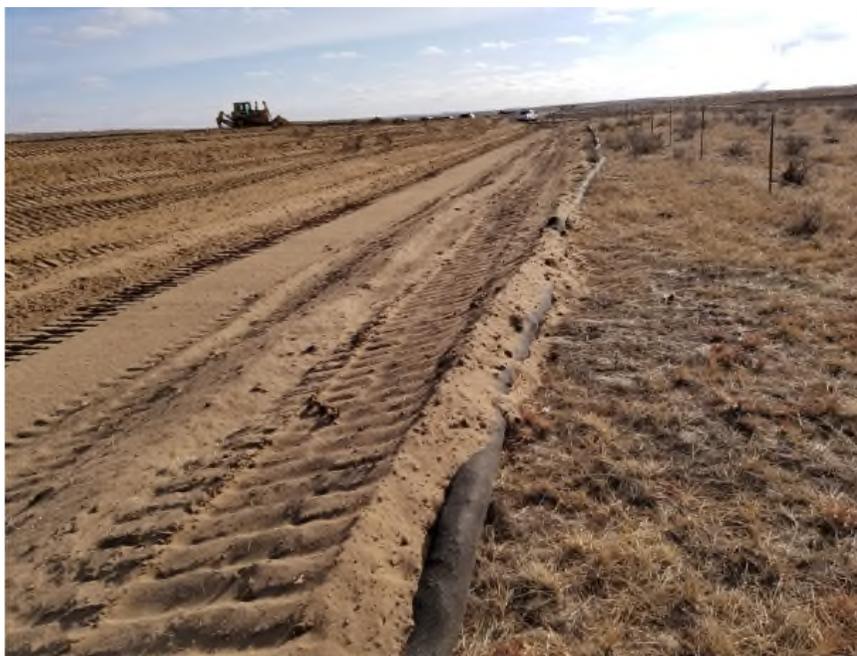
Photo 11. Photo taken from the Western perimeter of the location, facing South. Photo depicts soil placed over Filtrexx BMPs.

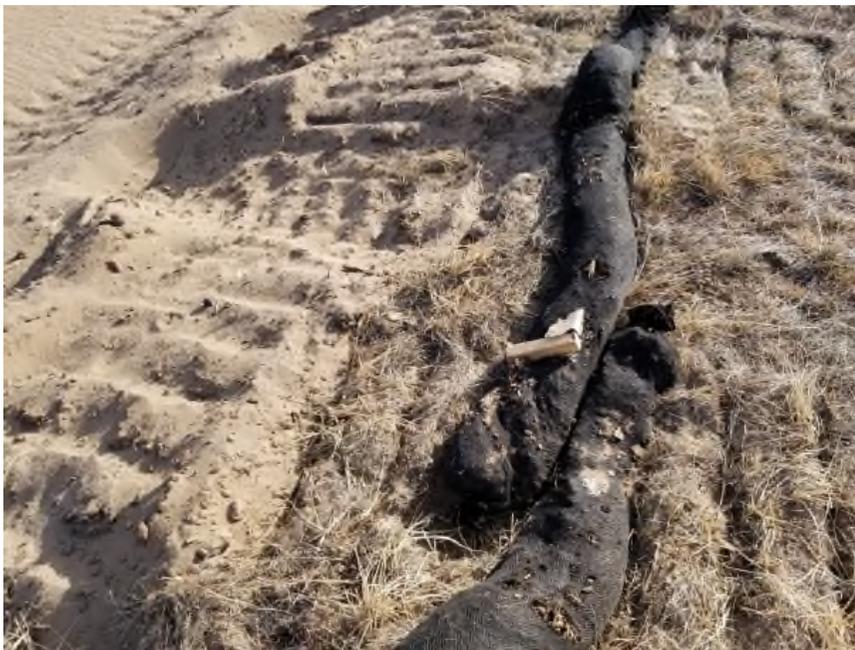
Photo 12. Photo taken from the Western perimeter of the location, facing South. Photo depicts soil Filtrexx BMPs apparently ran over by equipment.

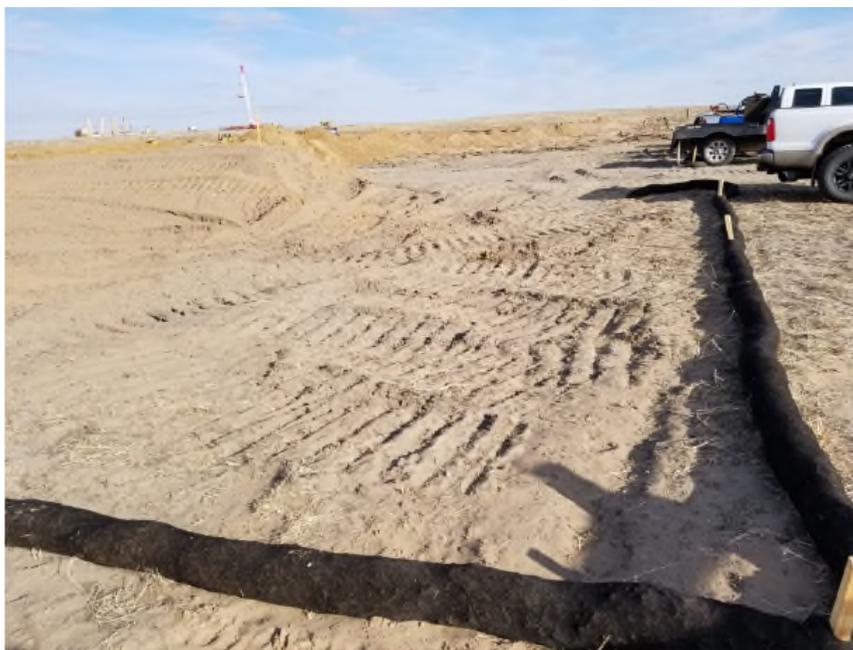
Photo 13. Photo taken from the southwestern perimeter of the location, facing East. See comments from Photo 1.

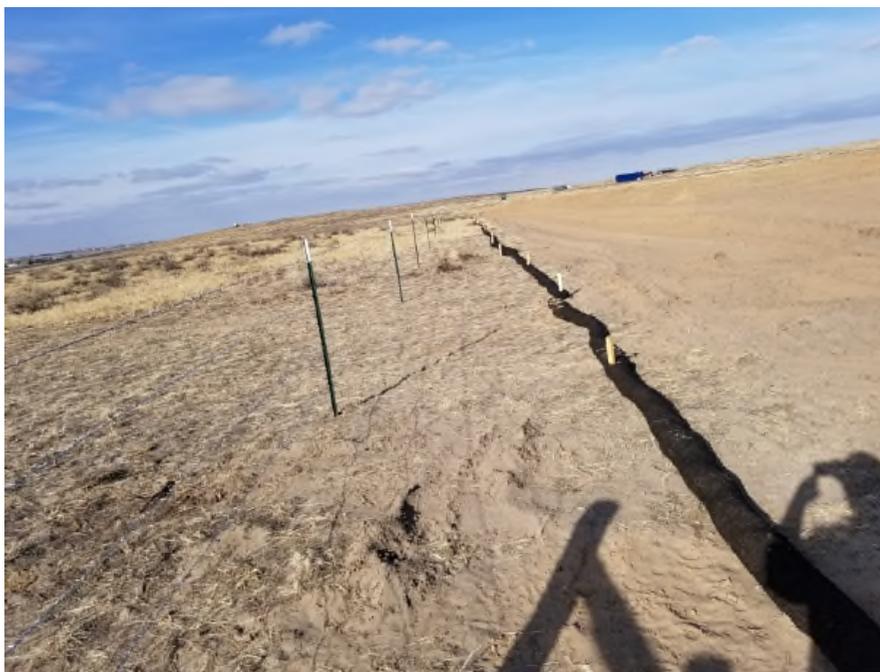
Photo 14. Photo taken from the southwestern perimeter of the location, facing North. See comments from Photo 1.
