Construction and Storm Water Inspection

January 15, 2019

Operator: KERR MCGEE OIL & GAS ONSHORE LP – 47120

Location ID: 460290

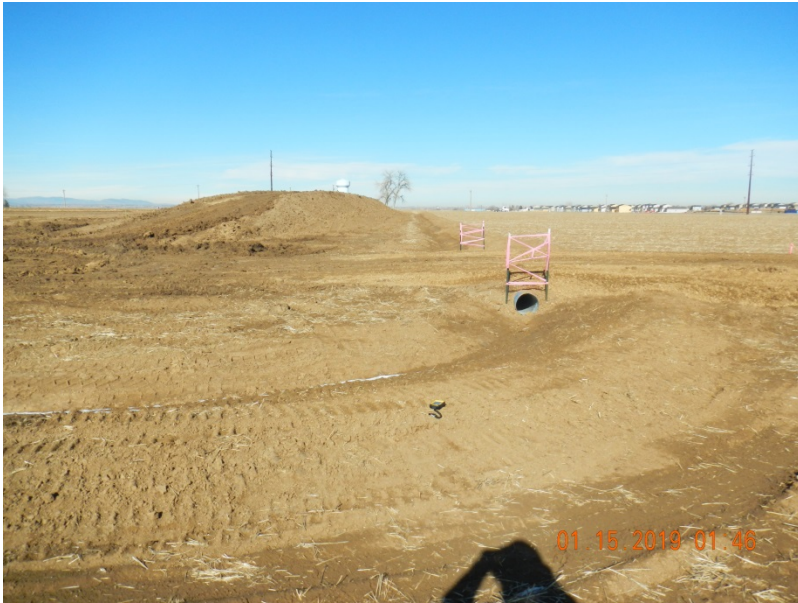
Photo 1. Photo taken from the southeastern perimeter of the location, facing North. Photo illustrates the ditch and berm BMP that has been installed around the perimeter of the location.

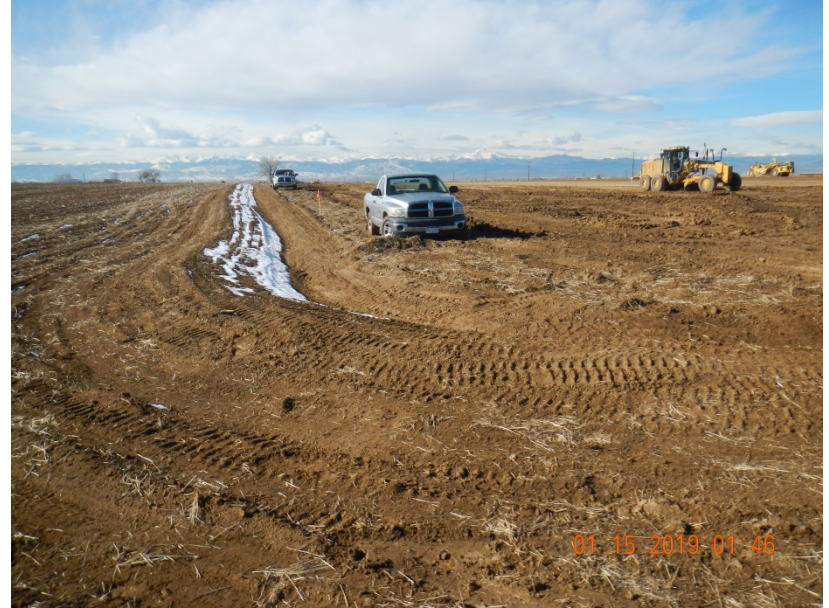
Photo 2. Photo taken from the southeastern perimeter of the location, facing West. Photo illustrates the ditch and berm BMP that has been installed around the perimeter of the location.

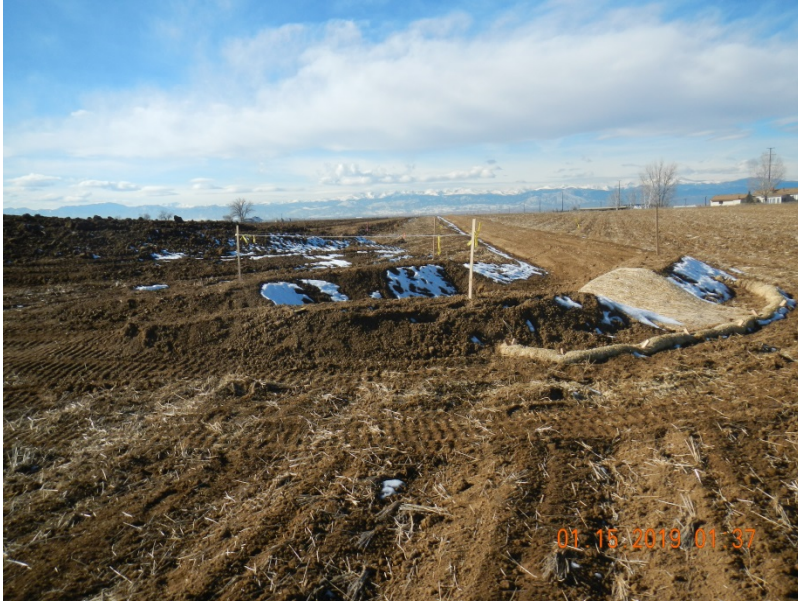
Photo 3. Photo taken from the northeastern perimeter of the location, facing West. Operator has installed a sediment trap with a temporarily stabilized outlet. See comments from Photo 1.

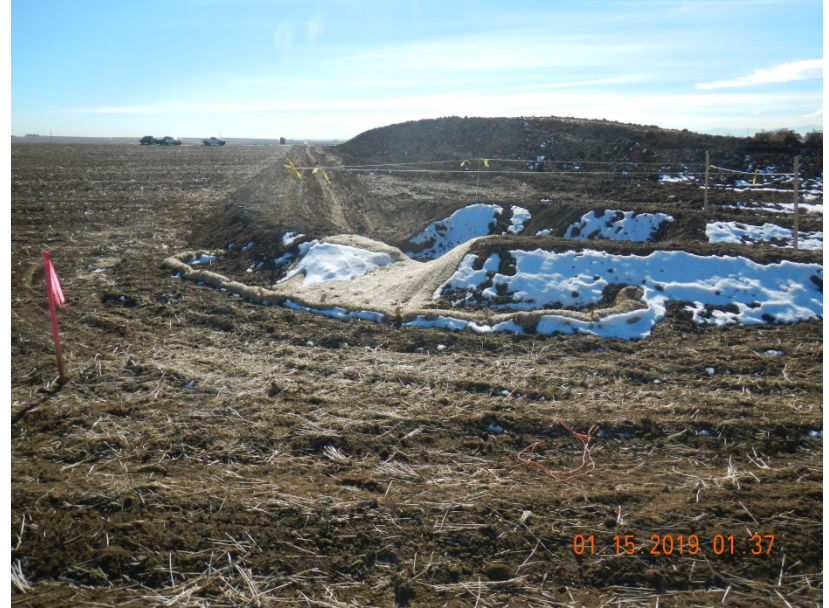
Photo 4. Photo taken from the northeastern perimeter of the location, facing South. See comments from Photo 1 and 2.

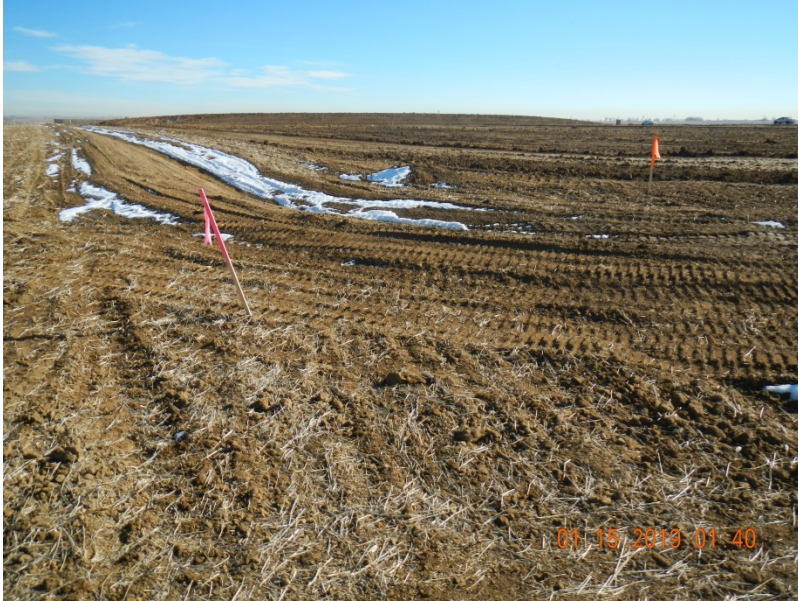
Photo 5. Photo taken from the northwestern perimeter of the location, facing East. See comments under Photo 1.

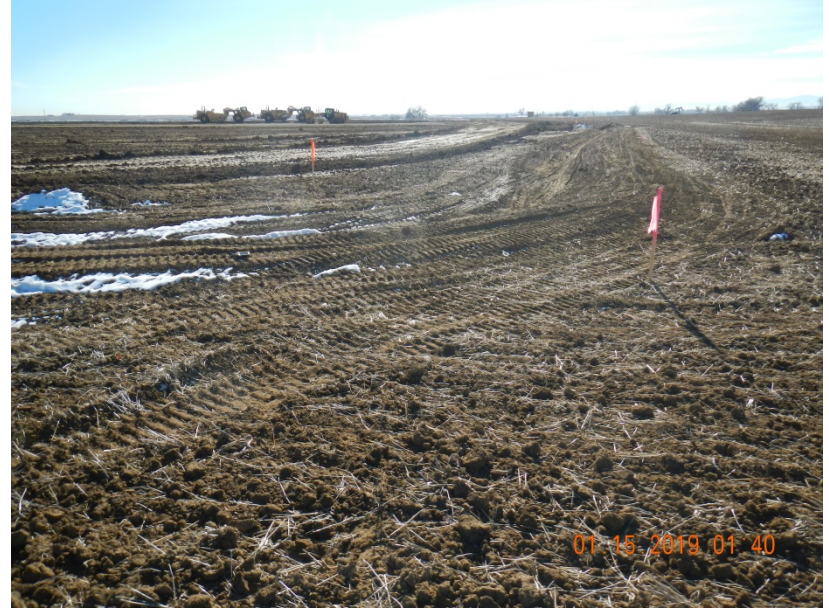
Photo 6. Photo taken from the northeastern perimeter of the location, facing South. See comments from Photo 1.

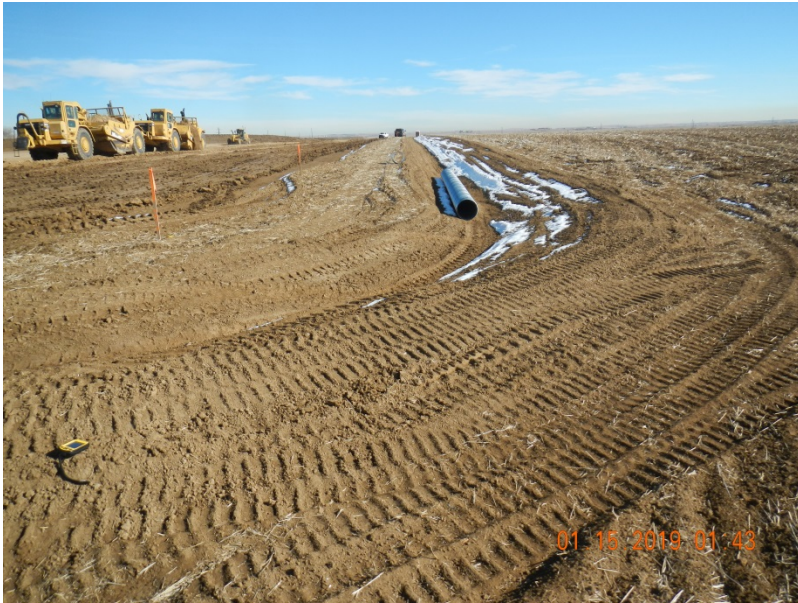
Photo 7. Photo taken from the southwestern perimeter of the location, facing East. See comments under Photo 1.

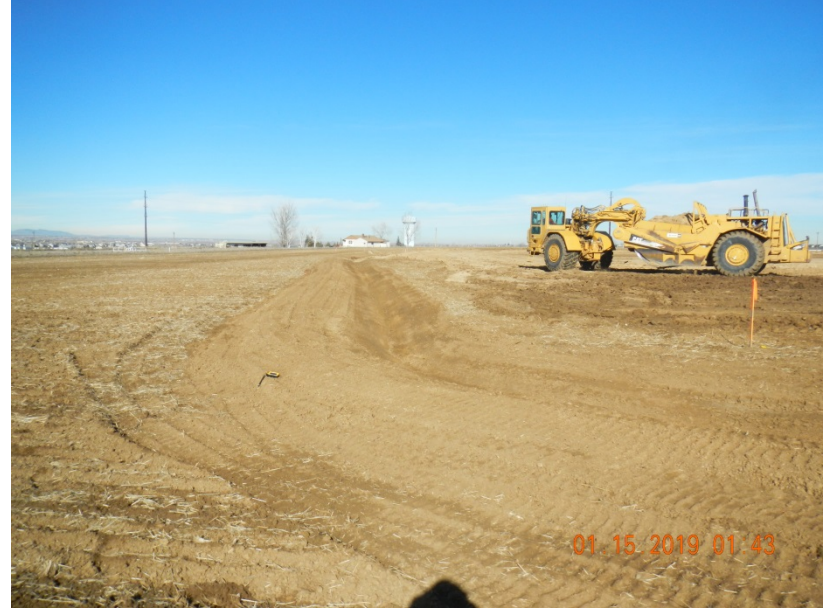
Photo 8. Photo taken from the southwestern perimeter of the location, facing North. See comments under Photo 1.

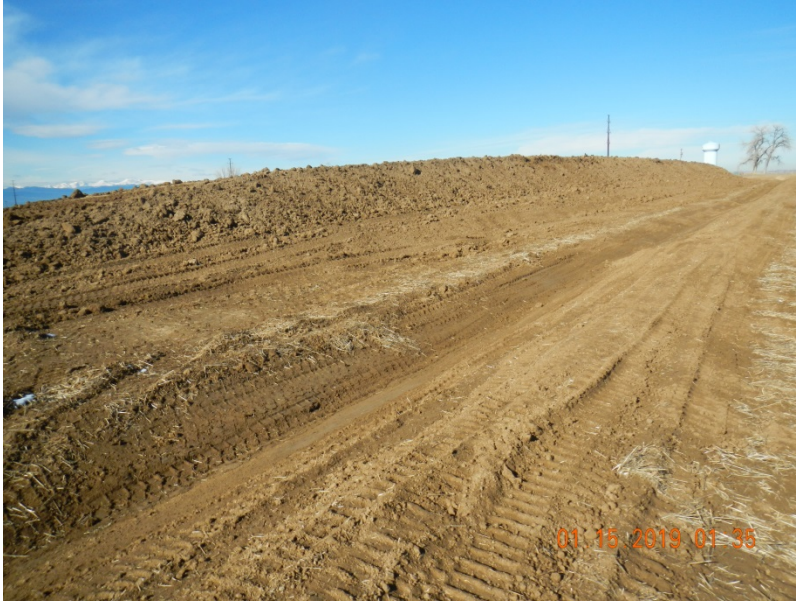
Photo 9. Photo taken from the eastern perimeter of the location, facing East. Operator has installed a sediment trap with a temporarily stabilized outlet. The topsoil stockpile being stored along the eastern area has been temporarily stabilized with equipment tracking.

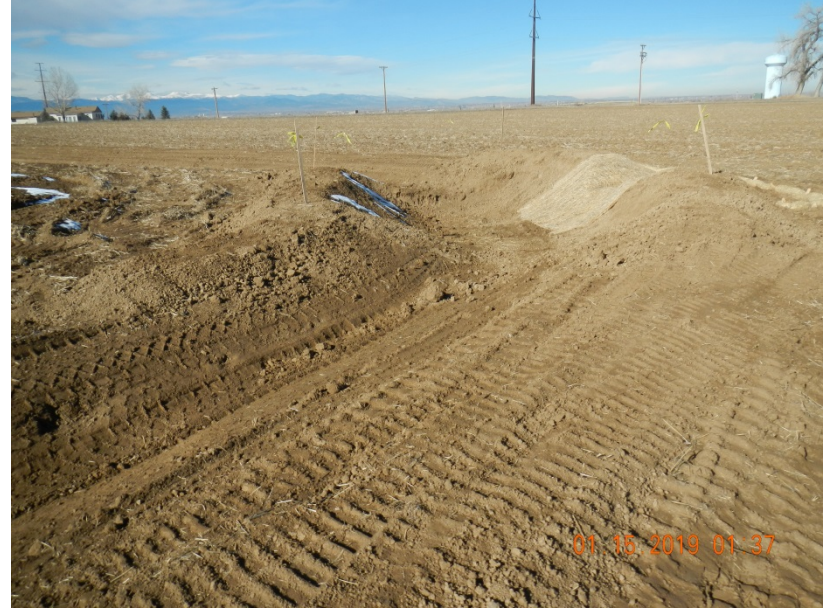
Photo 10. Photo taken from the southwestern perimeter of the location, facing North. See comments under Photo 1.

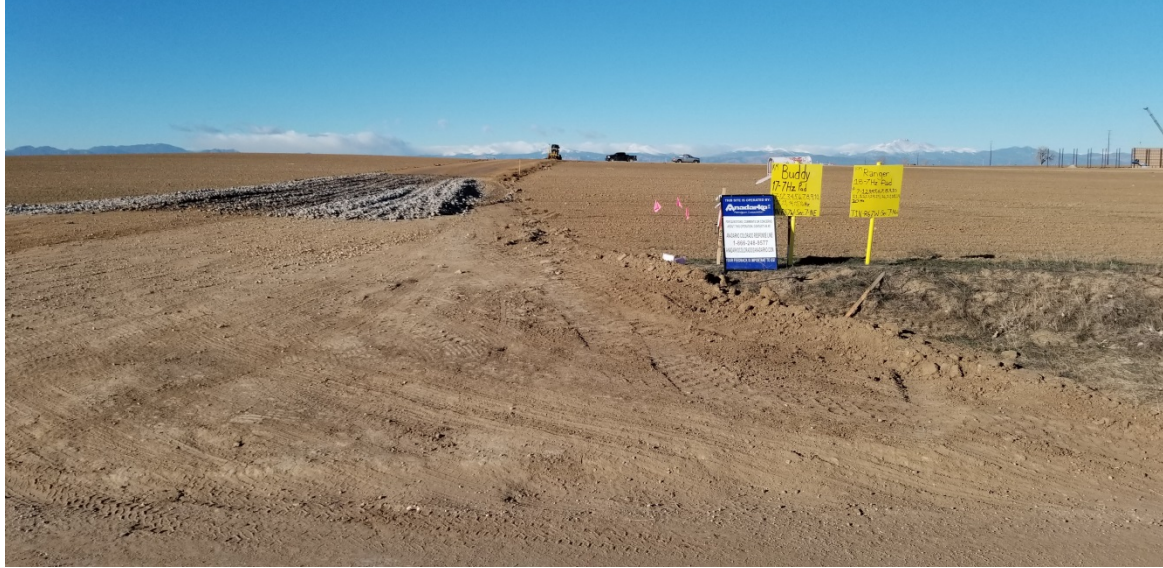
Photo 11. Photo taken from the entrance of the location off CR 15, facing West. Operator has installed gravel potentially to limit tracking onto the county road. BMPs in proper functioning condition at the time of this inspection.
