Inspection Photos
Location Name: Hwy. 151 34-4-30 MW #1
API: 05-067-06271

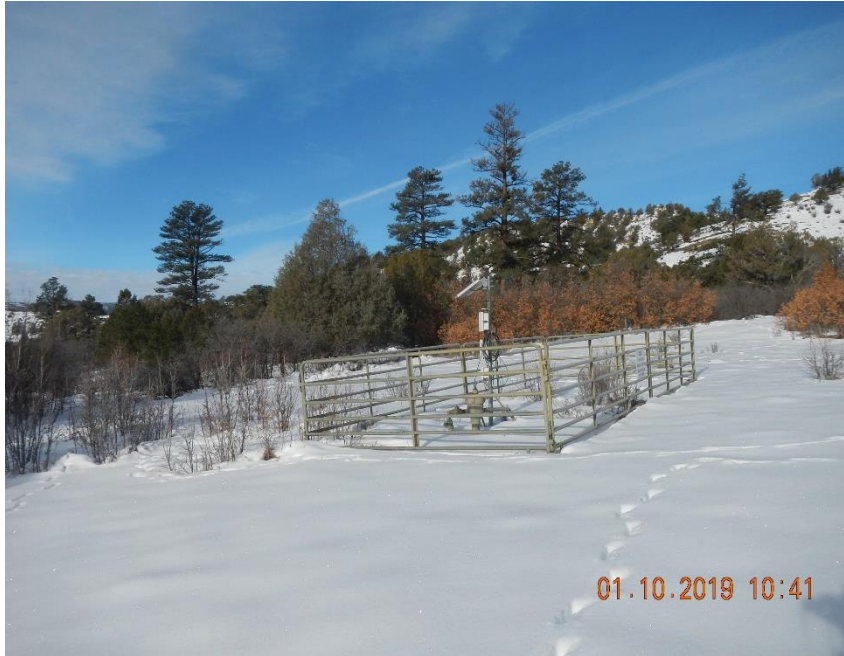
Hwy. 151 monitoring well location photo.

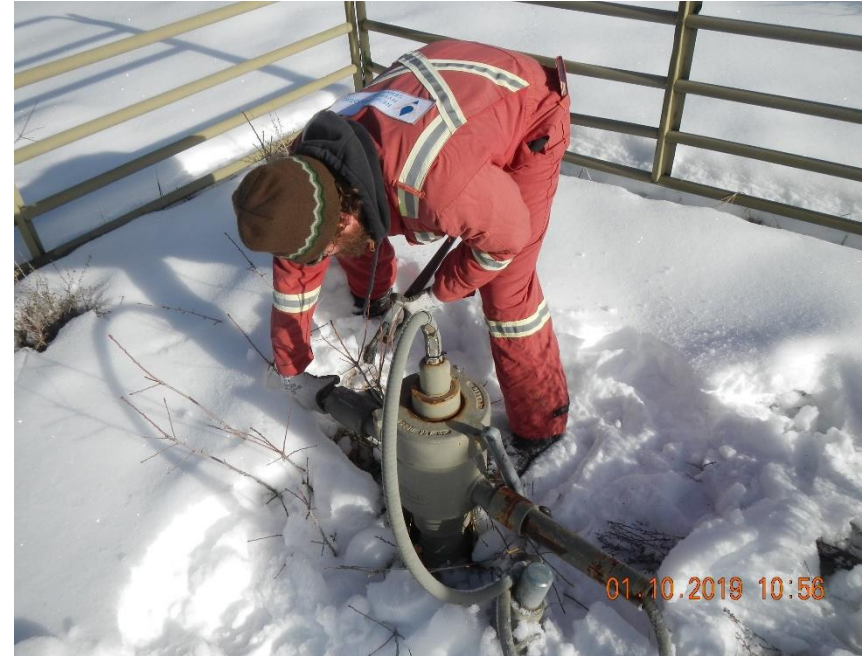
Monitoring well #1 bled down with a puff.

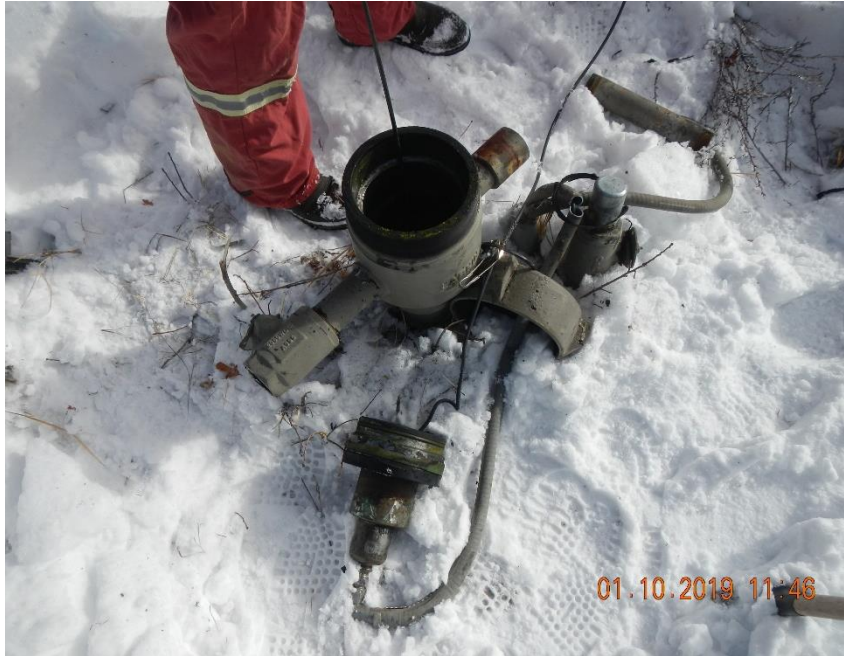
Removing rugged cable from well bore.

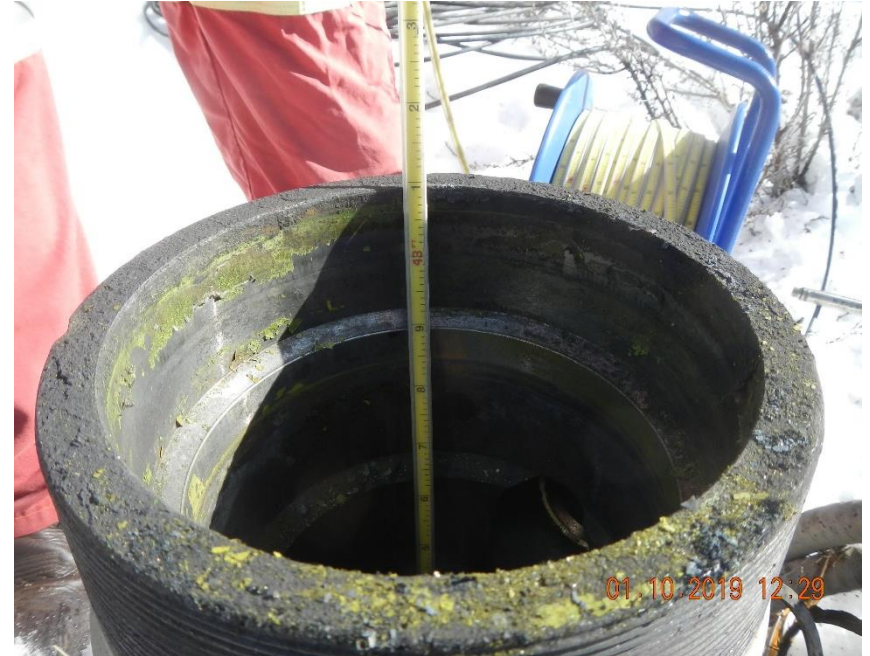
Water level measured at 43.10' from top of casing with 1.45' stick up from top of collar.

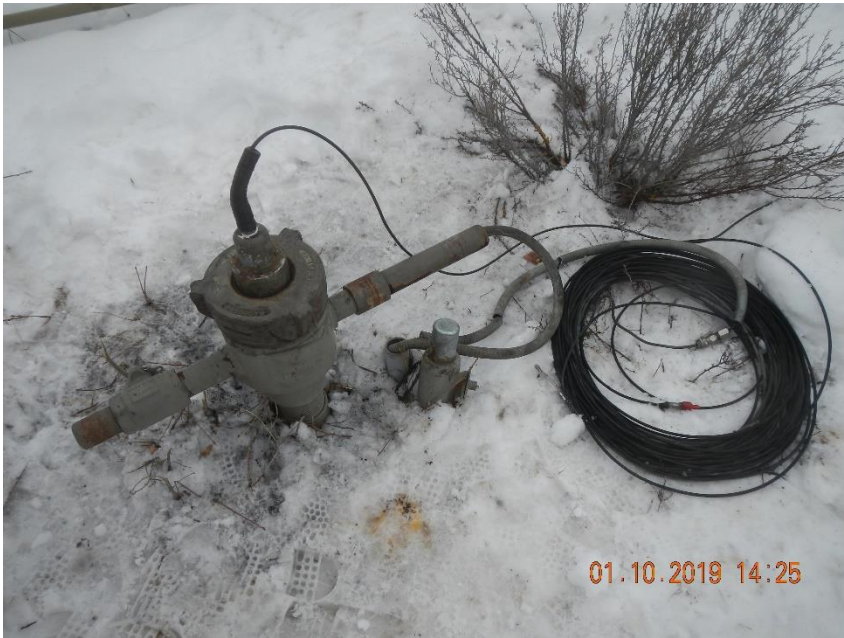
Monitoring well #1 after equipment replacements.

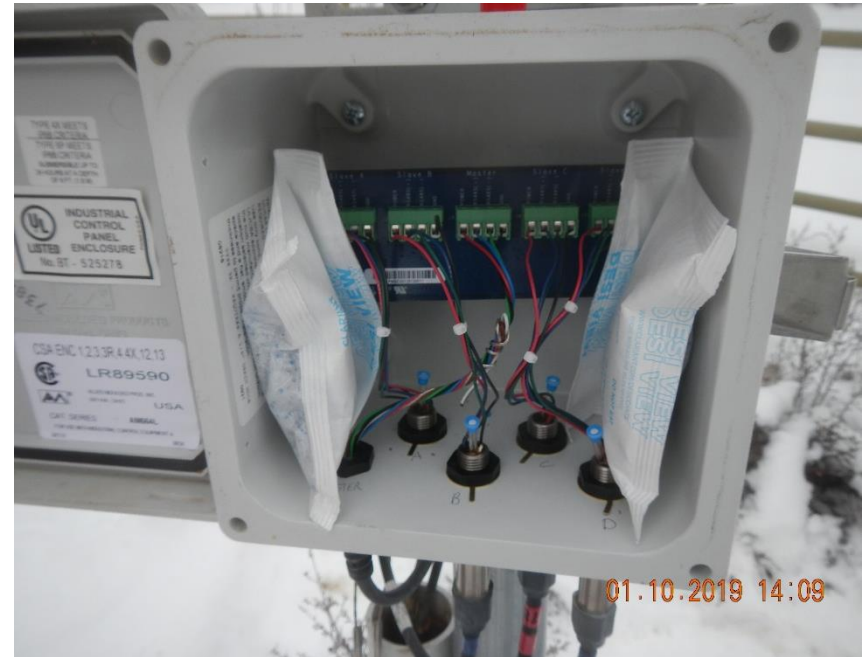
Desiccants replaced in July of 2018 appear fresh.
