Inspection Photo (s)
Specialty 43C
API # 05-045-14823
Inspection # 689303008

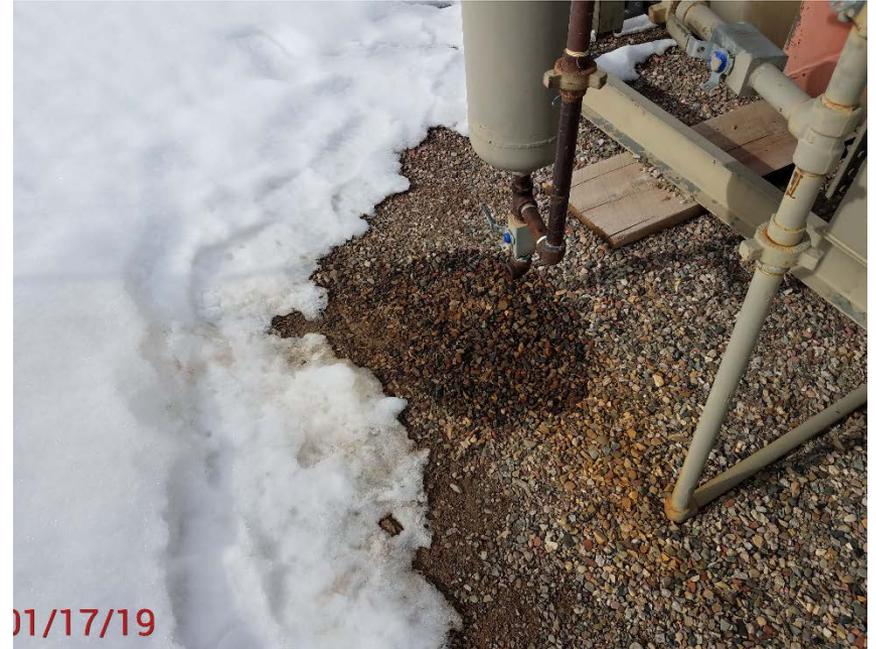
Location Photo #4, Stained ground under scrubber pot, on 34A.

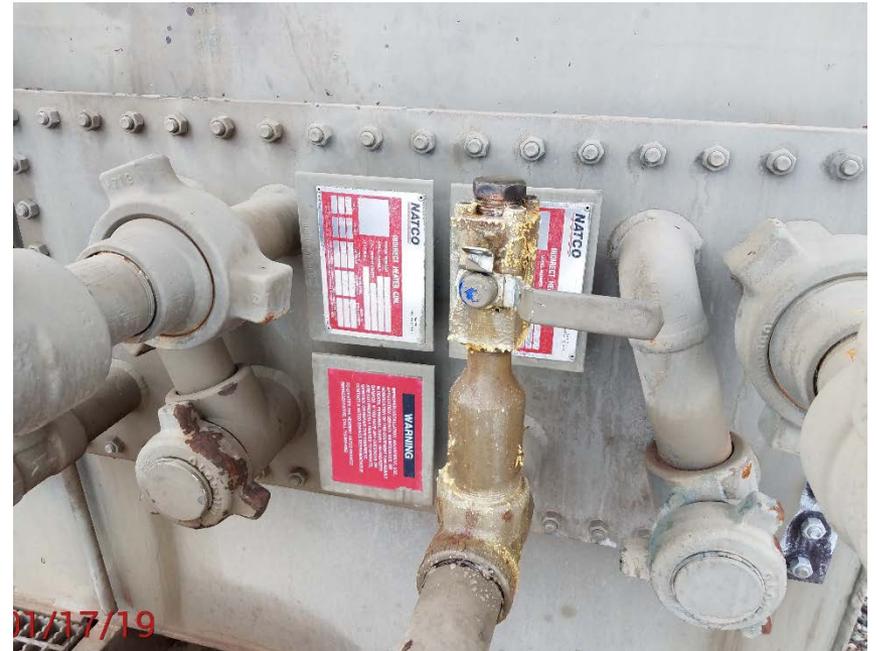
Location Photo #6, Dripping fitting.

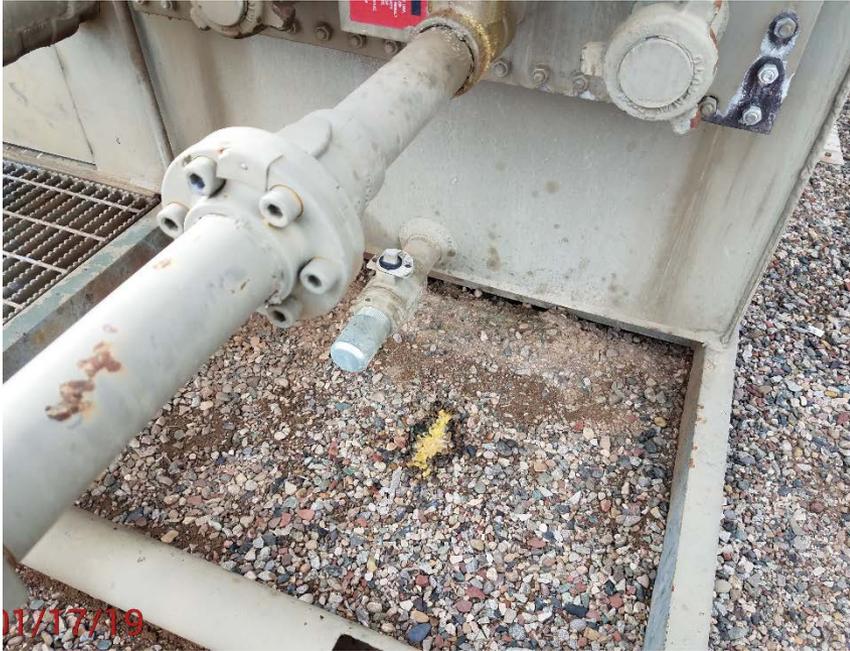
Location Photo #7, Oil spot below fitting on 43C.

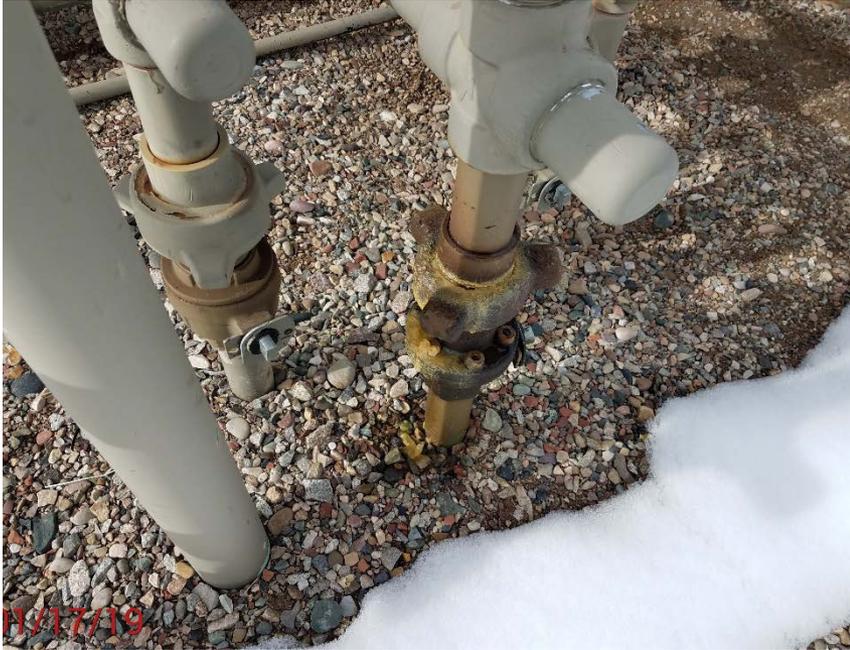
Location Photo #9, leaking hammer union on separator 34C.
