Inspection Photos
Location Name: AC 19-06
Location ID: 308934

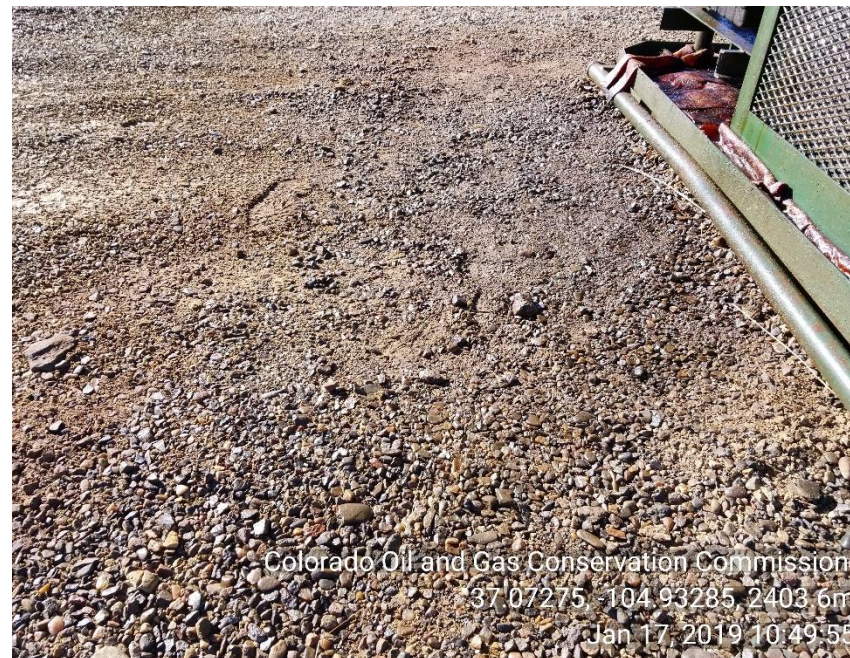
Photo 2 stained soil around liquid ring compressor

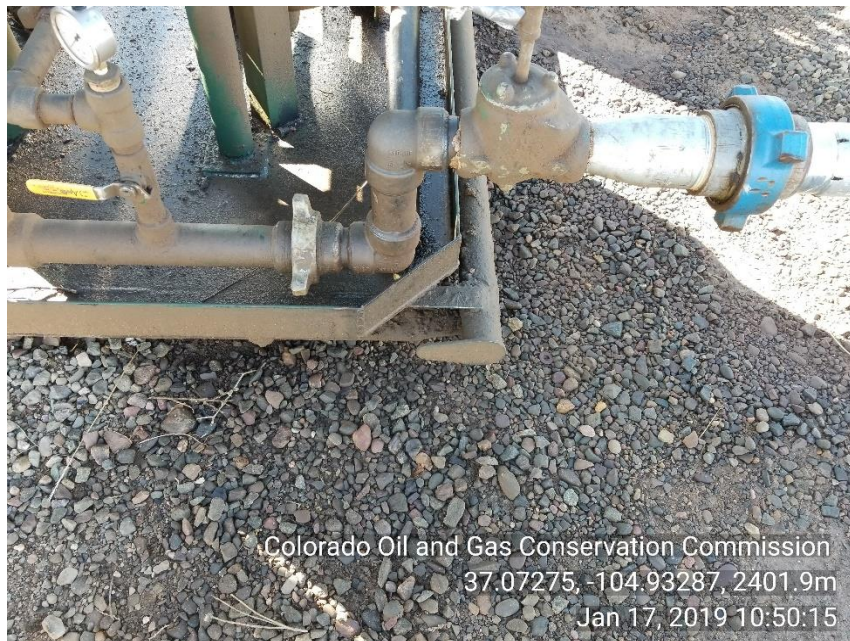
Photo 3 Stained soil around liquid ring compressor

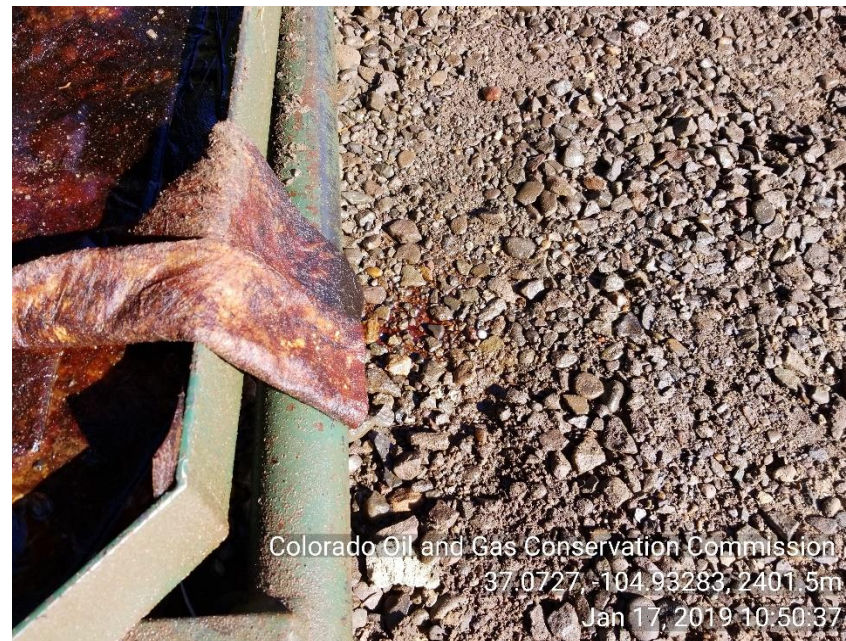
**Photo 4 fluid leaking out of liquid ring skid via diaphr.
Stained soil under diaphr.**

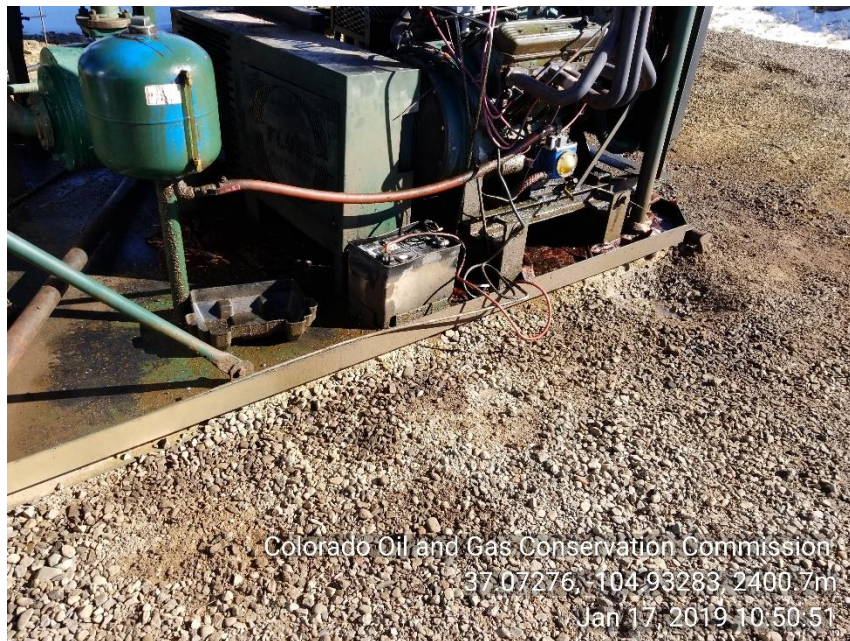
Photo 5 Stained soil around liquid ring compressor

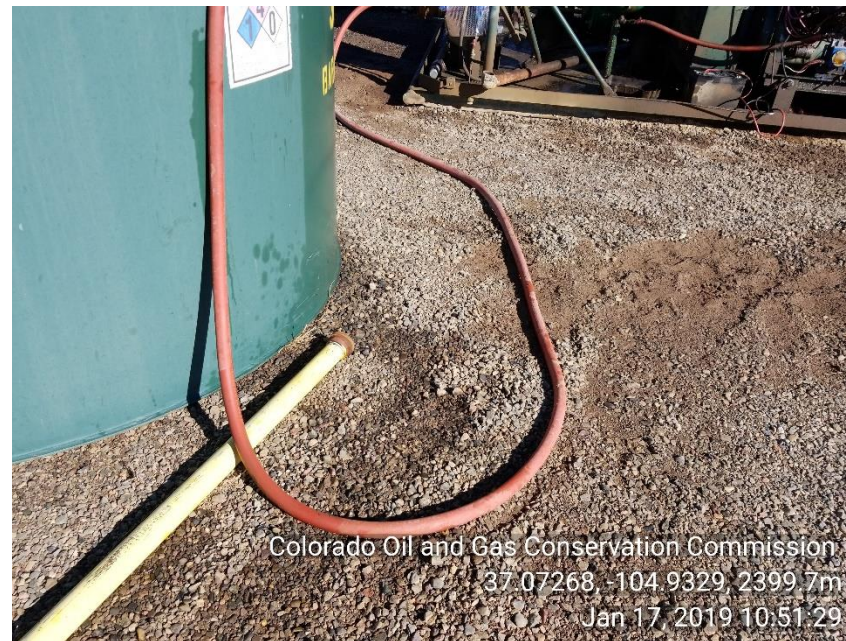
Photo 6 stained soil around 30BBL H2O tank

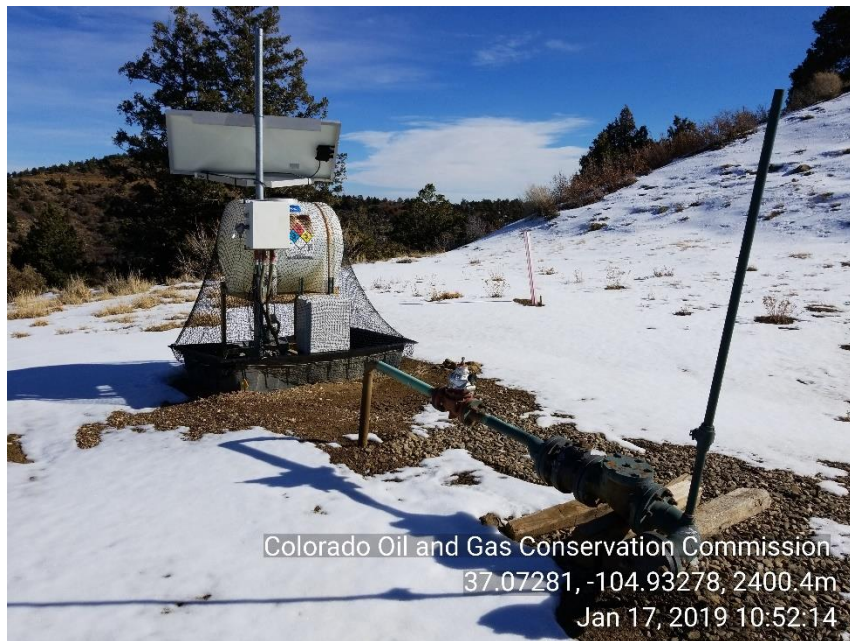
Photo 7 Unused equipment Methanol tank. Unused, unmarked and not LOTO riser.

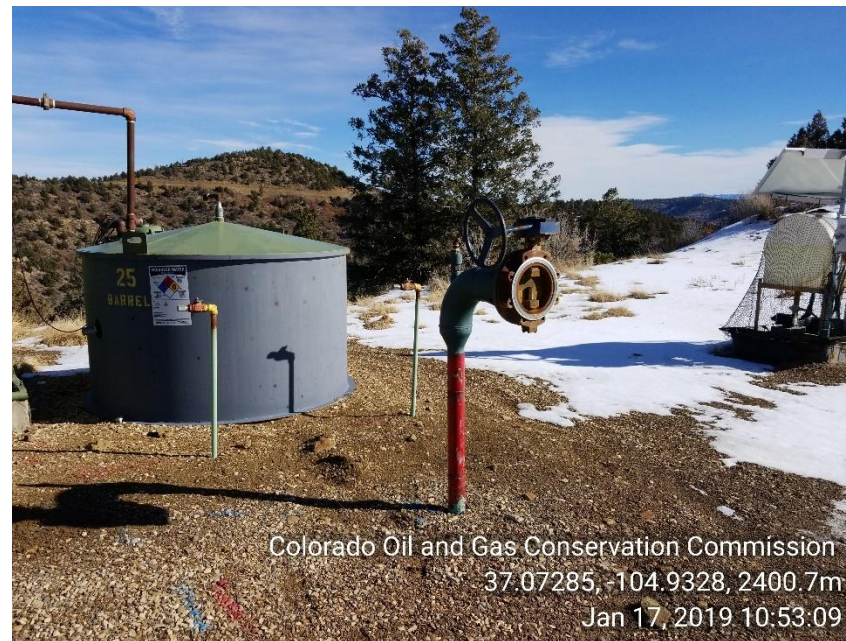
Photo 8 Unused, unmarked and not LOTO risers

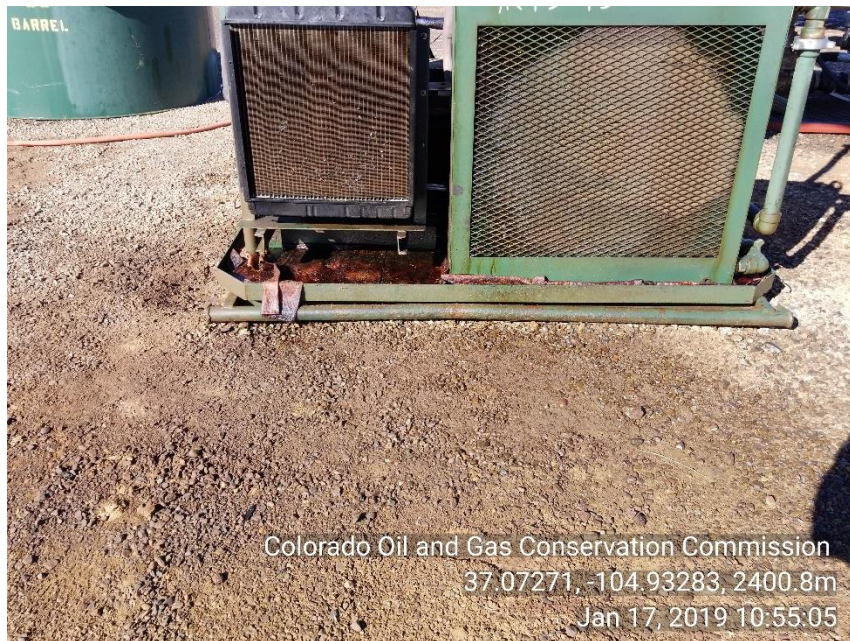
Photo 9 stained soil in front of liquid ring compressor

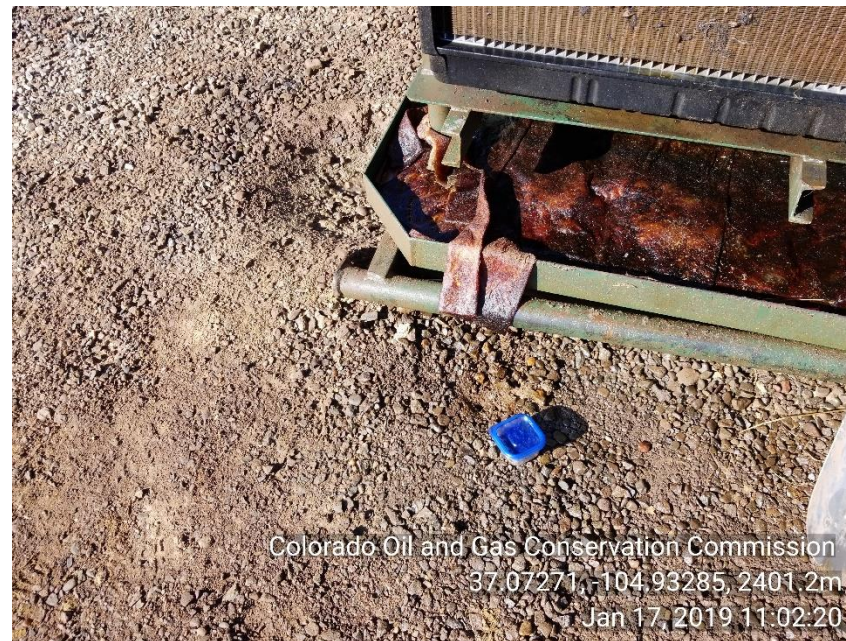
Photo 10 soil sample taken in front of radiator of liquid ring compressor.
