Inspection Photos
Location Name: GE 33-03
Location ID: 309417

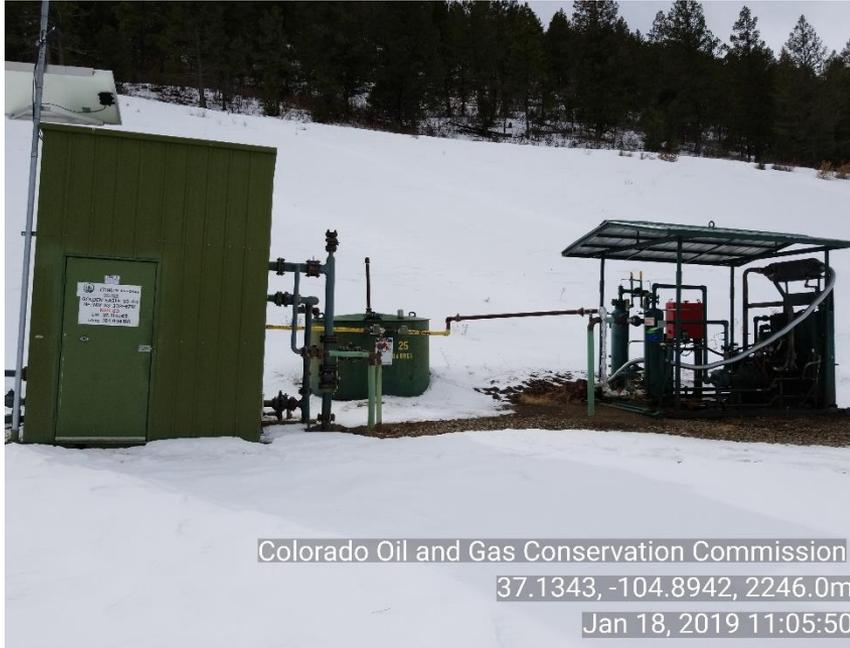
Photo 1 SEP and liquid ring

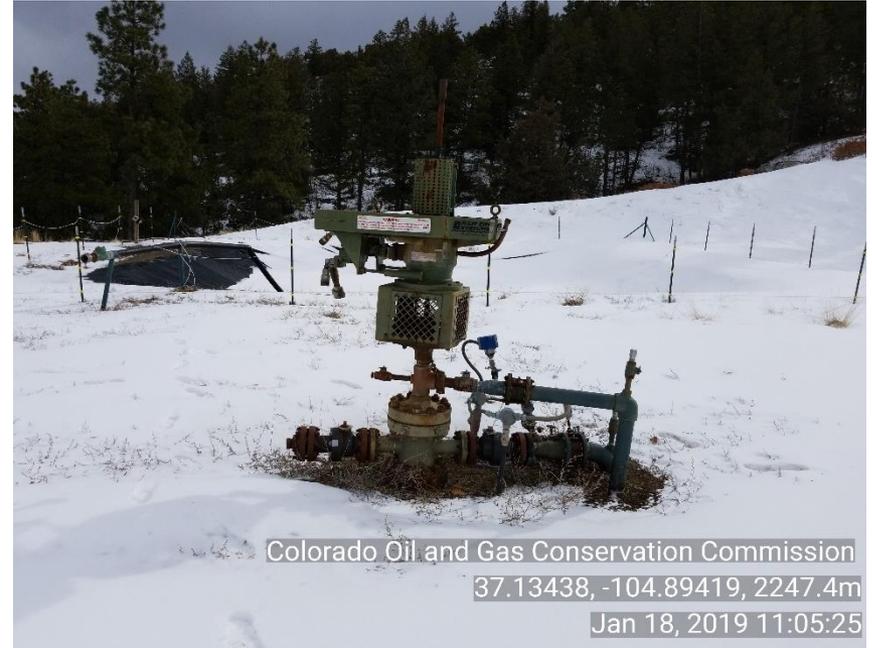
Photo 2 WH

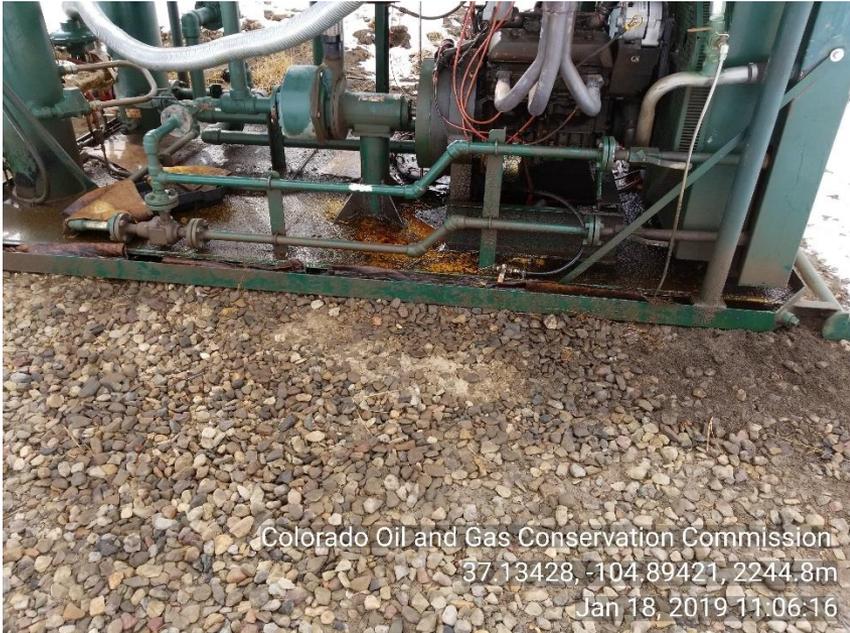
Photo 3 Stained soil around liquid ring

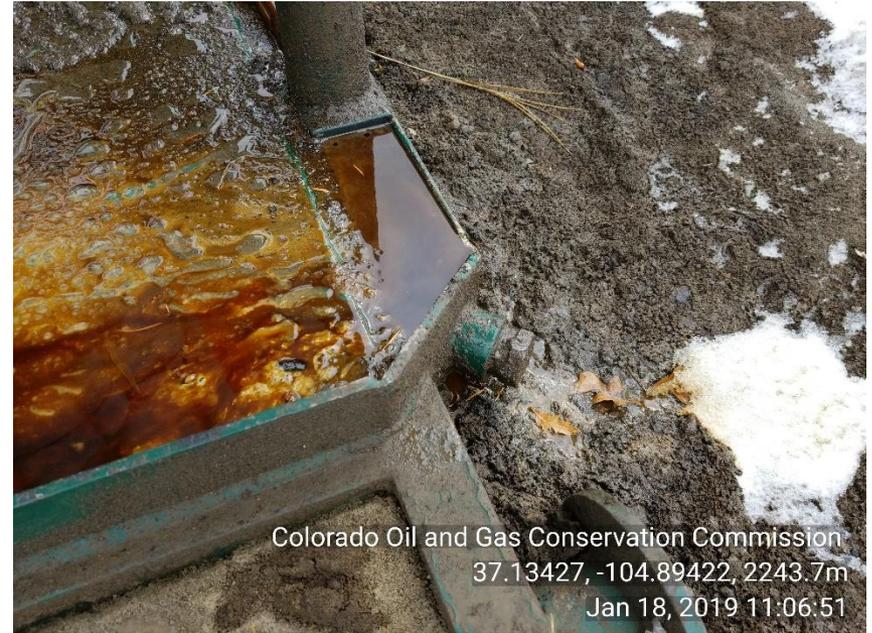
Photo 4 stained soil and fluid dripping out of liquid ring skid

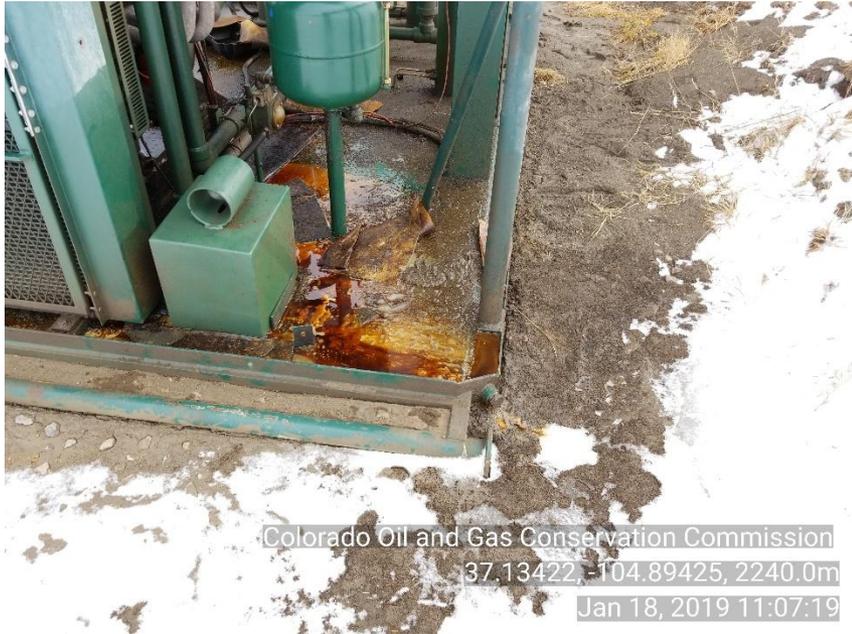
Photo 5 Stained soil around liquid ring and fluid dripping out of skid

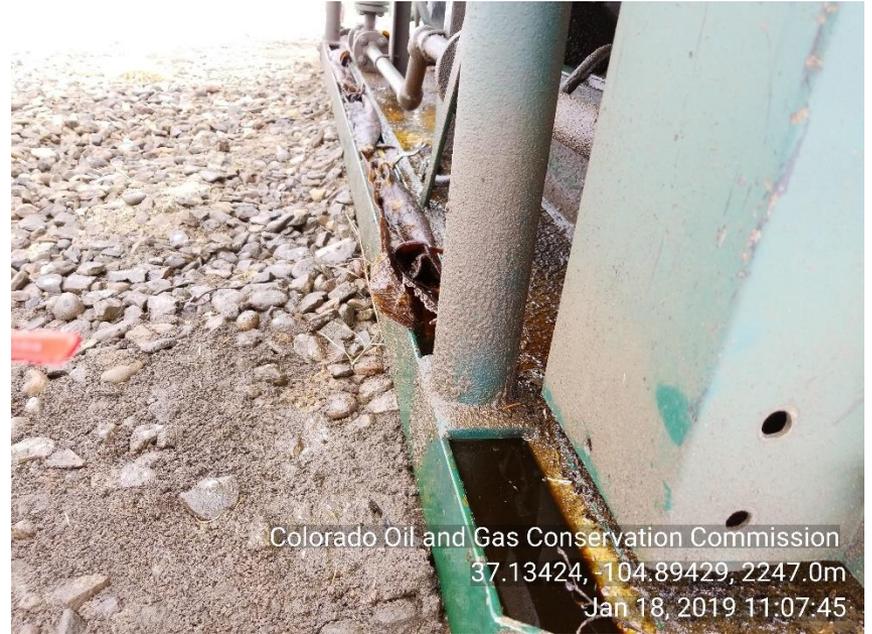
Photo 6 stained soil and fluid dripping out of liquid ring skid

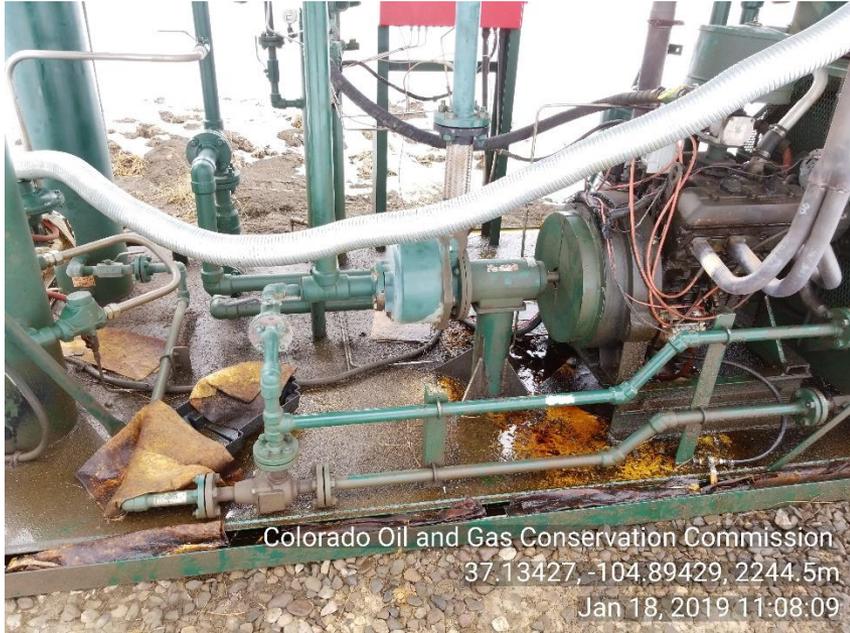
Photo 7 trash and debris inside liquid ring skid

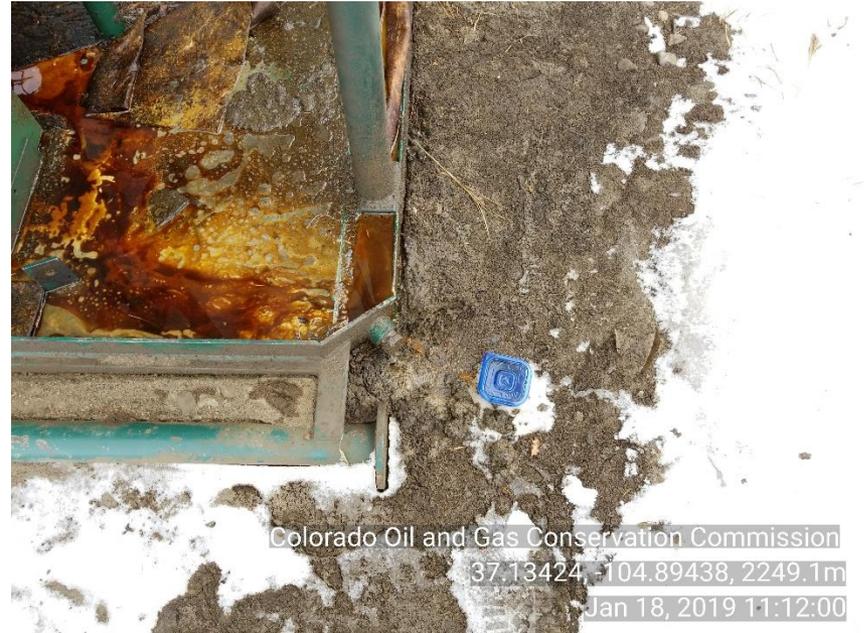
Photo 8 soil sample taken where fluid is dripping out of skid

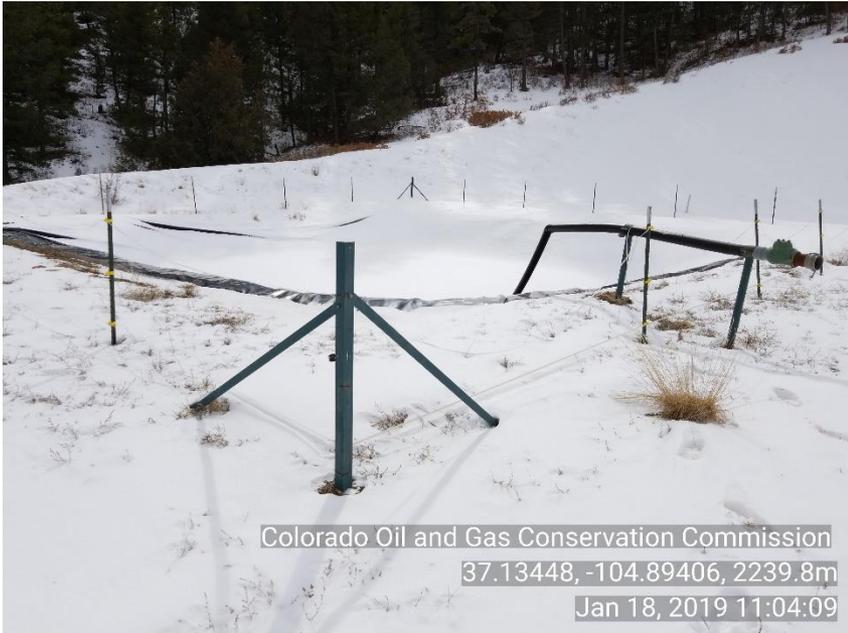
Photo 9 electric fence around lined pit in disrepair

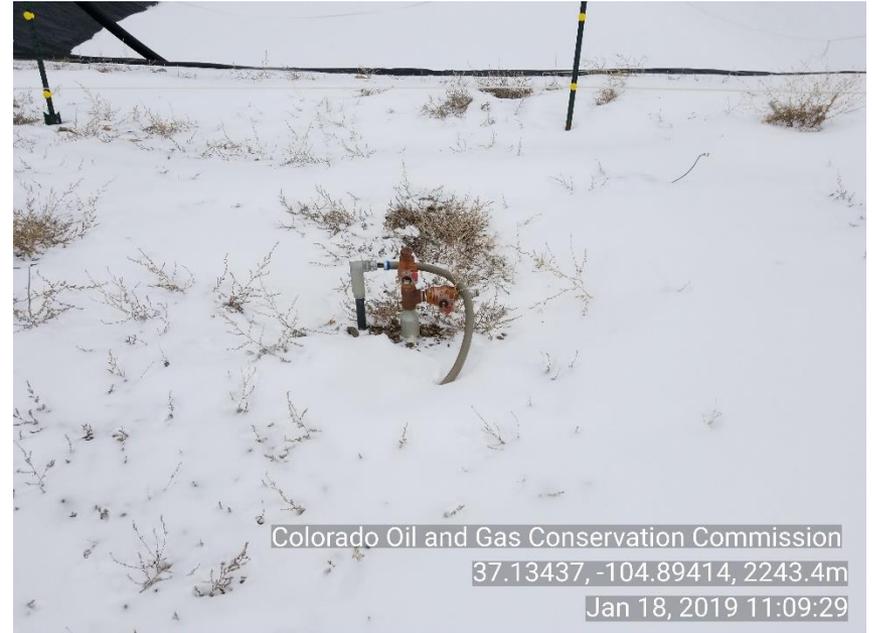
Photo 10 Unused, unmarked and not LOTO riser
