Inspection Photos  
Location Name: GE 30-14  
Location ID: 307898

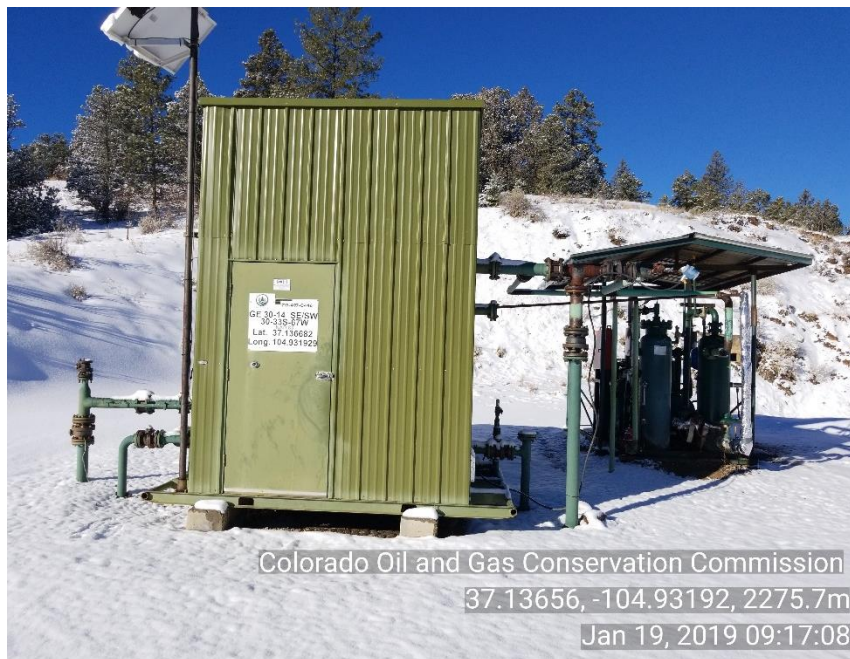
Photo 1 sep

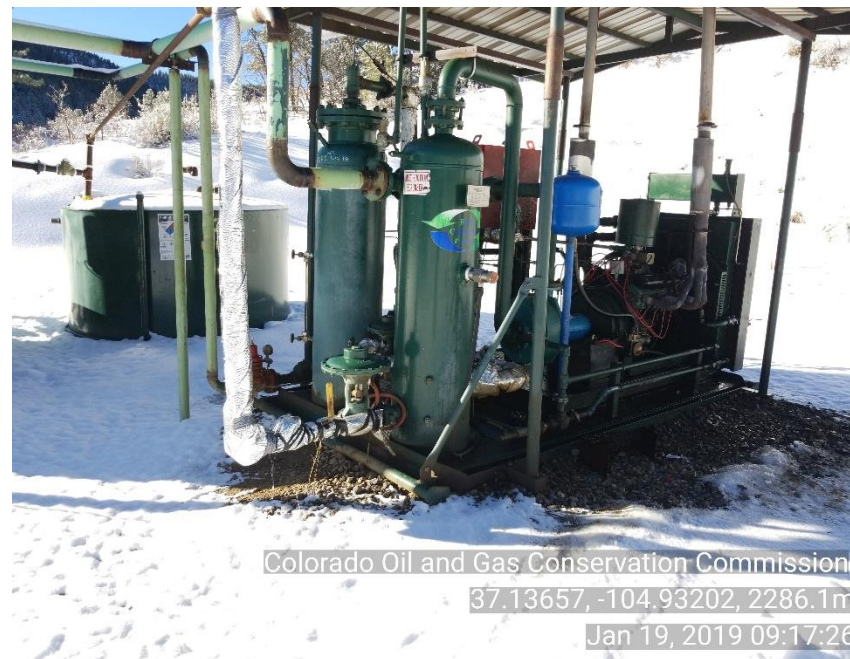
Photo 2 liquid ring and 30 BBL tank

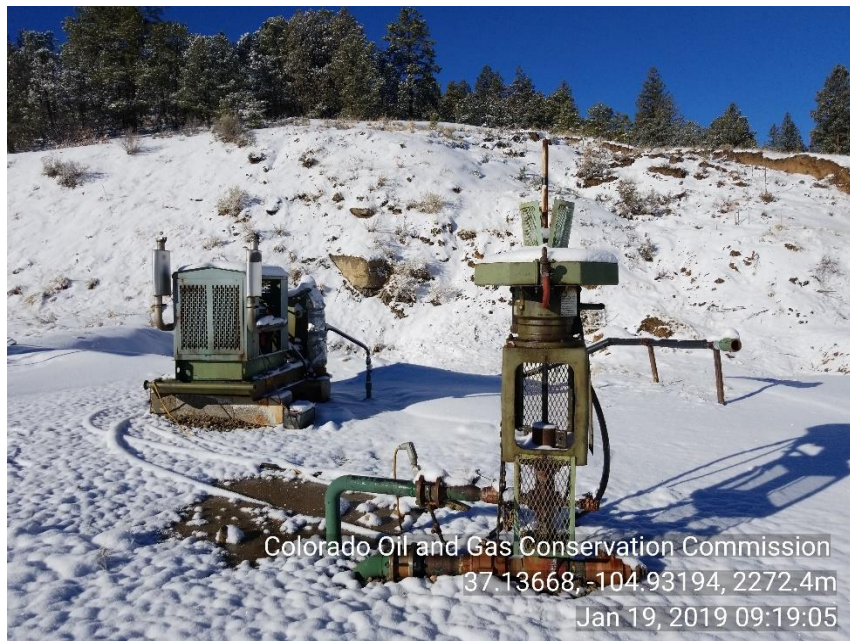
**Photo 3 WH and HYD motor**

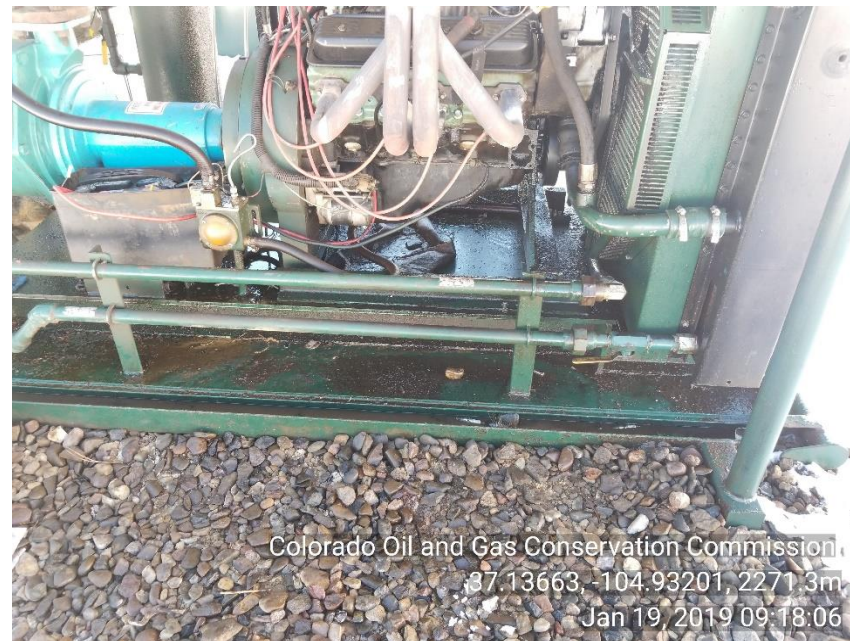
**Photo 4 stained soil around liquid ring skid**

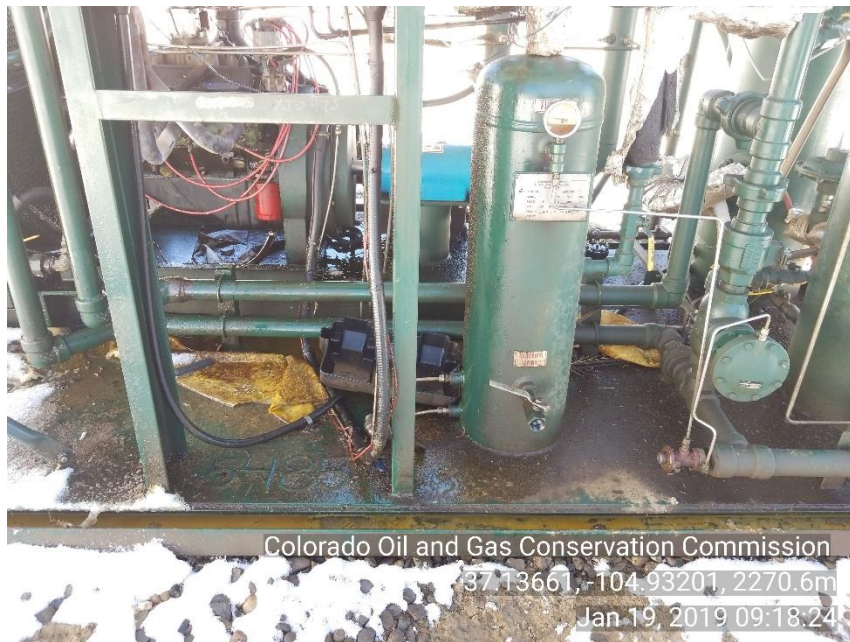
**Photo 5 trash inside liquid ring skid**

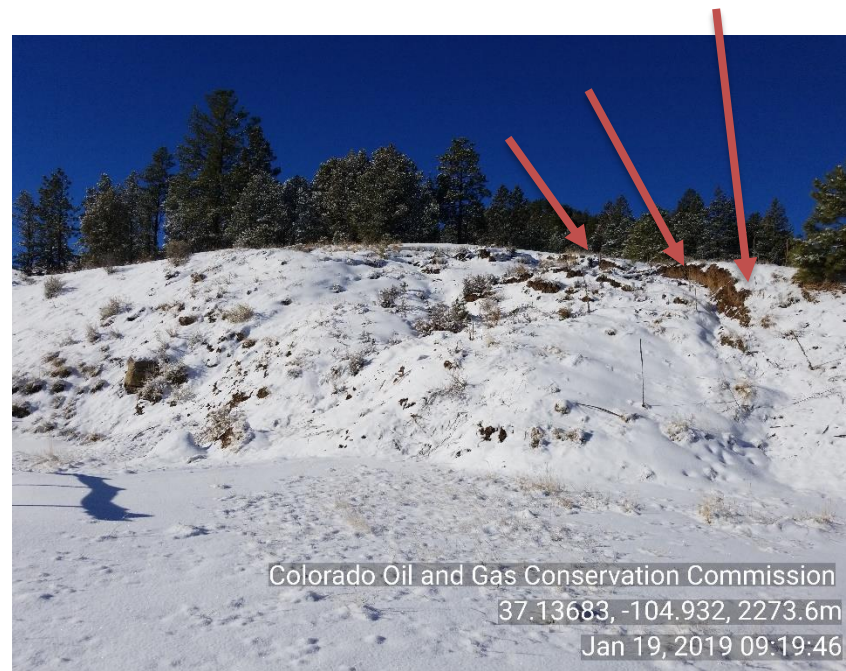
**Photo 6 Loc wall appears to have slid down onto location**

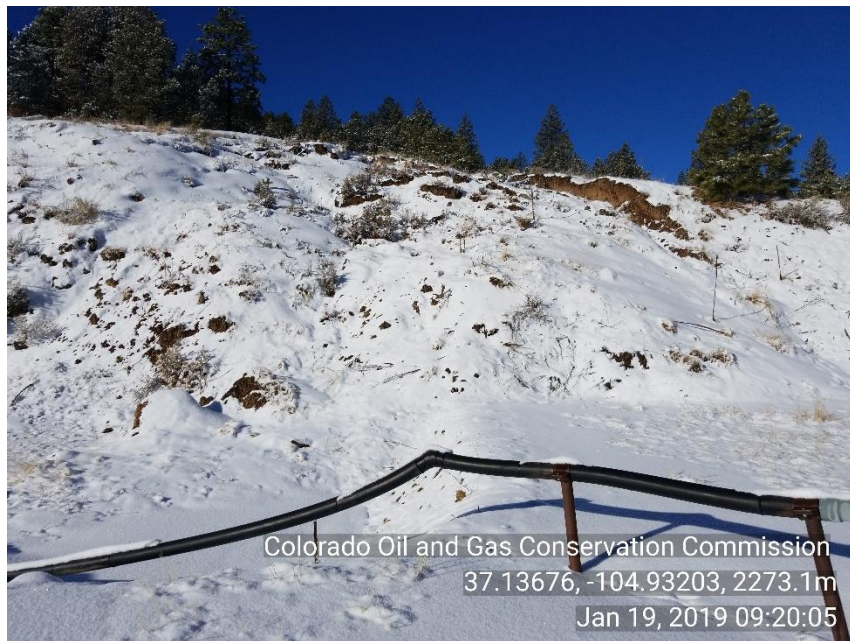
**Photo 7 Loc wall appears to have slid down onto location**

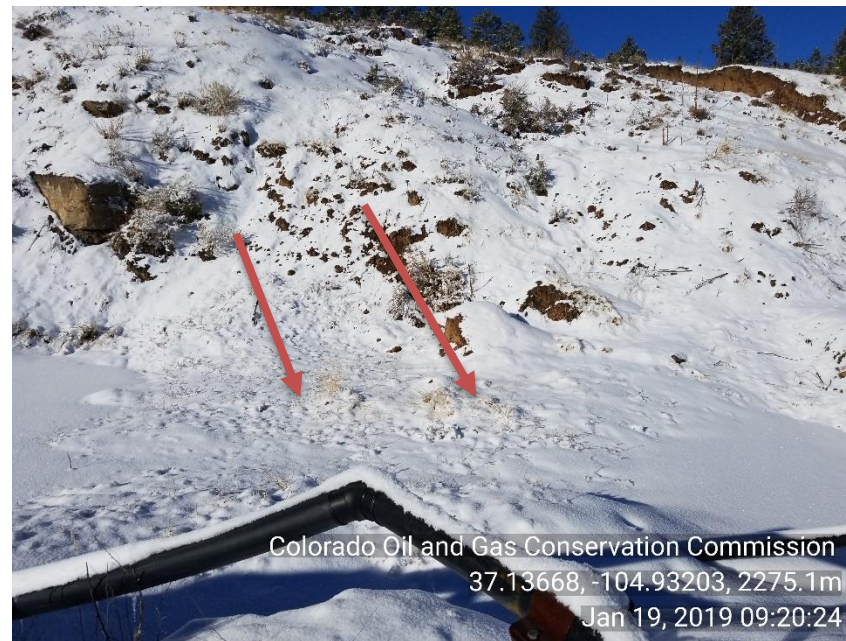
**Photo 8 vegetation in pit**
