Inspection Photos

Operator: D90 ENERGY LLC - 10706

Location ID: 450629

Inspection Doc. Number: 682504407

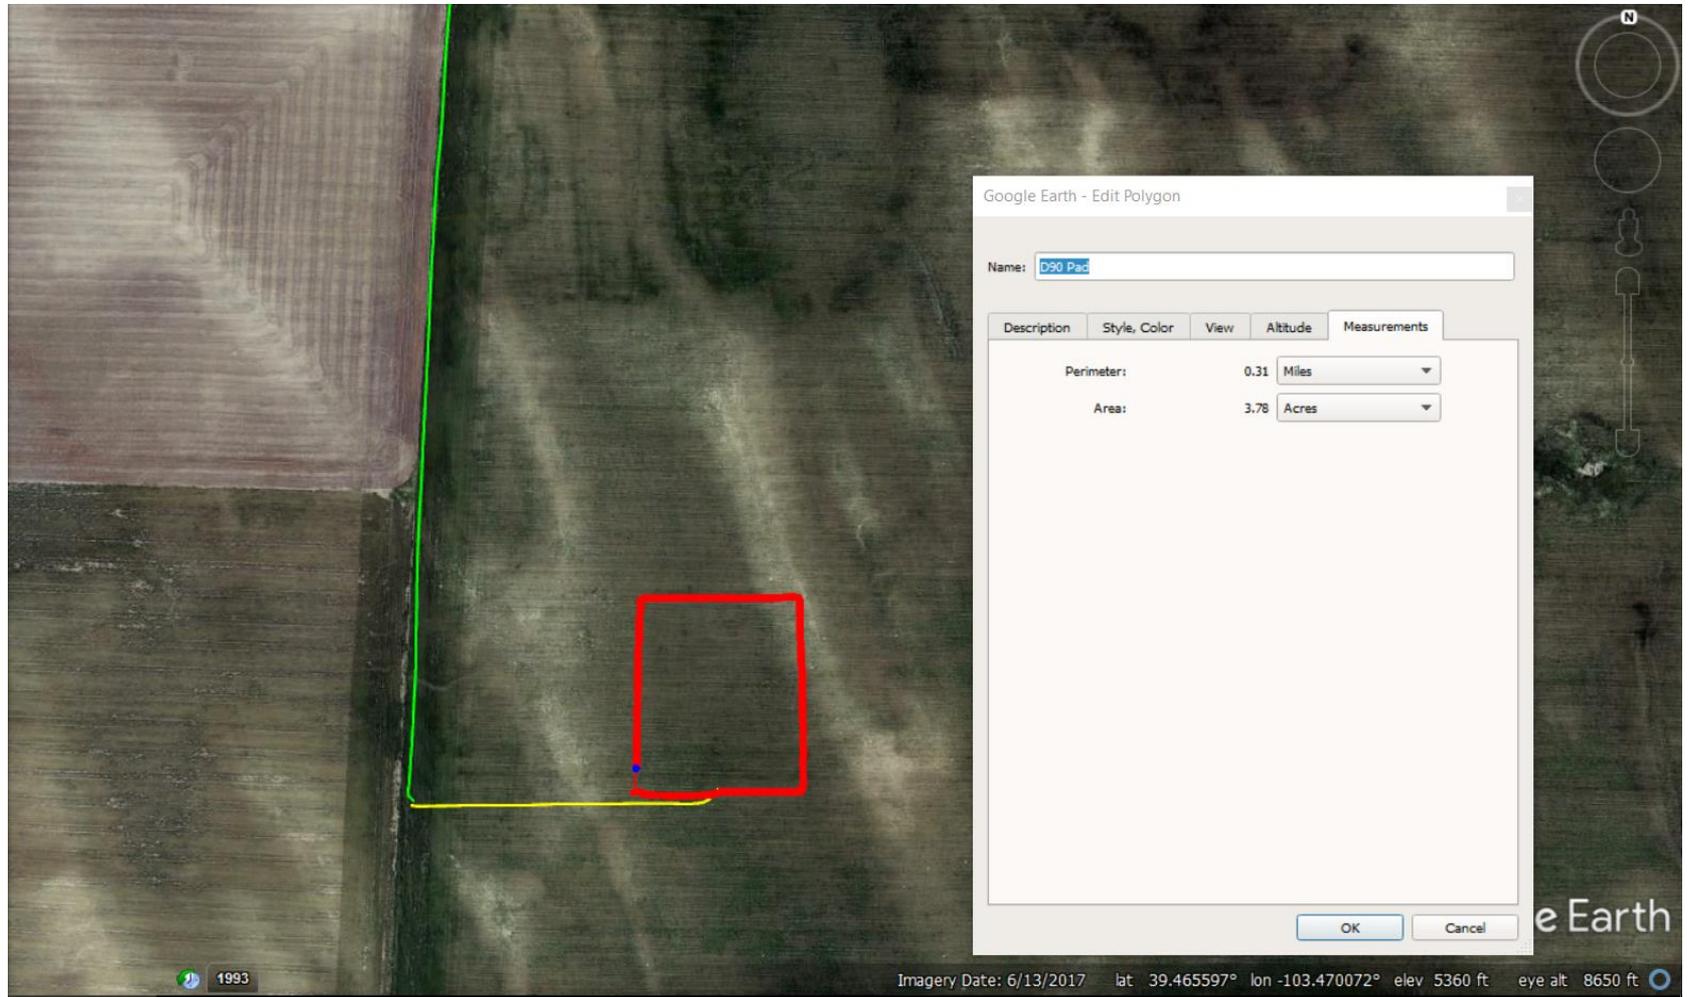
Photo 1: 2017 Google Earth aerial image. A disturbance area of 3.78 acres (red polygon) was mapped using a Trimble Juno 3B handheld device. This disturbance area exceeds the permitted disturbance of 3 acres per 2A doc. ##401846352. Photo also shows operator has utilized ~0.88 miles of pre-existing farm road (green line), and constructed a 700 foot road to the pad (yellow).

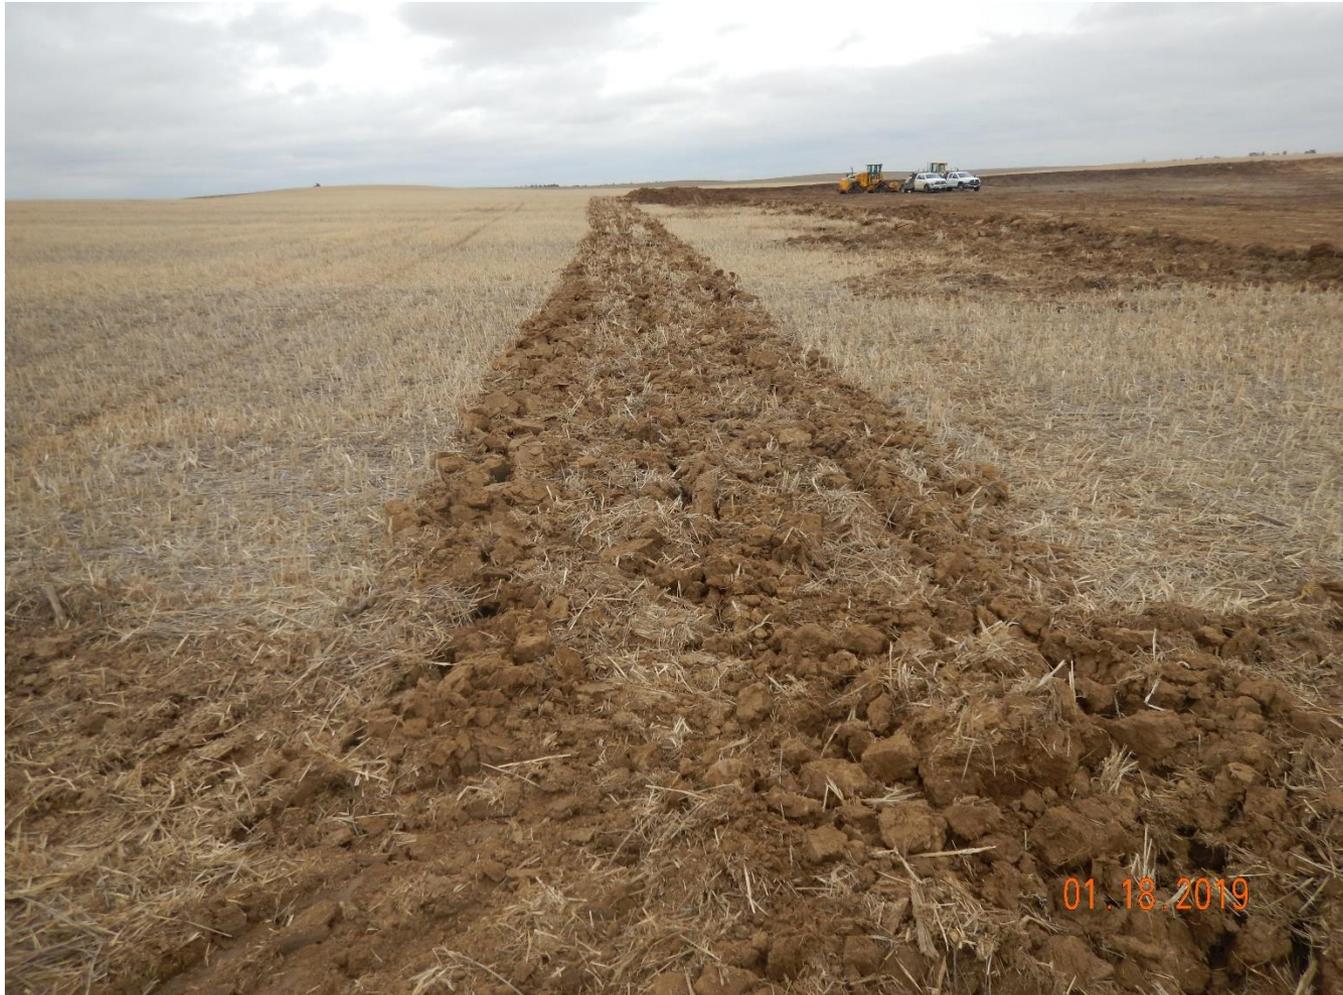
Photo 2: Photo taken from the southwest corner of the disturbance area, facing north. Photo shows operator has installed surface roughening (ripping) as a stormwater control BMP along the perimeter of the pad. BMP appears to have been installed in accordance with good engineering practices prior to and/or during construction activities, and in proper functioning condition.

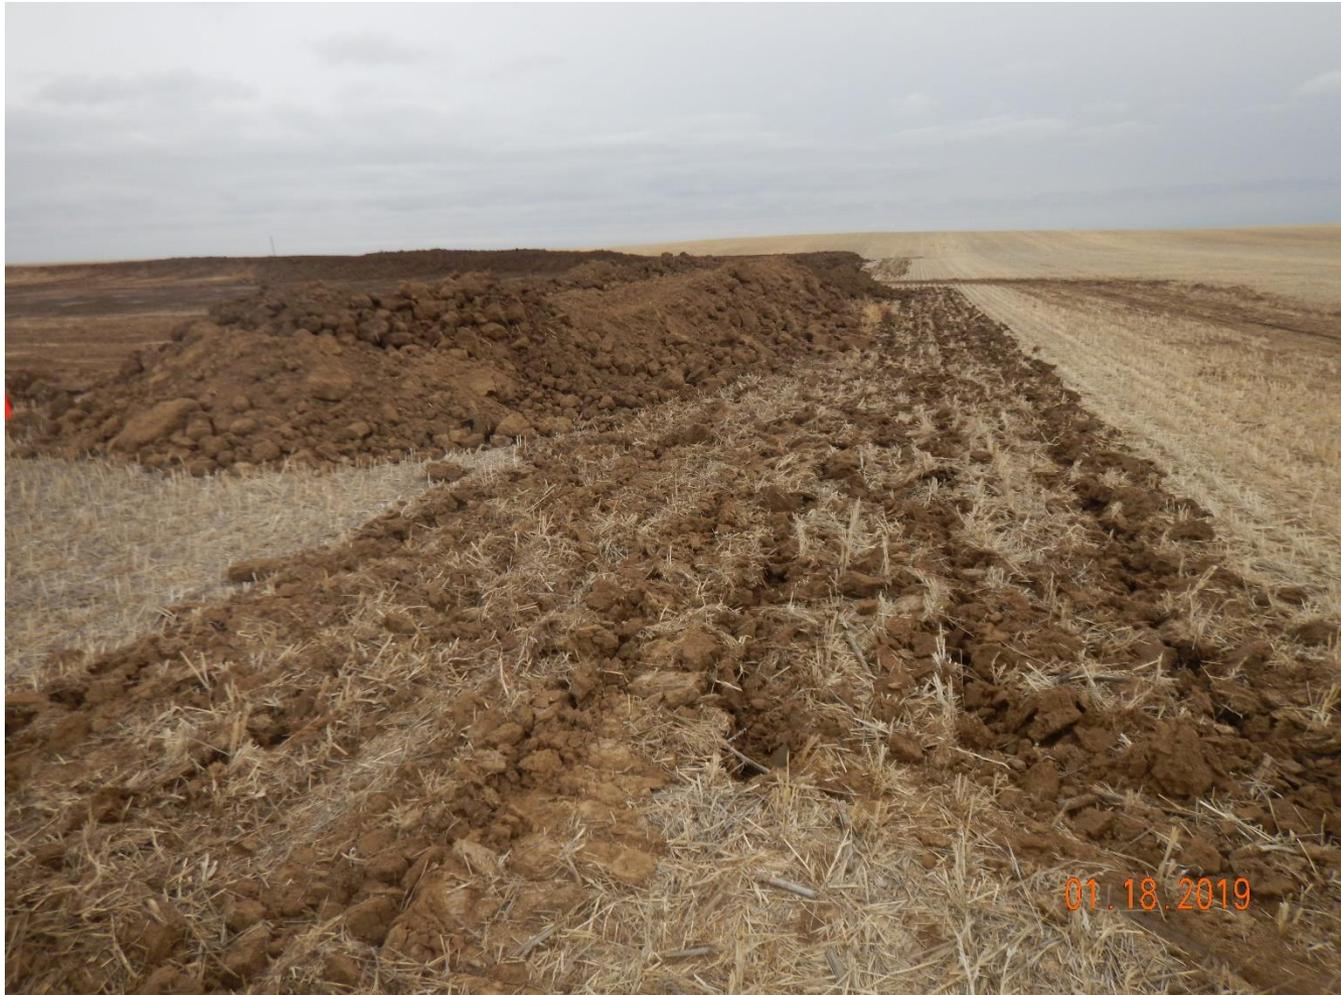
Photo 3: Photo taken from the southwest corner of the disturbance area, facing east.
See comments under photo 2.

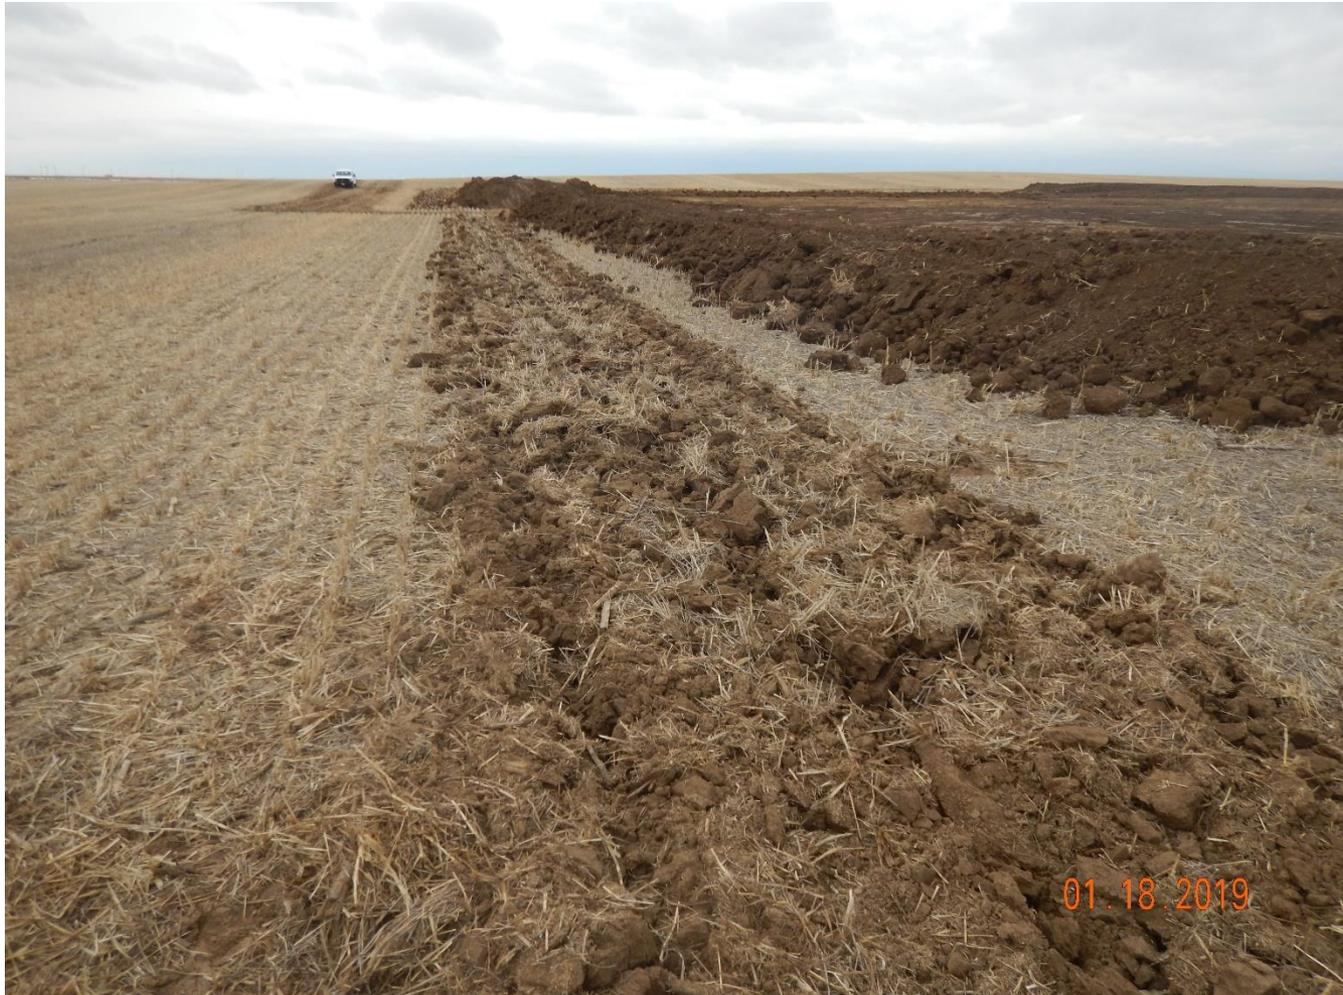
Photo 4: Photo taken from the southeast corner of the disturbance area, facing west.
See comments under photo 2.

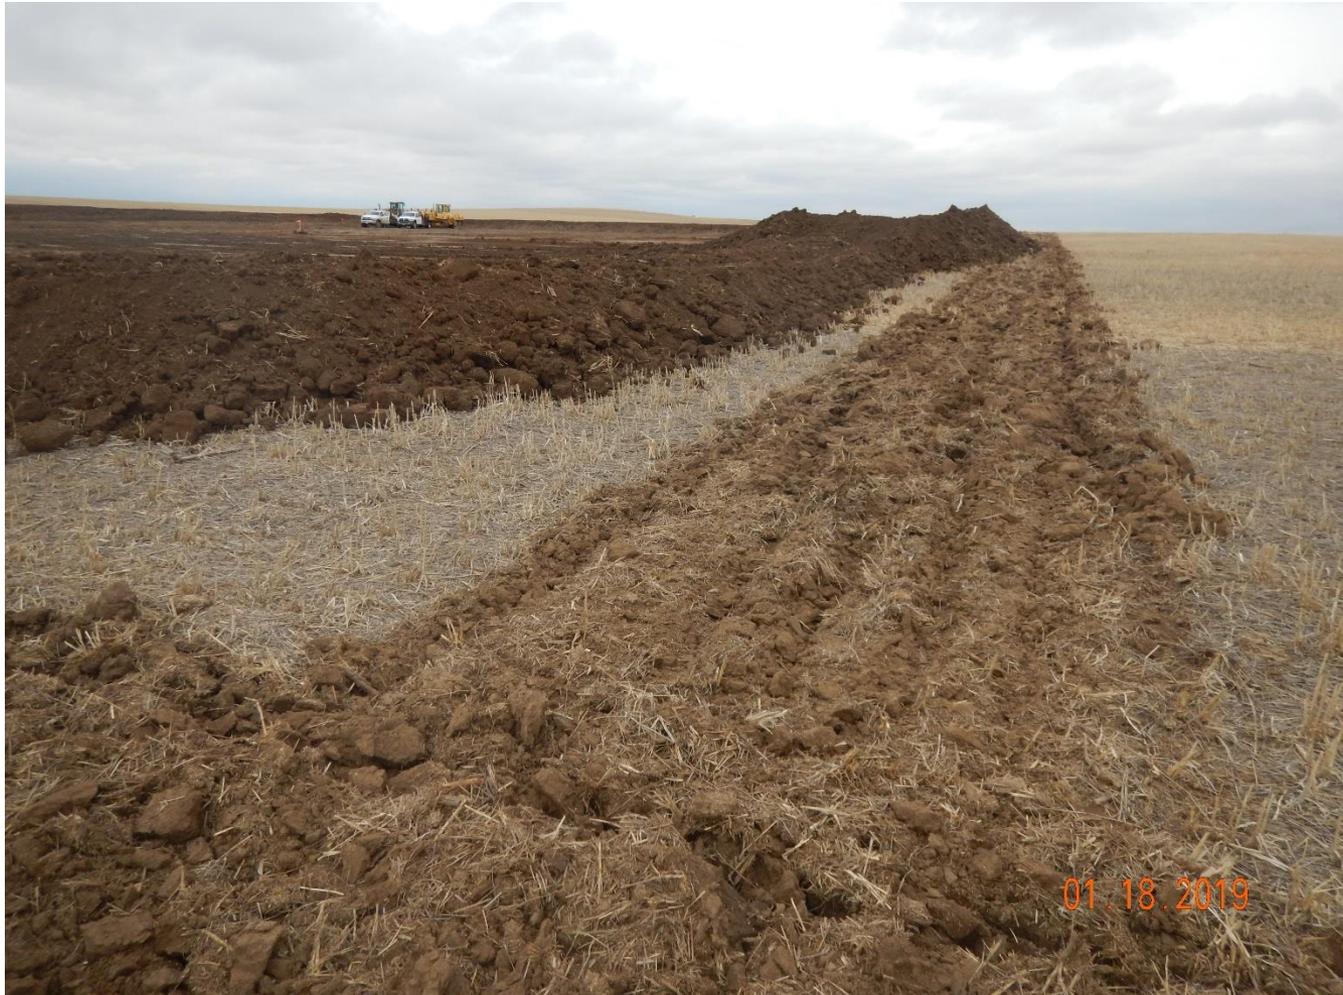
Photo 5: Photo taken from the southeast corner of the disturbance area, facing north. See comments under photo 2.

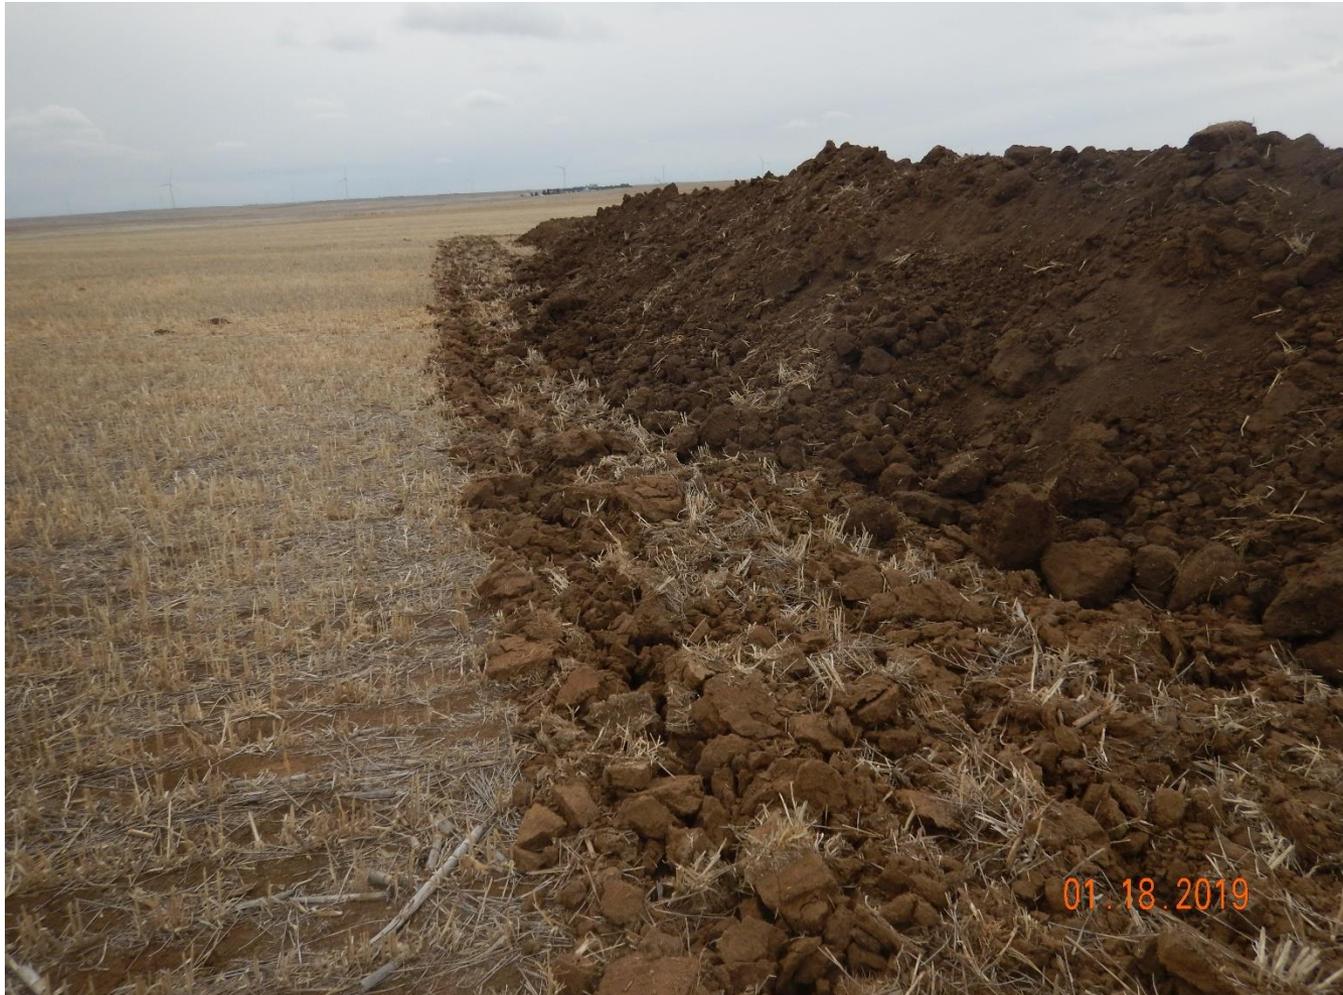
Photo 6: Photo taken from the east end of the disturbance area. Photo shows area where topsoil has been pushed onto the perimeter stormwater BMP. Advise maintenance to ensure BMP remains in proper functioning condition.

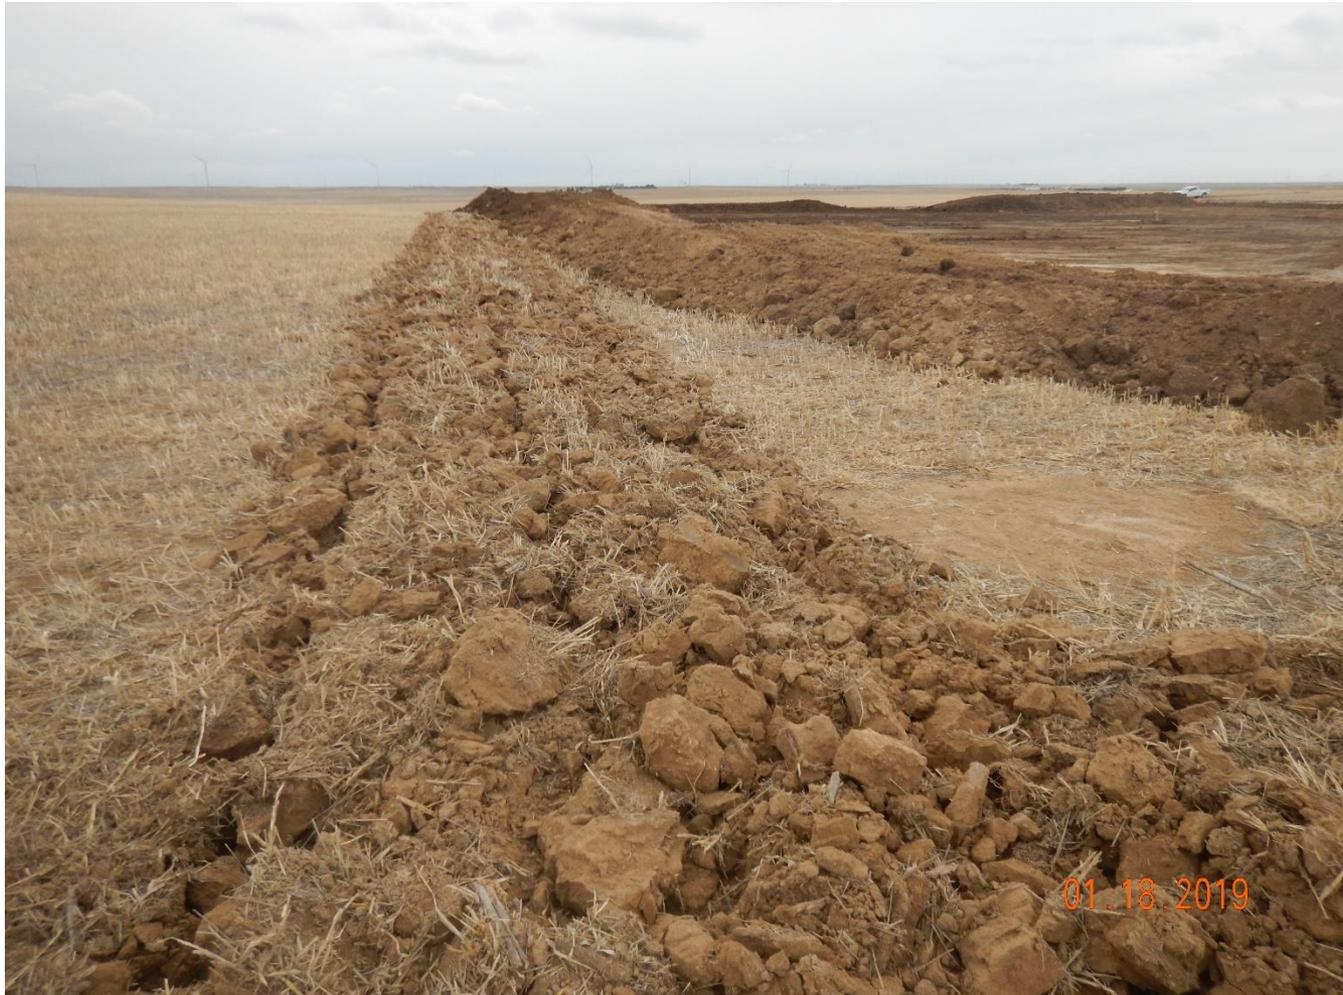
Photo 7: Photo taken from the northeast corner of the disturbance area, facing south. See comments under photo 2.

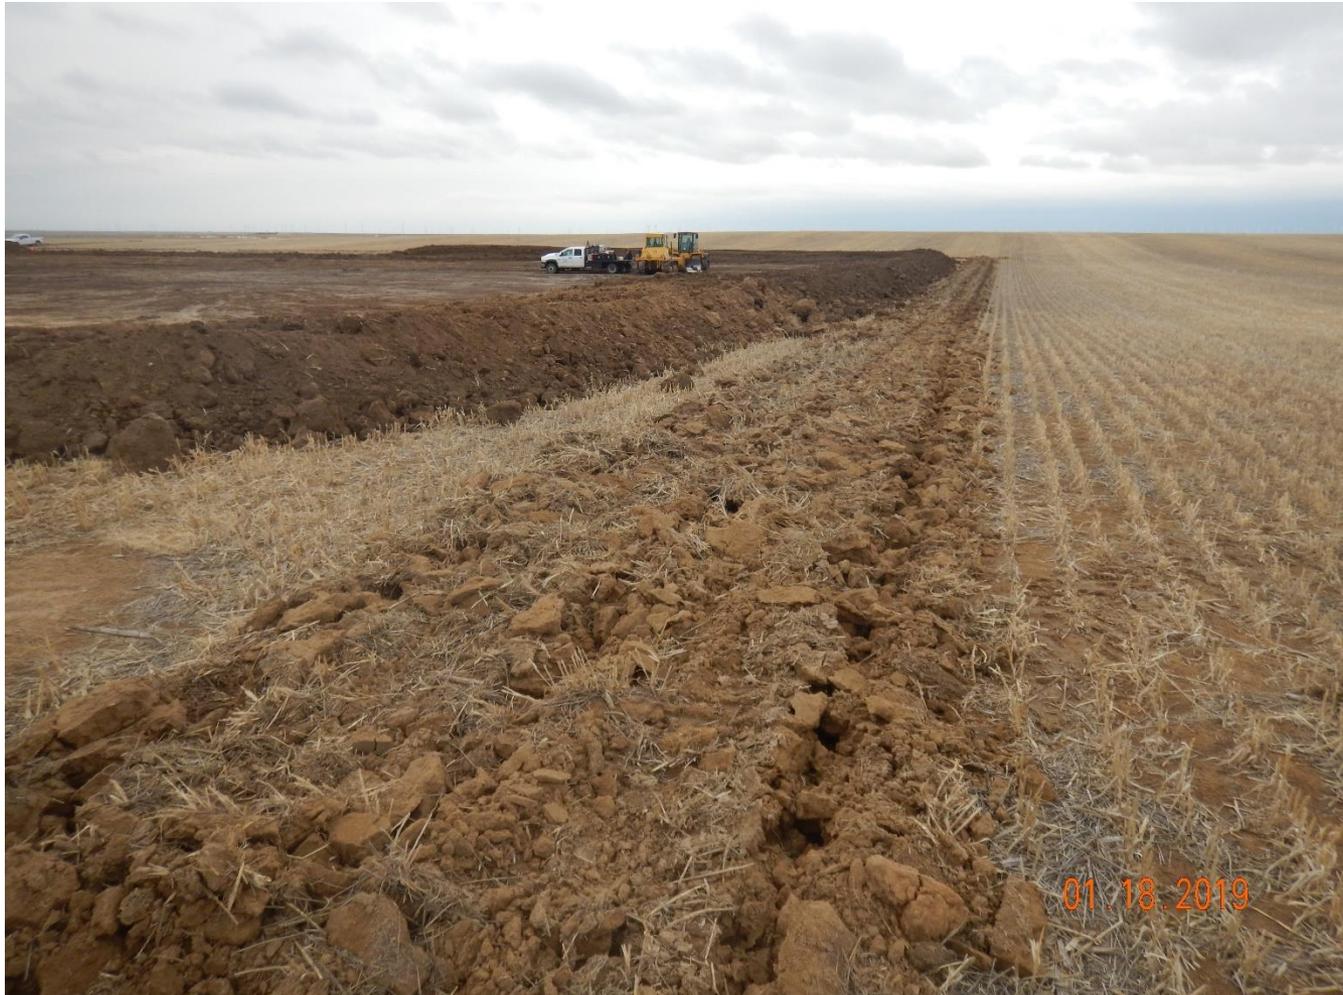
Photo 8: Photo taken from the northeast corner of the disturbance area, facing west.
See comments under photo 2.

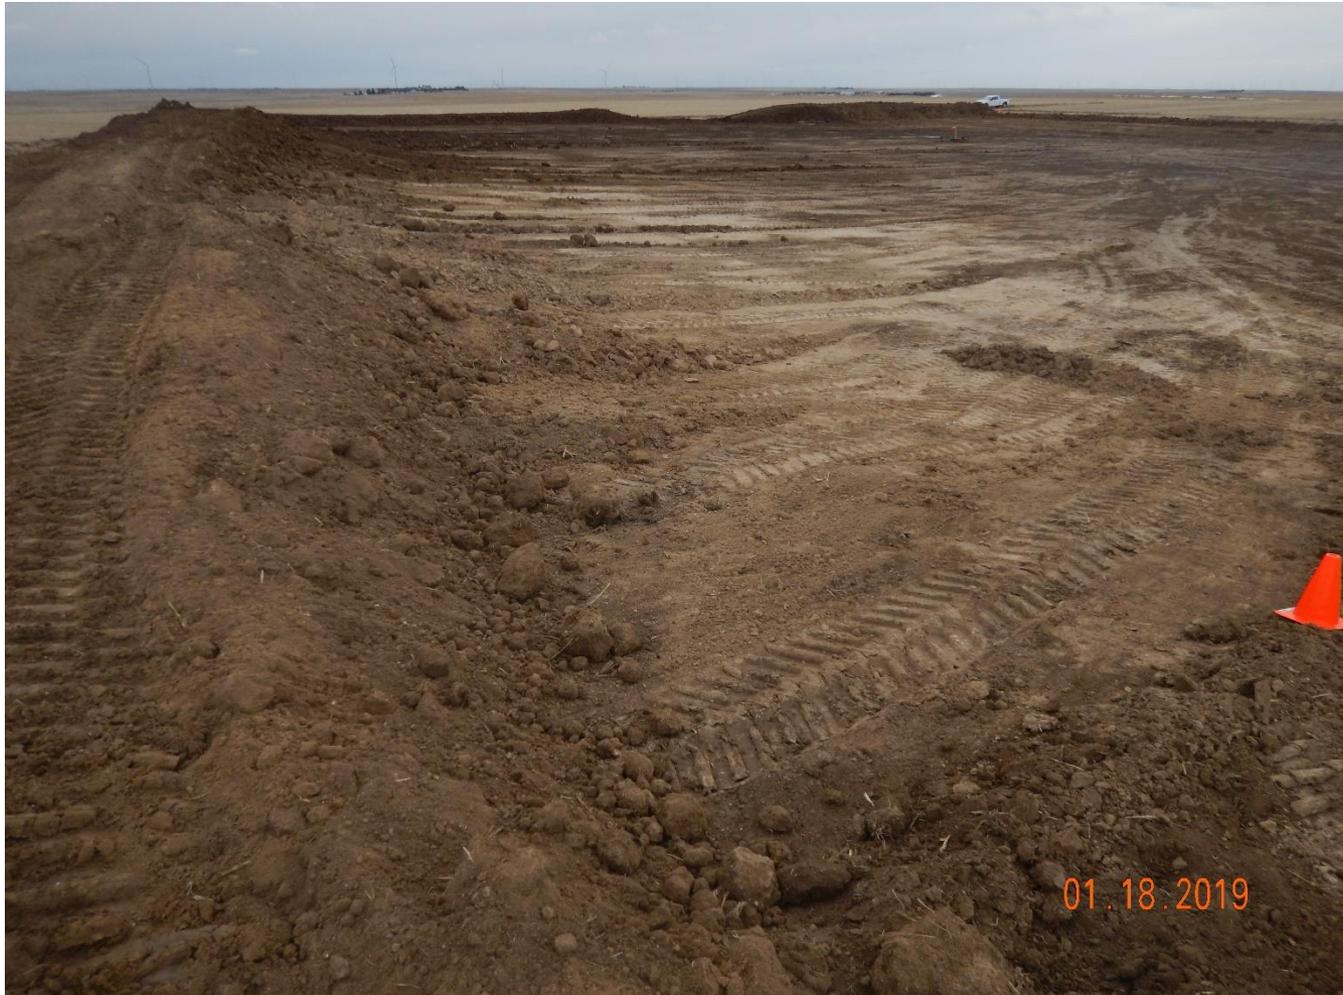
Photo 9: Photo taken from the northeast corner of the current pad, facing south. Photo shows sufficient soil salvage and segregation appears to be being conducted.

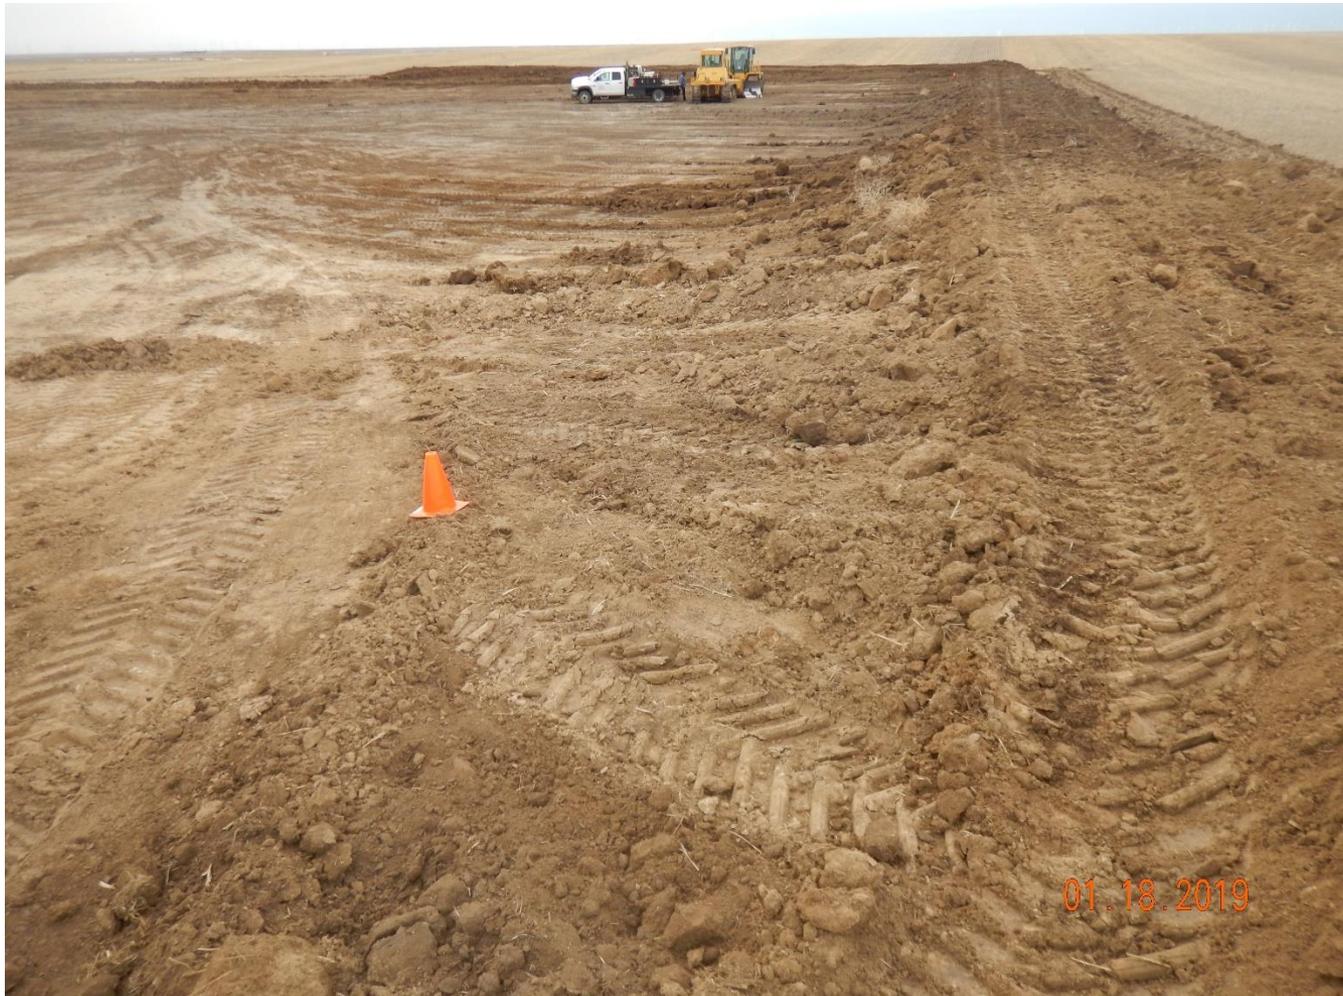
Photo 10: Photo taken from the northeast corner of the current pad, facing west. Photo shows sufficient soil salvage and segregation appears to be being conducted.

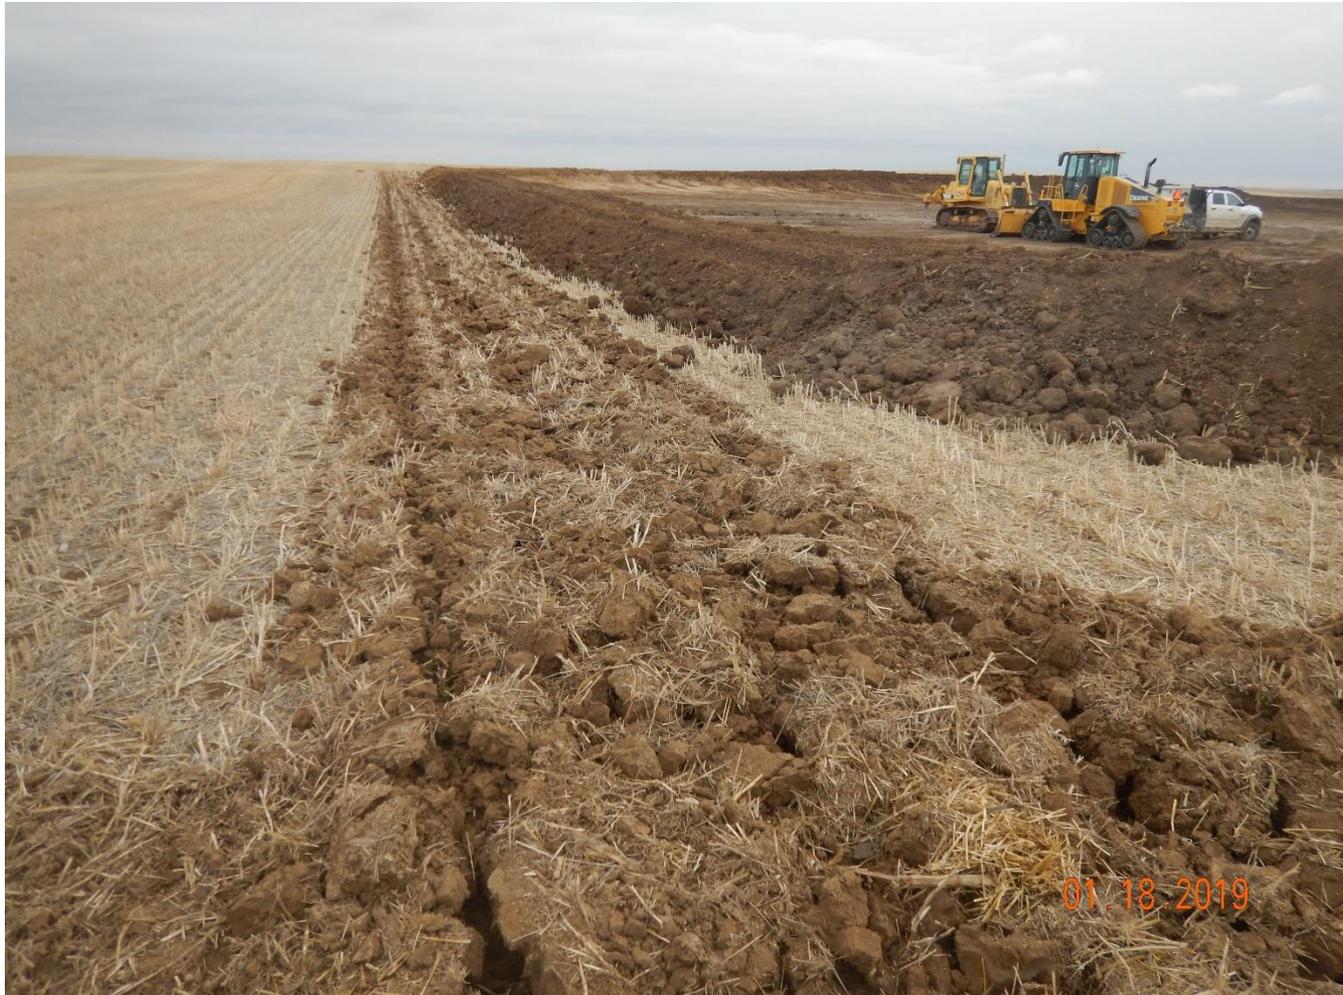
Photo 11: Photo taken from the northwest corner of the disturbance area, facing east.
See comments under photo 2.

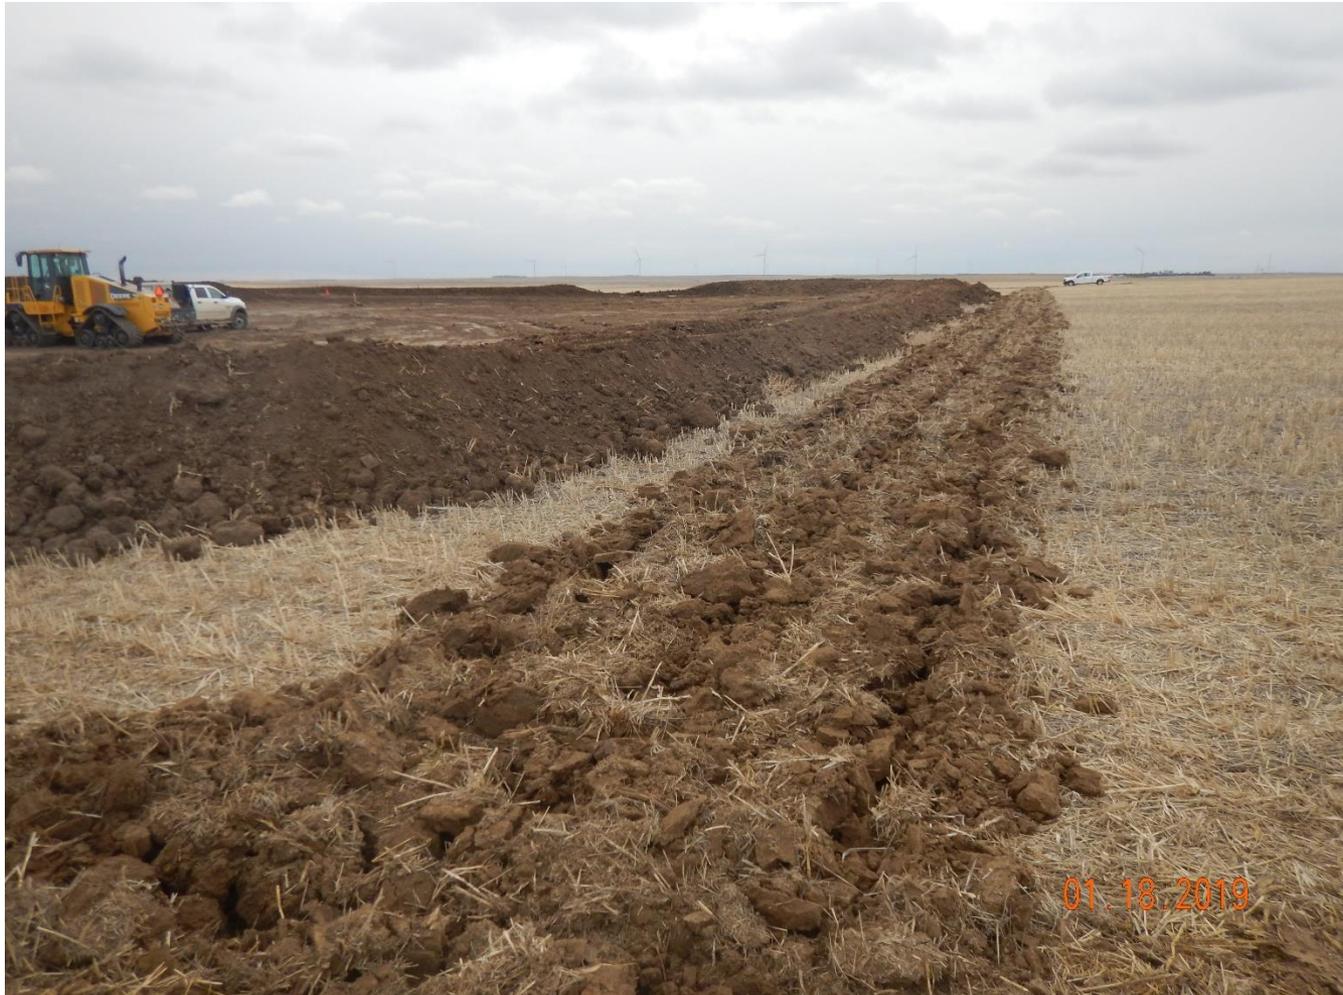
Photo 12: Photo taken from the northwest corner of the disturbance area, facing south. See comments under photo 2.

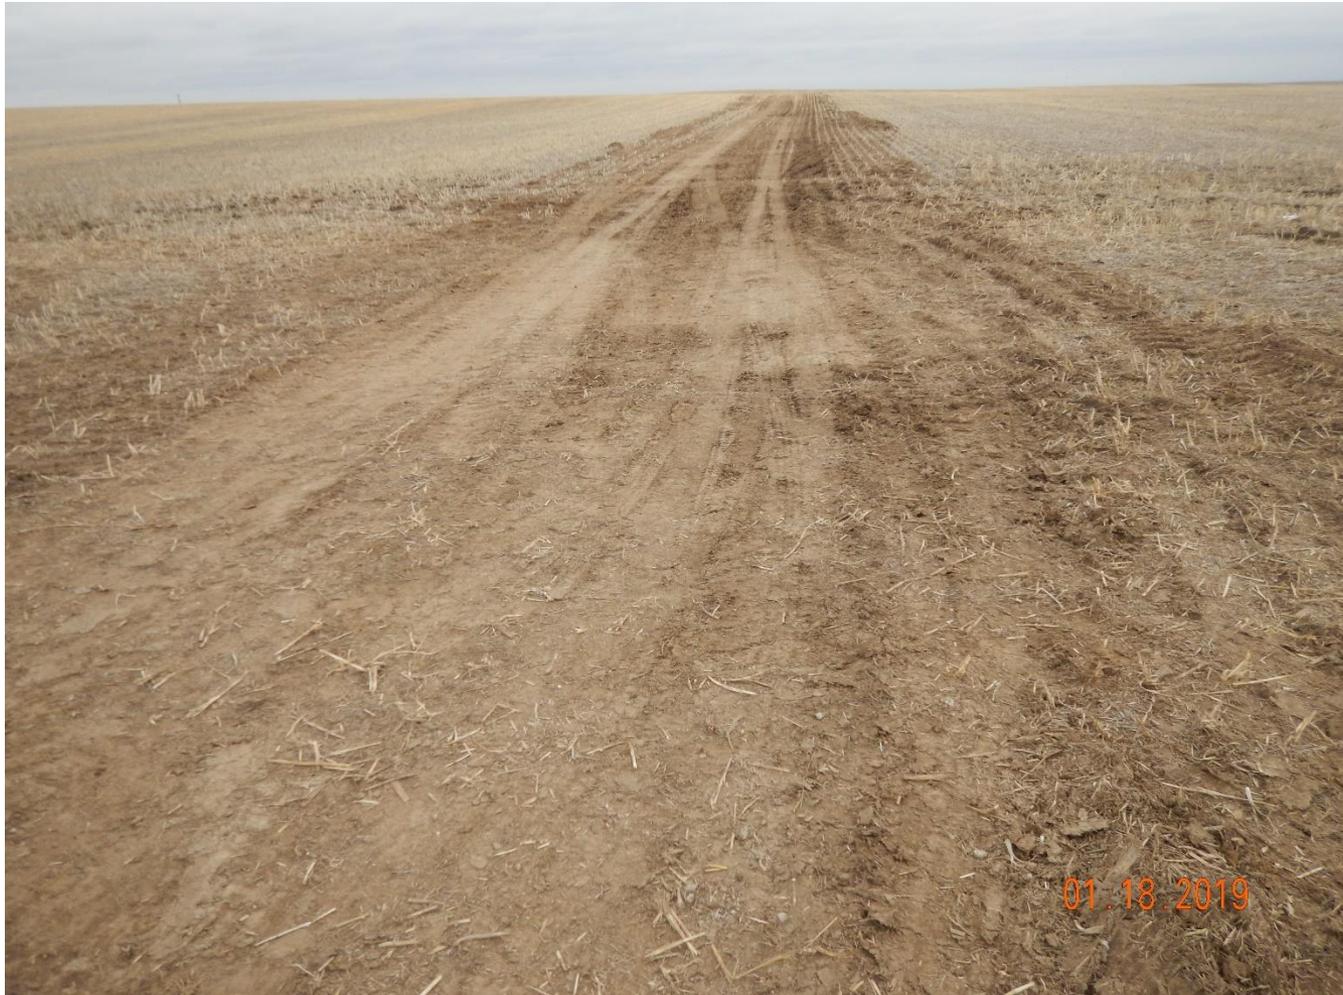
Photo 13: Photo taken from the south end of the location, facing west. Photo shows the east/west access road.

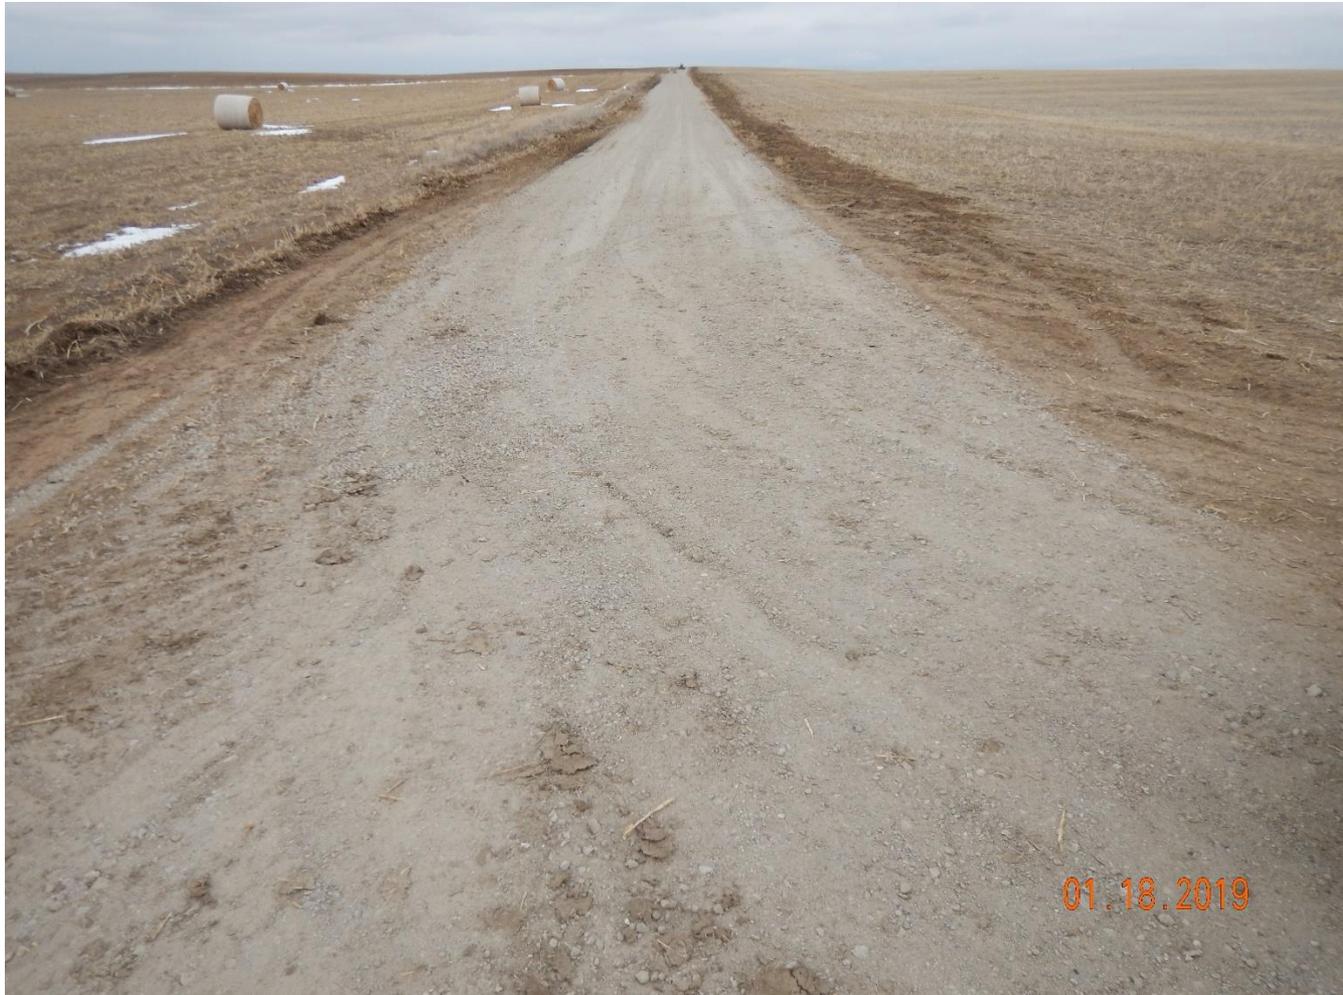
Photo 14: Photo taken from the west of the location. Photo shows the pre-existing farm road. Operator has placed road base on access road for stabilization.
