# Interim Reclamation and Stormwater Inspection

Operator: BONANZA CREEK ENERGY OPERATING COMPANY LLC - #8960

Location ID: 452874

Inspection Photos  
Location Name: Mustang /12-26 Pad  
Location ID: 452874

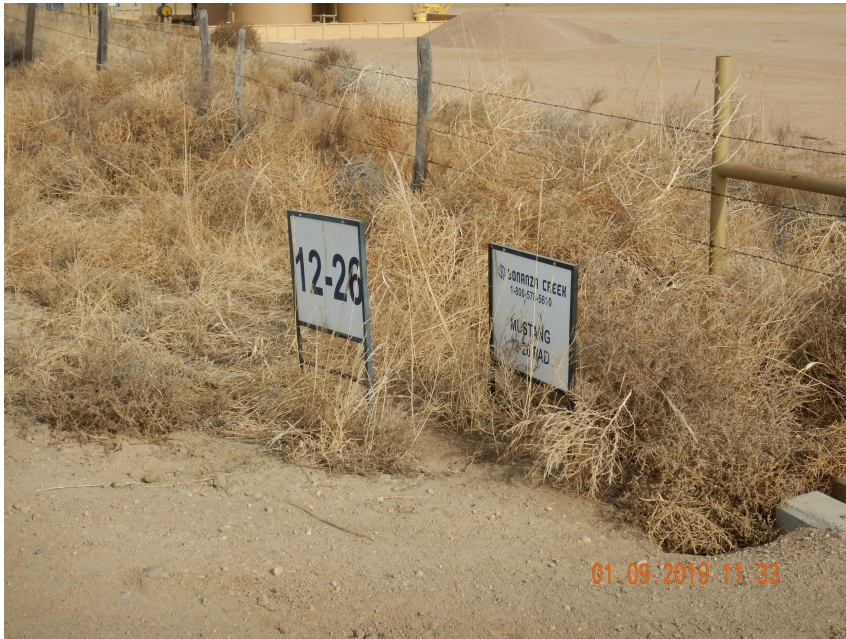
**Photo 1.** Photo taken from the entrance of the location, facing East. Photo illustrates Operator signs.

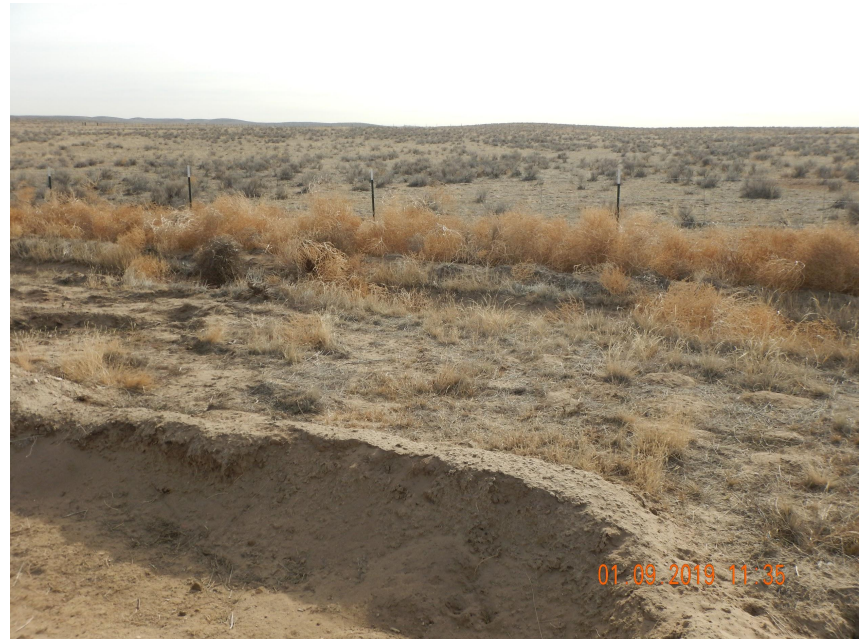
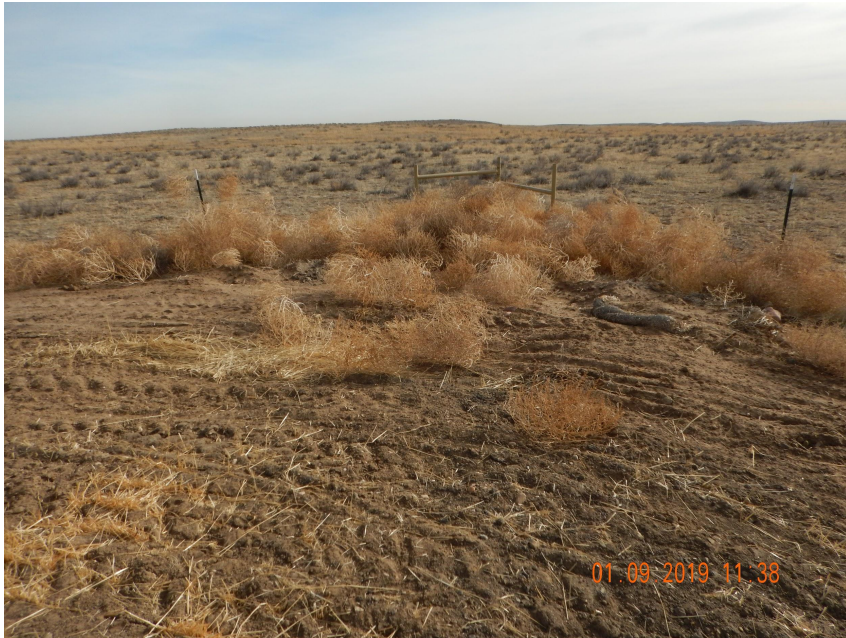
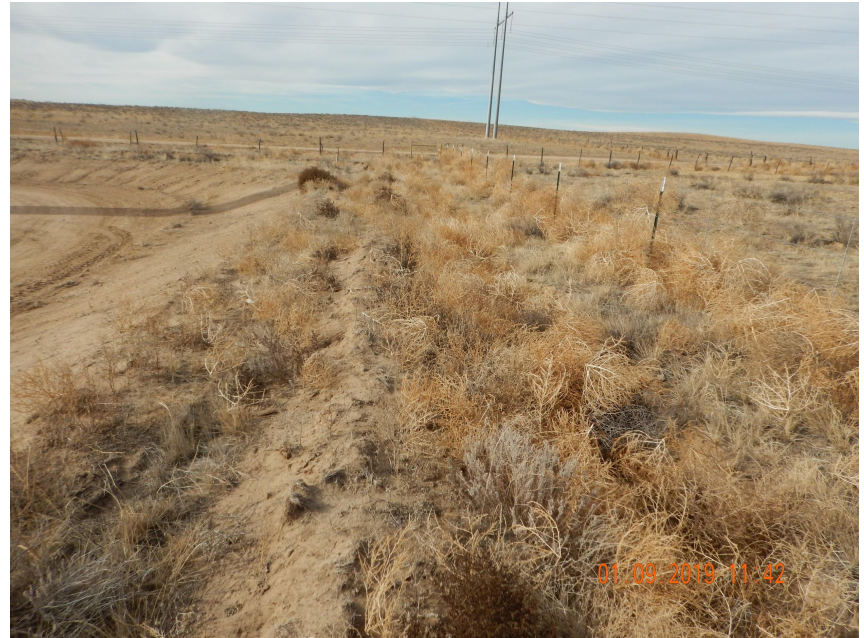
**Photo 2.** Photo taken from the southwest location, facing Southeast. Photo illustrates Russian thistle weed debris. More weed debris was observed along the southern and northern perimeter of the location.

**Photo 7.** Photo taken from the southeastern perimeter of the location, facing East. See comments under Photo 2.

**Photo 8.** Photo taken from the northern perimeter of the location, facing West. See comments under Photo 2.

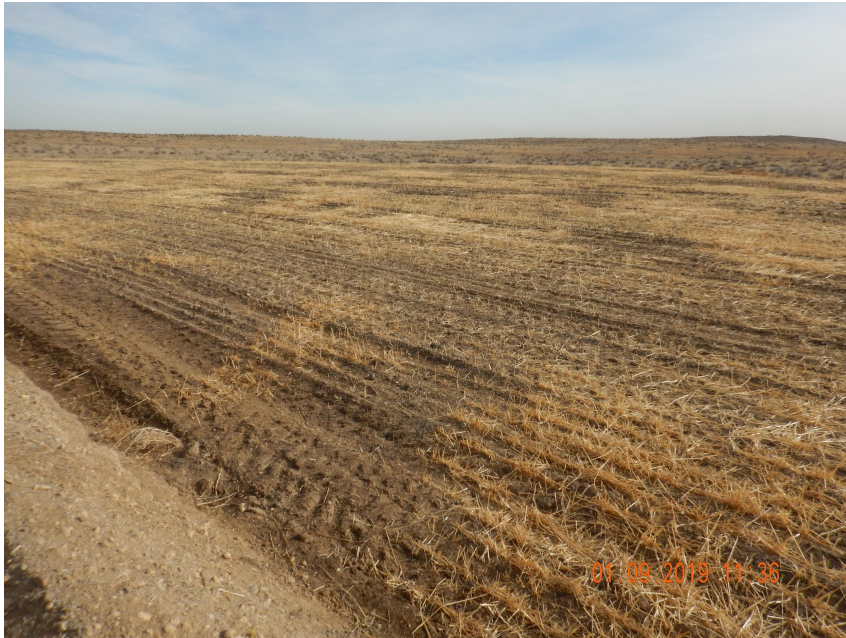
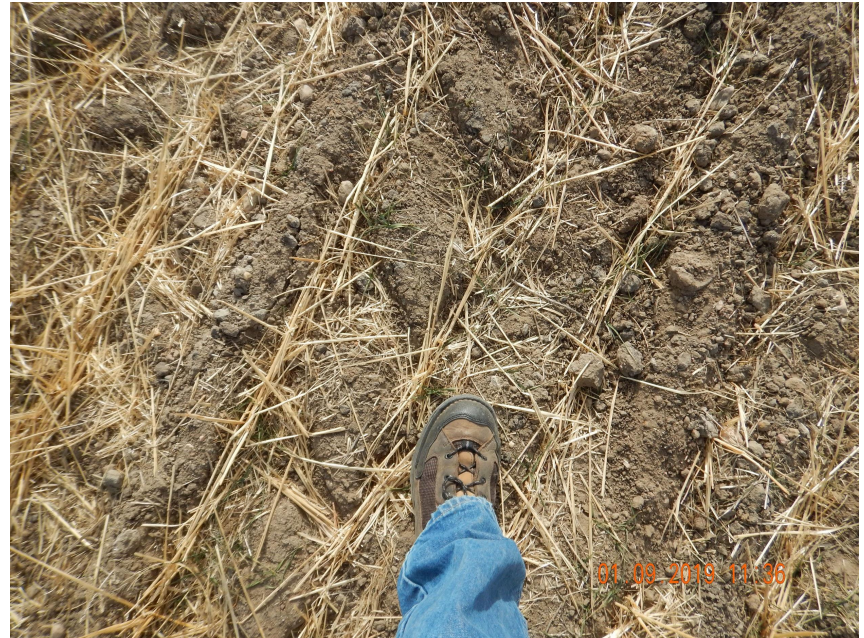
**Photo 3.** Photo taken from the eastern location, facing Northeast. Operator has performed interim reclamation activities with the evidence of drilling rows and straw crimped mulch. However, interim areas do not appear to be properly contoured to the surrounding landscape- see Photos 5 & 6.

**Photo 4.** Photo taken from the interim reclamation area. See comments under Photo 3.

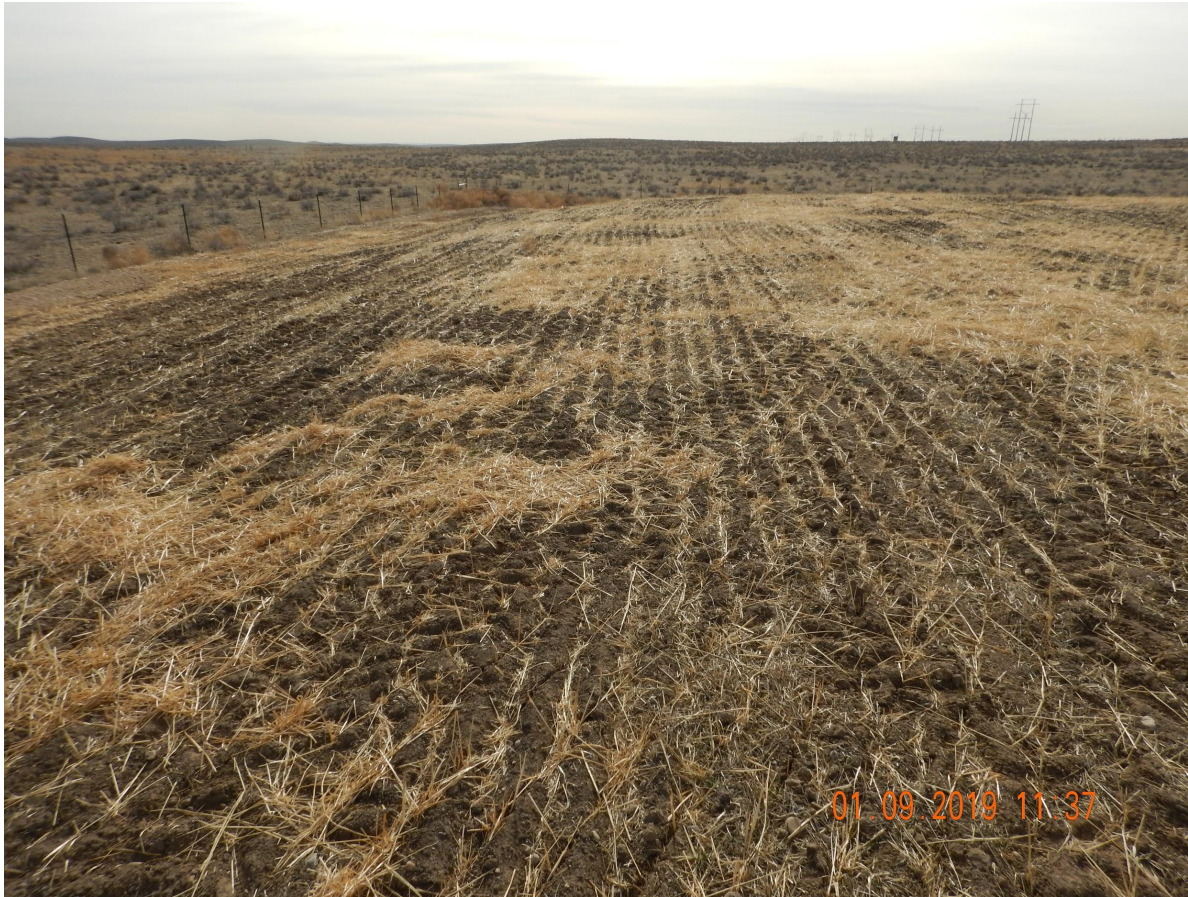
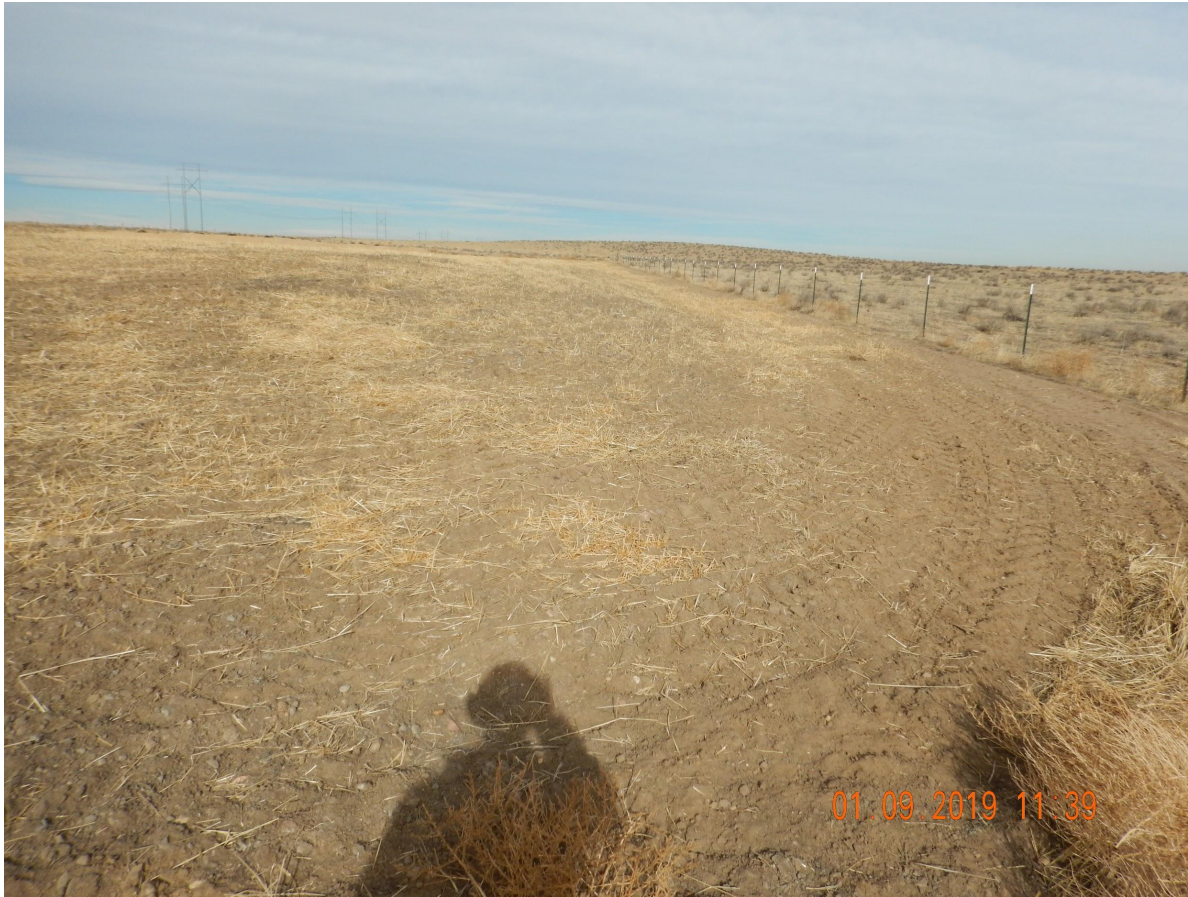
**Photo 5.** Photo taken from the southeastern interim area, facing South. Photo illustrates interim areas do not appear to be properly contoured to the surrounding landscape. Further review is required but Operator may need to perform additional contouring to comply with Rule 1003 standards.

**Photo 6.** Photo taken from the southeastern perimeter of the location, facing North. See comments under Photo 5.

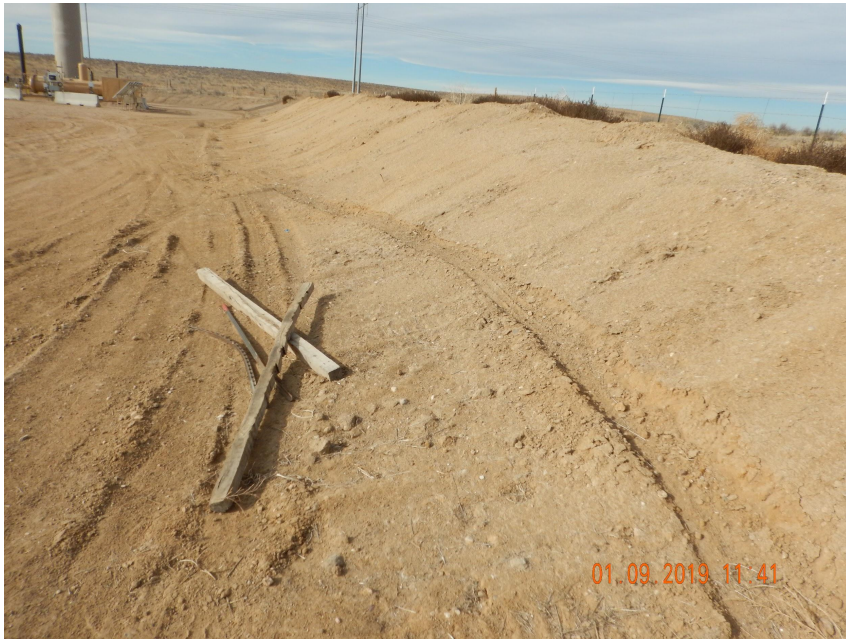
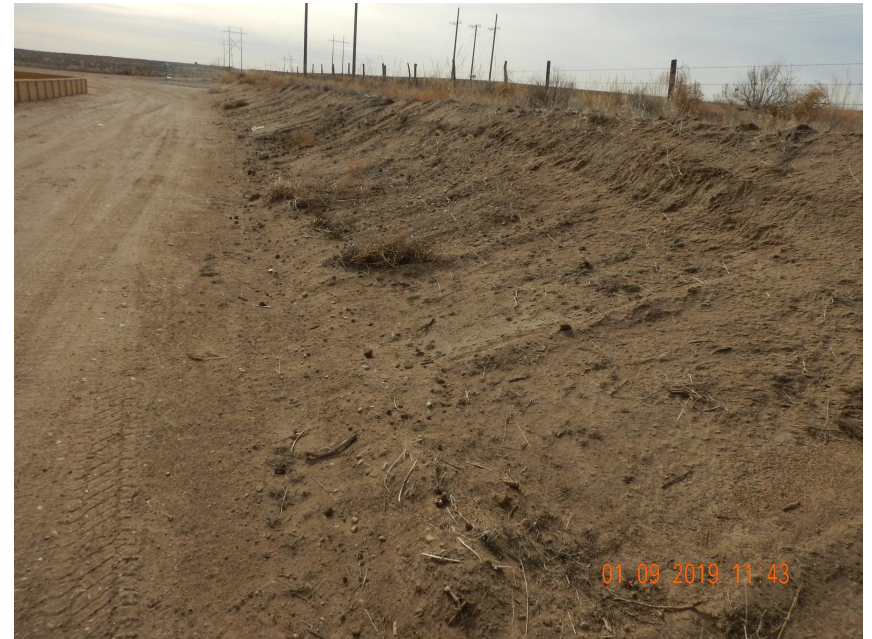
**Photo 9.** Photo taken from the northern location, facing West. Tackifier was observed on the cut slope but appears to be in need of maintenance. Also, remove any unused equipment from location.

**Photo 10.** Photo taken from the northwestern location, facing South. See comments under Photo 9.
