Inspection Photos

API: 05-009-06568

Operator: ENERGY ALLIANCE COMPANY

Inspection Date: 1/18/2019

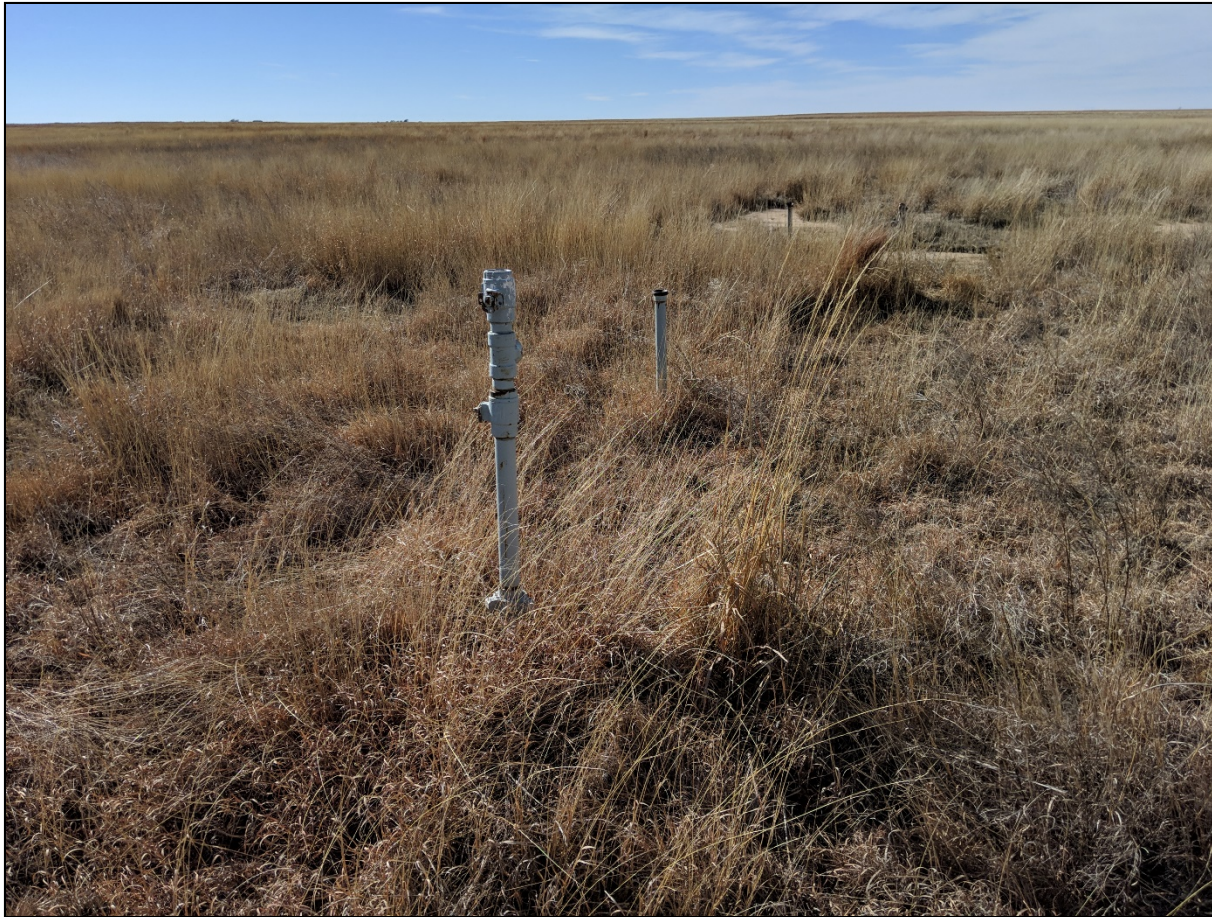
Photo 1. Facing west at the location. Pipe risers have not been removed.

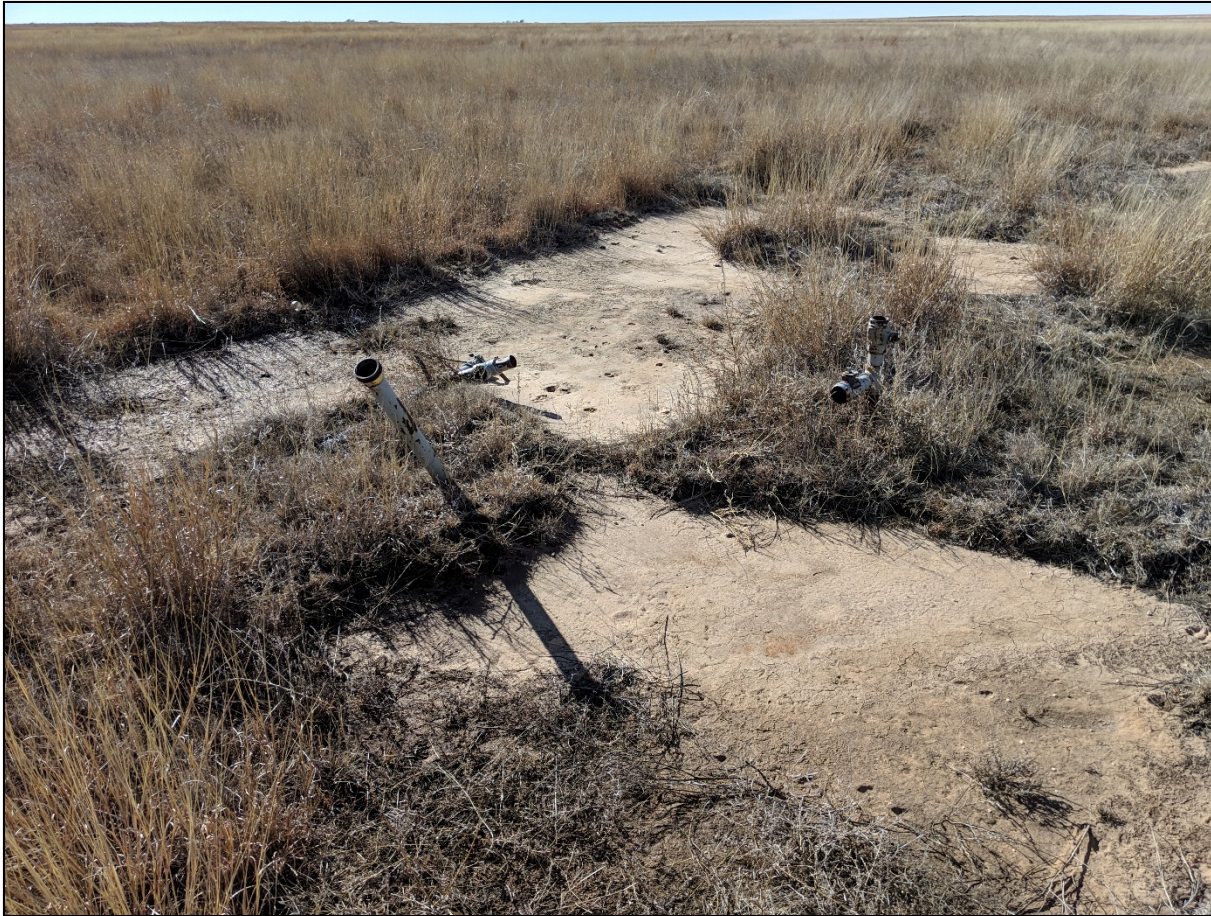
Photo 2. Pipe risers remain at the location.

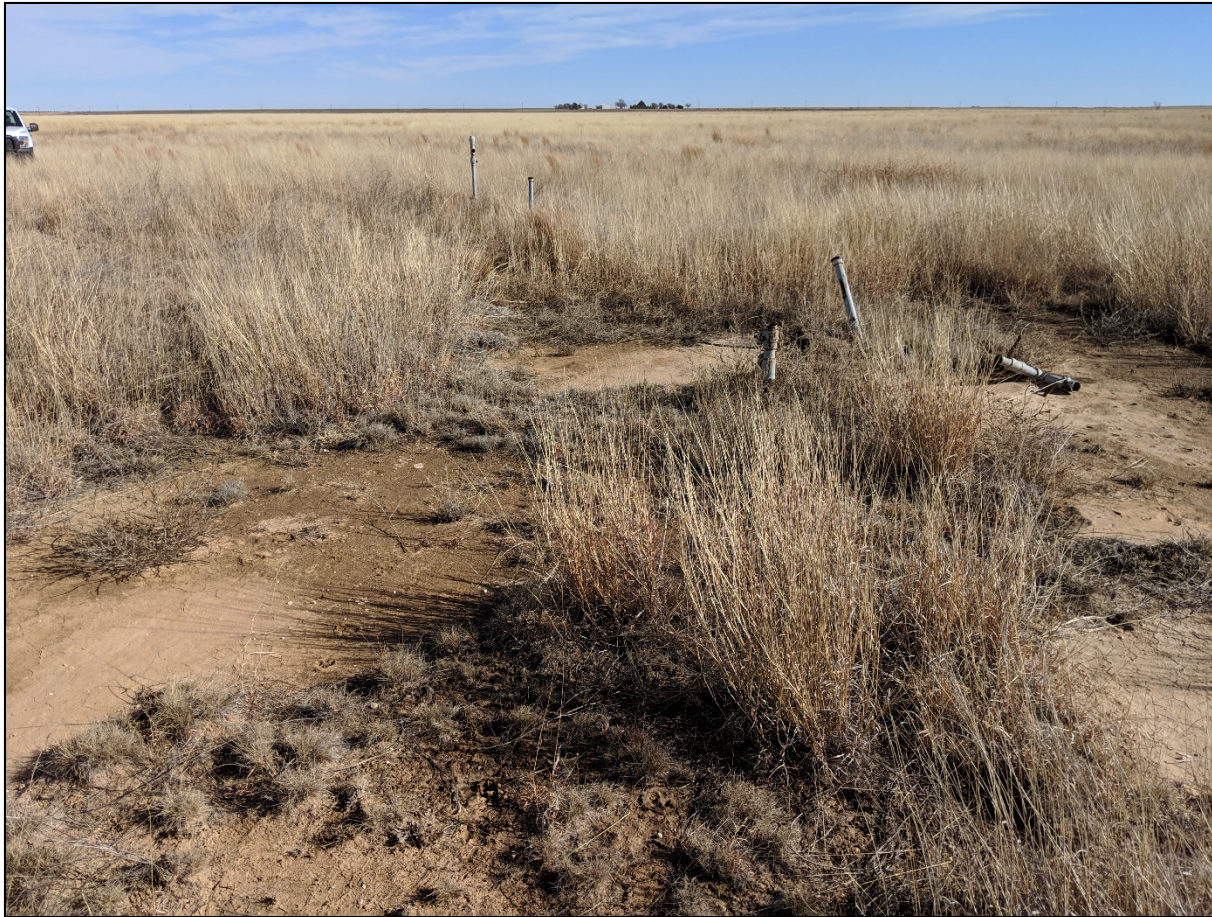
Photo 3. Facing east at the location. At least 5 pipe risers remain.
