Interim Reclamation and Stormwater Inspection

January 16, 2019

Operator: SRC ENERGY INC- #10311

Location ID: 432988

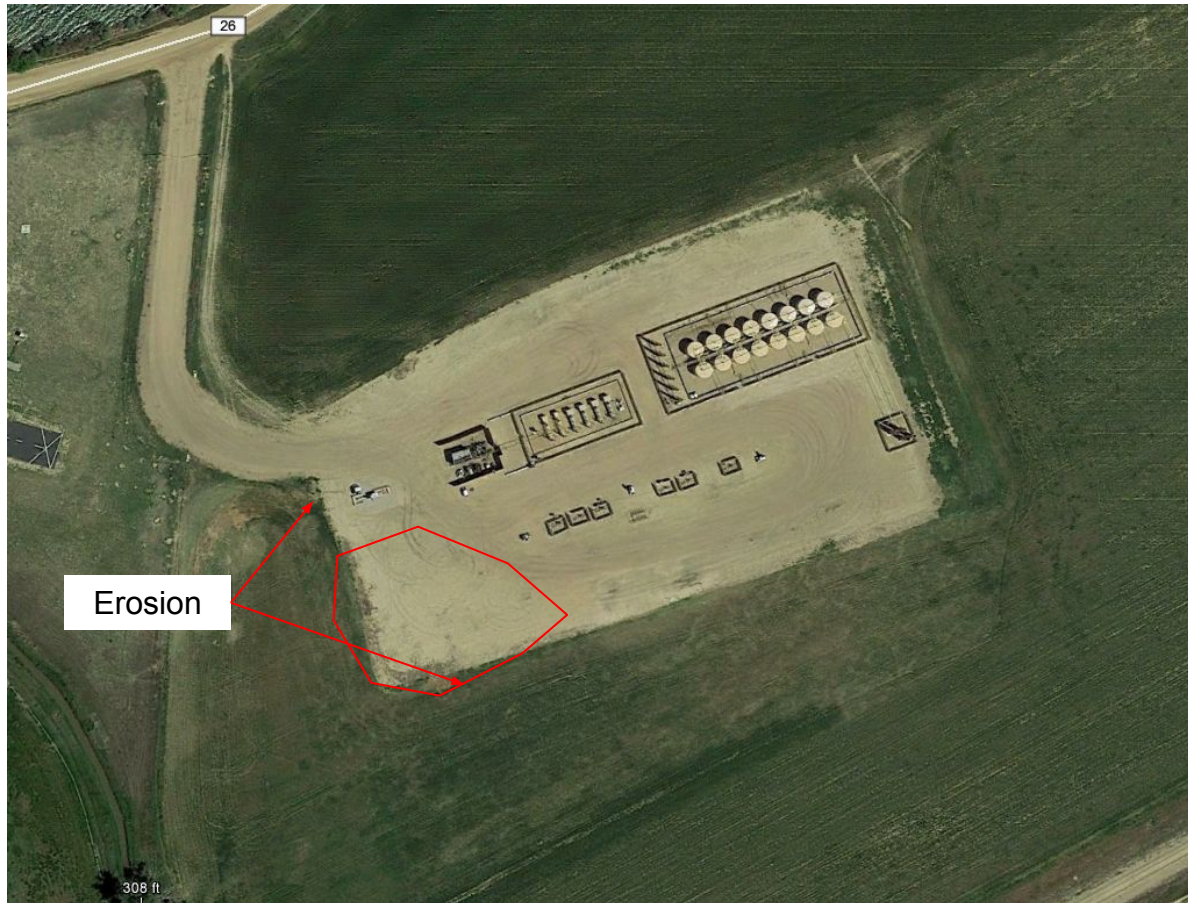
Google Earth aerial imagery taken May 31, 2018. Imagery illustrates an area marked in red that does not appear to be needed for production operations. Also, there was stormwater erosion observed along the western and southwestern location discharging off location.

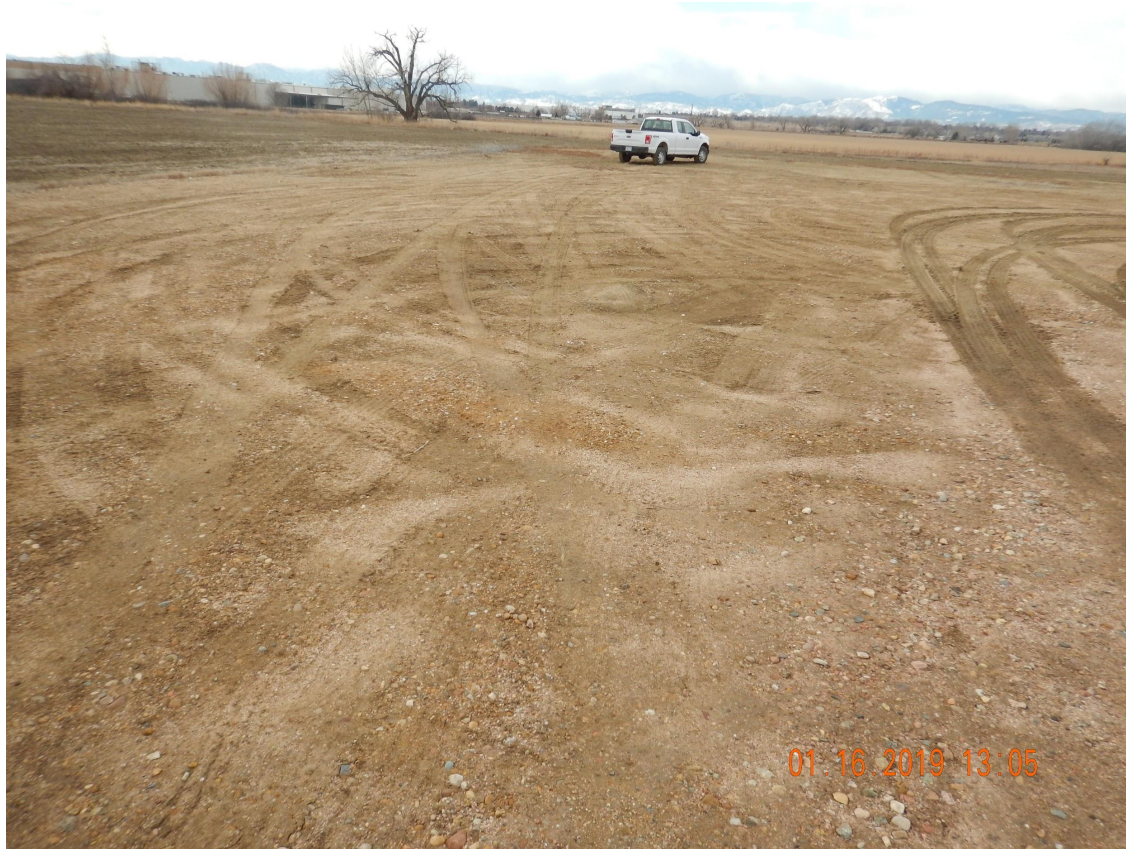
Photo 1. Photo taken from the southwestern well pad, facing West. Operator has failed to perform interim reclamation to reduce disturbance areas only needed for production operations. Also, there was stormwater erosion observed along the western and southwestern location discharging off location.

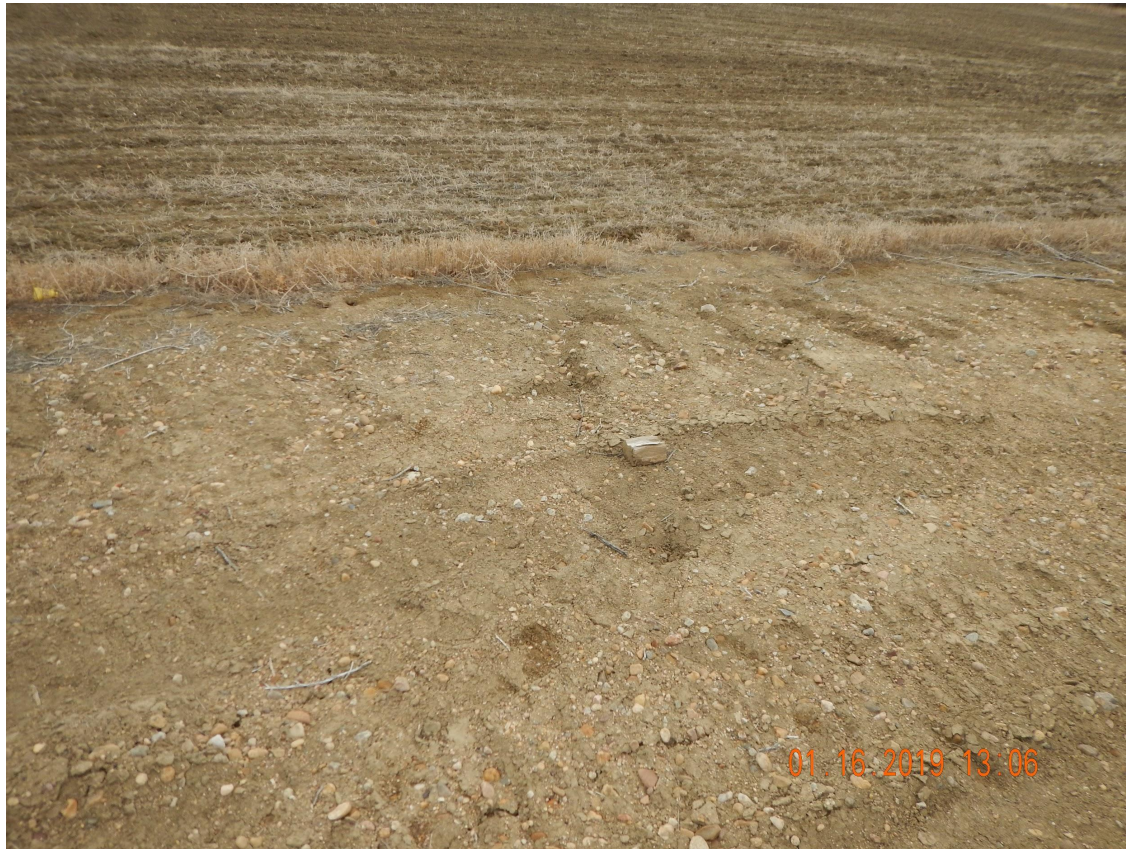
Photo 2. Photo taken from the southwestern well pad, facing South. Photo illustrates rill erosion discharging off location.

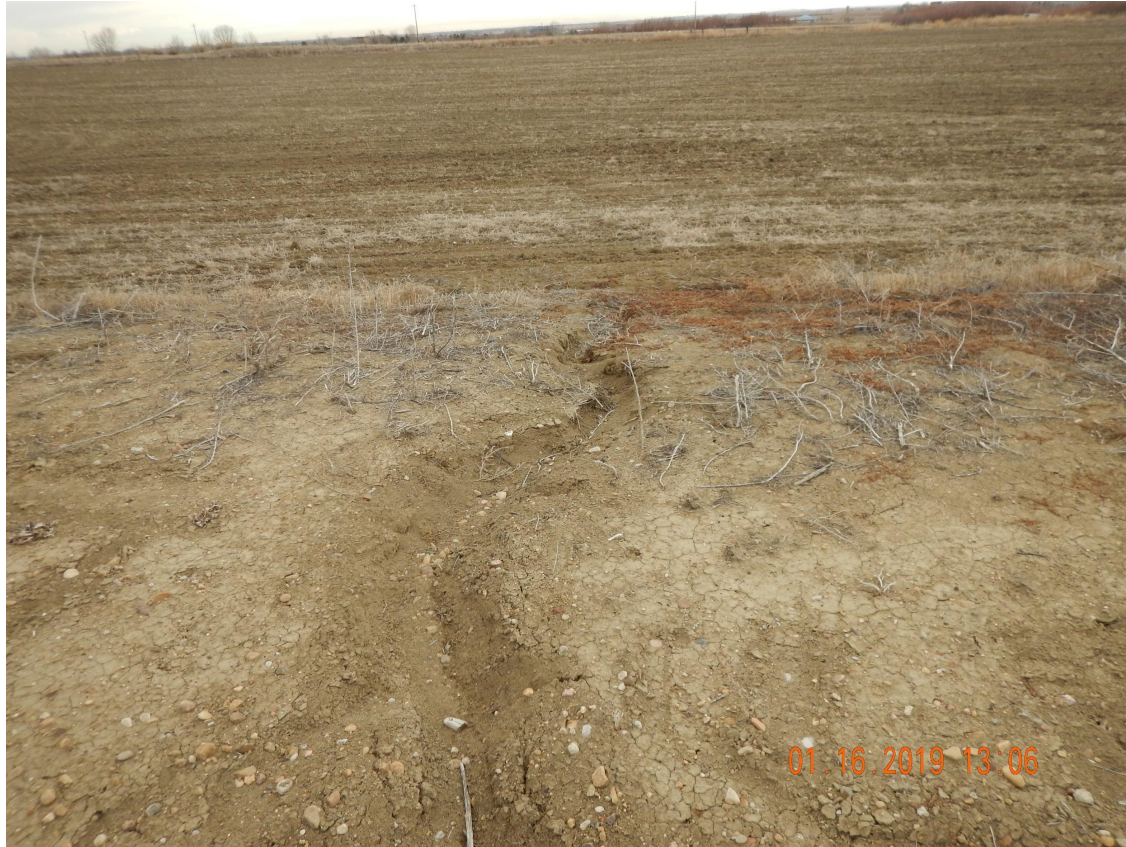
Photo 3. Photo taken from the southwestern well pad, facing South. See comments under Photo 2.

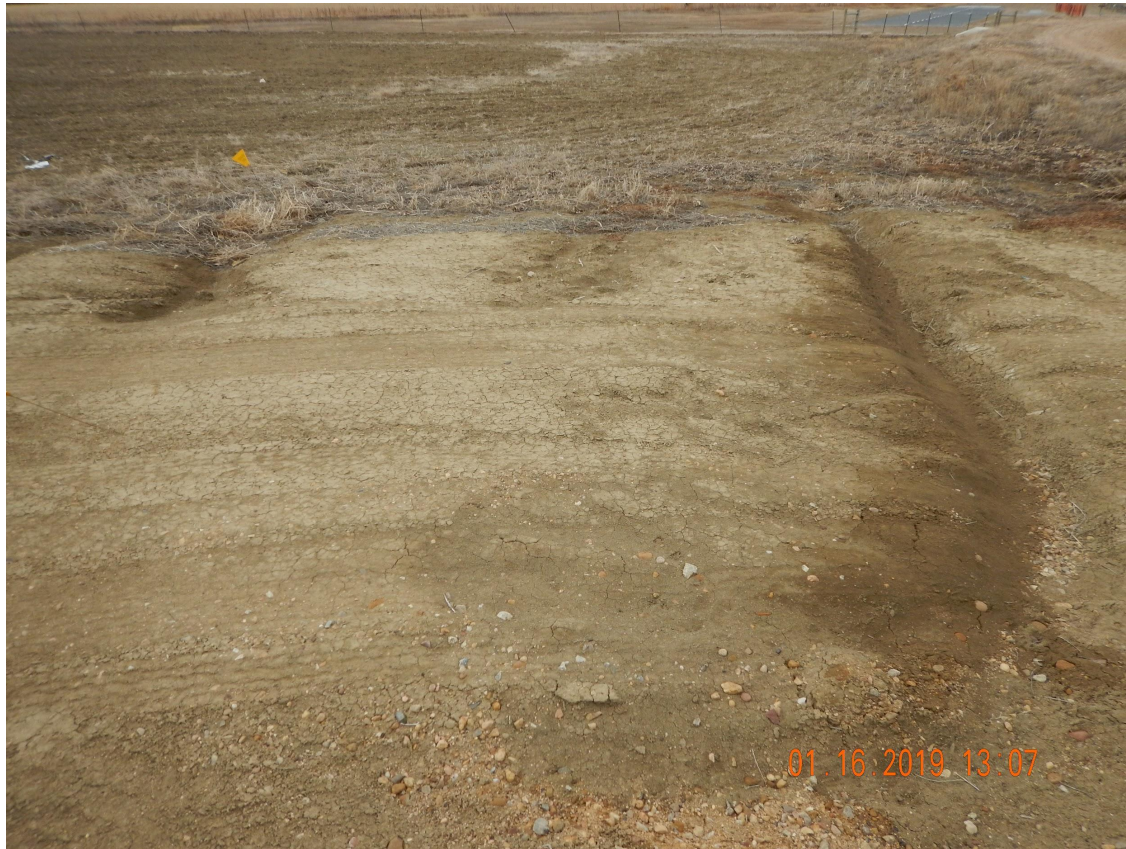
Photo 4. Photo taken from the western well pad, facing West. See comments under Photo 2.
