Inspection Photos
Operator Name: Bargath LLC
Facility ID: 460855

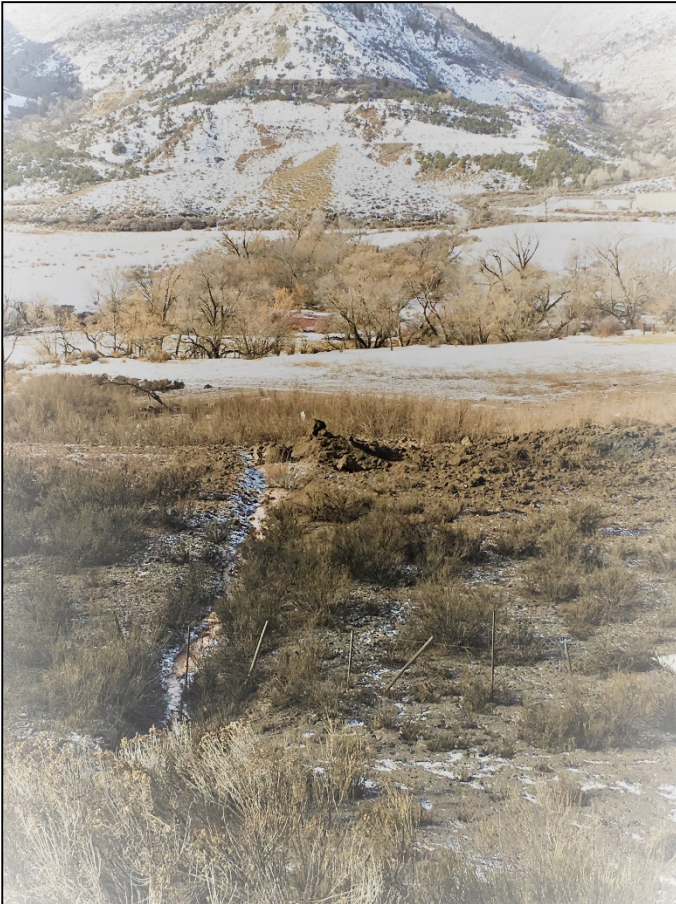
16" COPUC Gas Gathering Pipeline ruptured

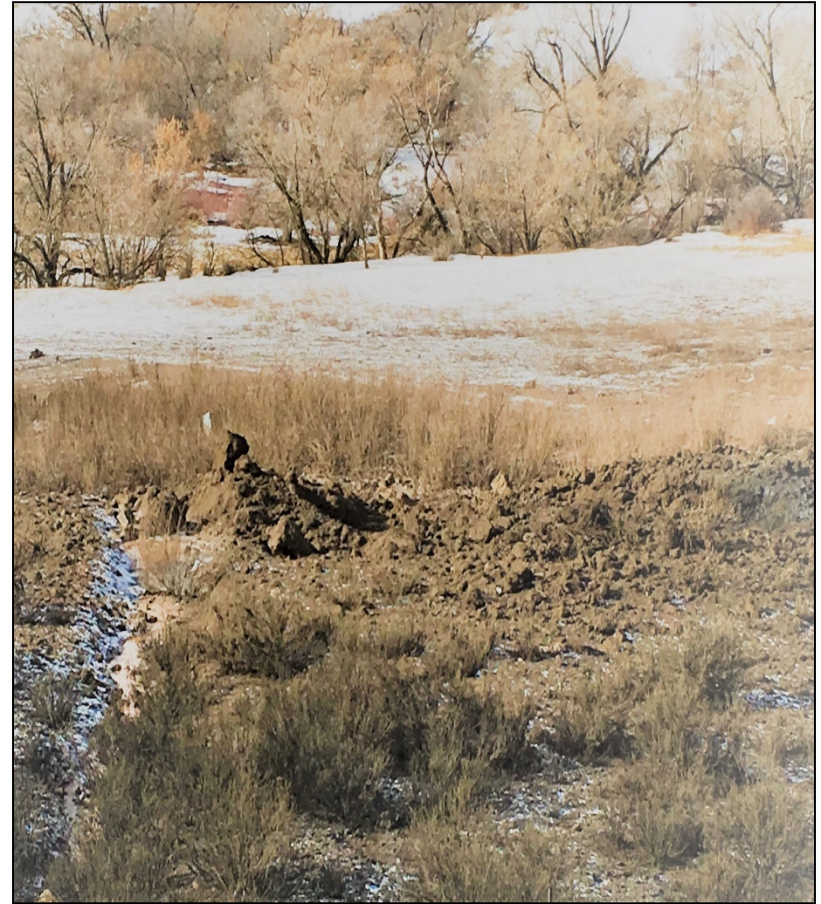
Closer view of Pipeline ruptured area

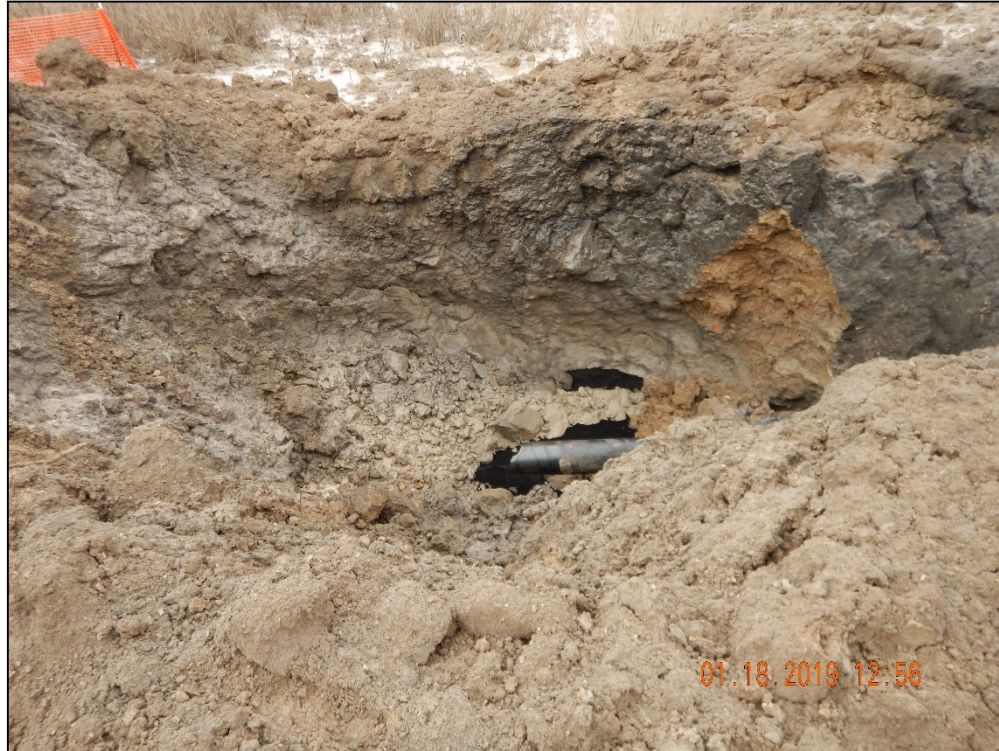
16" COPUC Gas Gathering Pipeline ruptured
