# Construction and Storm Water Inspection

Operator: EXTRACTION OIL & GAS INC – 10459

Location ID: 456747

Inspection Document #: 674902397

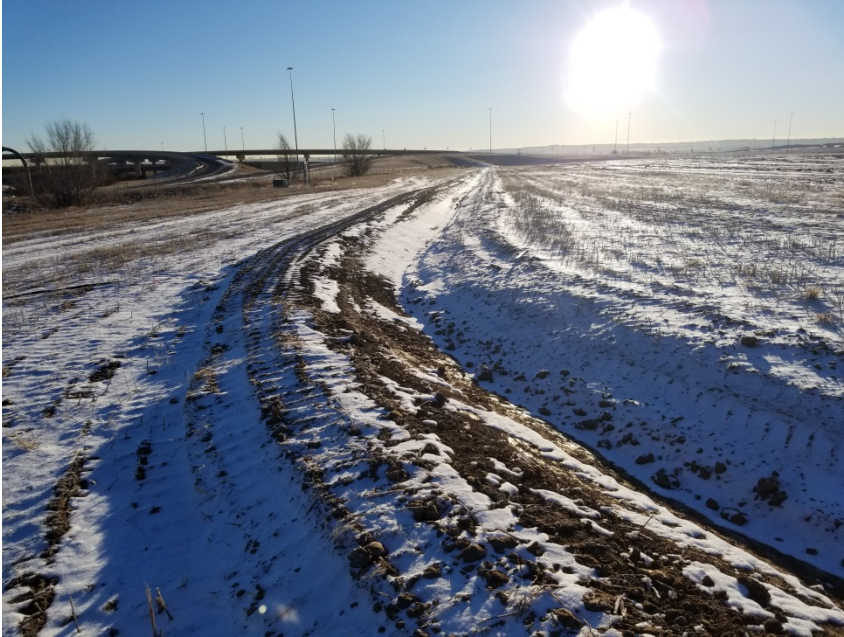
**Photo 1.** Photo taken from the northwestern perimeter of the location, facing East. Photo illustrates a ditch and berm BMP that has been installed around the perimeter of the location.

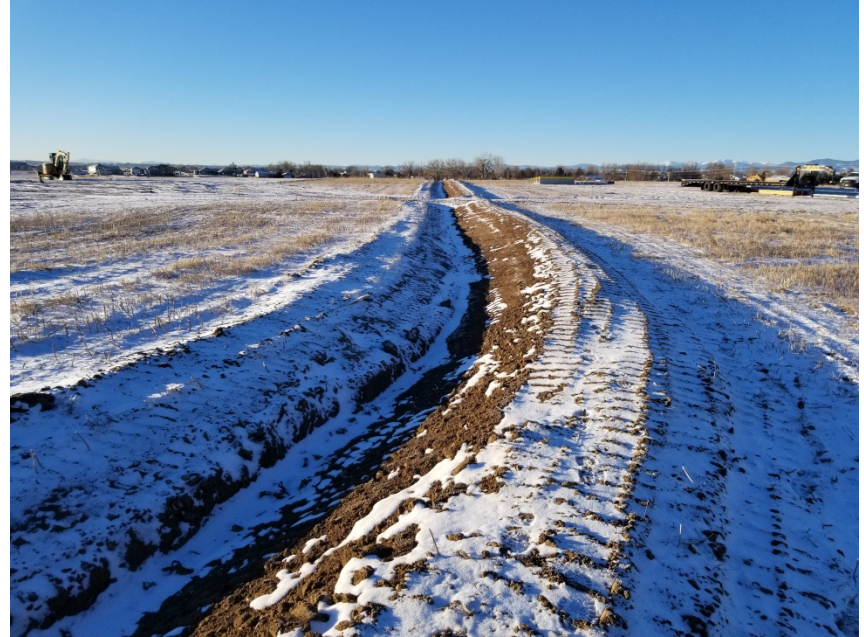
**Photo 2.** Photo taken from the northwestern perimeter of the location, facing West. See comments from Photo 1.

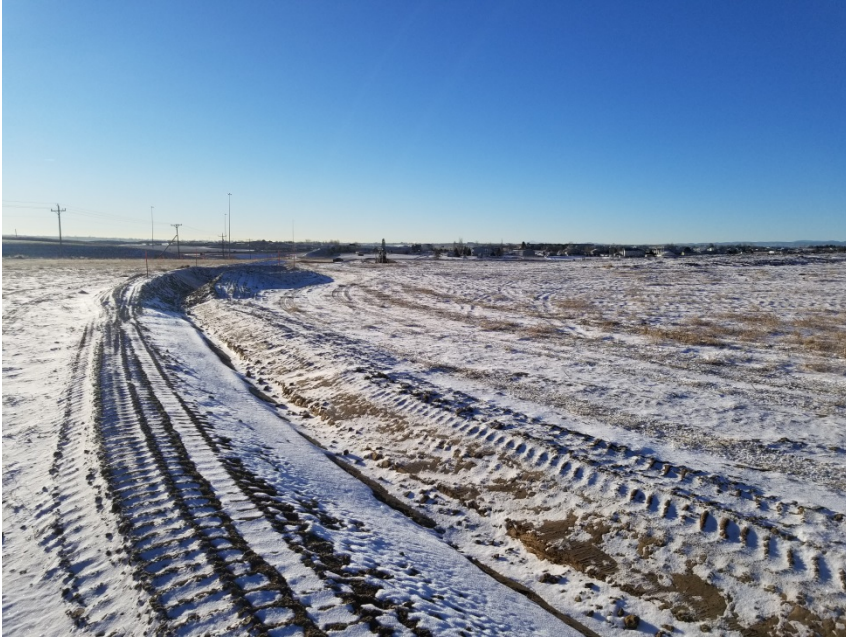
**Photo 3.** Photo taken from the northeastern perimeter of the location, facing East. See comments from Photo 1.

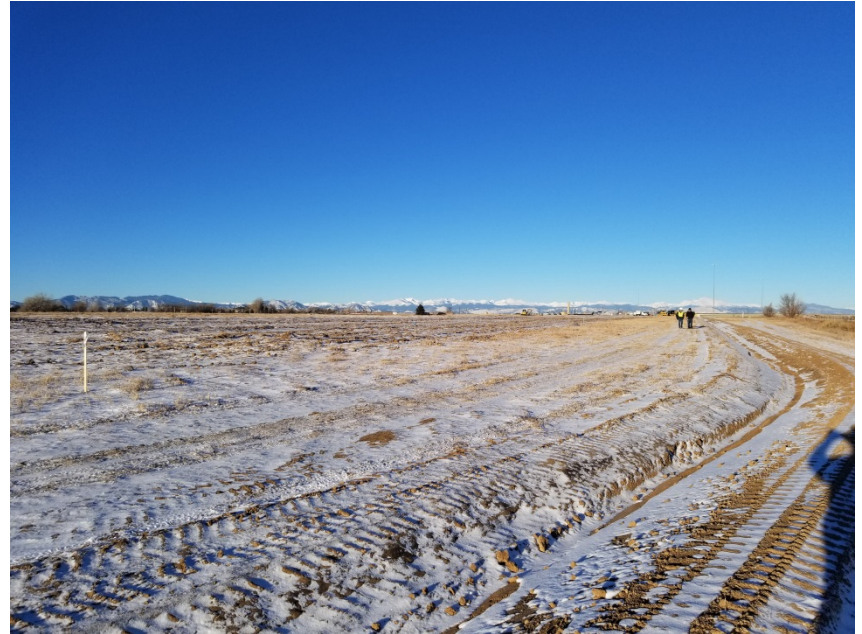
**Photo 4.** Photo taken from the northeastern perimeter of the location, facing West. See comments from Photo 1.

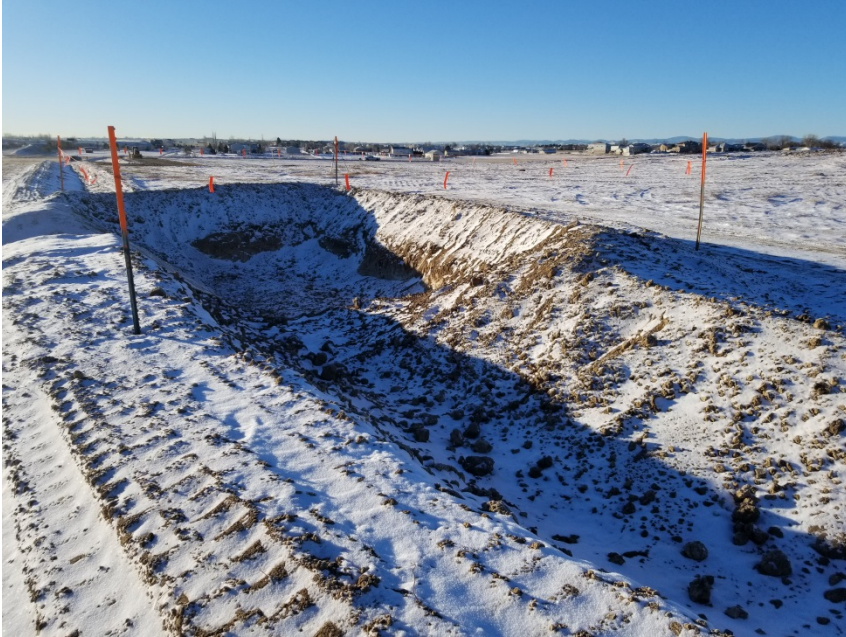
**Photo 5.** Photo taken from the Eastern perimeter of the location, facing South. Operator has installed a sediment trap with a temporarily stabilized outlet. See comments from Photo 1.

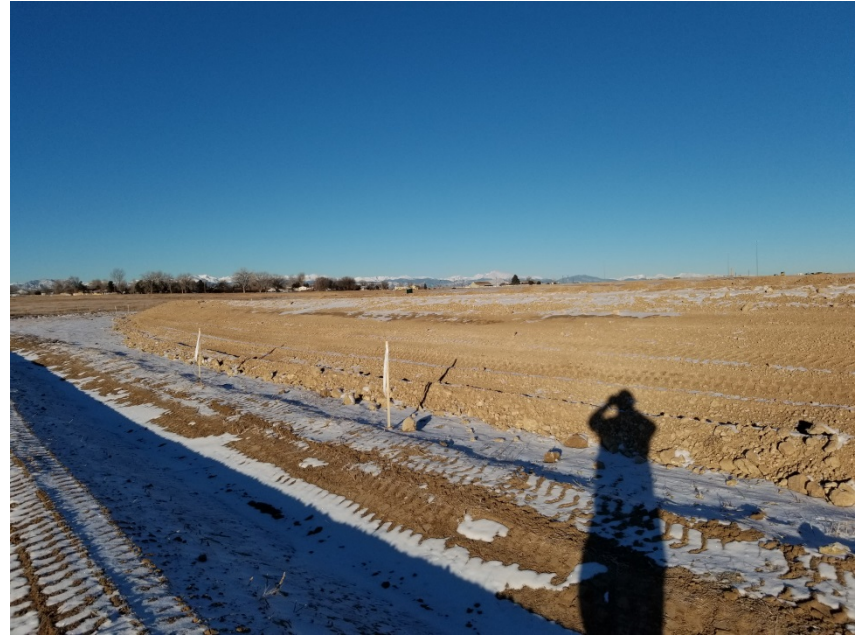
**Photo 6.** Photo taken from the southern perimeter of the location, facing West. See comments from Photo 1.

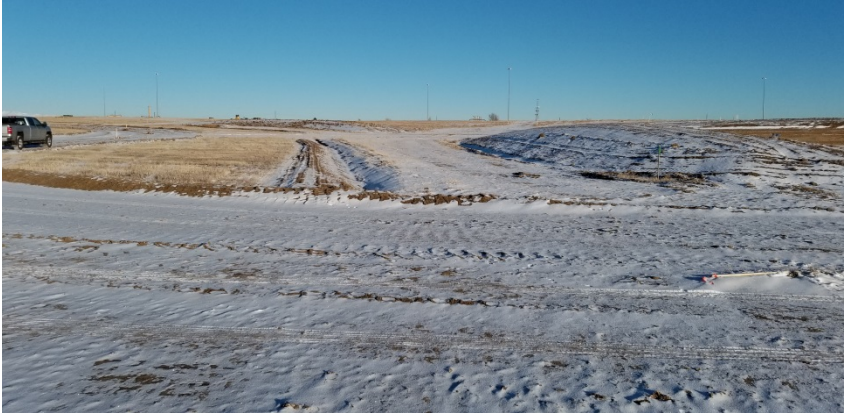
**Photo 7.** Photo taken from the southwestern perimeter of the location, facing West. The topsoil stockpile being stored along the eastern area has been temporarily stabilized with equipment tracking.

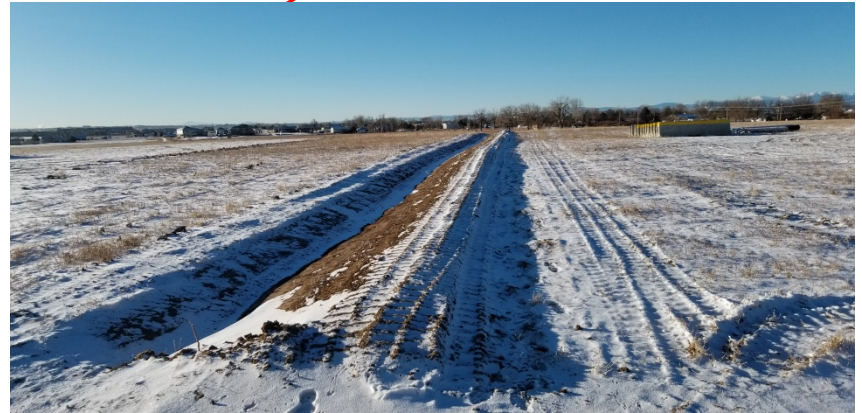
**Photo 8.** Photo taken from the western perimeter of the location, facing South. See comments under Photo 1.

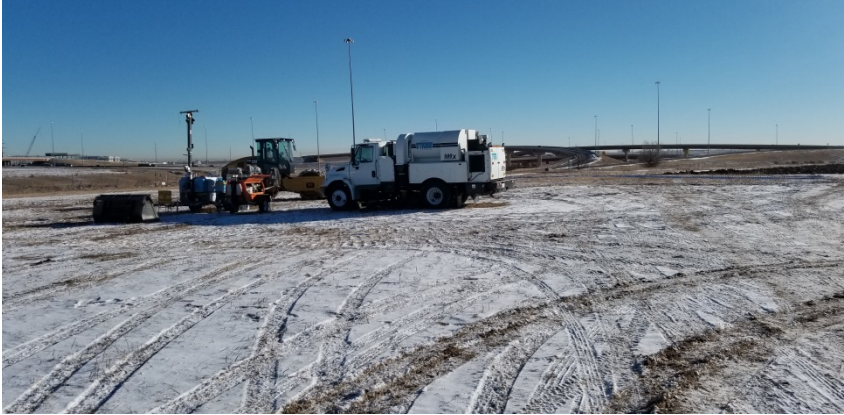
**Photo 9.** Photo taken from the northern perimeter of the location, facing East. Operator has a street sweeper on site 24/7 during construction operations.

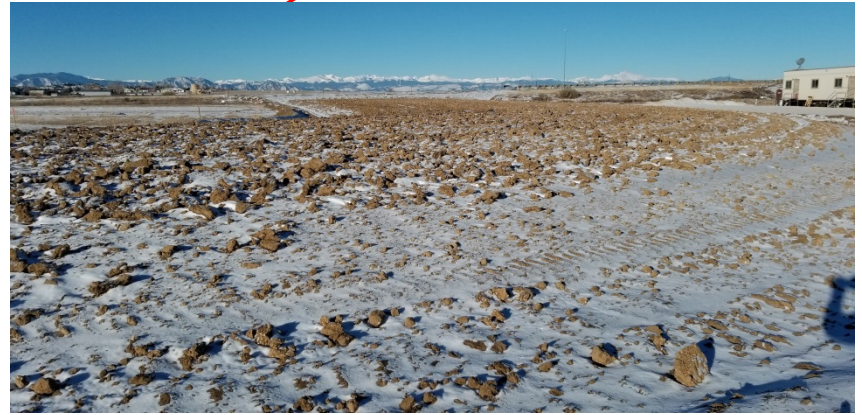
**Photo 10.** Photo taken from the access road, facing West. See comments from Photo 1.
