Inspection Photos
Location Name: RAZOR CLAM 23-27
Location ID: 308808

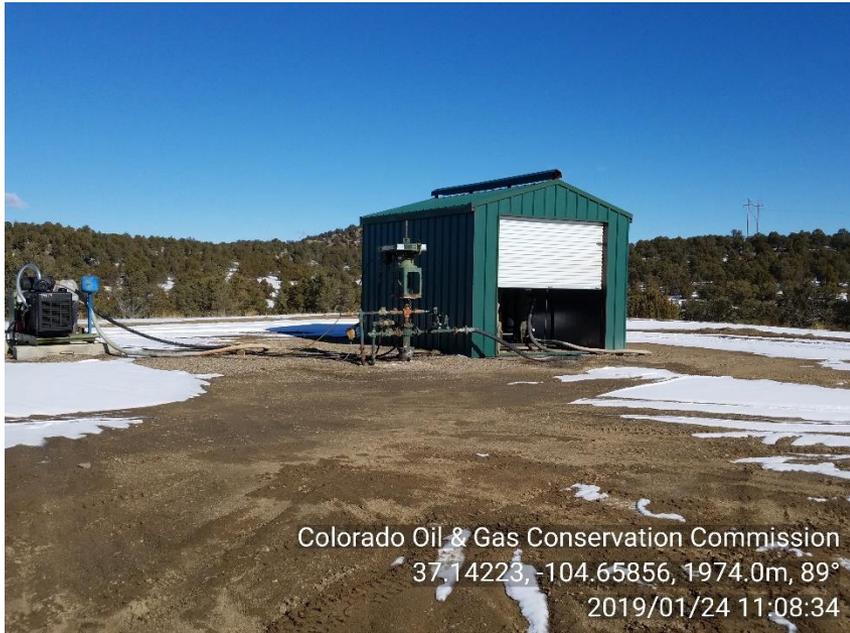
PHOTO 1: WELLHEAD

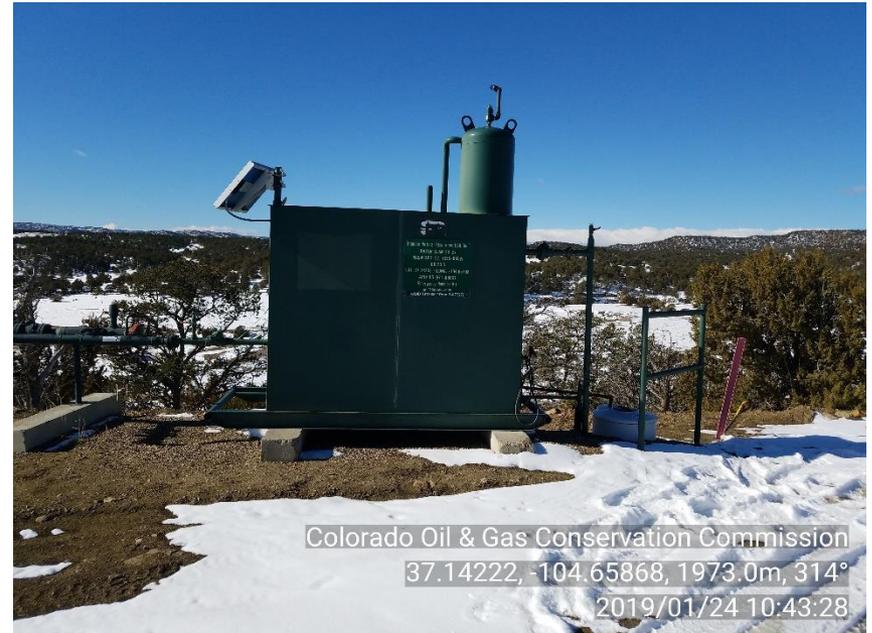
PHOTO 2: WELL SIGN/METER HOUSE

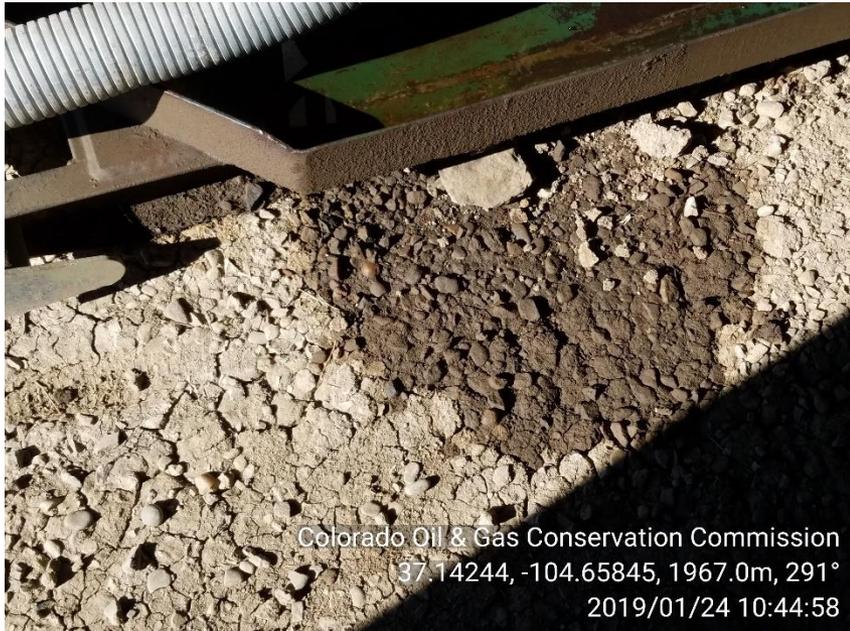
PHOTO 3: STAINED SOIL UNDER DRAIN PLUG ON COMPRESSOR SKED.

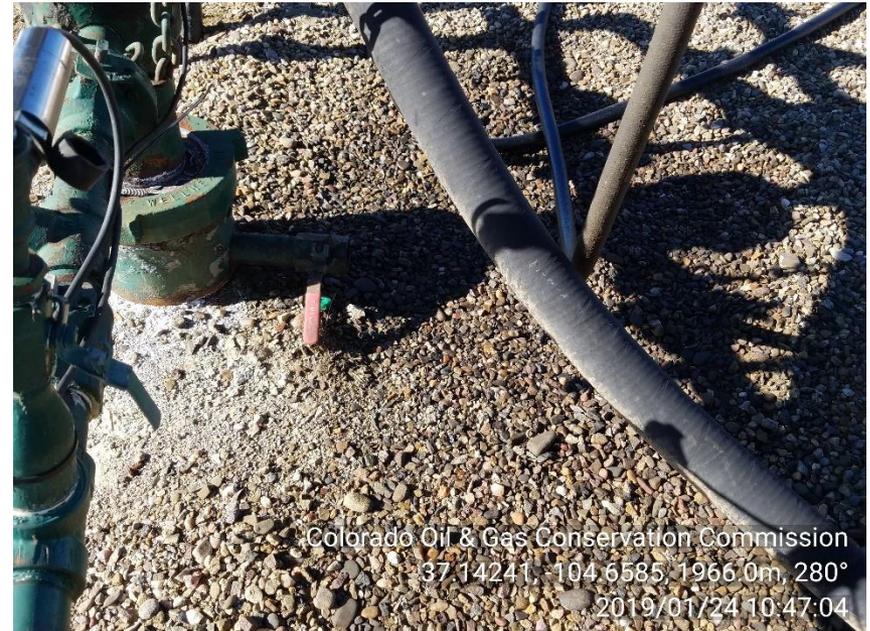
PHOTO 4: STAINED SOIL NEAR WELLHEAD

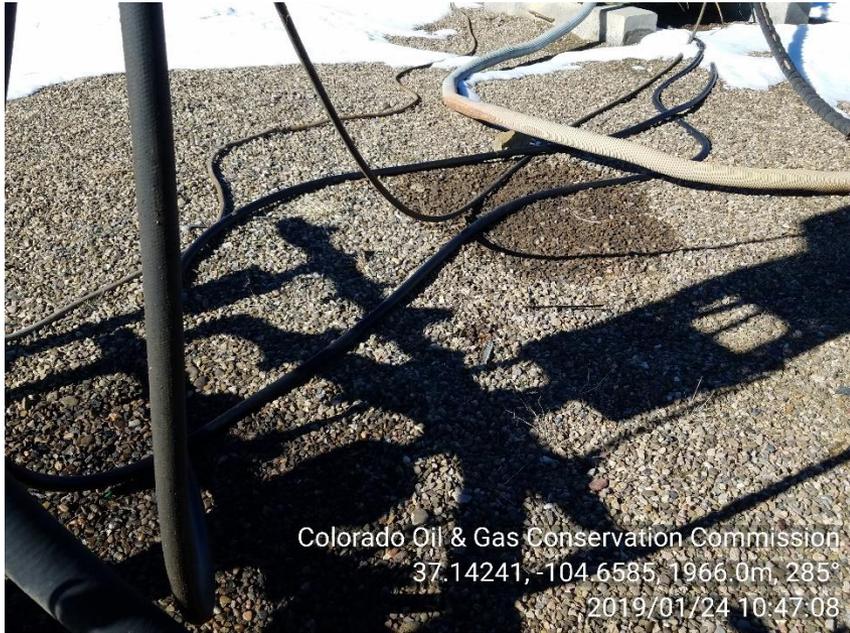
PHOTO 3: STAINED SOIL AROUND WELLHEAD AND BETWEEN ENGINE SKID.
