Inspection Photos
Location Name: ERMELINDA 22-26
API #: 05-071-07006

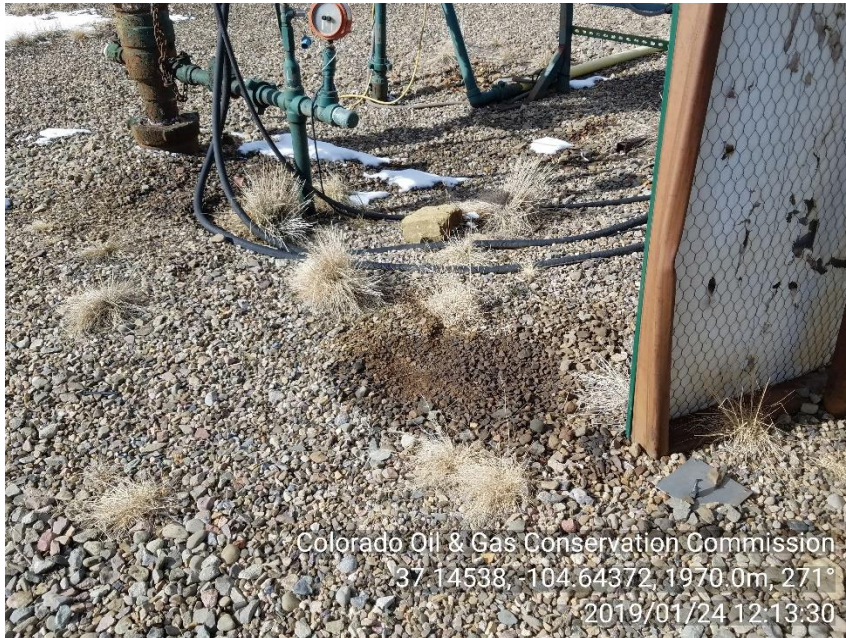
PHOTO 3: STAINED SOIL BETWEEN SOUND WALL AND WELLHEAD.

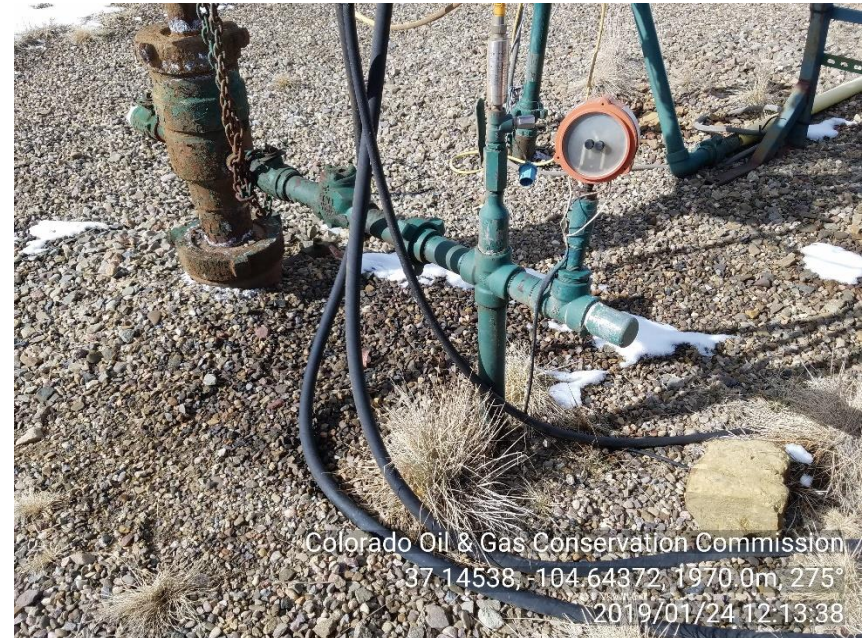
PHOTO 4: STAINED SOIL NEAR WELLHEAD.

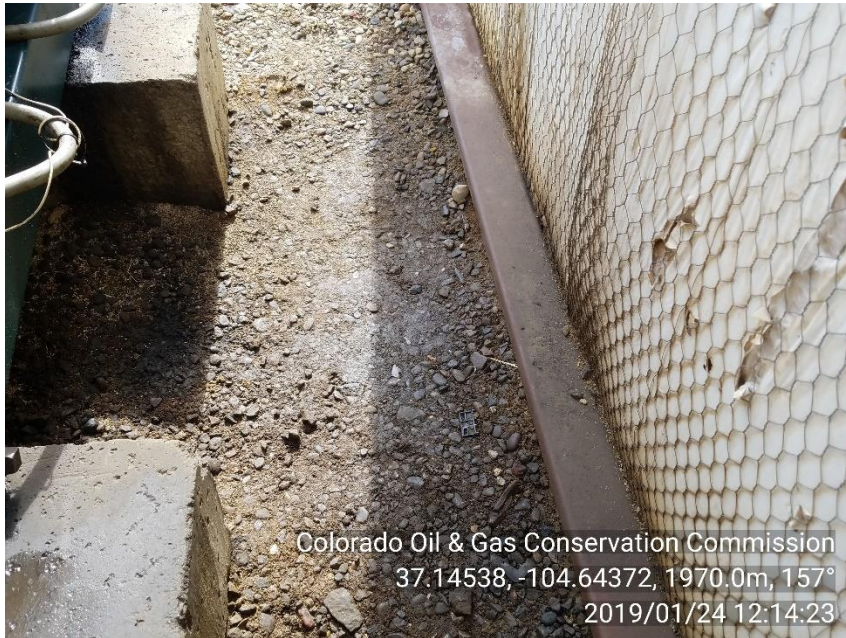
**PHOTO 5: STAINED SOIL NEAR ENGINE SKID ON WEST SIDE
INSIDE SOUND WALL.**

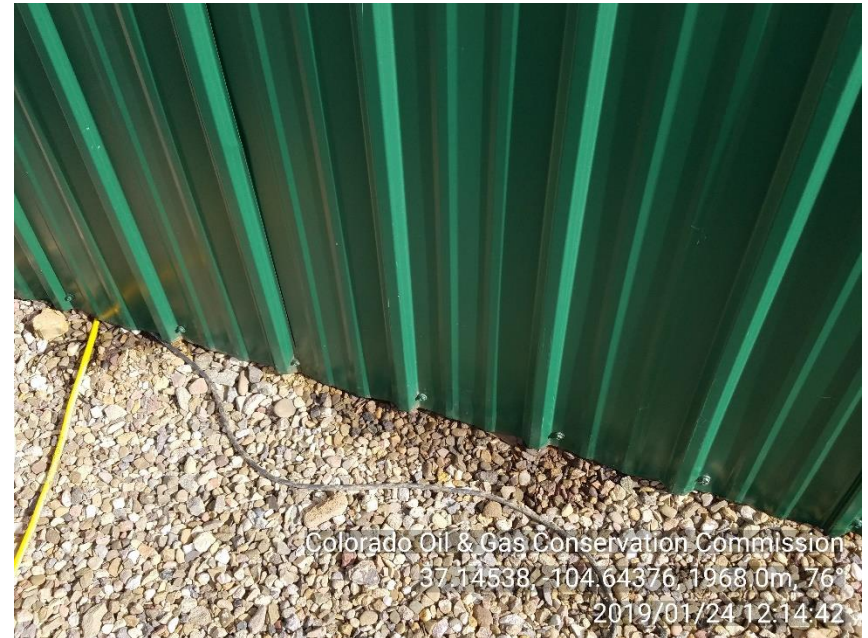
**PHOTO 6: STAINED SOIL SPREADING UNDER SOUND WALL
ON WEST SIDE.**

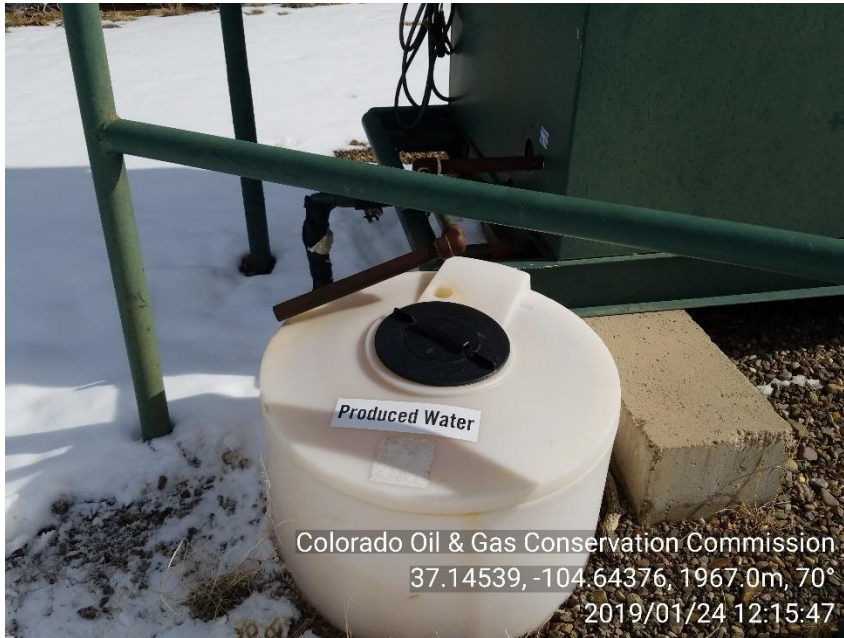
PHOTO 7: DRAIN FROM SEPARATOR INSIDE METER HOUSE IS NO LONGER PLUMBED TO PRODUCED WATER TANK MAKING IT APPEAR THAT SEPARATOR IS BEEING DRAINED ON THE GROUND WHICH WOULD BE A COGCC RULE VIOLATION. CANNOT CONFIRM DUE TO SNOW COVERING GROUND IN THE VICINITY OF SEPARATOR DRAIN.

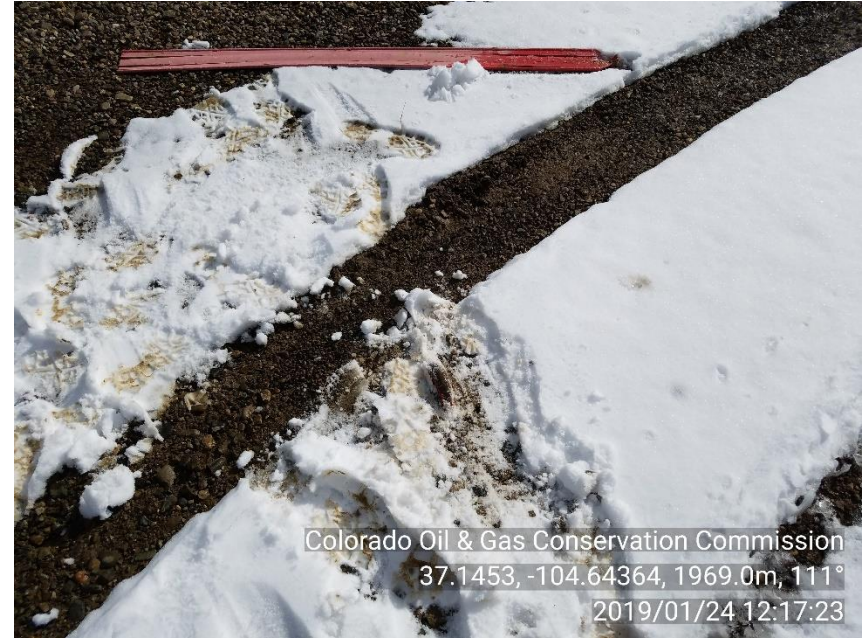
PHOTO 8: ANCHOR MARKER IS DOWN THIS IS A CORRECTIVE ACTION ON PREVIOUS INSPECTION DOC# 03636879
