# Inspection Photos

Operator: BAYHORSE PETROLEUM LLC - 10234

Location ID: 384908

Inspection Doc. Number: 682504424

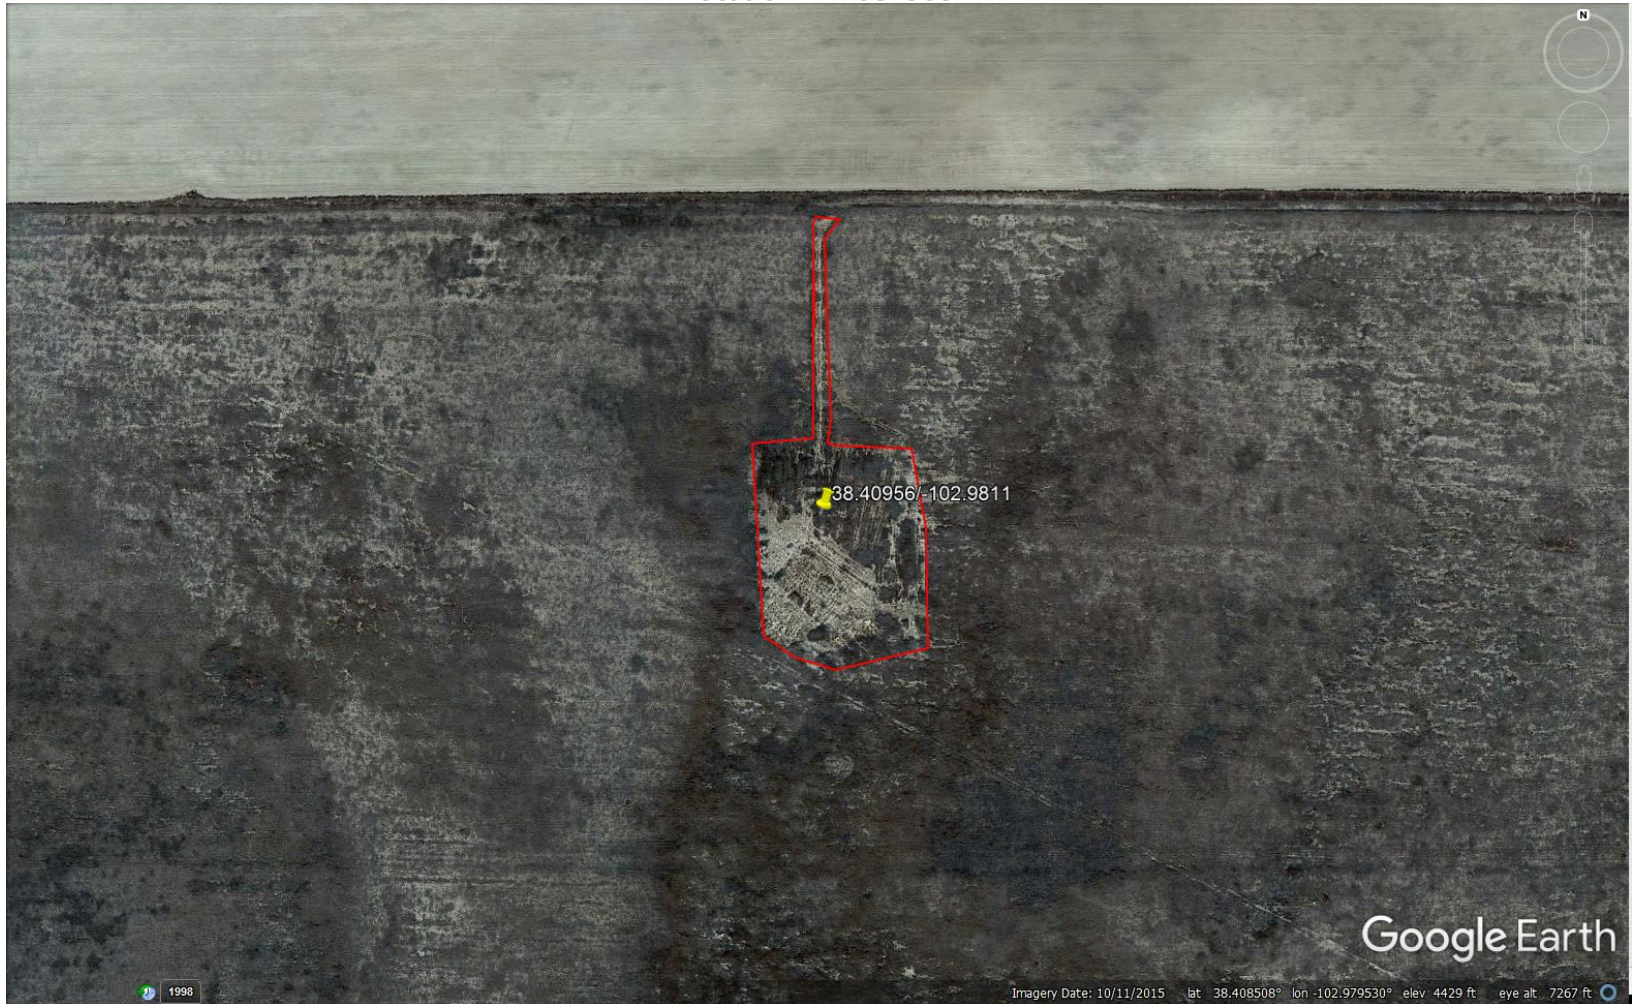
**Photo 1:** 2017 Google Earth aerial image. Photo shows areas of the location (red polygon, ~4 acres) where vegetation has not achieved a uniform desirable perennial vegetative cover. Photo also shows access road. Access road remains predominantly bare and exposed soil.

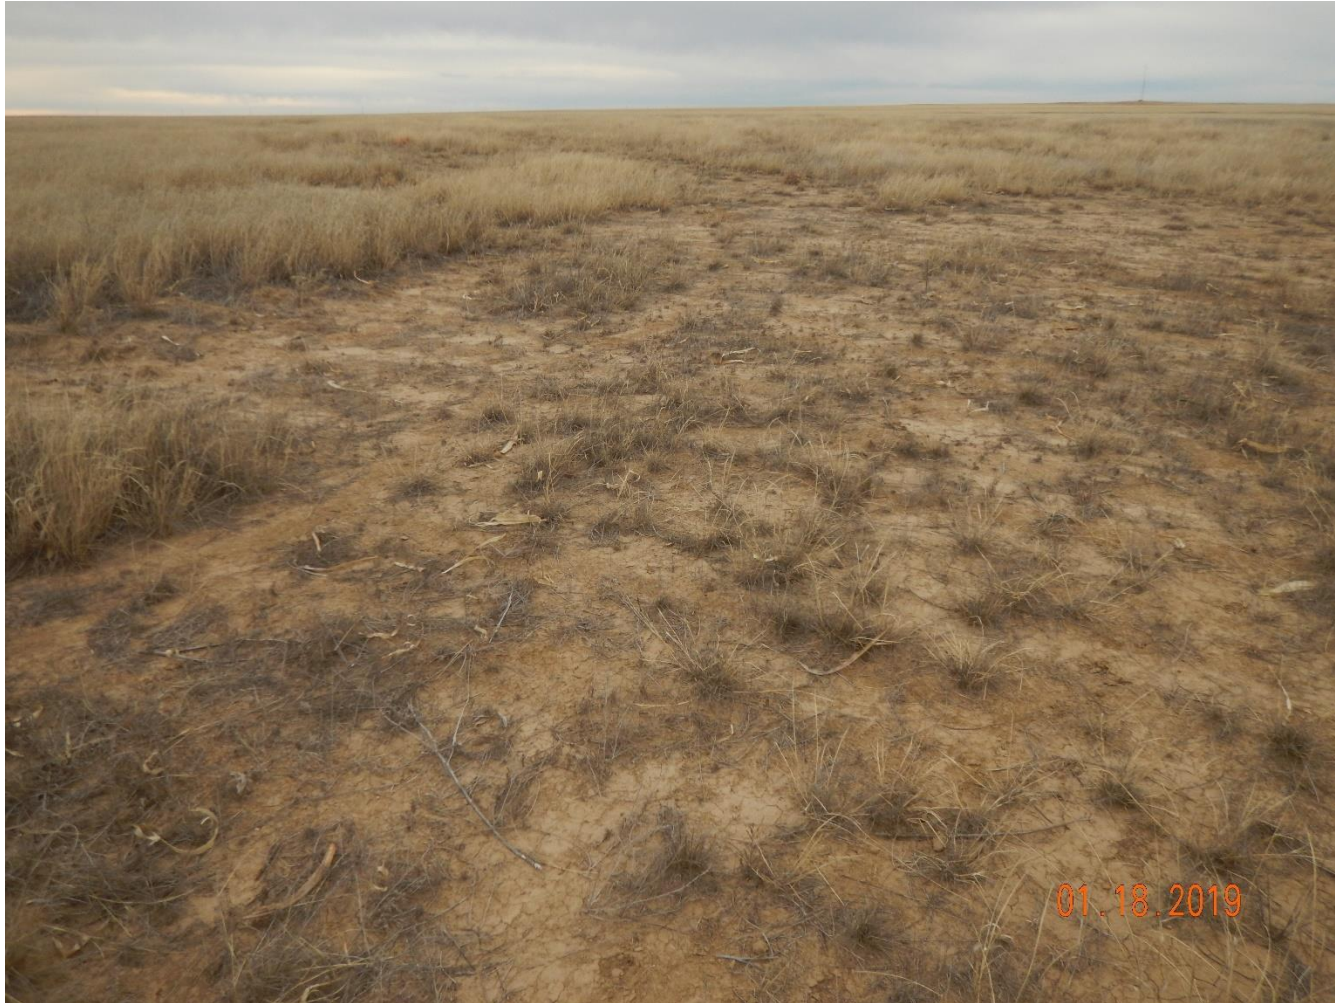
**Photo 2:** Photo taken from the western end of the location, facing east. Photo shows large areas of the location that remains predominantly bare and exposed soil.

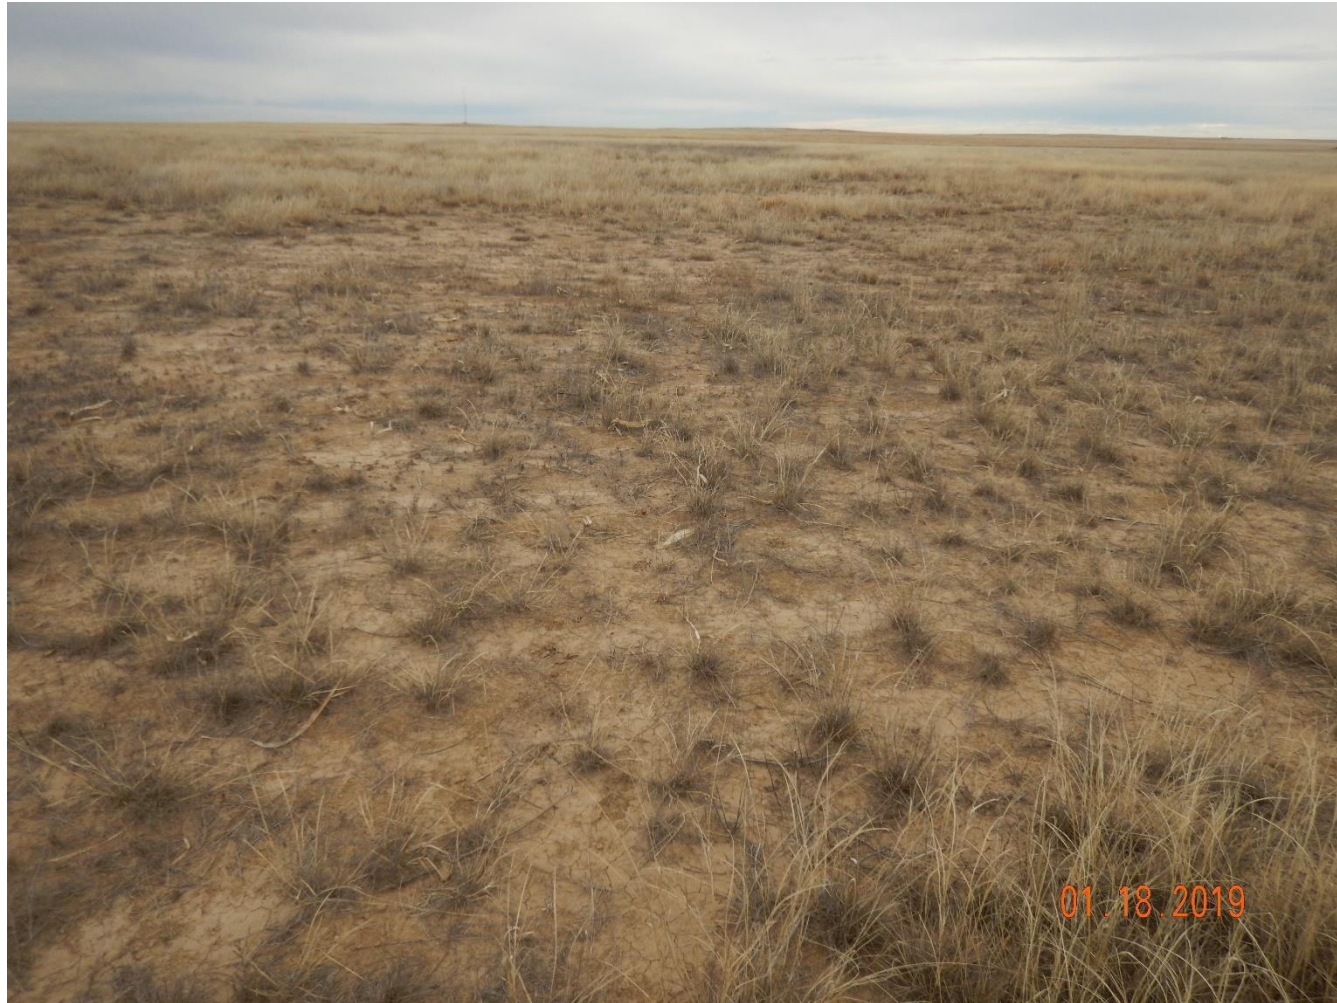
**Photo 3:** Photo taken from the western end of the location, facing southeast. See comments under photo 2.

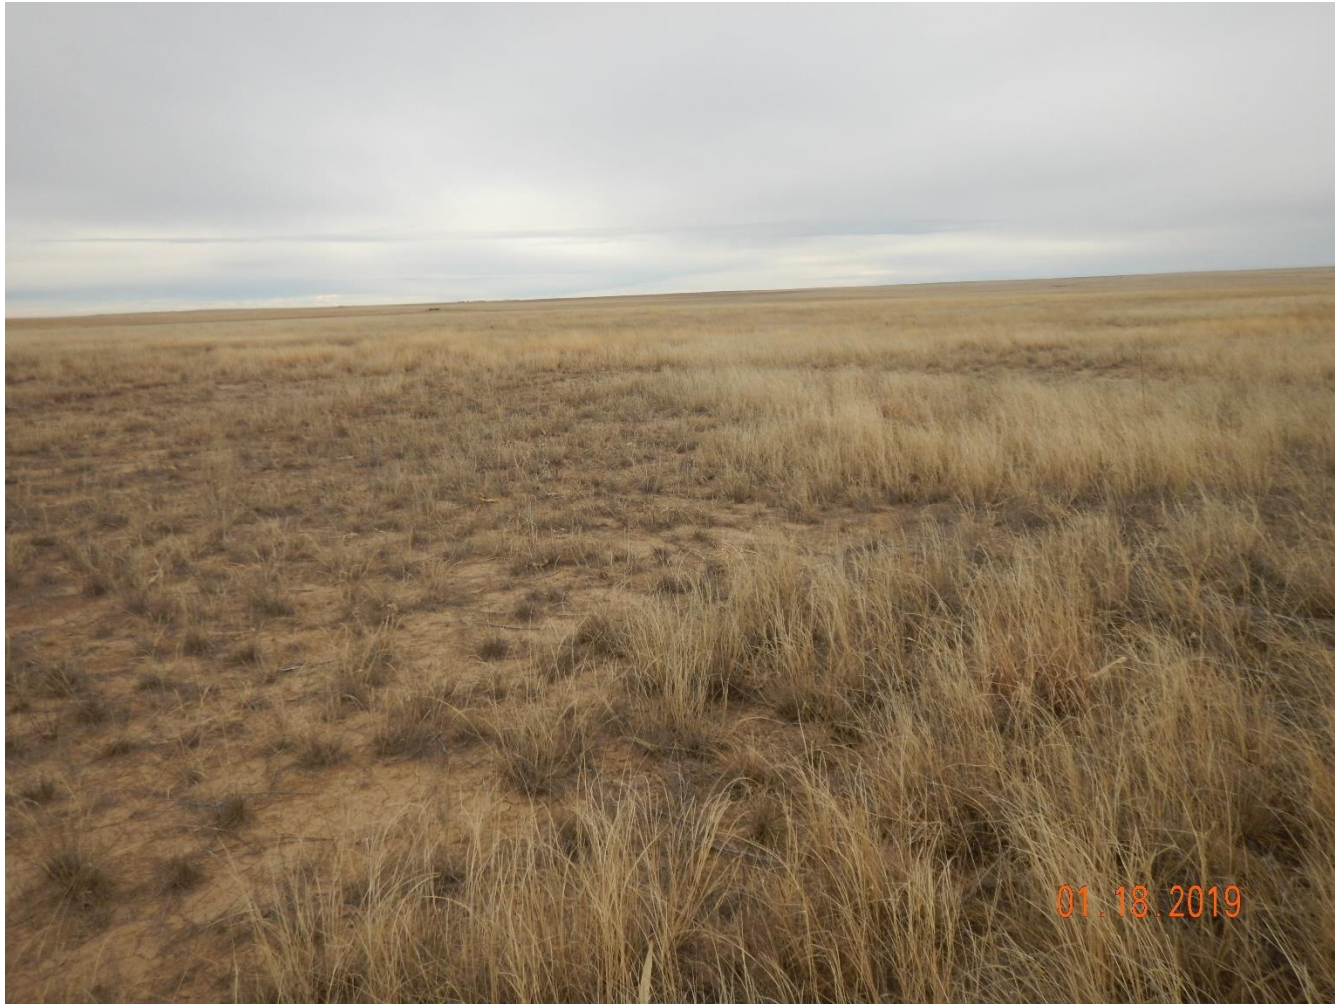
**Photo 4:** Photo taken from the western end of the location, facing south. See comments under photo 2.

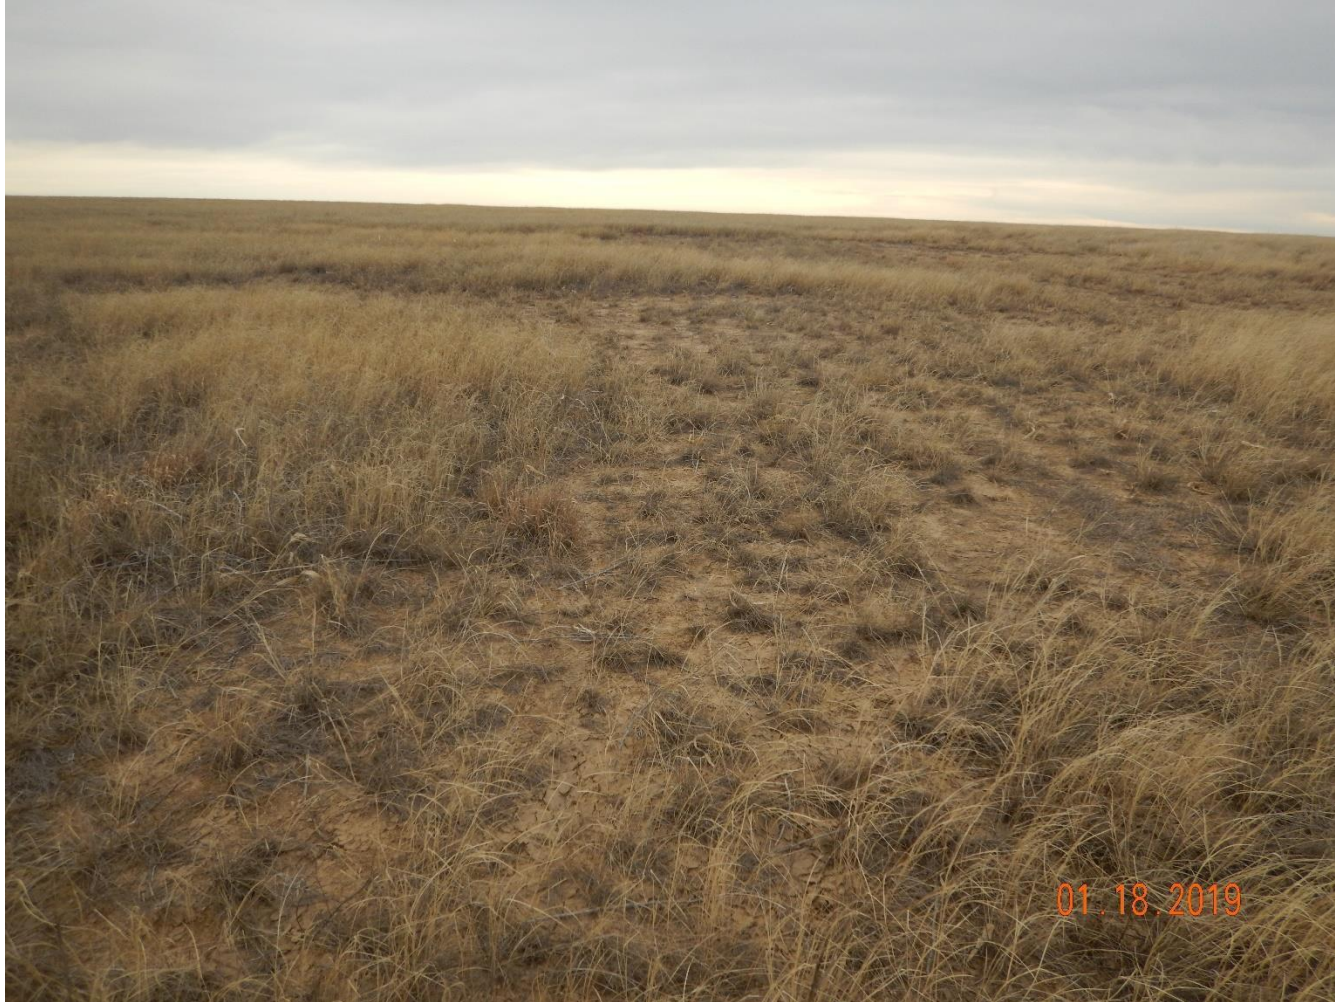
**Photo 5:** Photo taken from the western end of the location, facing east. See comments under photo 2.

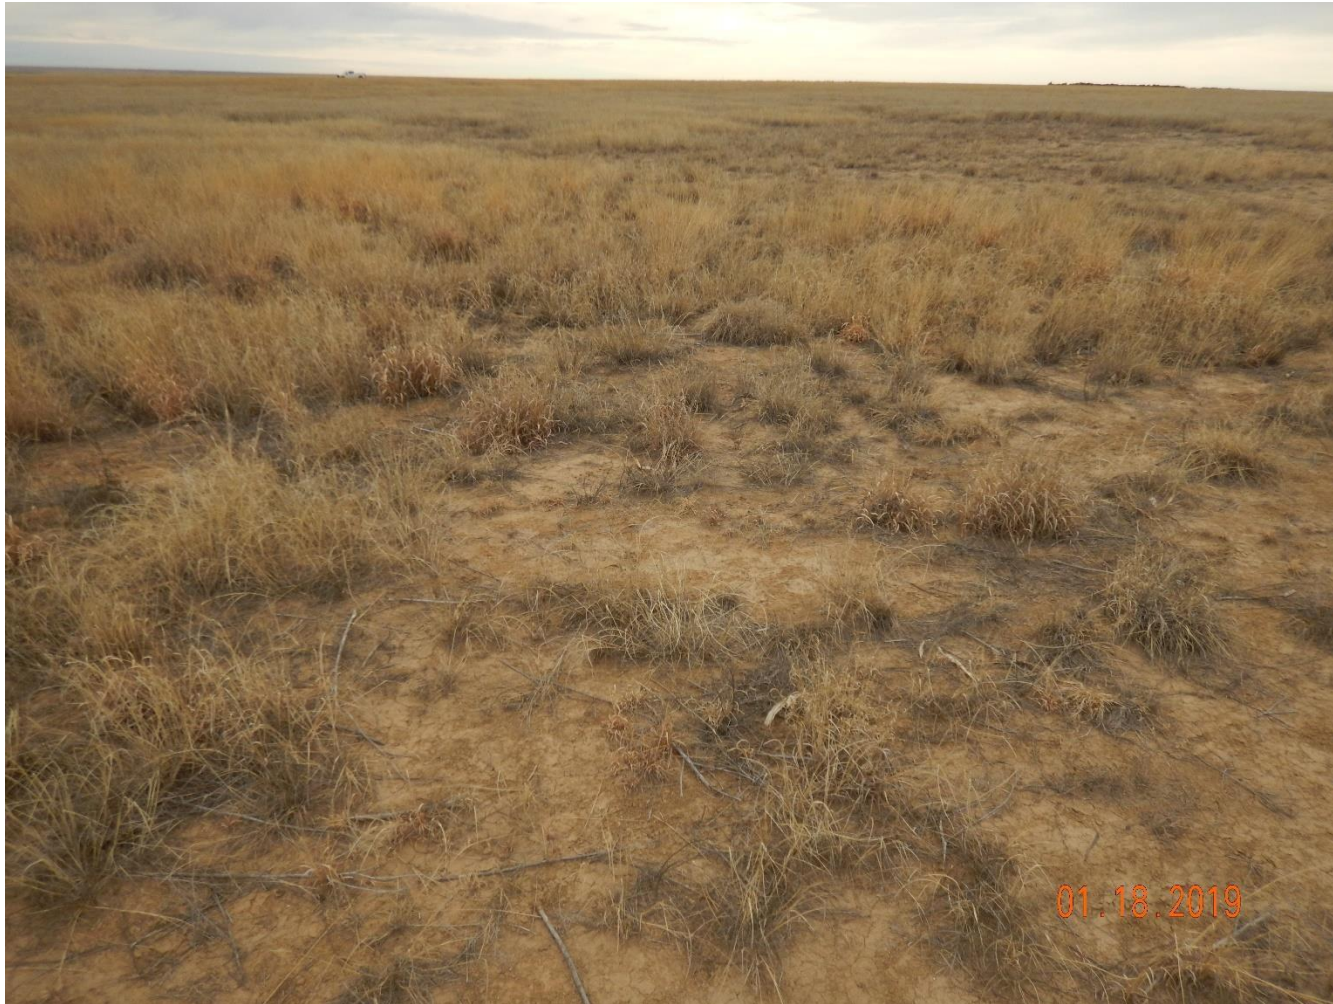
**Photo 6:** Photo taken from the central areas of the location, facing south. Though there are patchy areas where vegetation establishment is occurring, location is largely bare and exposed soil.

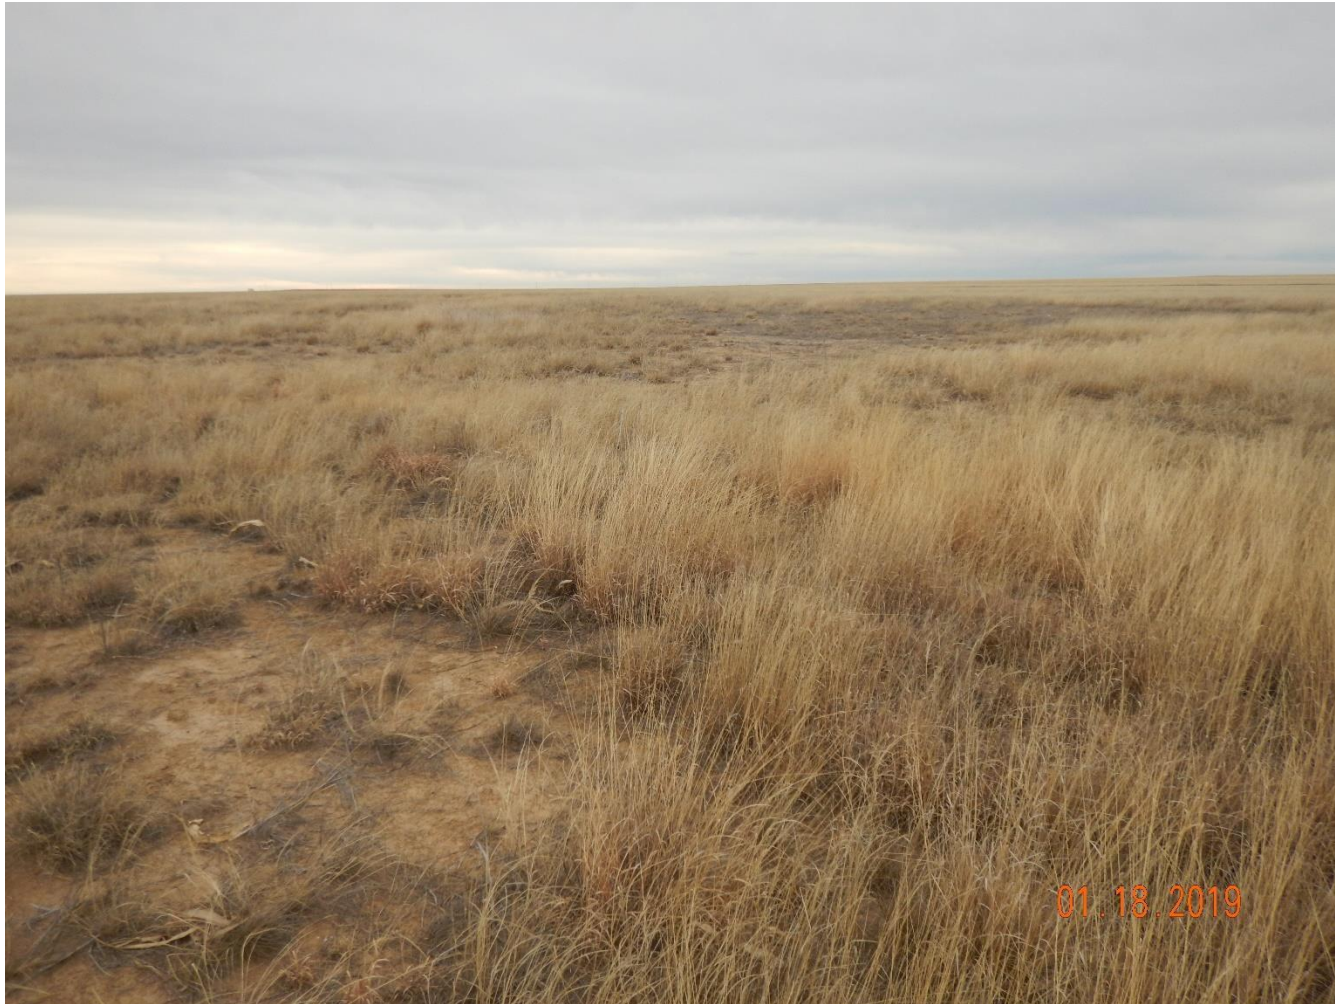
**Photo 7:** Photo taken from the central areas of the location, facing south. See comments under photo 6.

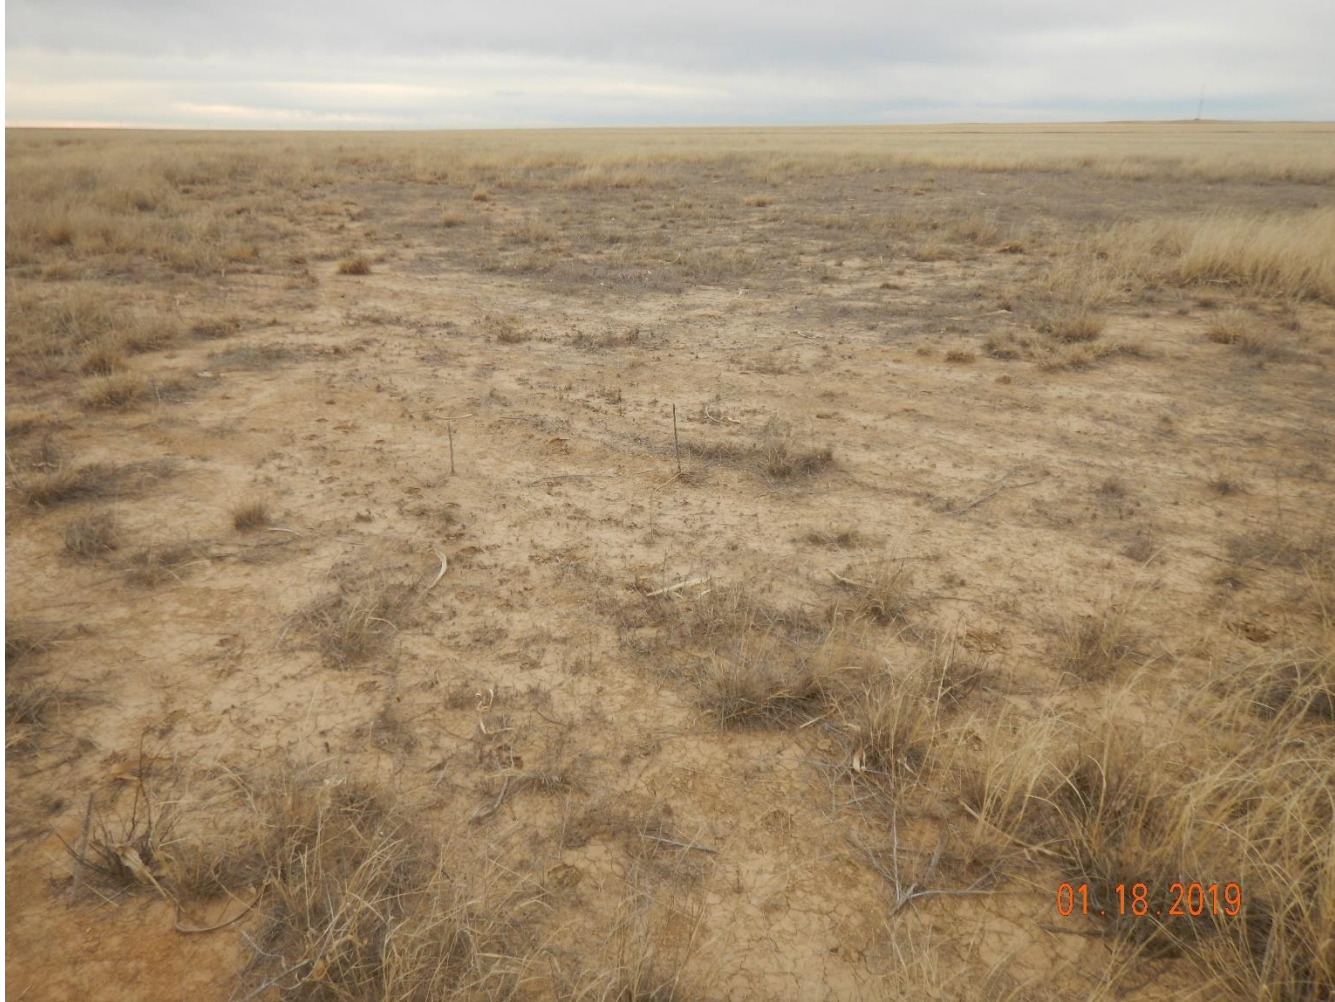
**Photo 8:** Photo taken from the south-central area of the location, facing south. Photo shows large areas of the location that remains predominantly bare and exposed soil.

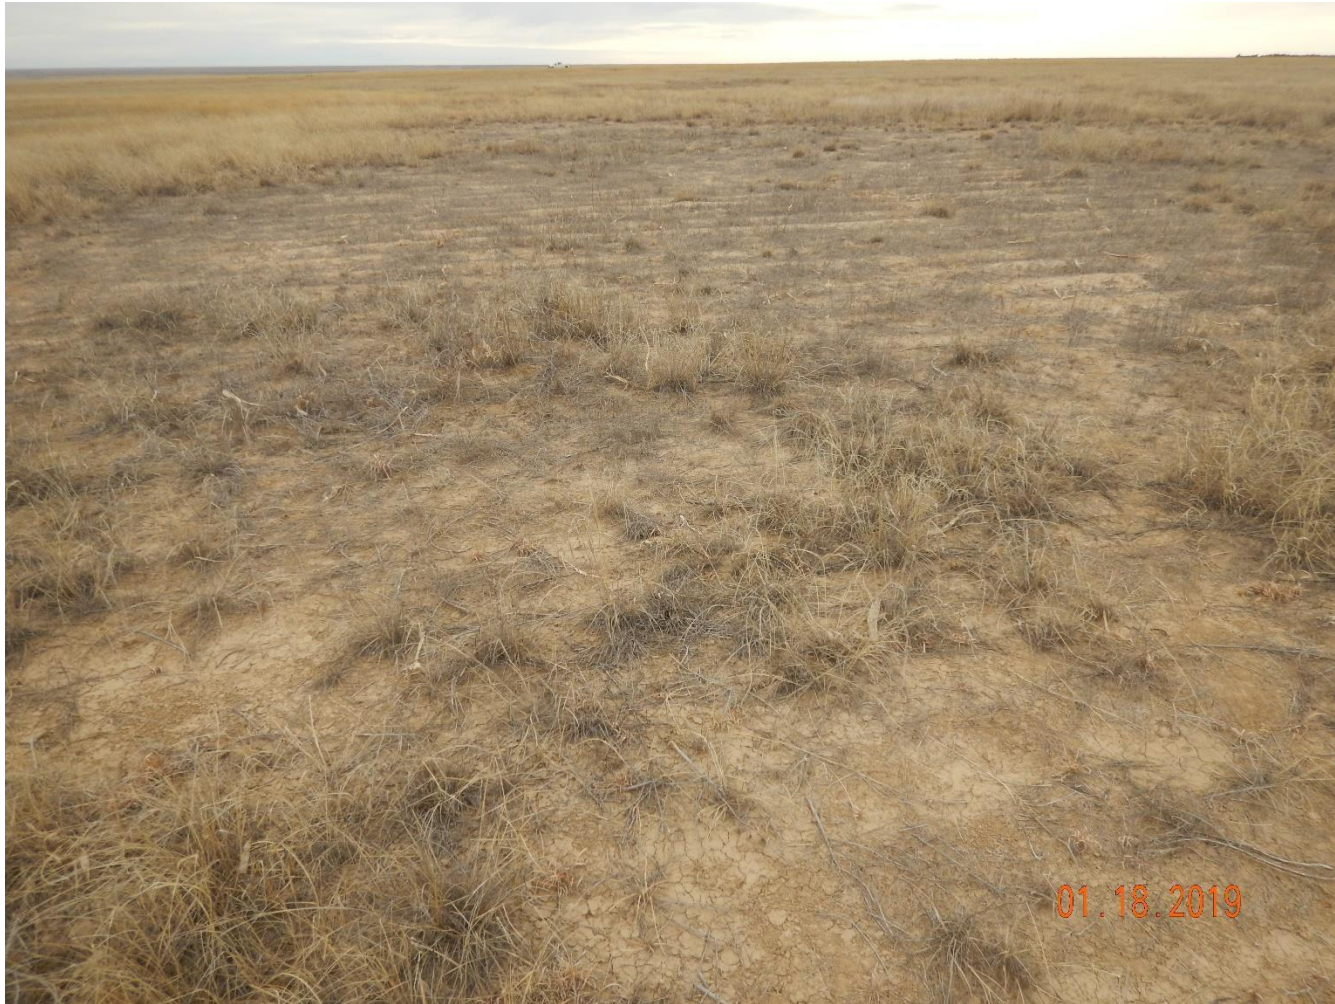
**Photo 9:** See comments under photo 8.

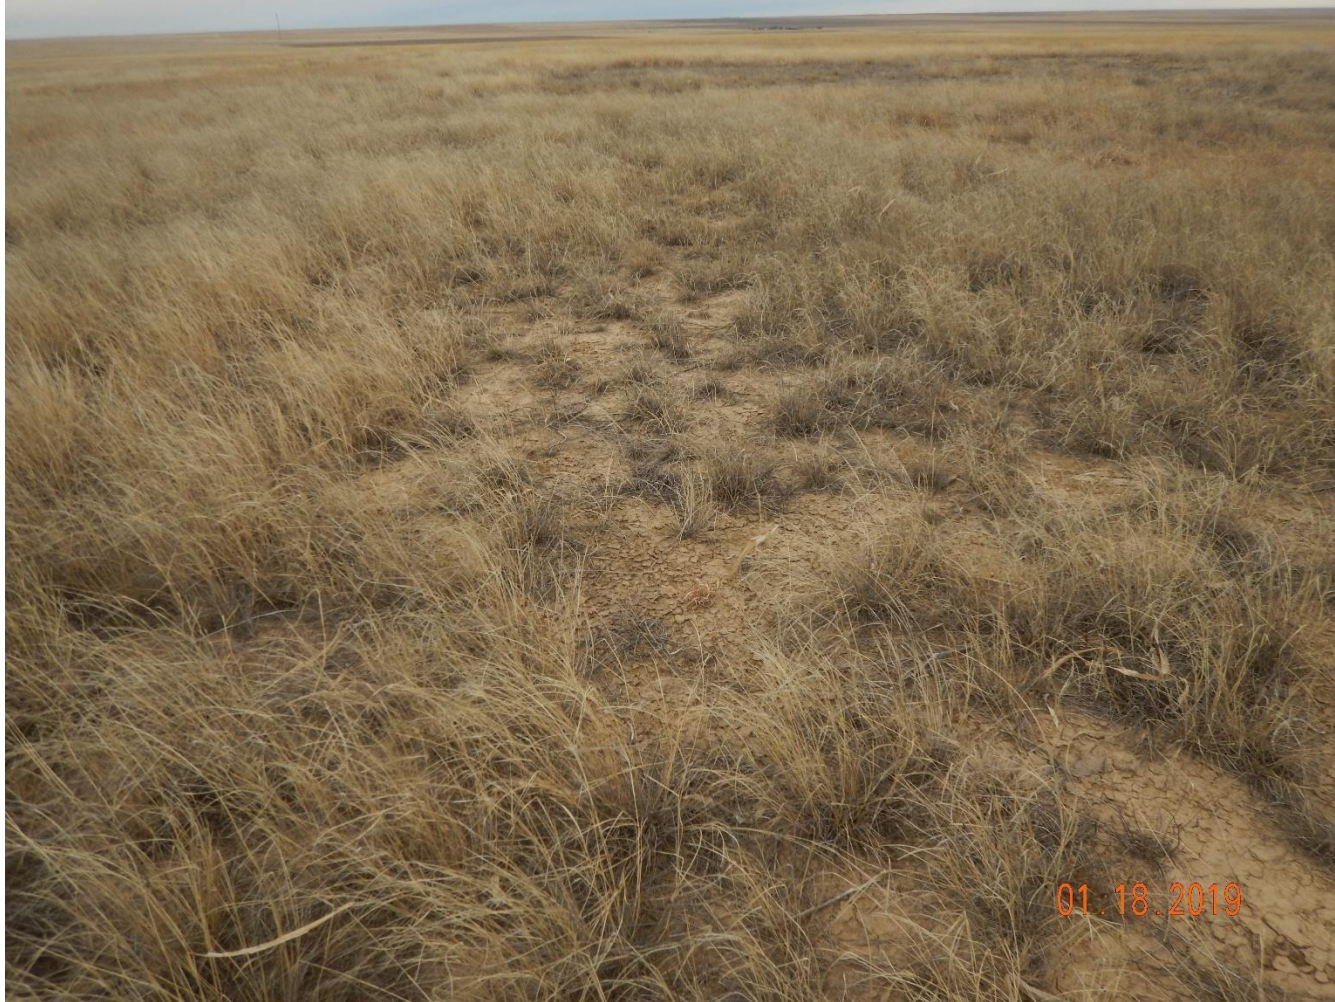
**Photo 10:** Photo taken from the southeastern end of the location, facing west. Photo shows areas where although there are patchy areas where vegetation establishment is occurring, vegetation establishment is not uniform throughout the location.

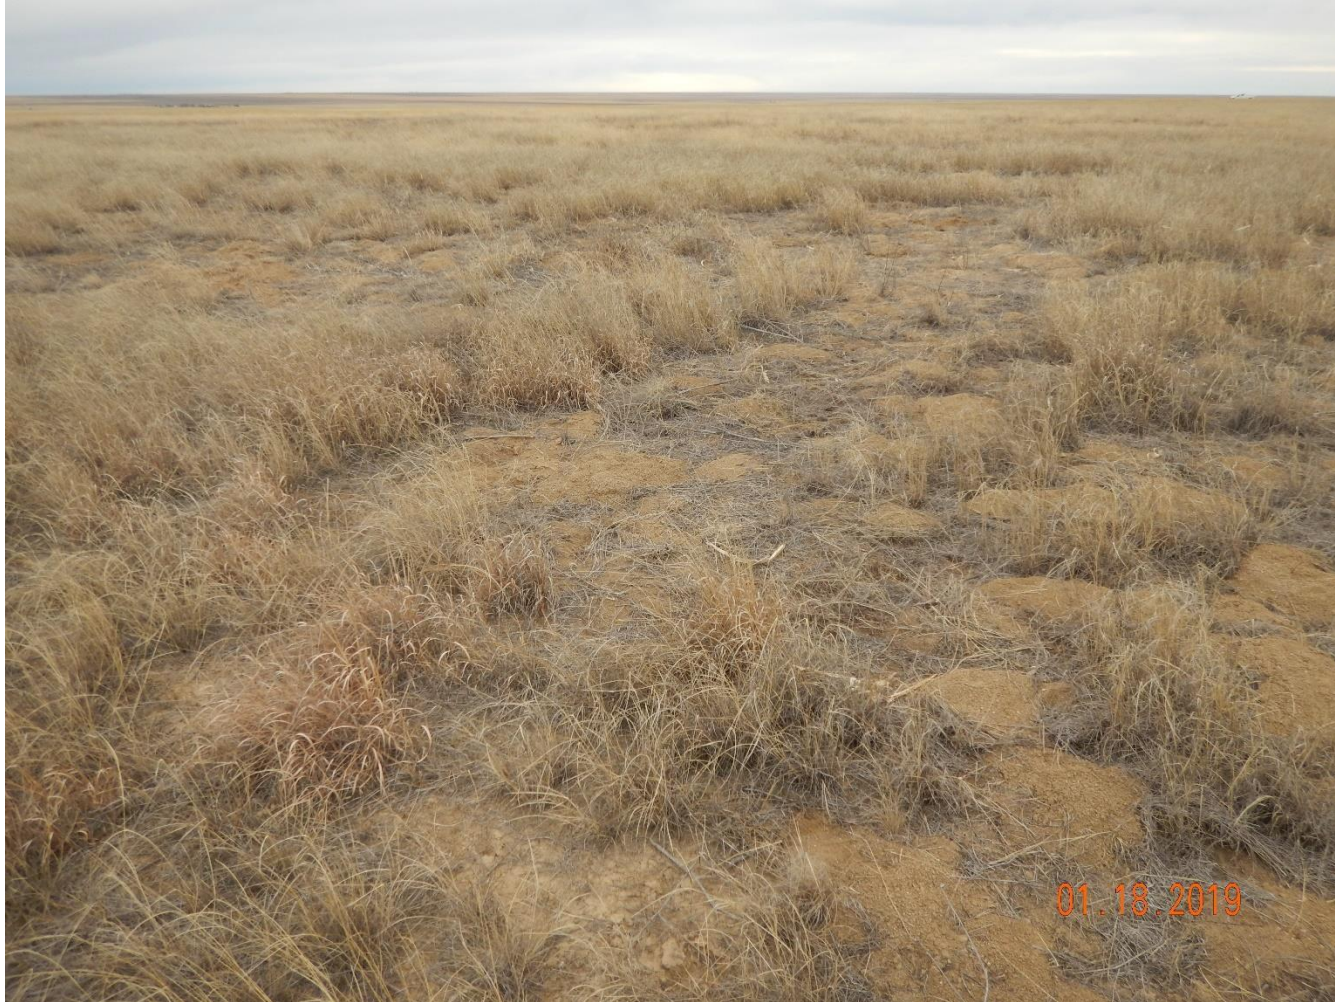
**Photo 11:** Photo taken from the southeastern end of the location, facing northwest.  
See comments under photo 12.

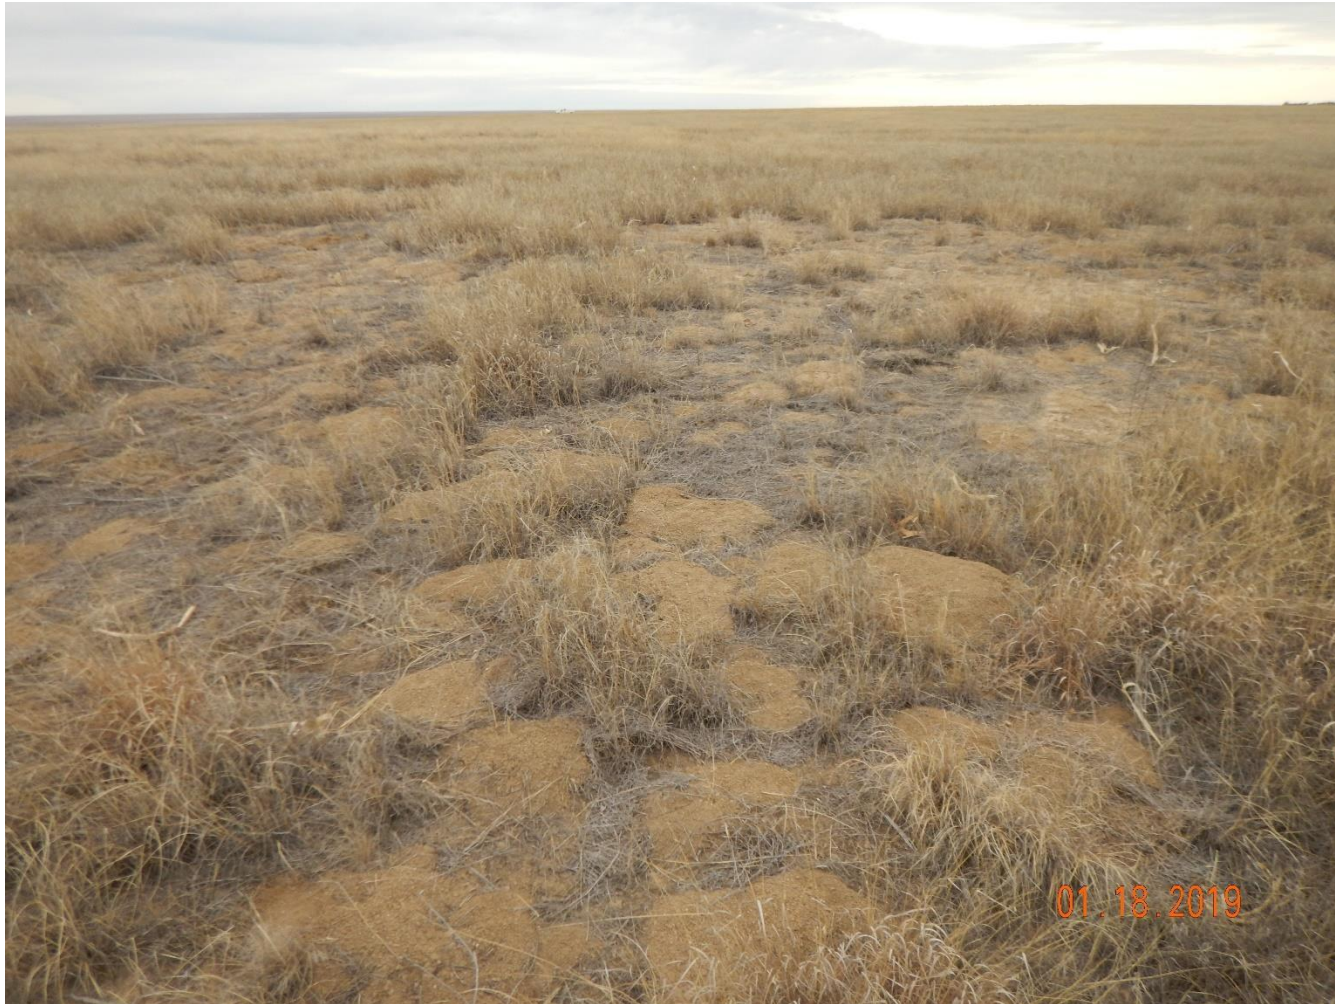
**Photo 12:** Photo taken from the southeastern end of the location, facing north. See comments under photo 12.

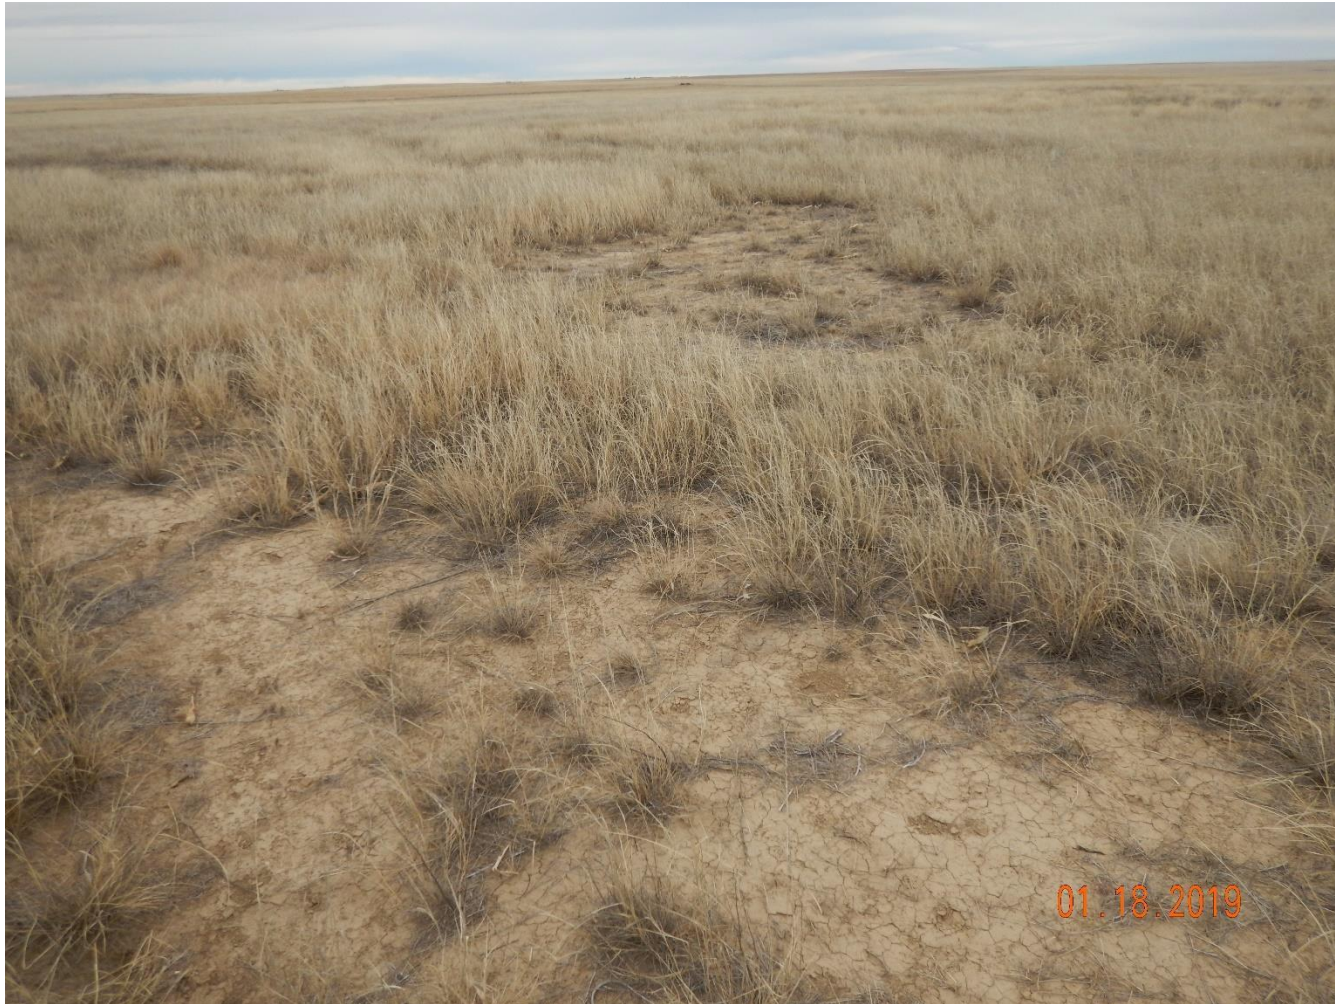
**Photo 13:** Photo taken from the northeastern end of the location, facing west. See comments under photo 12.

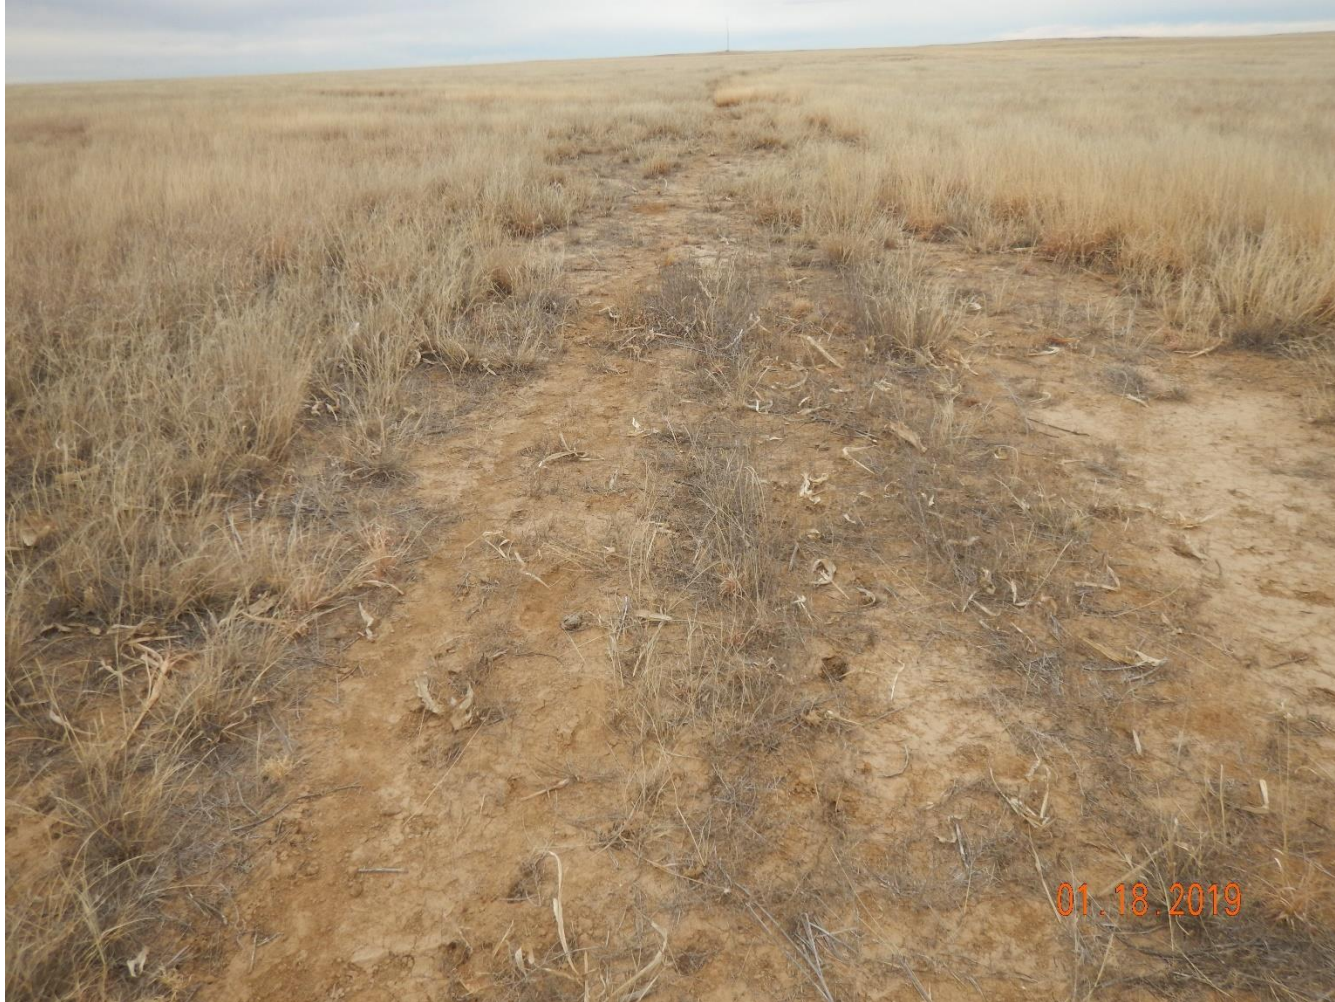
**Photo 14:** Photo taken from the north end of the location, facing north. Photo shows access road. Though there are areas of the access road where vegetation establishment is occurring, vegetation establishment is not uniform; access road remains predominantly bare and exposed soil.

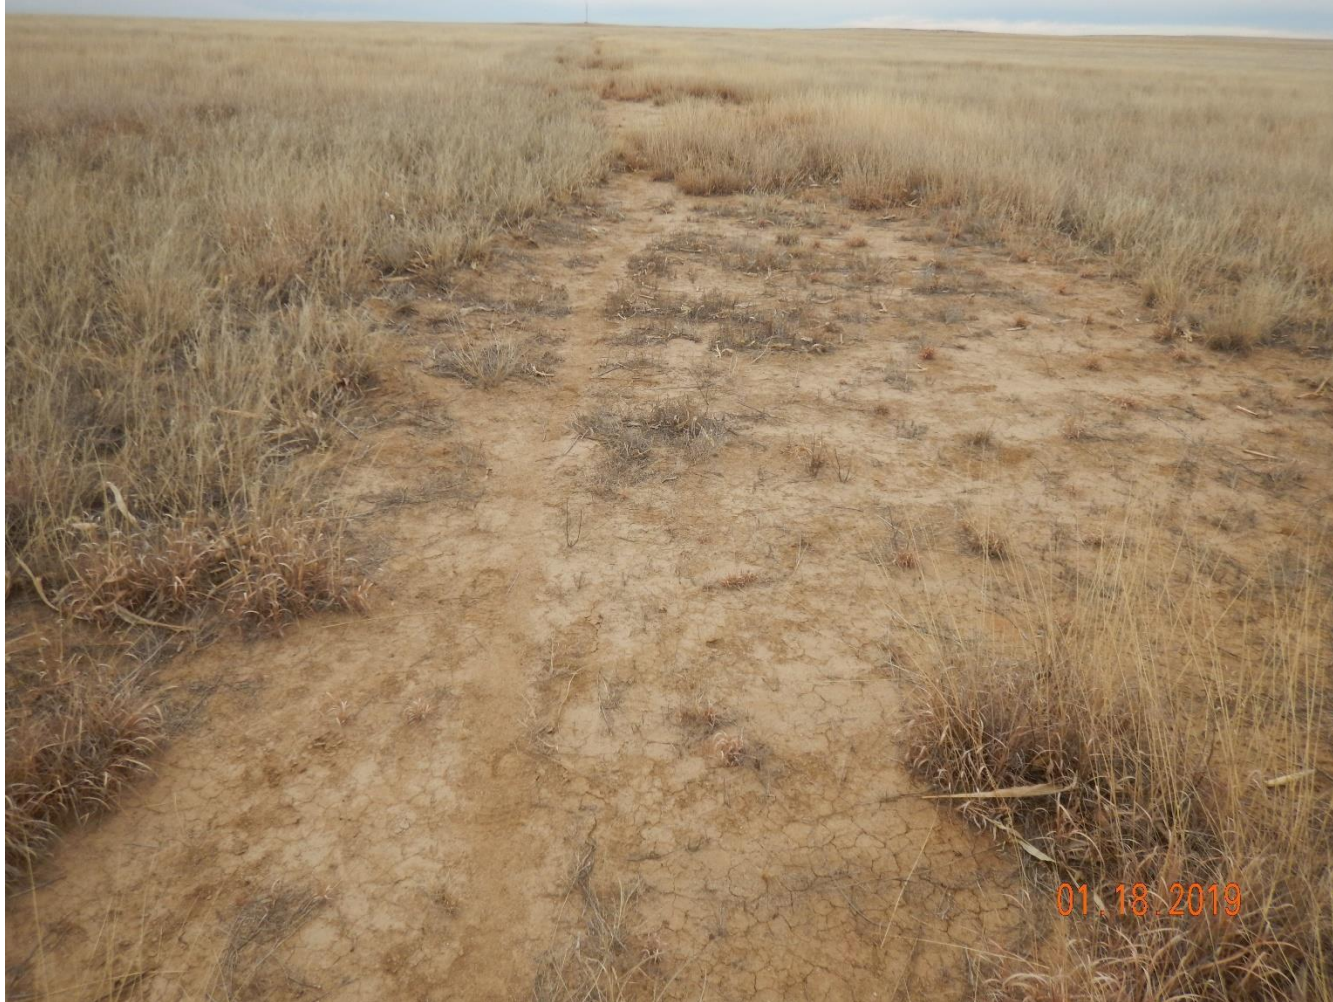
**Photo 15:** Photo taken from the north end of the access road, facing south. See comments under photo 16.
