# Construction and Storm Water Inspection

January 29, 2019

Operator: KERR MCGEE OIL & GAS ONSHORE LP – 47120

Location ID: 460006

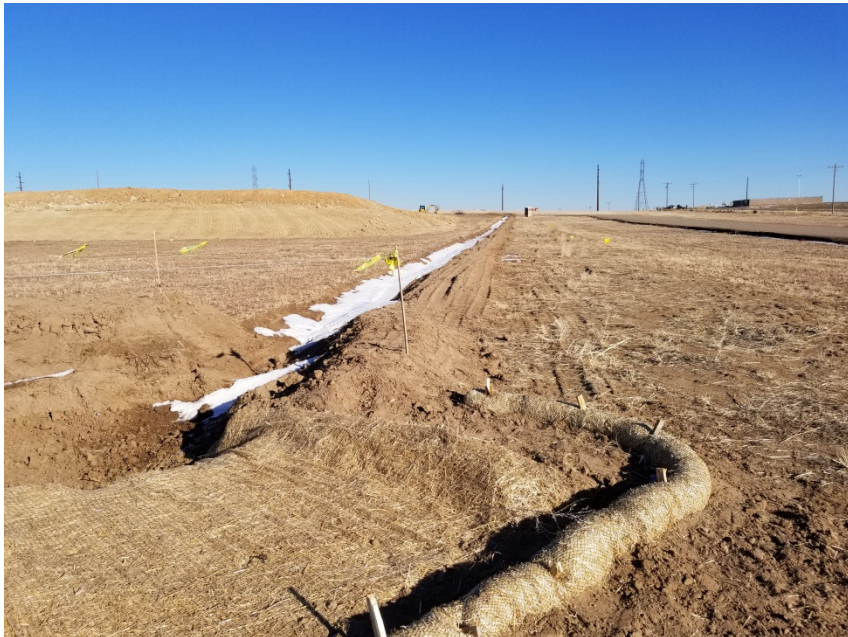
**Photo 1.** Photo taken from the southwestern location, facing East. Operator has installed a sediment trap with a temporarily stabilized outlet. A ditch and berm BMP has been installed around the perimeter of the location. BMPs in proper functioning condition at the time of this inspection.

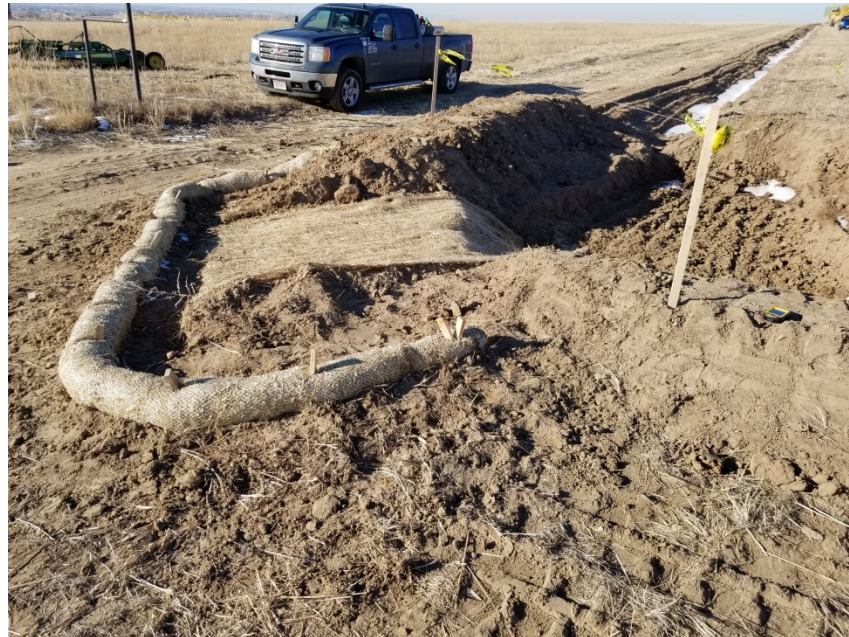
**Photo 2.** Photo taken from the southwestern location, facing North. See comments from Photo 1.

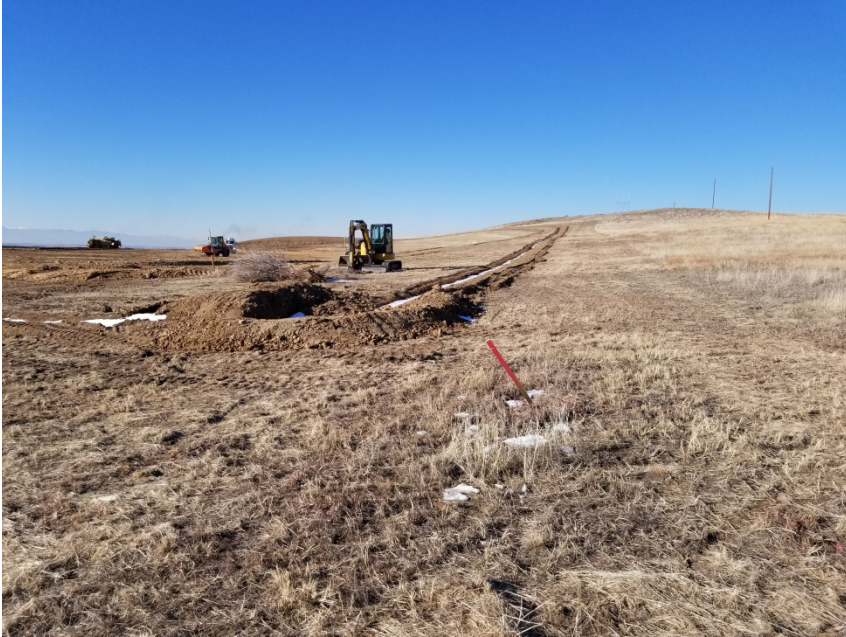
**Photo 3.** Photo taken from southeastern perimeter of the location, facing North. See comments from Photo 1.

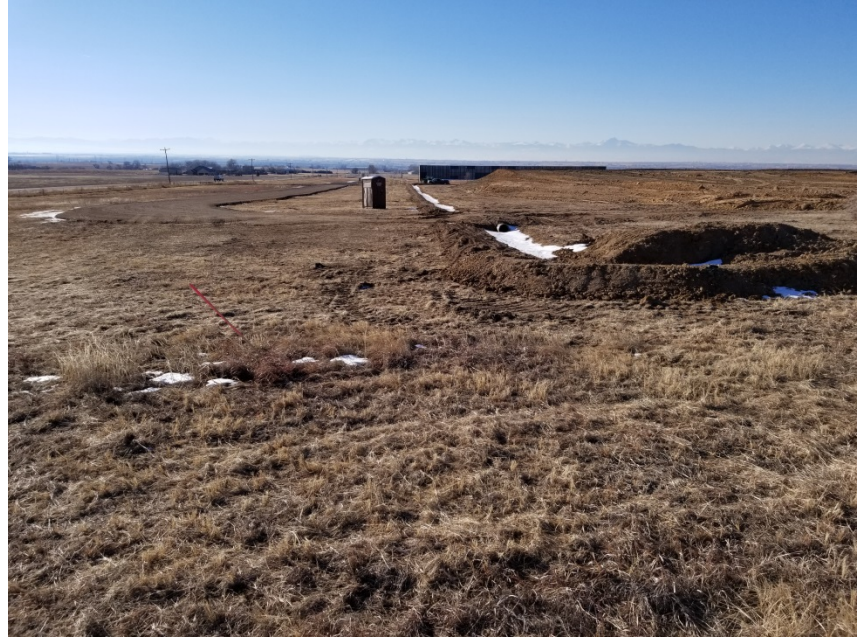
**Photo 4.** Photo taken from southeastern perimeter of the location, facing West. See comments from Photo 1.

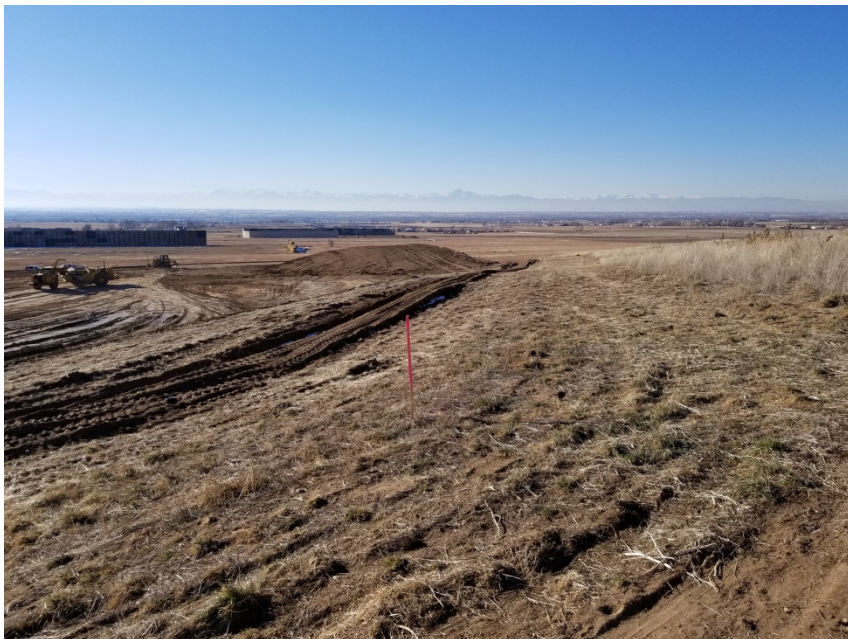
**Photo 5.** Photo taken from northeastern perimeter of the location, facing West. See comments from Photo 1.

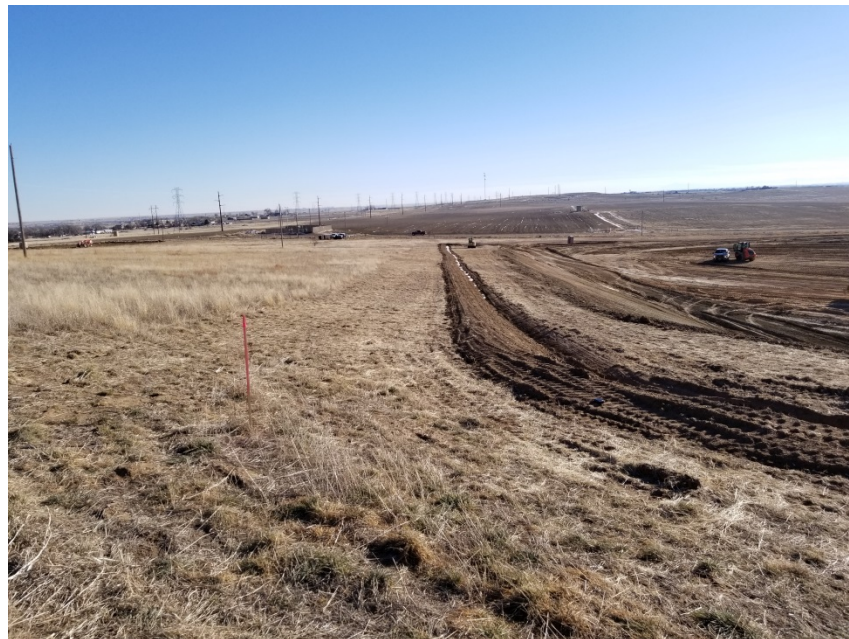
**Photo 6.** Photo taken from northeastern perimeter of the location, facing South. See comments from Photo 1.

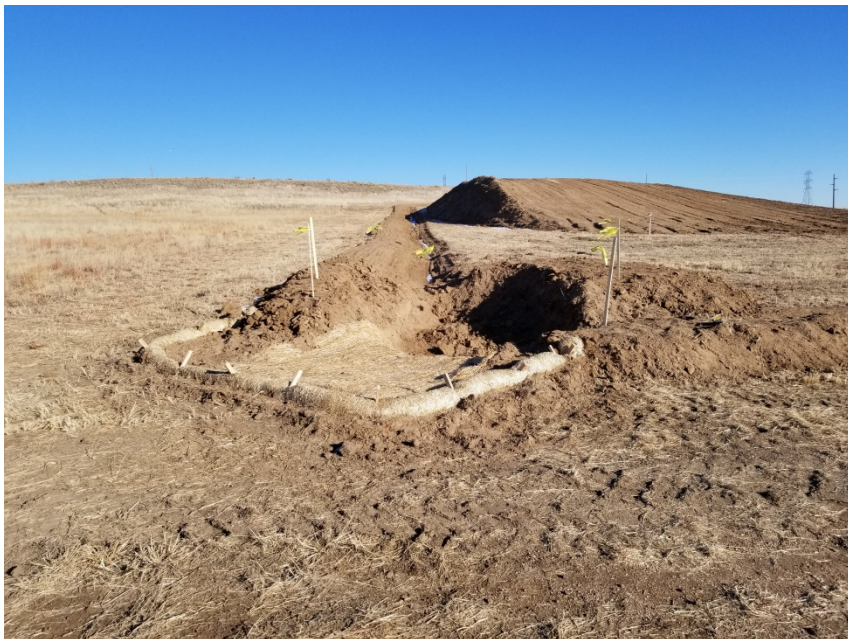
**Photo 7.** Photo taken from northwestern perimeter of the location, facing East. The topsoil stockpile being stored along the northern area has been temporarily stabilized with equipment tracking .

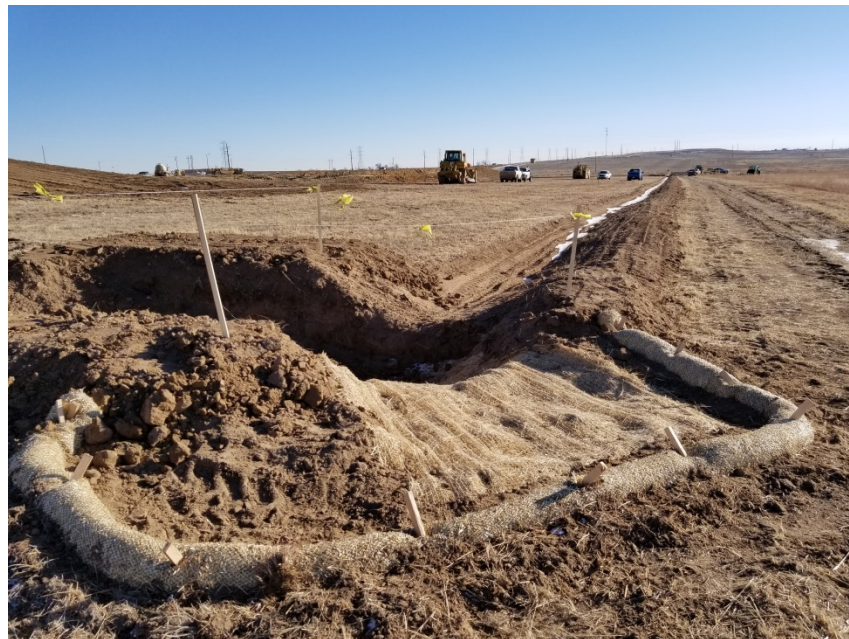
**Photo 8.** Photo taken from northwestern perimeter of the location, facing East. See comments from Photo 1.
